SUNRISE RESIDENCE INN

BUILDING CONDITION DUE DILIGENCE

July 3, 2024

Alachua County
Sunrise Residence Inn
Due Diligence Report
2105 & 2120 SW 14TH ST
Gainesville, FL 32608

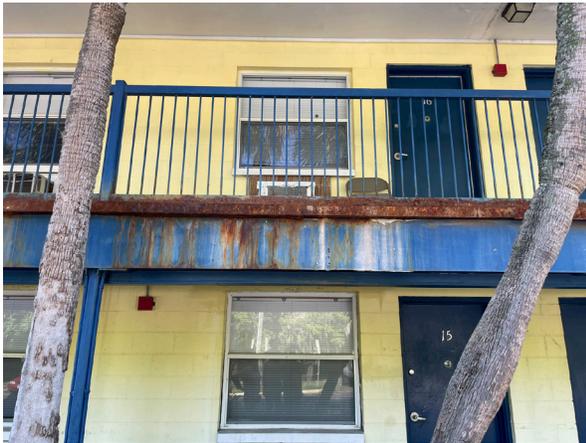
Figure 4 - Rusting Steel Structure NE Building

- 1) Condensation from A/C units on both buildings should be corrected. On the Northeast building, this has led to rusting on the steel structure, as well as cracking and movement in the concrete walkway and stairs. (See *photo/figure 4*) On the Southwest building, there appears to be cosmetic repairs to the steel structure. (Refer to the structural report for additional discussion of the walkway structure).

- 3) The condensation from the A/C units is not managed. There appears to be condensate drain piping in place that is intended to carrying the water away in a controlled fashion, however this seems to have mostly been abandoned, and currently the condensation is being collected in a bus pan under each AC unit. Many of the bus pans were full and overflowing during our visit. This creates a breeding environment for mosquitoes, algae, etc., and the pans overflow water onto the concrete walkways, which pools and runs over the edge of the second level walkways. On the second floor of this building, this has led to rusting on the steel structure of the walkway (Figures 4, 5, 6, & 7). See the structural report below for additional discussion of the second level walkways.

- 2) The soffit, ceilings inside the units, and the floors in the units all need minor maintenance.
- 3) The condensation of the A/C units needs to be addressed with proper drainage, currently the condensation is not managed well.

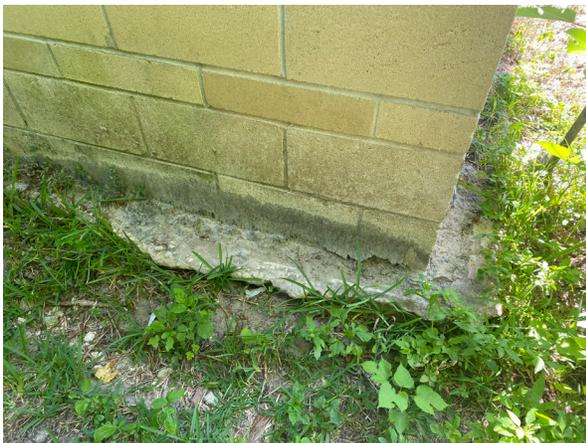
Figure 6 - Exposed Footing SW Building

- 3) The Southwest building exhibits a significant amount of erosion at grade on the southwest corner, and the west side, due to water falling from the roof. At the southwest corner of the building, the footing appears to be exposed. (See *photo/figure 6*) The recommendation would be to provide gutters and downspouts at both buildings. (See structural report for additional discussion of the southeast building foundation.)

- 4) The concrete walkway and stairs have cracking and rust on the supporting structure.
- 5) The SW building has part of the foundation exposed, this needs to be buried and proper water runoff through gutters and downspouts will prevent this in the future.

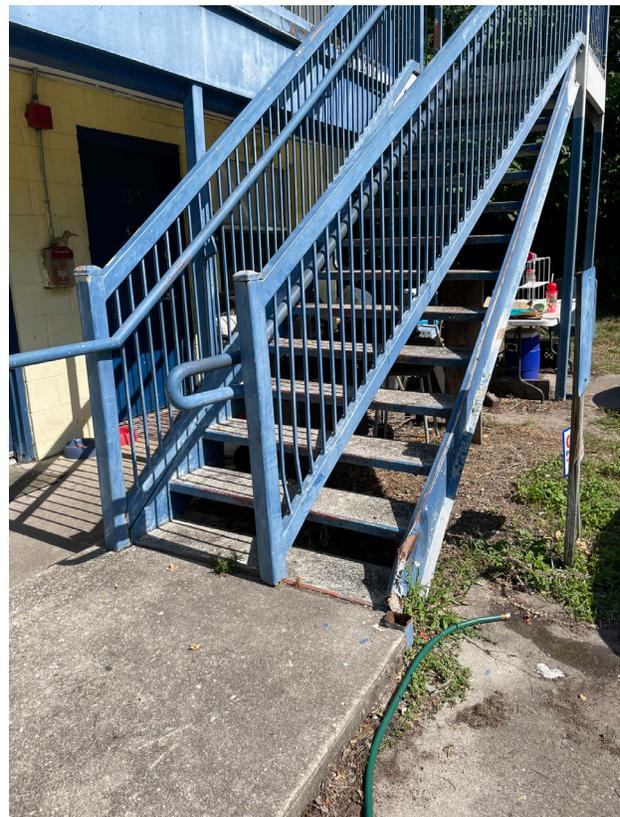
Figure 5 - Guard Rail SW Building

- 2) At the southwest building, the handrail/guardrail on the north stair is broken. It appears to have been hit by a vehicle, and is sheared off at the base. This is a significant hazard to life safety and should be corrected as soon as possible. (See *photo/figure 5*).

- 1) One of the guard rails on the North staircase is broken and loose. Our hypothesis is a combination of the steel structure rusting and possibly being hit by a vehicle from the parking lot. (See photo/figure 5)
- 2) The Southwest corner of the building possibly has an exposed part of the foundation. We believe erosion on this corner is from water falling from the roof. (See photo/figure 6) This should be corrected - see structural report for additional discussion of this item.
- 3) Each unit in this building has one single hung window and one exterior hollow metal door located on the same wall. Both the windows and doors are generally in good condition. (See photo/figure 16)
- 4) Apartments are heated and cooled by a single through-wall mounted AC unit located below the windows. (See photo/figure 17)

- 6) One of the stairs on the SW building has a broken guard rail that is a safety concern and needs to be replaced.
- 7) While repairs have been made to previous water staining on the interior ceilings, we recommend having these areas addressed by a professional contractor.

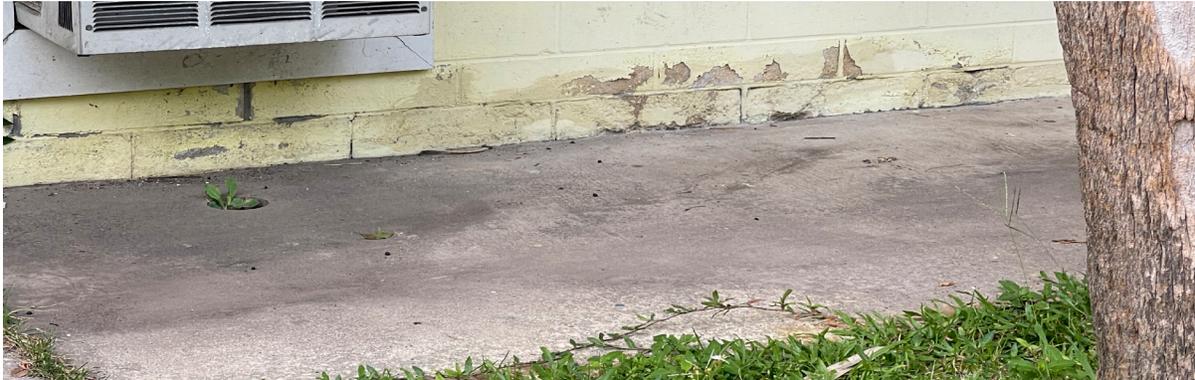
Figure 10 - Flood Damage in NE Building

- 7) It was noted that several units in the Northeast building have flooded. We observed repairs on these ground floor units, and were told that the water resulted from the stormwater system on the neighboring property. Water damage appears to have been corrected, although there is evidence of peeling exterior paint on the walls facing walkway specifically in front of these units.

- 4) It was reported that three units (Units 13, 15, & 17) on the ground floor flooded recently from a retention pond on the adjacent property. There are signs of this in paint discoloration at the base of the building. (See photo/figure 10). The interior of these units has been repaired and the flooring has been replaced, there is currently no remaining indication of water intrusion inside these units. One of the units was still partially demoed, and the floor/ceiling assembly was visible. This unit was being used as storage.

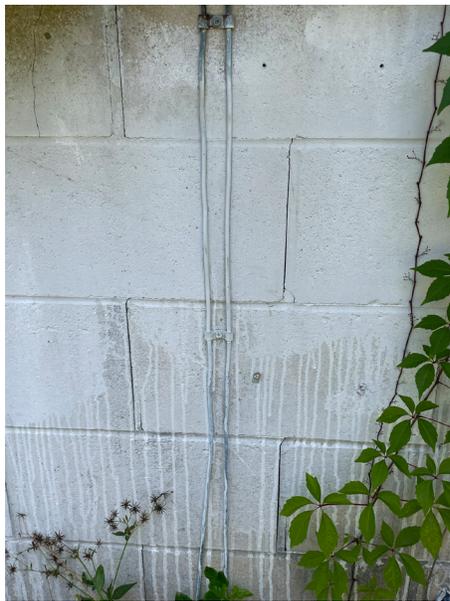
Figure 11 - Stair stepping in CMU walls

- 5) CMU walls are in generally good condition. Minor “stair step” cracking was observed but is generally within or below the expected range for a building this age. (See photo/figure 11) Minor remediation may include providing sealant at small cracks the next time the building is painted. See the structural report for additional comments on the CMU condition.
- 6) According to the Owner’s representative, the roof on this building is approximately 3 years old. The property appraiser’s website indicates a roof permit was pulled in 2016. Our observation is that the roof is in “good” to “very good” condition. Estimate this roof has another 12 to 15 years of service remaining. (See photo/figure 12 &13)

- 1) The structure of both building is generally good, including CMU bearing walls, roof, and the walls separating the units. Only minor cosmetic repairs for stair step cracks is needed.

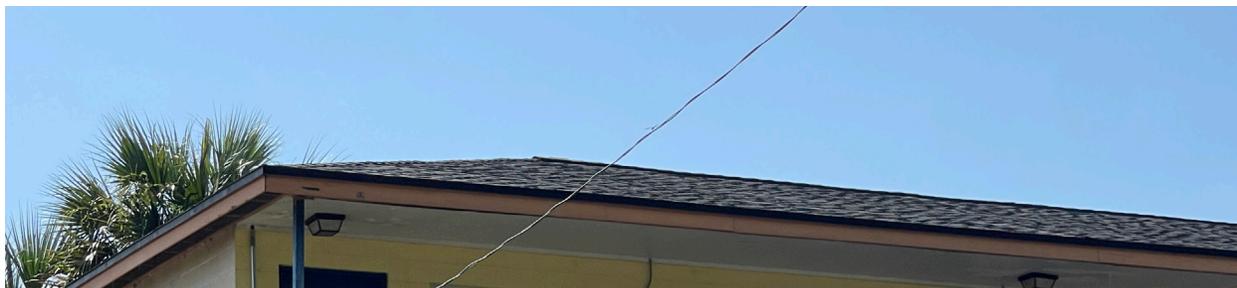
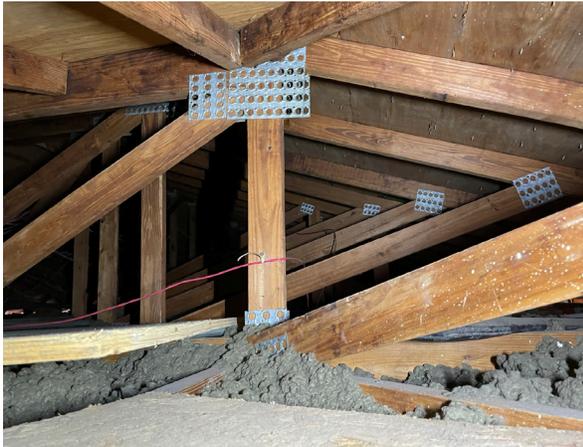
Figure 12 - Exterior Roof NE Building

Figure 13 - Interior Roof NE Building

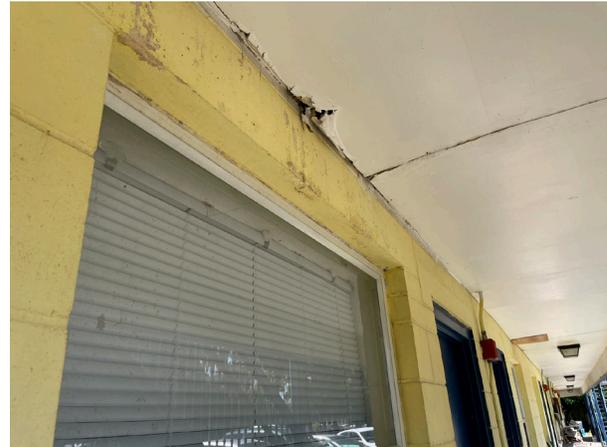
Figure 14 - Damaged soffit NE Building

- 7) Some maintenance is required on parts of the soffit. (See photo/figure 14)
- 8) Paint is peeling on the lintels above the windows on the first floor, but the lintels on the second floor do not have this occurring. We believe that that moisture is causing the paint to peel in these locations, due to the condensation from the A/C units on the second floor. (See photo/figure 15)

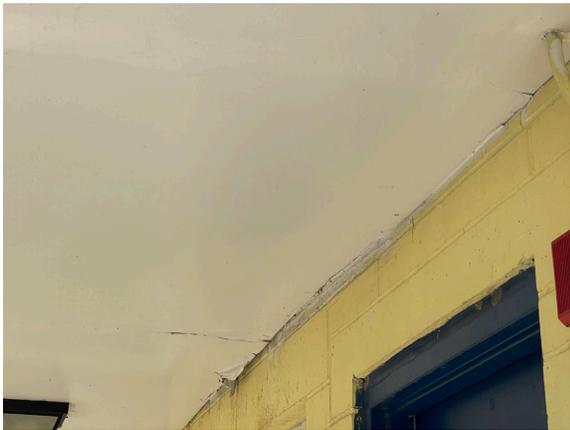
Figure 18 - Paint peeling on lintels above windows

- 7) The roof on this building is in “below average” condition. We estimate this roof has another 5 to 7 years of service remaining. (See photo/figure 20)
- 8) Some maintenance is required on parts of the soffit. (See photo/figure 21)
- 9) Paint is peeling on the lintels above the windows on the first floor, but the lintels on the second floor do not have this occurring. We believe that condensation moisture from the A/C units on the second floor is causing the paint to peel in these locations. (See photo/figure 18)

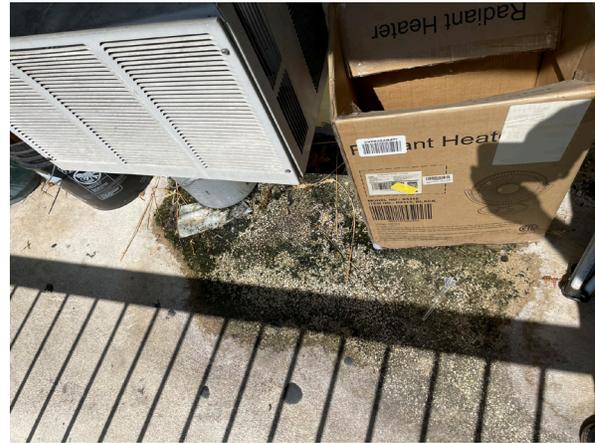
Figure 19 - AC unit condensation overflow SW building

- 5) The condensation from the A/C units is not managed. Condensate drains are in place, but seem to have been abandoned over the years, and currently the condensation is being collected in a bus pan under each window. When these are not emptied, they overflow, and the water runs out across the walkway. (See photos/figures 18 & 19) On this building, the rusting on the exterior walkway is not as prominent, but it also appears that there has been attempts to repair and clean the steel have been undertaken. As we did not perform any destructive observations on these areas, we cannot describe the full extent of potential structural issues with the walkway. See structural report for additional discussion.

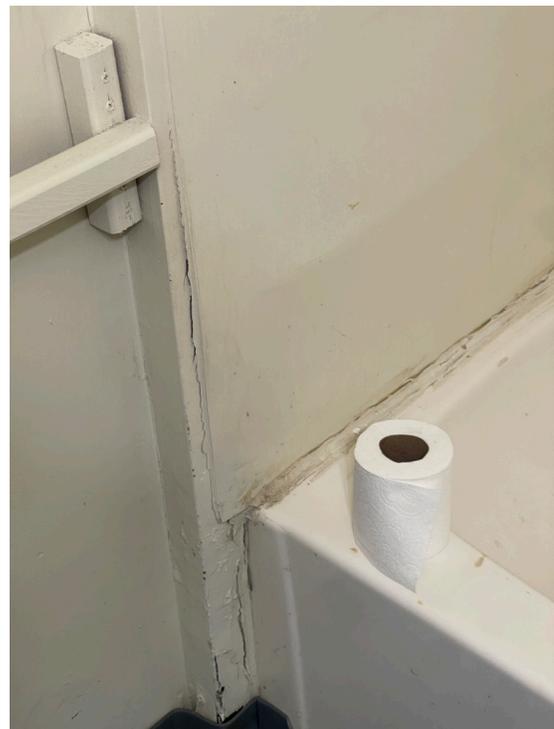
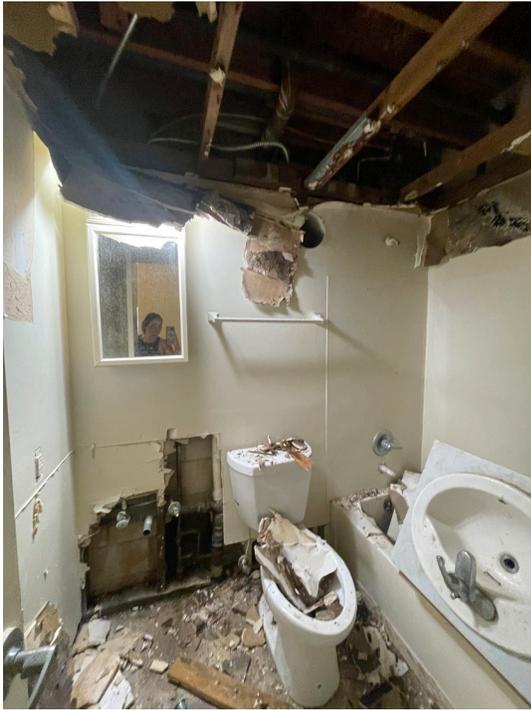
- 13) The bathroom and tub/shower: some are in good condition, and some need maintenance. Primarily in the sealant around the tub/shower. *(See photo/figure 29 & 30)*

Figure 29 - Close up bathroom tub

Figure 30 - Tore up bathroom in NE building

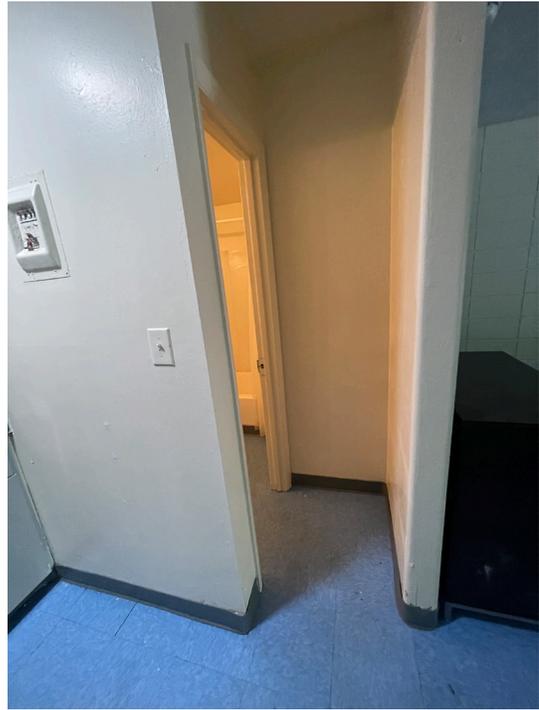
Figure 31 - Narrow bathroom door

- 2) Interior layout of the units includes doorways into the bathroom and kitchen that are very narrow, at 24" (*see typical unit plan.*) While the code minimum door width of 32" does not apply to Group R2 Residential units (*FBC-B Section 1010.1.1*), 24" is very narrow, and it would be advisable to enlarge these openings.

- 14) Bathroom door (24") and the other thresholds in the units are small. *(See photo/figure 31)*
- 15) There is a vent fan in both the kitchen and the bathroom. These exhaust through the wall to the rear of the building.

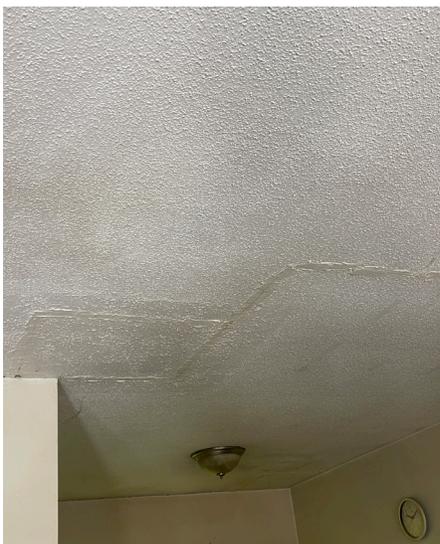
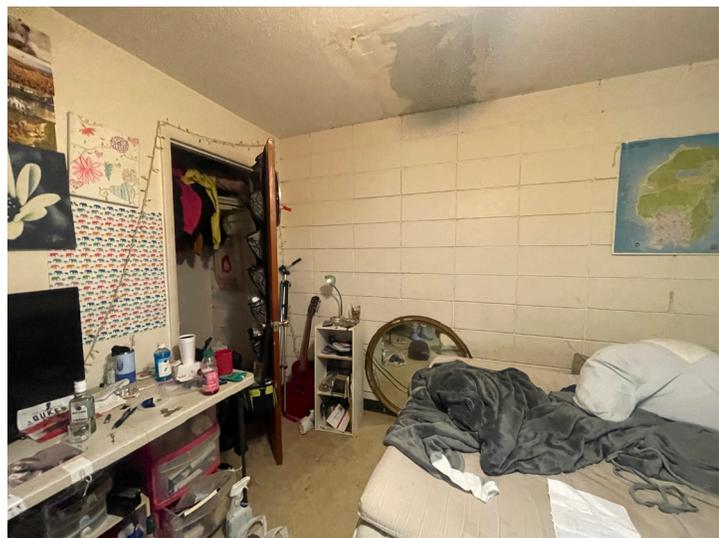
- 1) The 2nd floor in this building has one 2-bedroom unit that occupies the area of two regular units. This apartment includes windows on the rear of the building provide emergency escape and rescue from the second bedroom. There is evidence of repair to water damage in the ceiling. According to the owner's representative, there was a pipe that broke in the attic over this unit, but this was repaired. (See photos/figures 32 & 33)

Figure 32 - Repaired water leak above dining room in larger unit SW building

Figure 33 - Repaired water leak above second bedroom in larger unit SW building

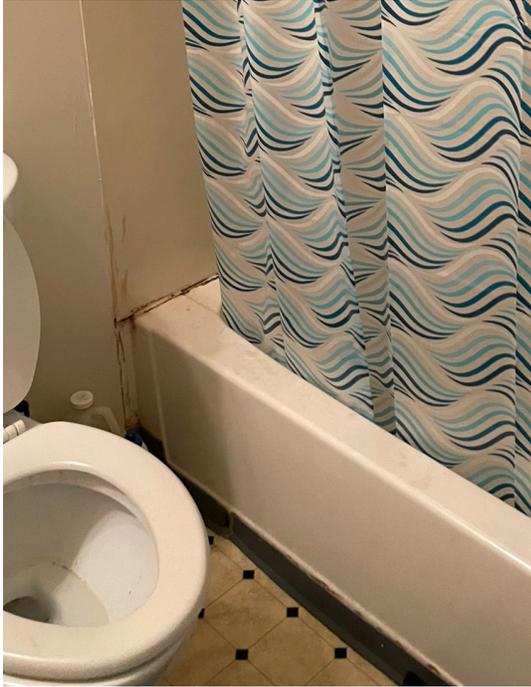
Figure 36 - Typical tub condition

- 5) Ceilings are in generally fair condition. We observed signs of repairs and patches, but no active water issues were observed.
- 6) Some bathroom tub/showers are in good condition, and some need maintenance. Primarily in the sealant around the tub/shower. (See photo/figure 36)
