RE: Sunrise Residence Inn Due Diligence Report
CSEI Project No. 24038

Campbell Spellicy Engineering, Inc. (CSEI) was commissioned to perform a due diligence investigation, survey, and report of the Sunrise Residence Inn property located at 2105 SW 14th St. Gainesville, FL. The objective of this assessment was to evaluate the current condition of the buildings, with a focus on identifying existing Code deficiencies and providing recommendations based on safety and best practices to provide Alachua County with guidance as they look to purchase this property for conversion for use as transient housing.

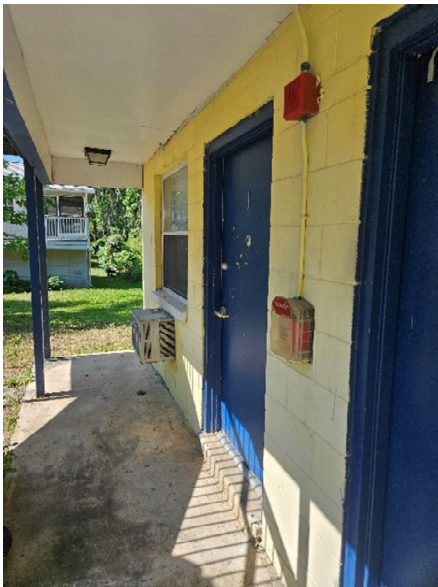
The interior lighting of the units was found to be adequate. The units had standard construction ceiling-mounted residential fixtures, all of which were functioning properly, with no missing or faulty covers. No additional lighting was required for any interior rooms. However, the exterior lighting presented several concerns. The existing bulb-style fixtures appeared outdated and were not vandal-resistant. Due to the daylight conditions during the survey, a full evaluation of exterior lighting functionality was not possible. However, it was evident that there were no parking lot pole lights, and the lighting in the parking lot and exterior stairways was insufficient for safety and security.

Figure 1: Typical exterior lighting fixture and fire alarm peripheral devices.

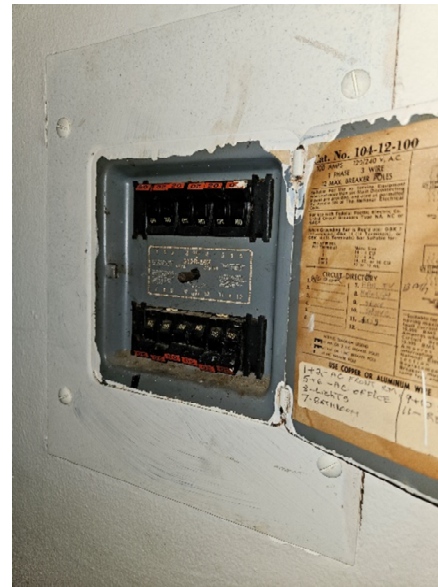
Figure 2: Typical unit electrical panel.

The electrical system for both buildings is identified as 120/240V single phase. Two parallel overhead conductors feed into the exterior of each building through two safety disconnects. Each building has a newer type of electrical meter, but there are no individual meters for tenants. The main distribution panels showed no signs of corrosion, overheating, or poor connections. Each typical unit has a 100A, 120/240V electrical panel located in the kitchenette area. These panels do not have main circuit breakers, indicating that main overcurrent protection is provided upstream at the main panel. The interior panels are equipped with outdated breakers, raising concerns due to the unavailability of replacement parts. Some panels were missing covers, although no exposed wiring was observed. It is important to note that old circuit breakers have a significantly higher failure rate, with some failing to trip between 25% to 65% of the time under fault conditions, posing a considerable fire hazard. We strongly recommend replacing all interior electrical panels.

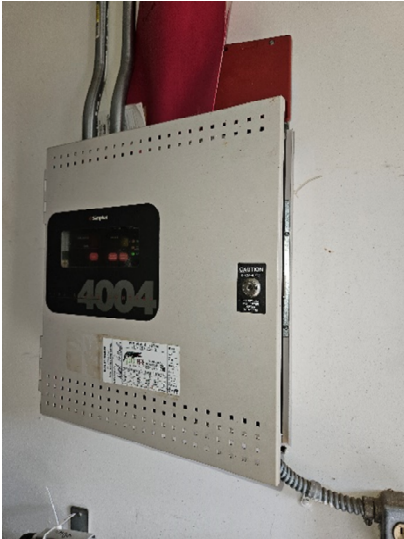
The property is equipped with an outdated 4004 fire alarm control panel. The functionality of individual devices could not be confirmed, but the system's age and the unavailability of replacement parts warrant concern. The design and layout of fire alarm devices appeared code-compliant, with pull stations, smoke detectors, and notification devices appropriately located. We recommend replacing the outdated fire alarm control panel and devices, potentially reusing existing pathways for the new system. No records of regular maintenance or recent inspections for the fire alarm system were found.

Figure 3: Cover of obsolete Fire Alarm Control Panel.

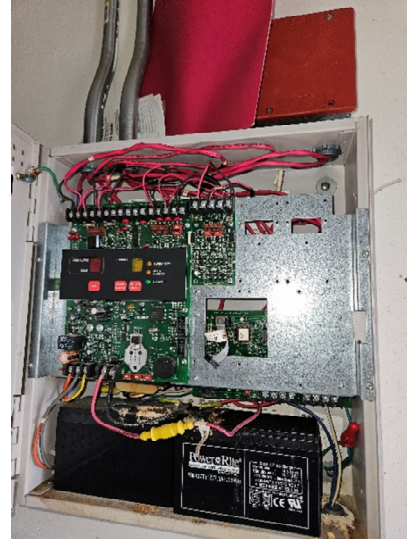
Figure 4: Interior of obsolete Fire Alarm Control Panel.

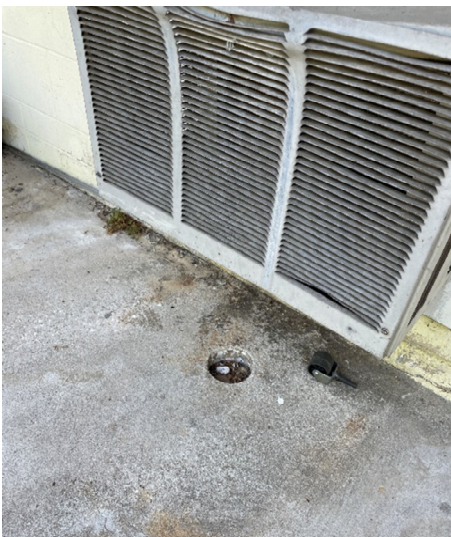
Each unit is conditioned by a packaged through-the-wall air conditioner (PTAC) located on the front wall near the entry door. During our site survey, we observed that some of the units were damaged and most of them were in poor condition. While the functionality of each unit was not fully tested, these air conditioners were observed to be nearing end-of-life. To reduce future maintenance issues, make provisions for condensate drainage, and improve occupant comfort, we recommend replacing each of the air conditioners with new.

Figure 2: Damaged air conditioner and condensate dry well

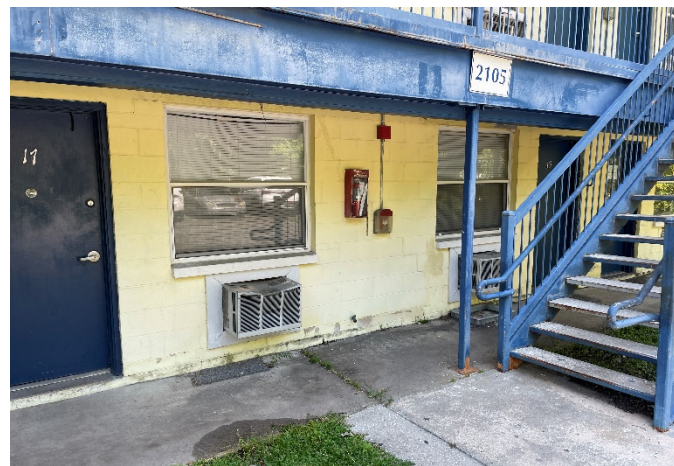
Figure 3: Damaged air conditioner

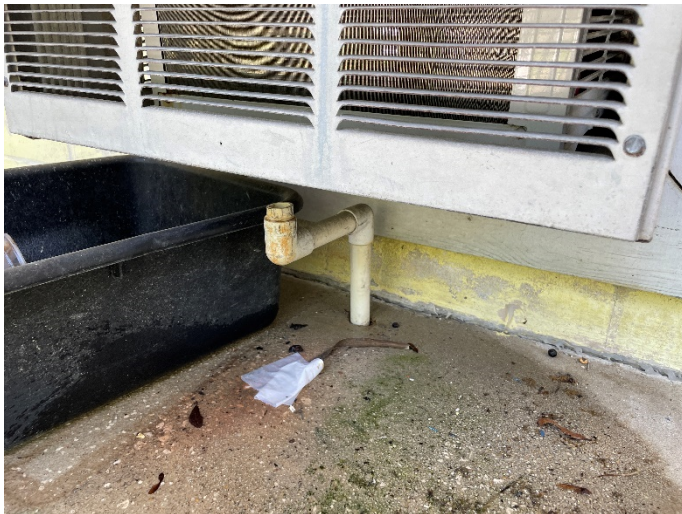
When the buildings were first constructed, the wall air conditioners were provided with condensate piping from the drain pan. On the first floor, the piping was routed to a dry well in the concrete walkway. On the second floor, the piping was routed through the balcony, down the balcony supports, and drained to grade. Since then, the piping has been disconnected from each of the air conditioners, allowing the drain pan to overflow onto the concrete walkway. This has led to algae growth on the walkway and could pose a potential slip hazard without correction. The condensate overflow has also caused corrosion on the steel structural components of the second-floor balcony. We recommend providing new condensate piping and restoring the original drainage path for each of the air conditioners.

Figure 3: Disconnected condensate drain

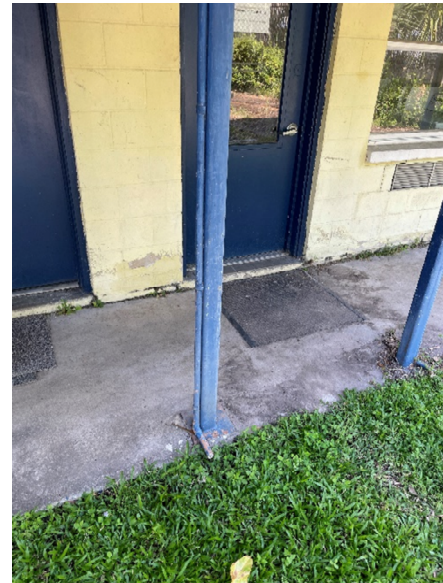
Figure 5: Condensate piping routed down support to grade

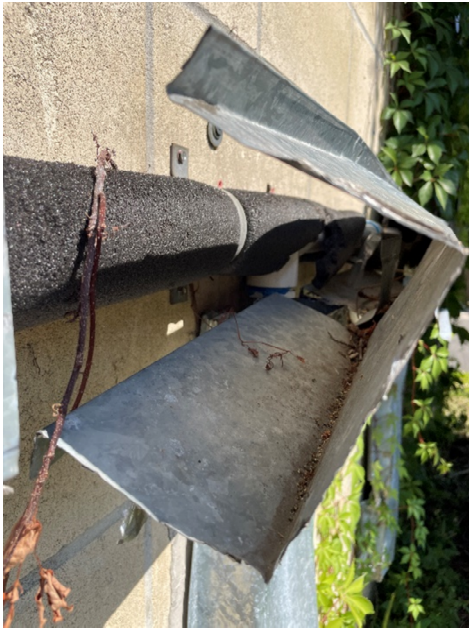
The domestic cold-water piping for the east building is surface mounted on the outside of the east exterior wall. The piping is insulated and protected by a metal shroud. In various locations the shroud is damaged, separating from the building, or experiencing corrosion. Where the shroud is pulling away from the building, light is contacting the piping insulation which is causing degradation of the insulation material. To prevent future damage and reduce the amount of exposed piping, we recommend removing the surface mounted piping and shroud back to the main piping at the northeast corner of the building, routing the piping underground along the north side of the building, and rising along the exterior wall to reconnect to each penetration. At a minimum, the damaged shroud and piping insulation should be repaired or replaced.

Figure 8: Shroud removed from the building

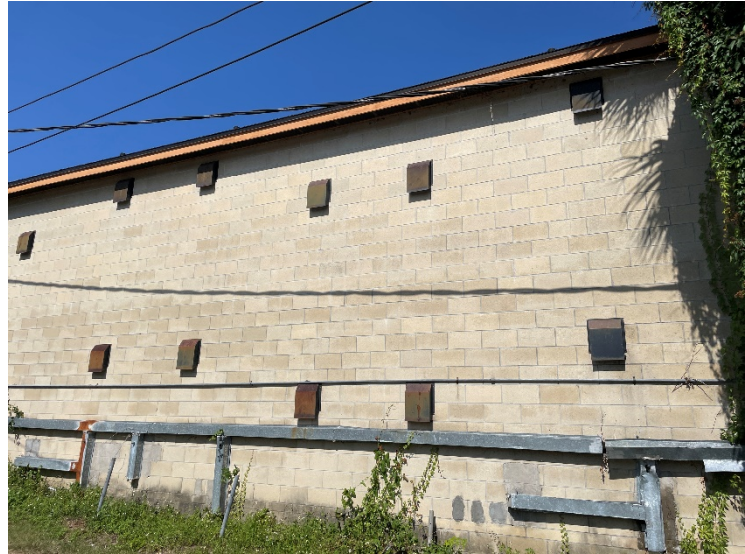
Figure 6: Surface mounted piping on building exterior

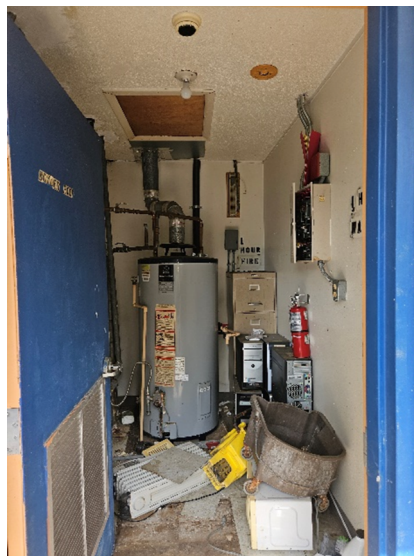
The hot water piping from the water heaters is uninsulated within the boiler room. Per FBC Energy Conservation R403.5.3, all hot water piping larger than $\frac{3}{4}$ " or serving more than one dwelling unit must be provided with insulation having a minimum thermal resistance of R-3. Given the proposed change in occupancy, adding this insulation to meet the current Code will be required.

Figure 7: Hot water piping in boiler room
