RE: Due Diligence Report – Burkhardt Sales & Service

As part of the County's due diligence efforts to evaluate the conditions of the existing commercial industrial warehouse building (Burkhardt Sales & Service) located at 6125 NW 18<sup>th</sup> Drive, Gainesville, FL 32653, Paul Stresing Associates (PSA) was tasked with conducting an inspection of the facility to evaluate its condition prior to entering into a full purchase agreement to its purchase. On May 30, 2024, I was accompanied by KPI Engineering (KPI) where we walked the roof and interior of the facility with Mr. Matt Fultz of the Alachua County Facilities Department and Mr. Daniel Burkhardt, representing the seller where we gained access to the site and buildings to begin our evaluation efforts.

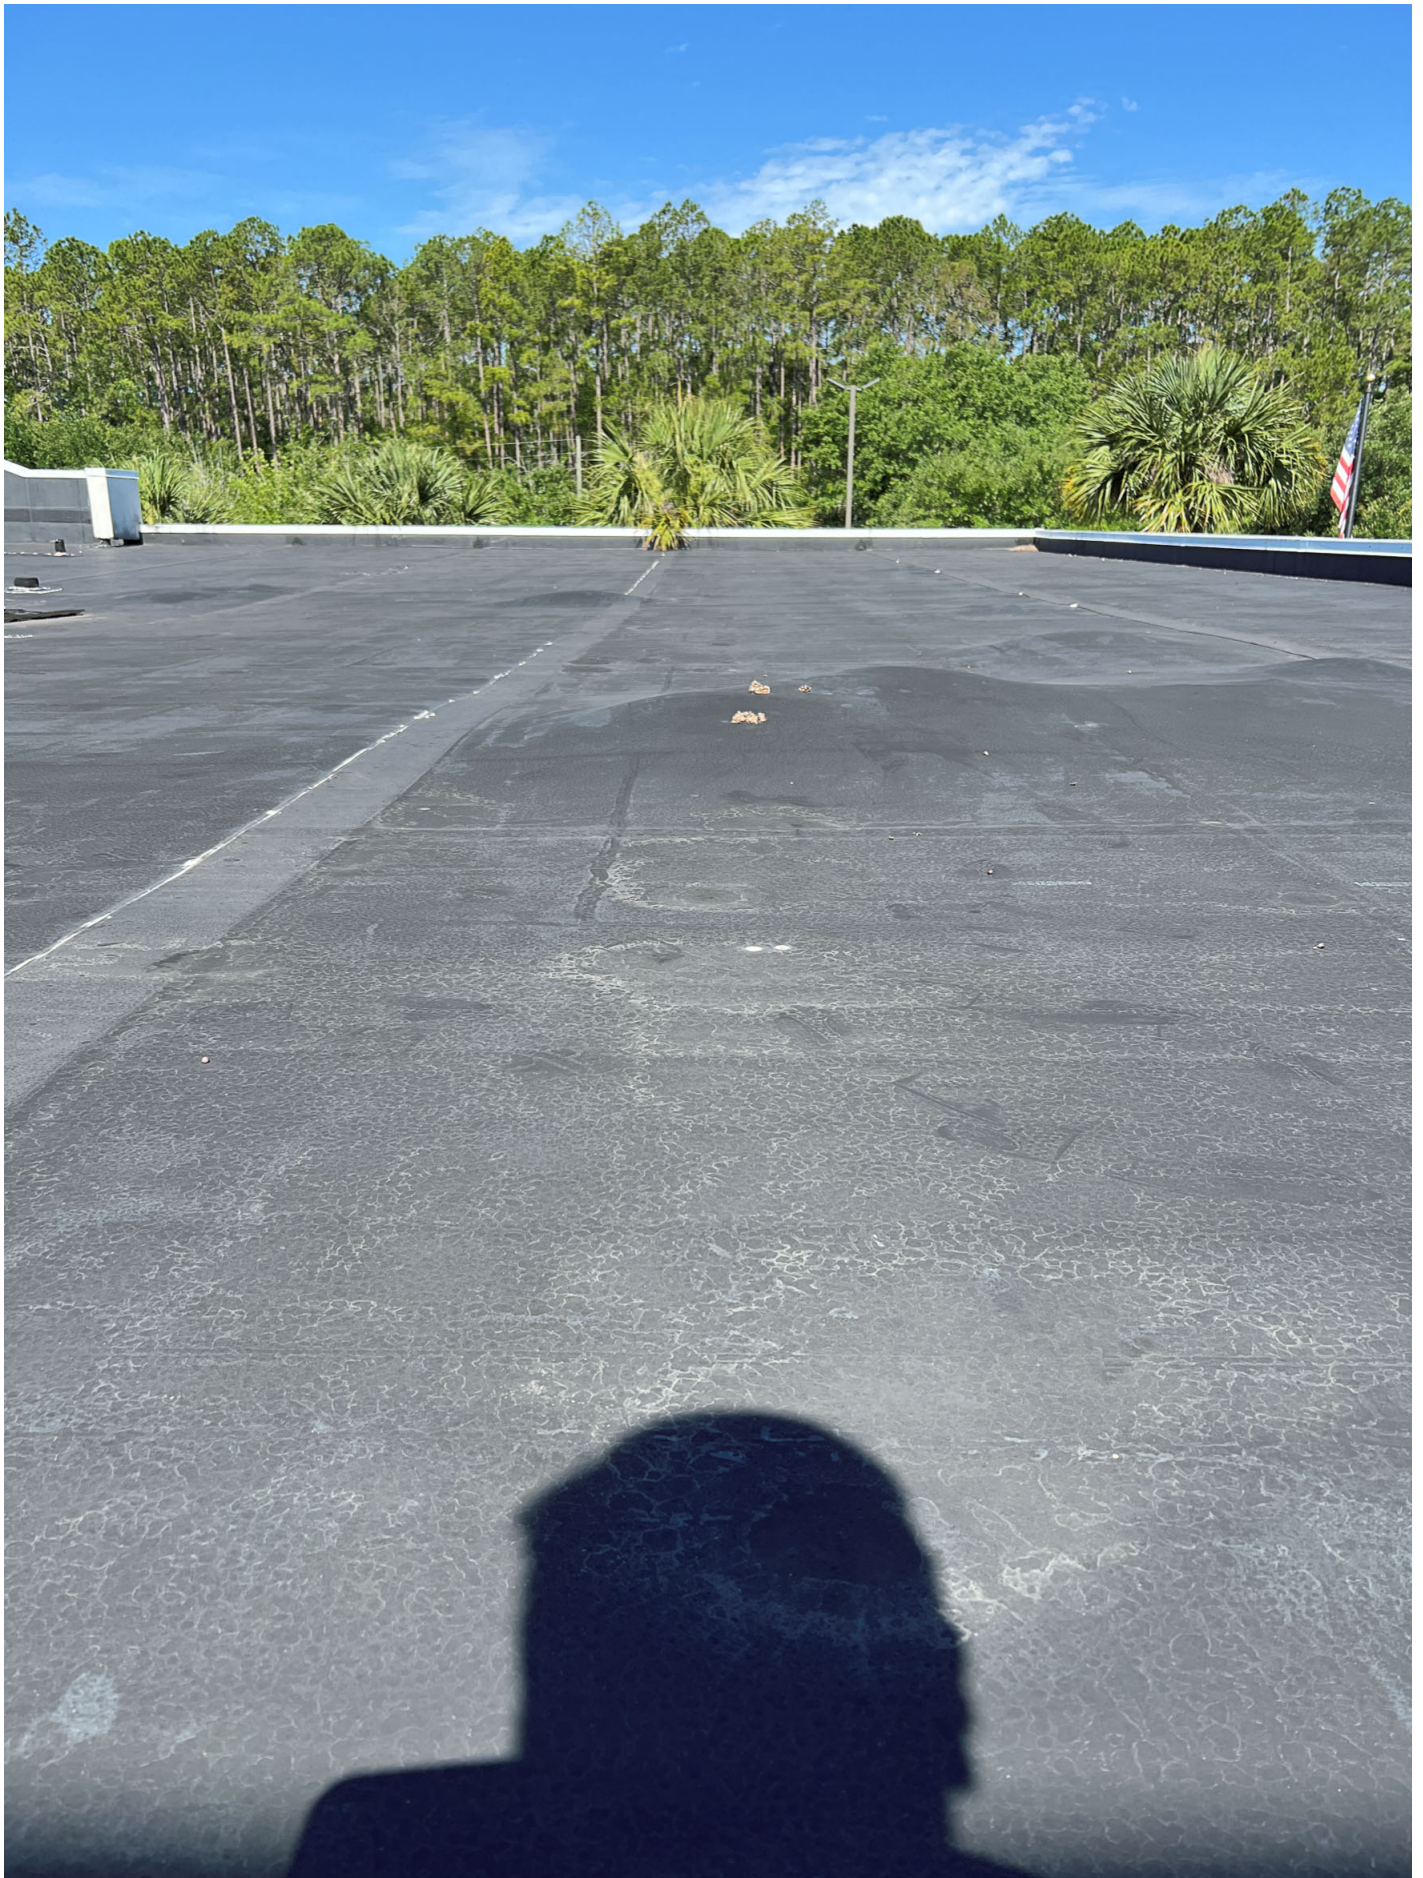
temperatures, climate regions of high temperatures or high precipitation. Over time the higher temperatures can cause the rubber to shrink and crack which can lead to seam separation and compromise. With its black color the EPDM membrane is not in any way energy efficient, and its black color makes the roof highly absorptive of heat from the sun, adding extra demand on the air conditioning system. The typical performance expectation and warranty is at its best, 20 years, and its performance warranty consisting of numerous special conditions. The 2000 main building means that the EPDM' is 24 years old and shows obvious signs of previous membrane and seam repairs. Walking the roof, a number of large vapor bladders were encountered, many of them being as large as a watermelon or football. These bladders or balloon type deformations are typically due to entrapped moisture that vaporizes during the heat of the day causing a shrink / expansion cycling of the single-ply membrane. Refer to the attached photographic documentation.

Open roof area with large vapor bladders scattered throughout the roof deck

asphalt paved areas and replacement of the two-roof top A/C units this could be done to minimize daily operation inconvenience once the facility is fully operational. The re-roofing efforts can occur at this time or with substantial patching and repairs the building can gain a little more time out of the 24-year-old roof, but it needs to be pointed out the roof has exceeded any roof warranty issued at the time its installation.

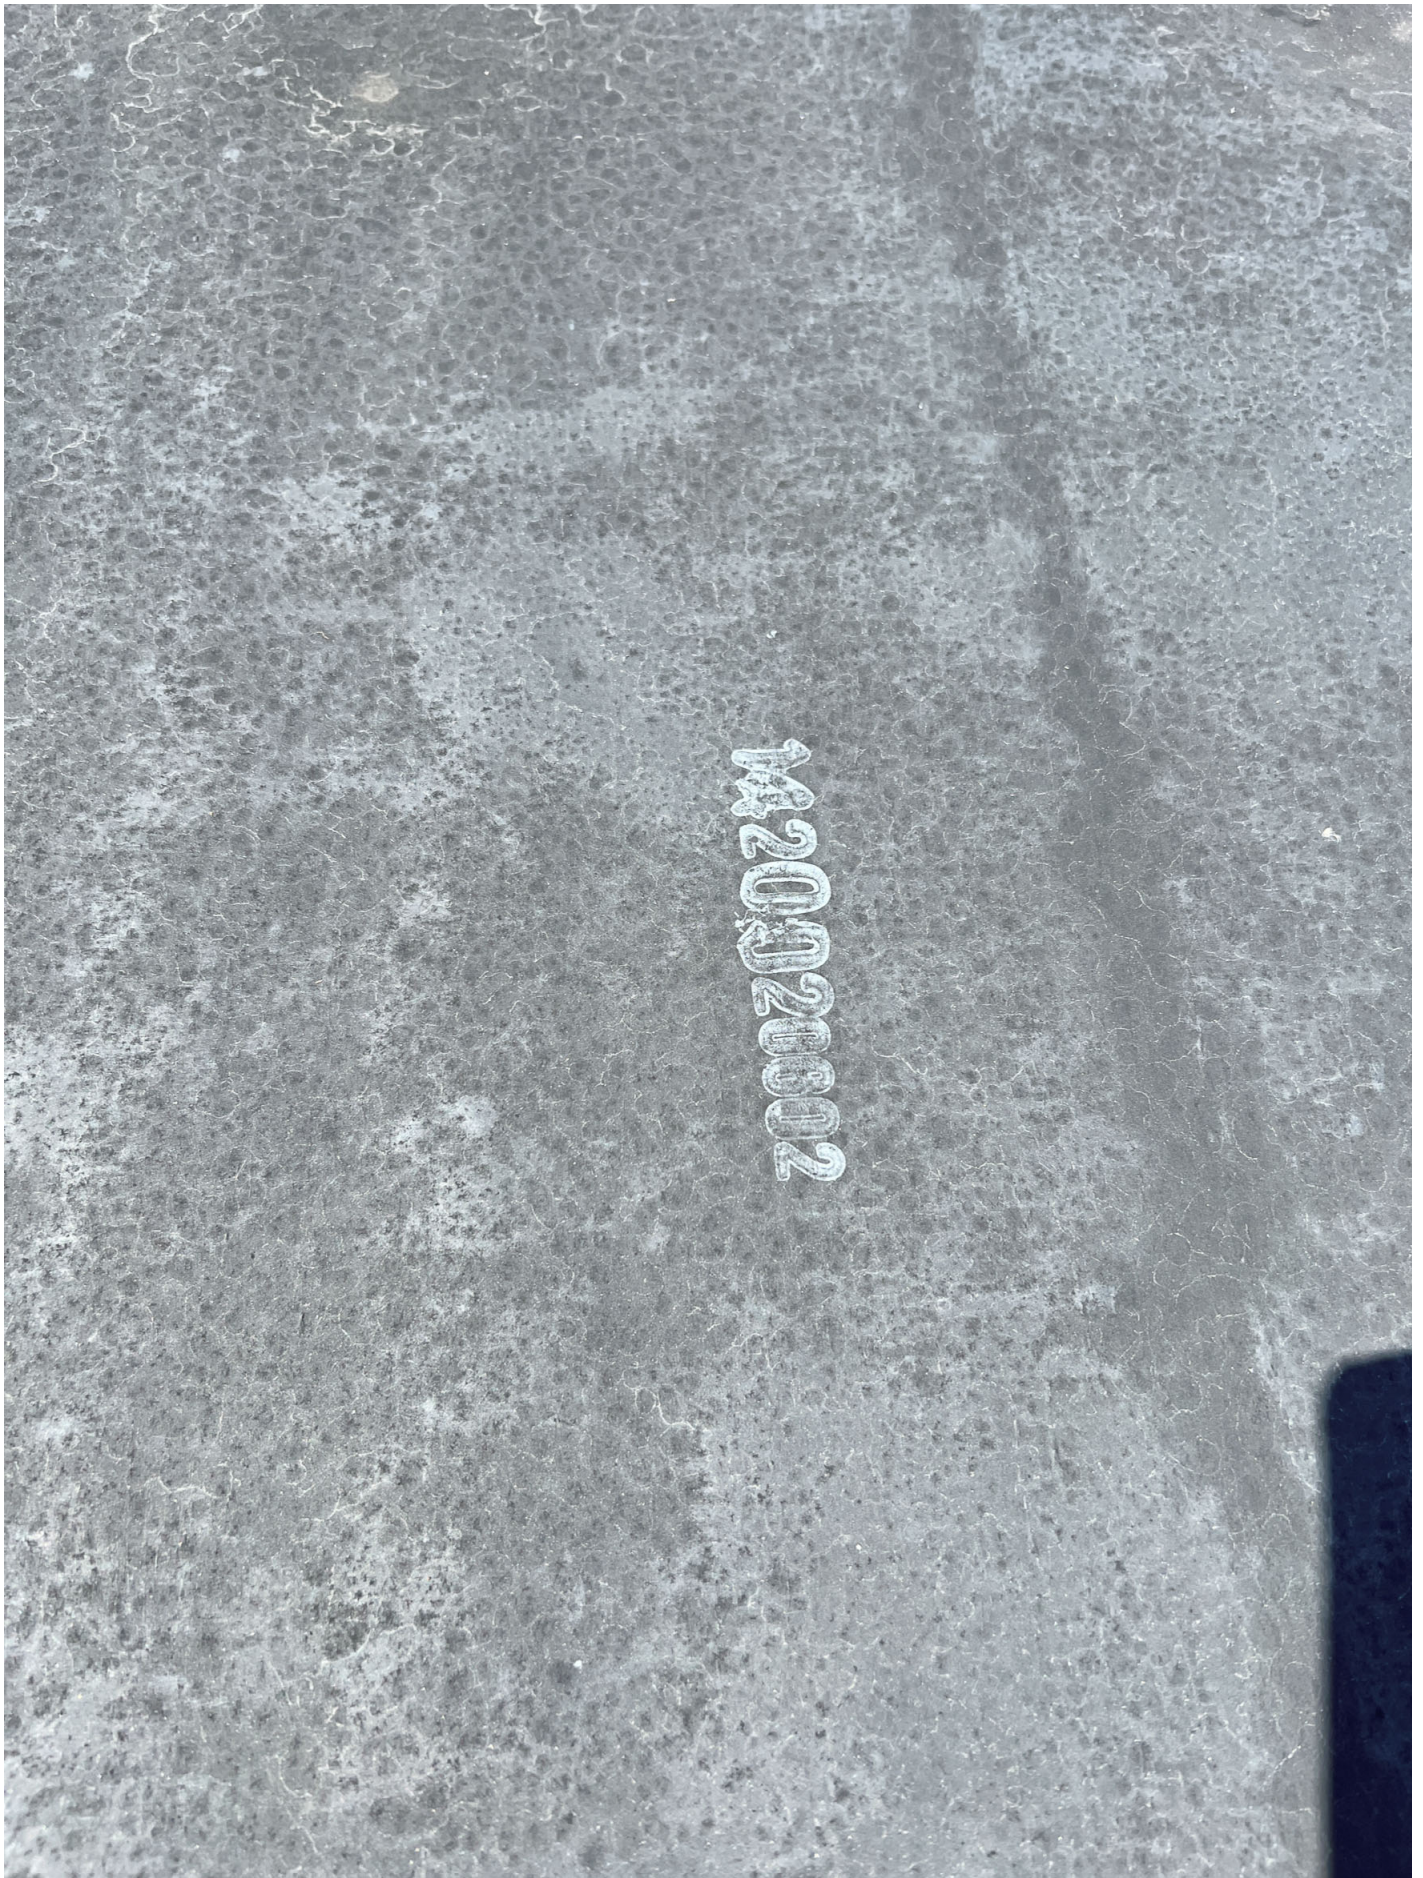
Admin roof area EPDM roof membrane breaking down from intense UV exposure

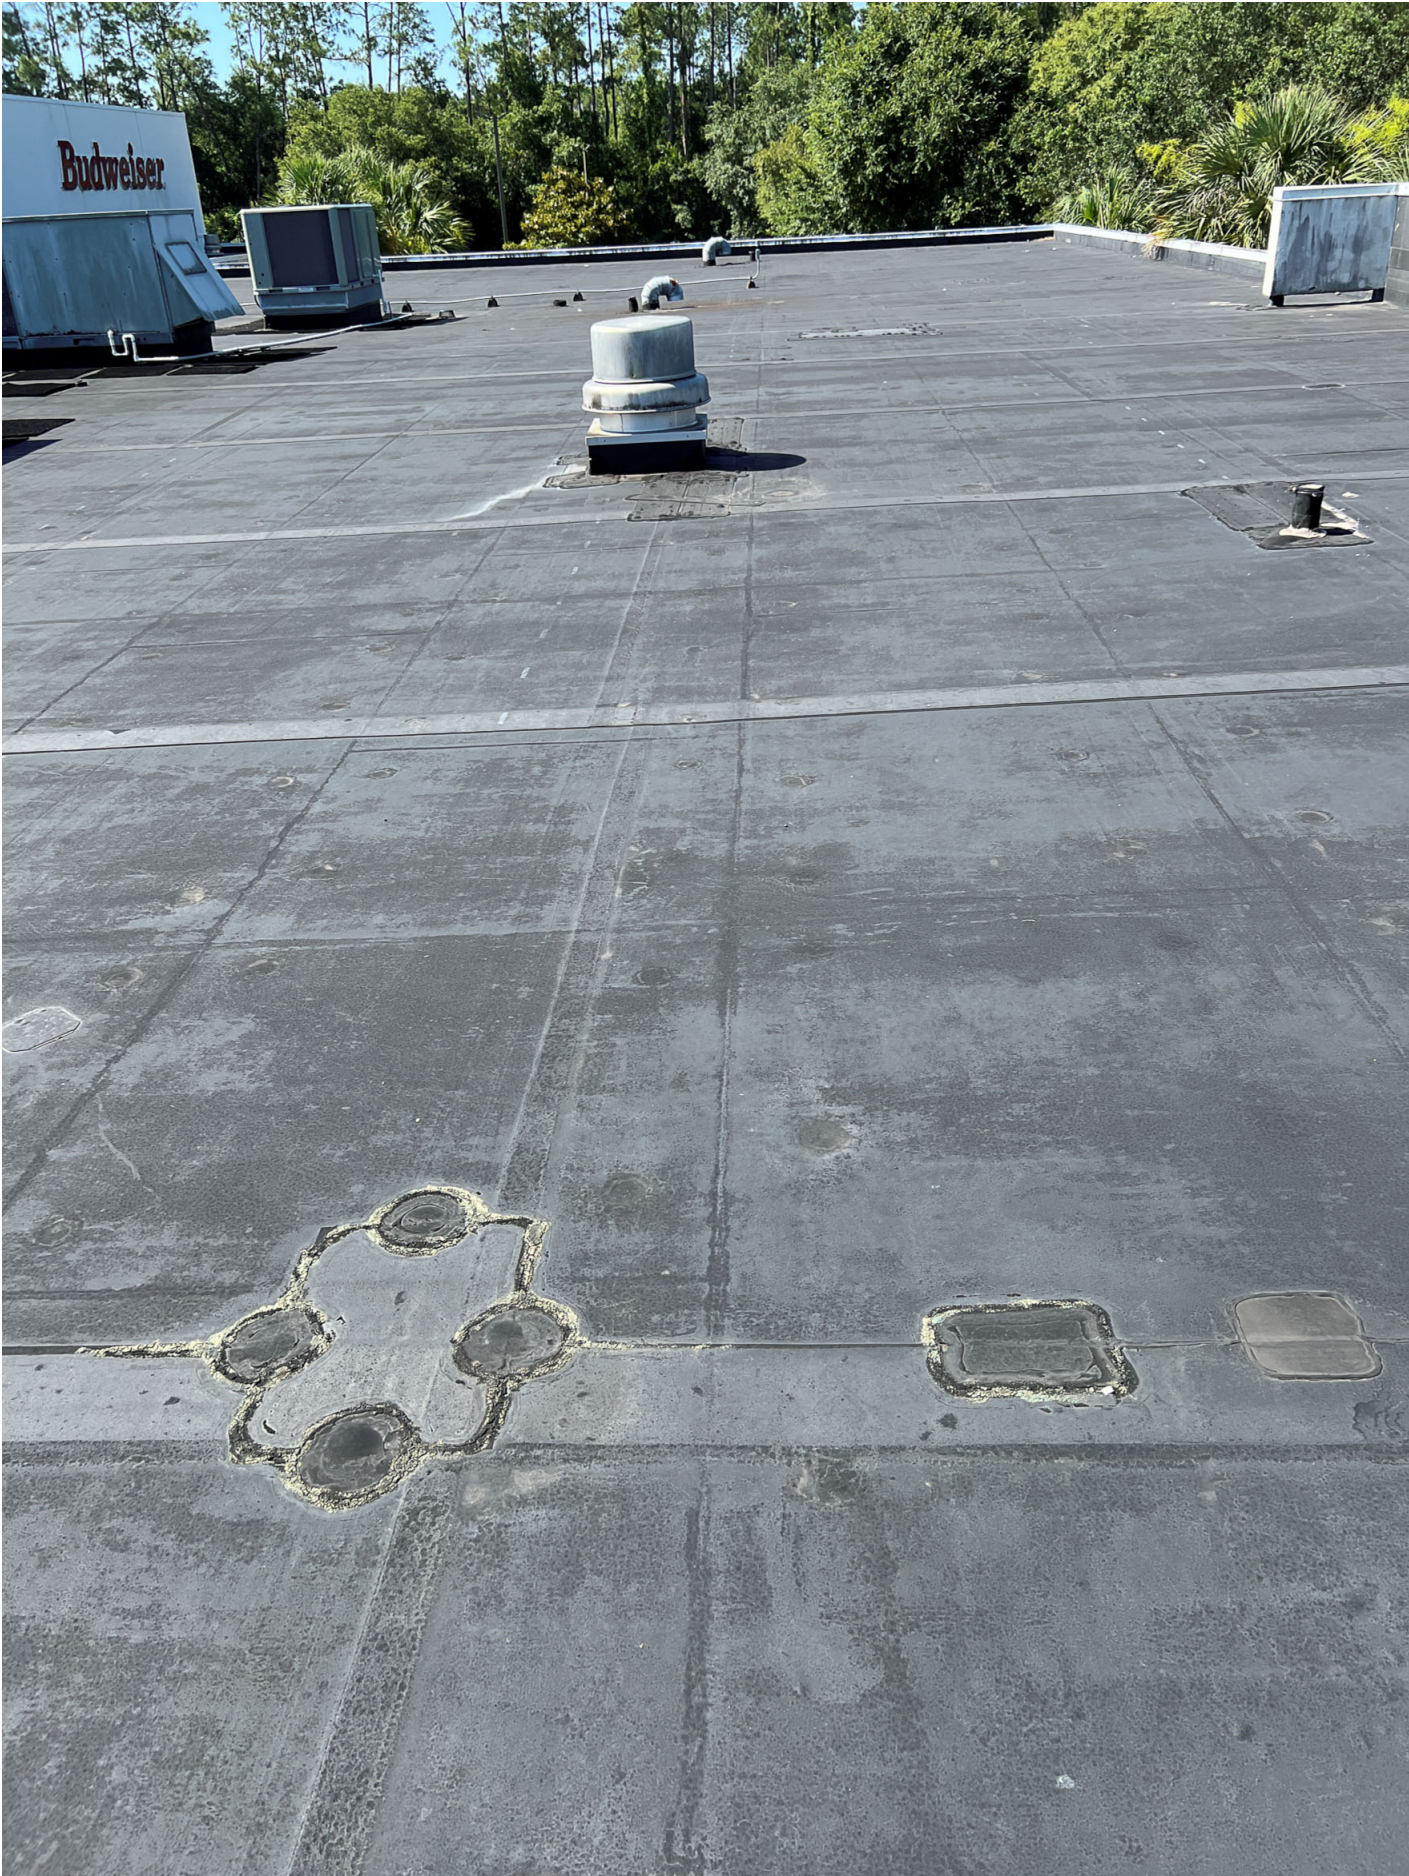
Lower Admin roof area previous patching

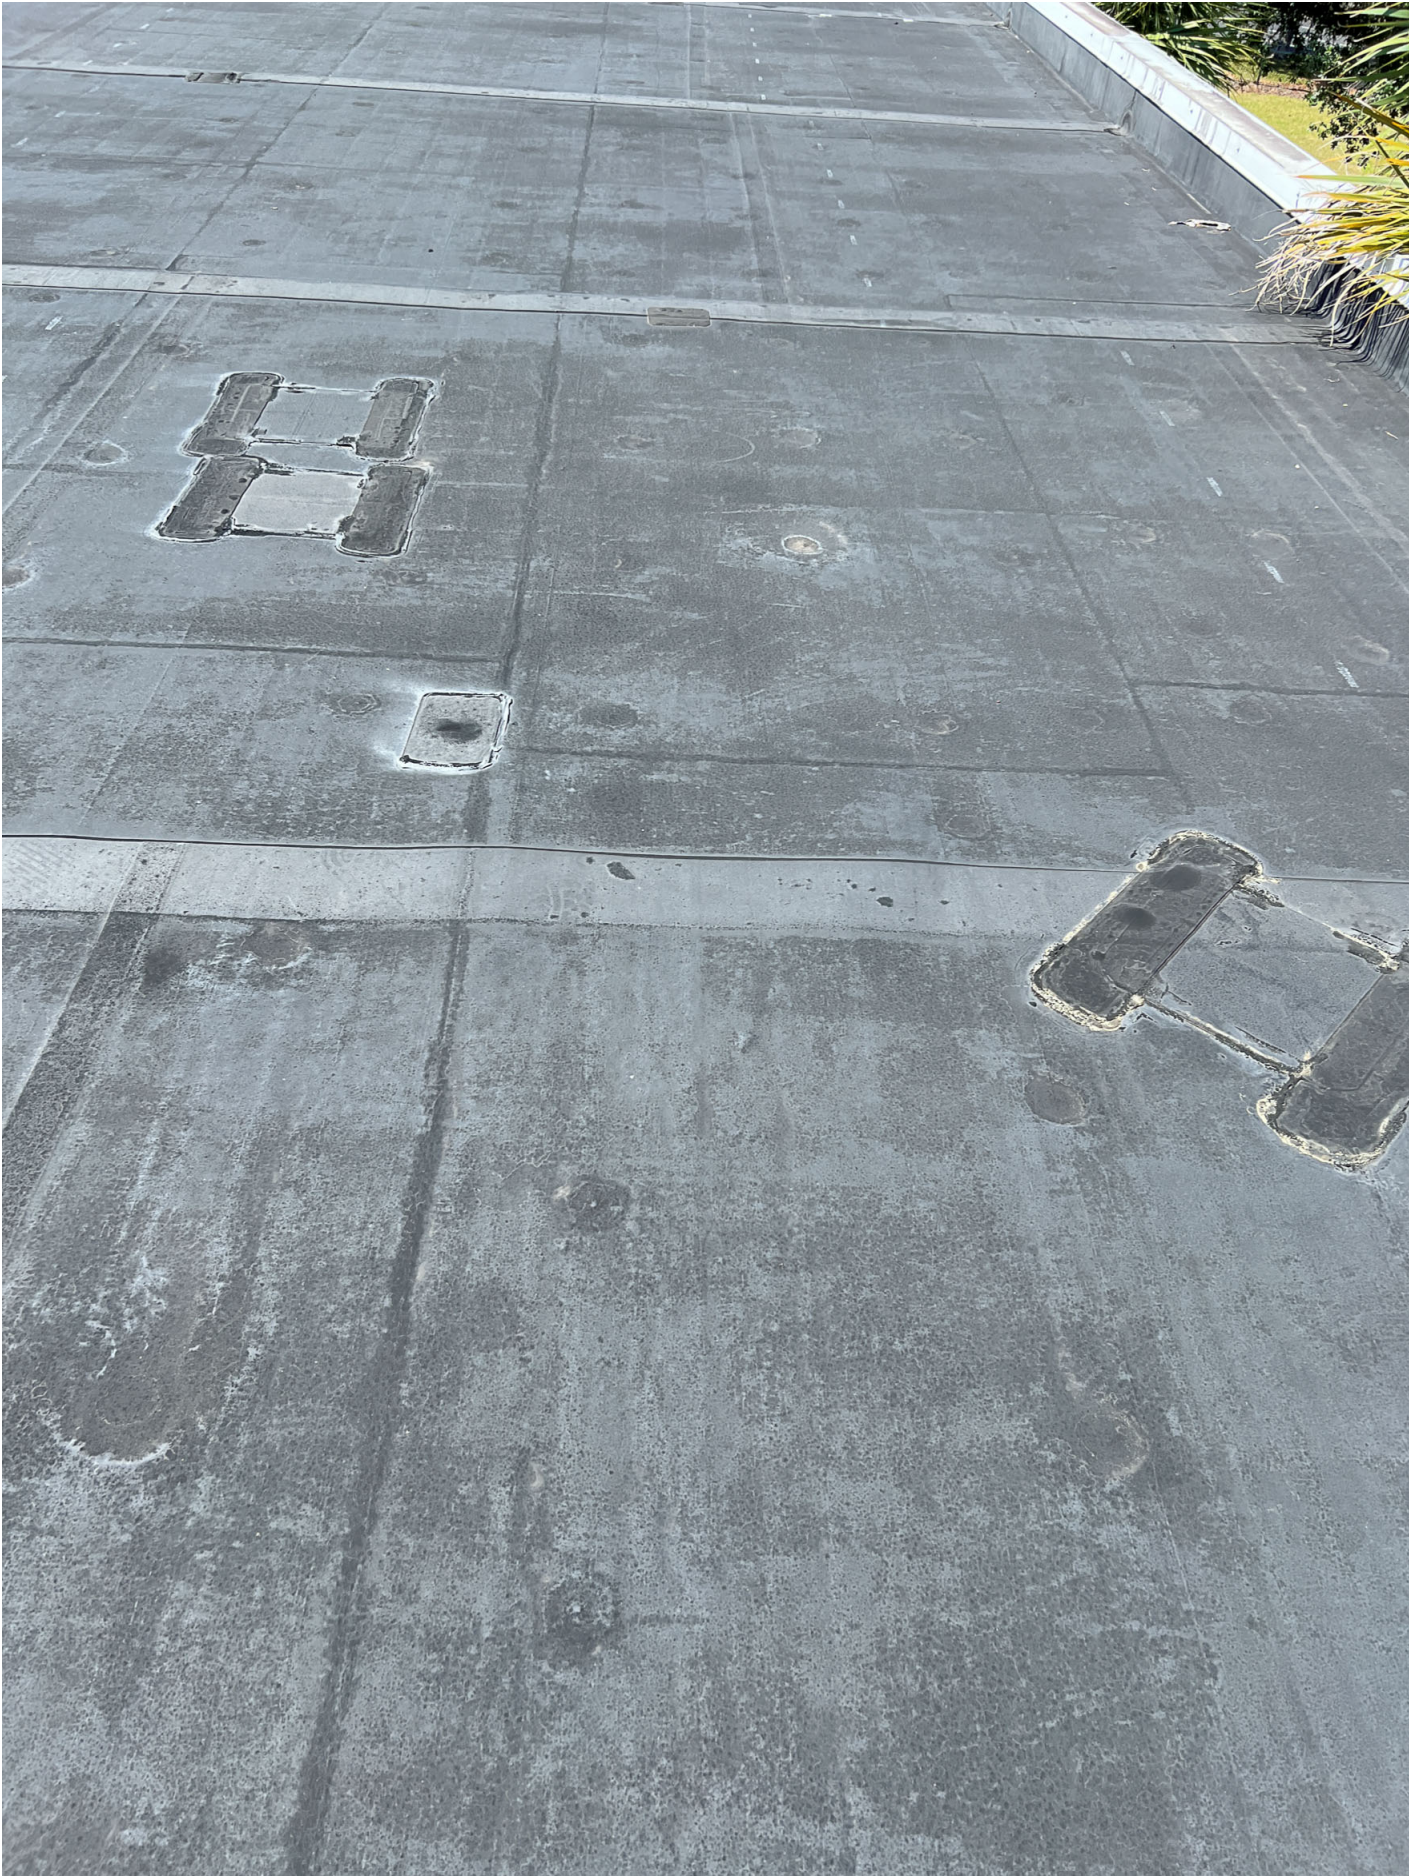
Lower Admin roof area previous patching

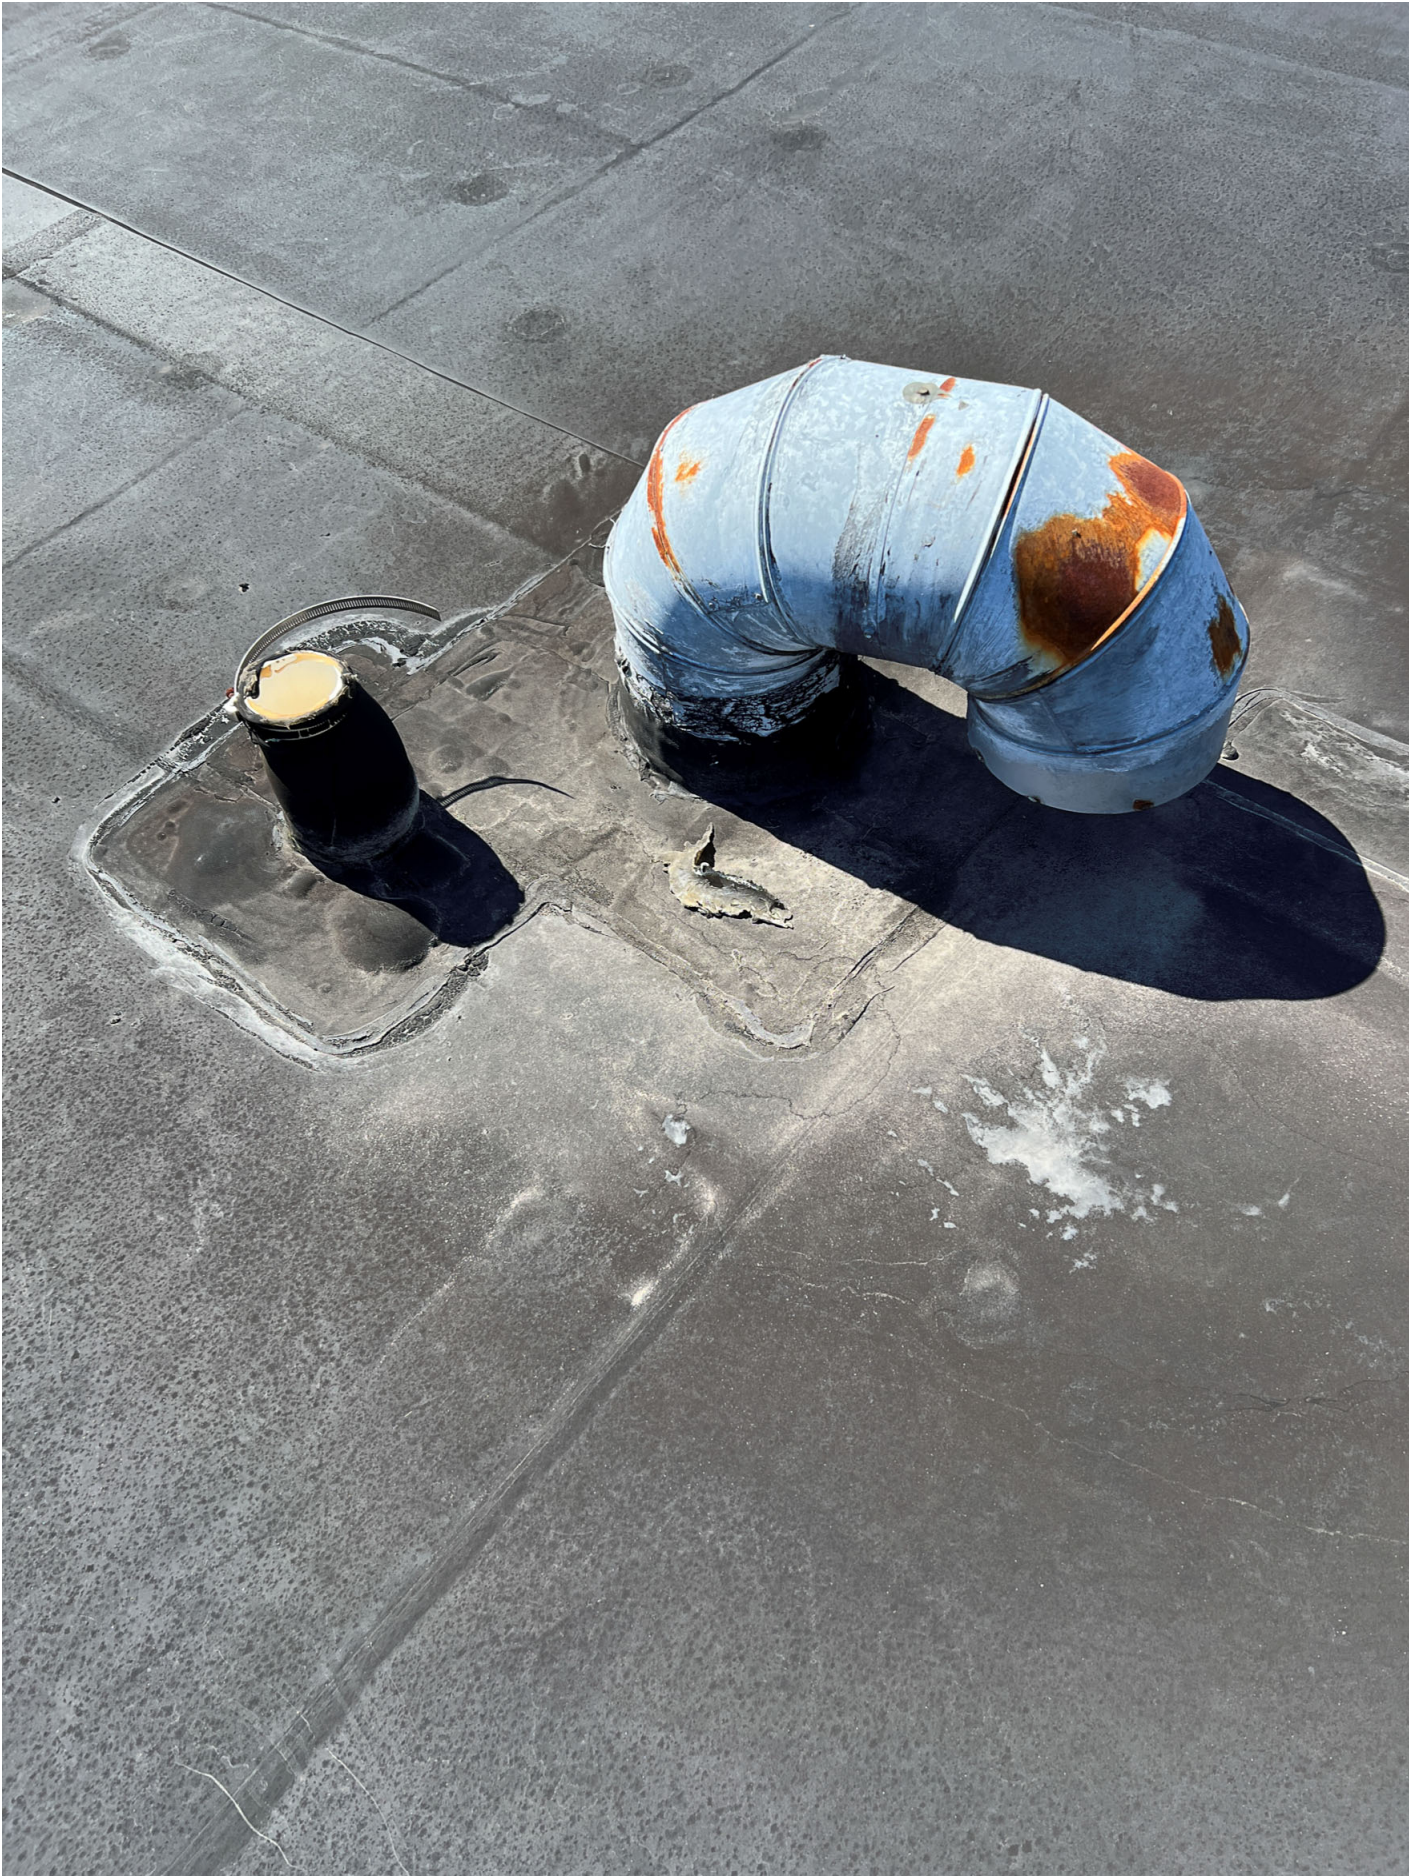
Lower Admin roof area previous patching

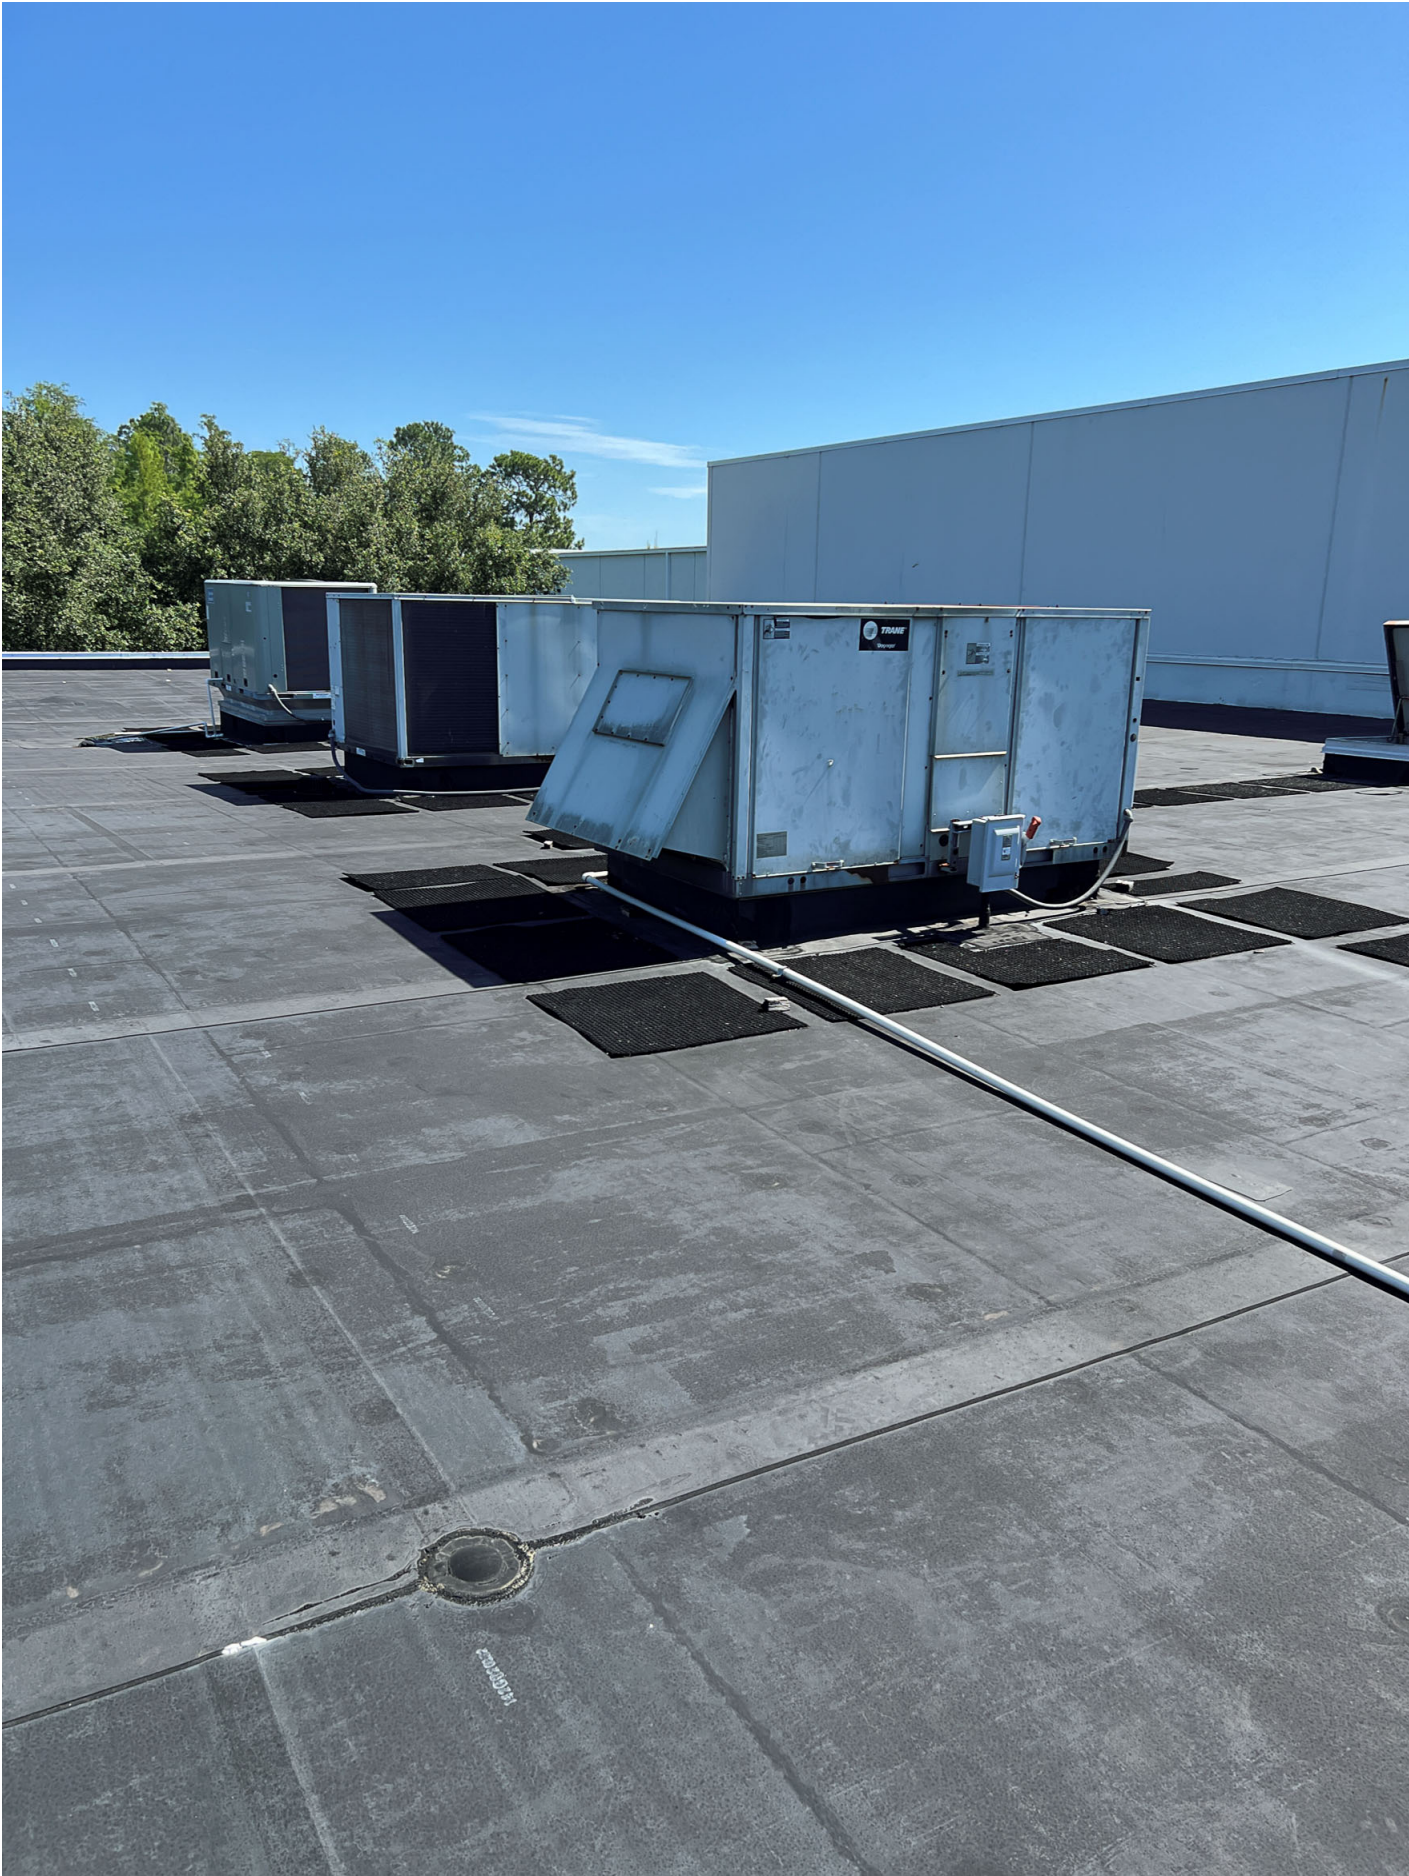
- Using a roof access ladder and roof hatch we gained access to the lower roof administration area roof we walked the roof area, and four roof top air handlers were mounted ranging from 6 to 10-ton units, two of which were original and two units that appear to be about three to four years old based on their information plates. Even through the two original units are functioning they are roughly 22 to 23 years old and have served their expected service life, therefore anticipate their replacement in the near future.

Lower admin roof area - Roof top A/C units

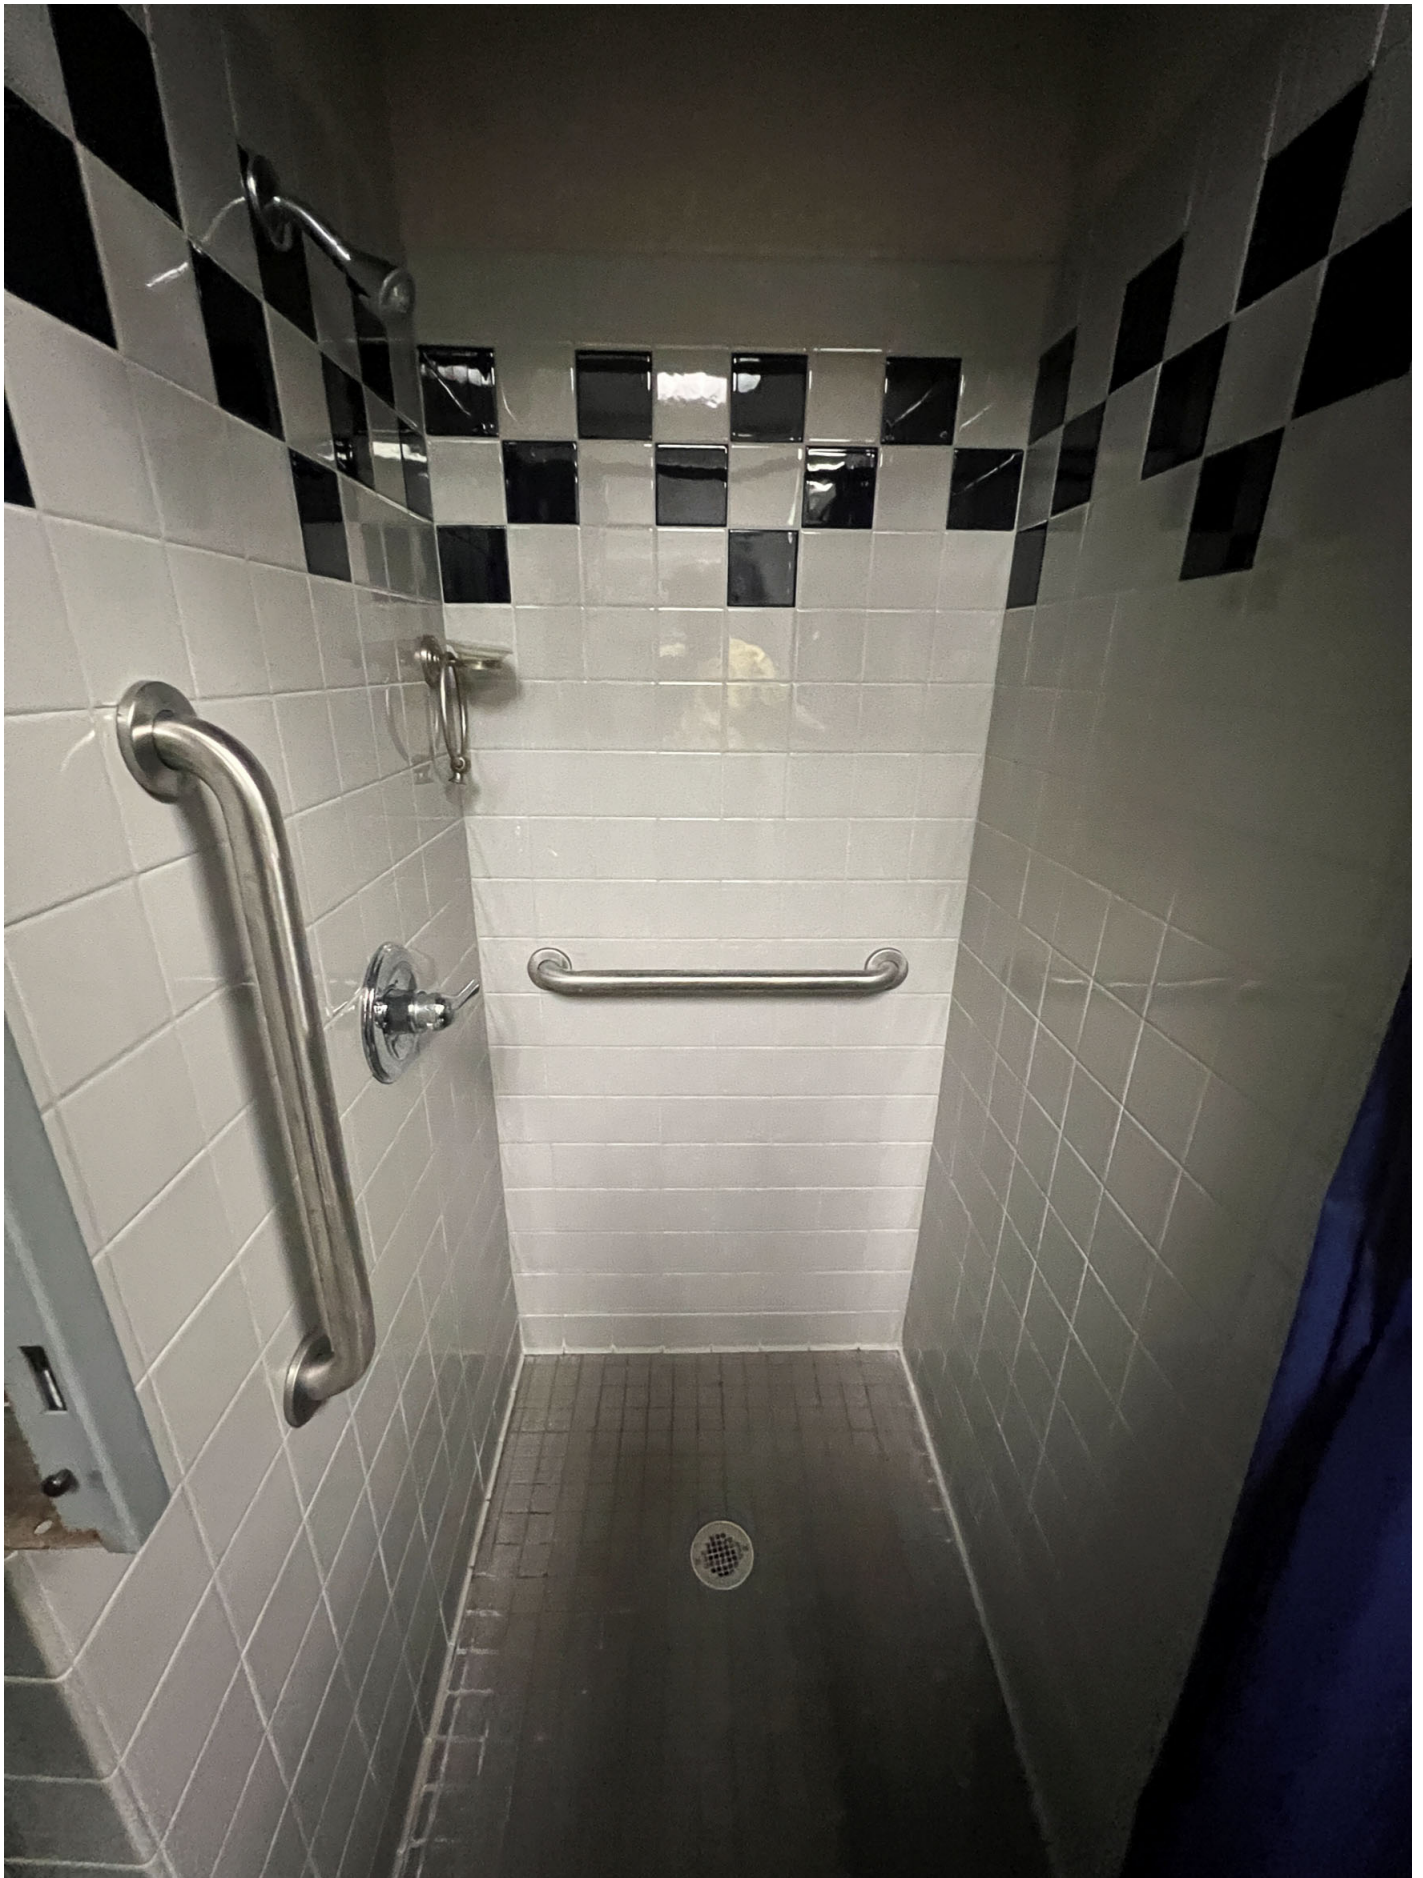
The existing showers in the Men's and Women's restrooms have 3'x3' shower that does not meet current ADA requirements and needs an adjustable spray-head and fold-down seat.

3' x 3' shower stall

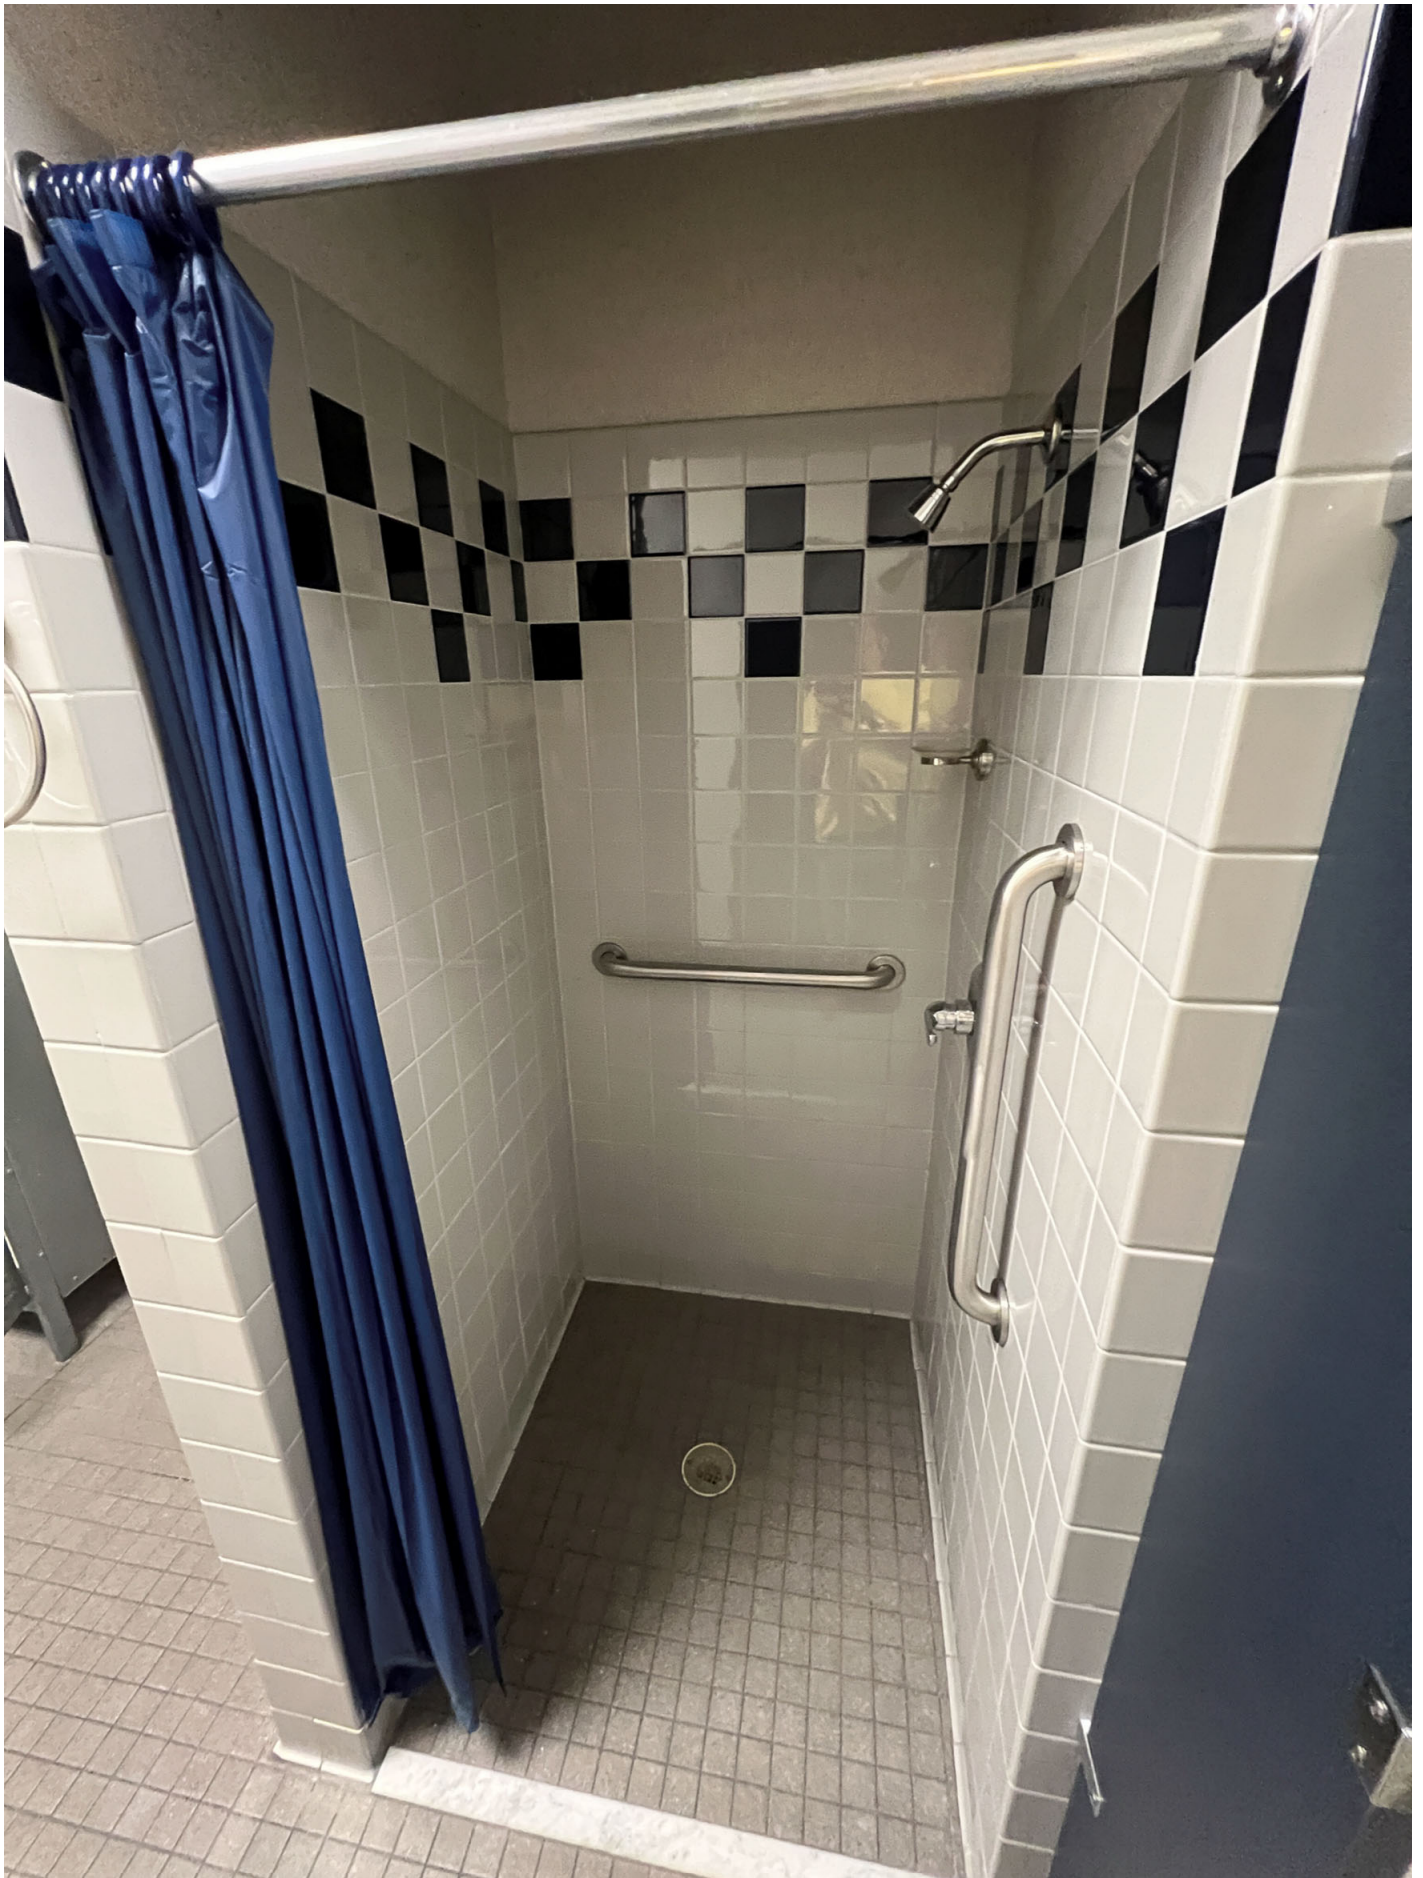
Shower needs hand held sprayer & fold down seat to make handicap
