RE: Due Diligence Report – Burkhardt Sales & Service

As part of the County's due diligence efforts to evaluate the conditions of the existing commercial industrial warehouse building (Burkhardt Sales & Service) located at 6125 NW 18<sup>th</sup> Drive, Gainesville, FL 32653, Paul Stresing Associates (PSA) was tasked with conducting an inspection of the facility to evaluate its condition prior to entering into a full purchase agreement to its purchase. On May 30, 2024, I was accompanied by KPI Engineering (KPI) where we walked the roof and interior of the facility with Mr. Matt Fultz of the Alachua County Facilities Department and Mr. Daniel Burkhardt, representing the seller where we gained access to the site and buildings to begin our evaluation efforts.

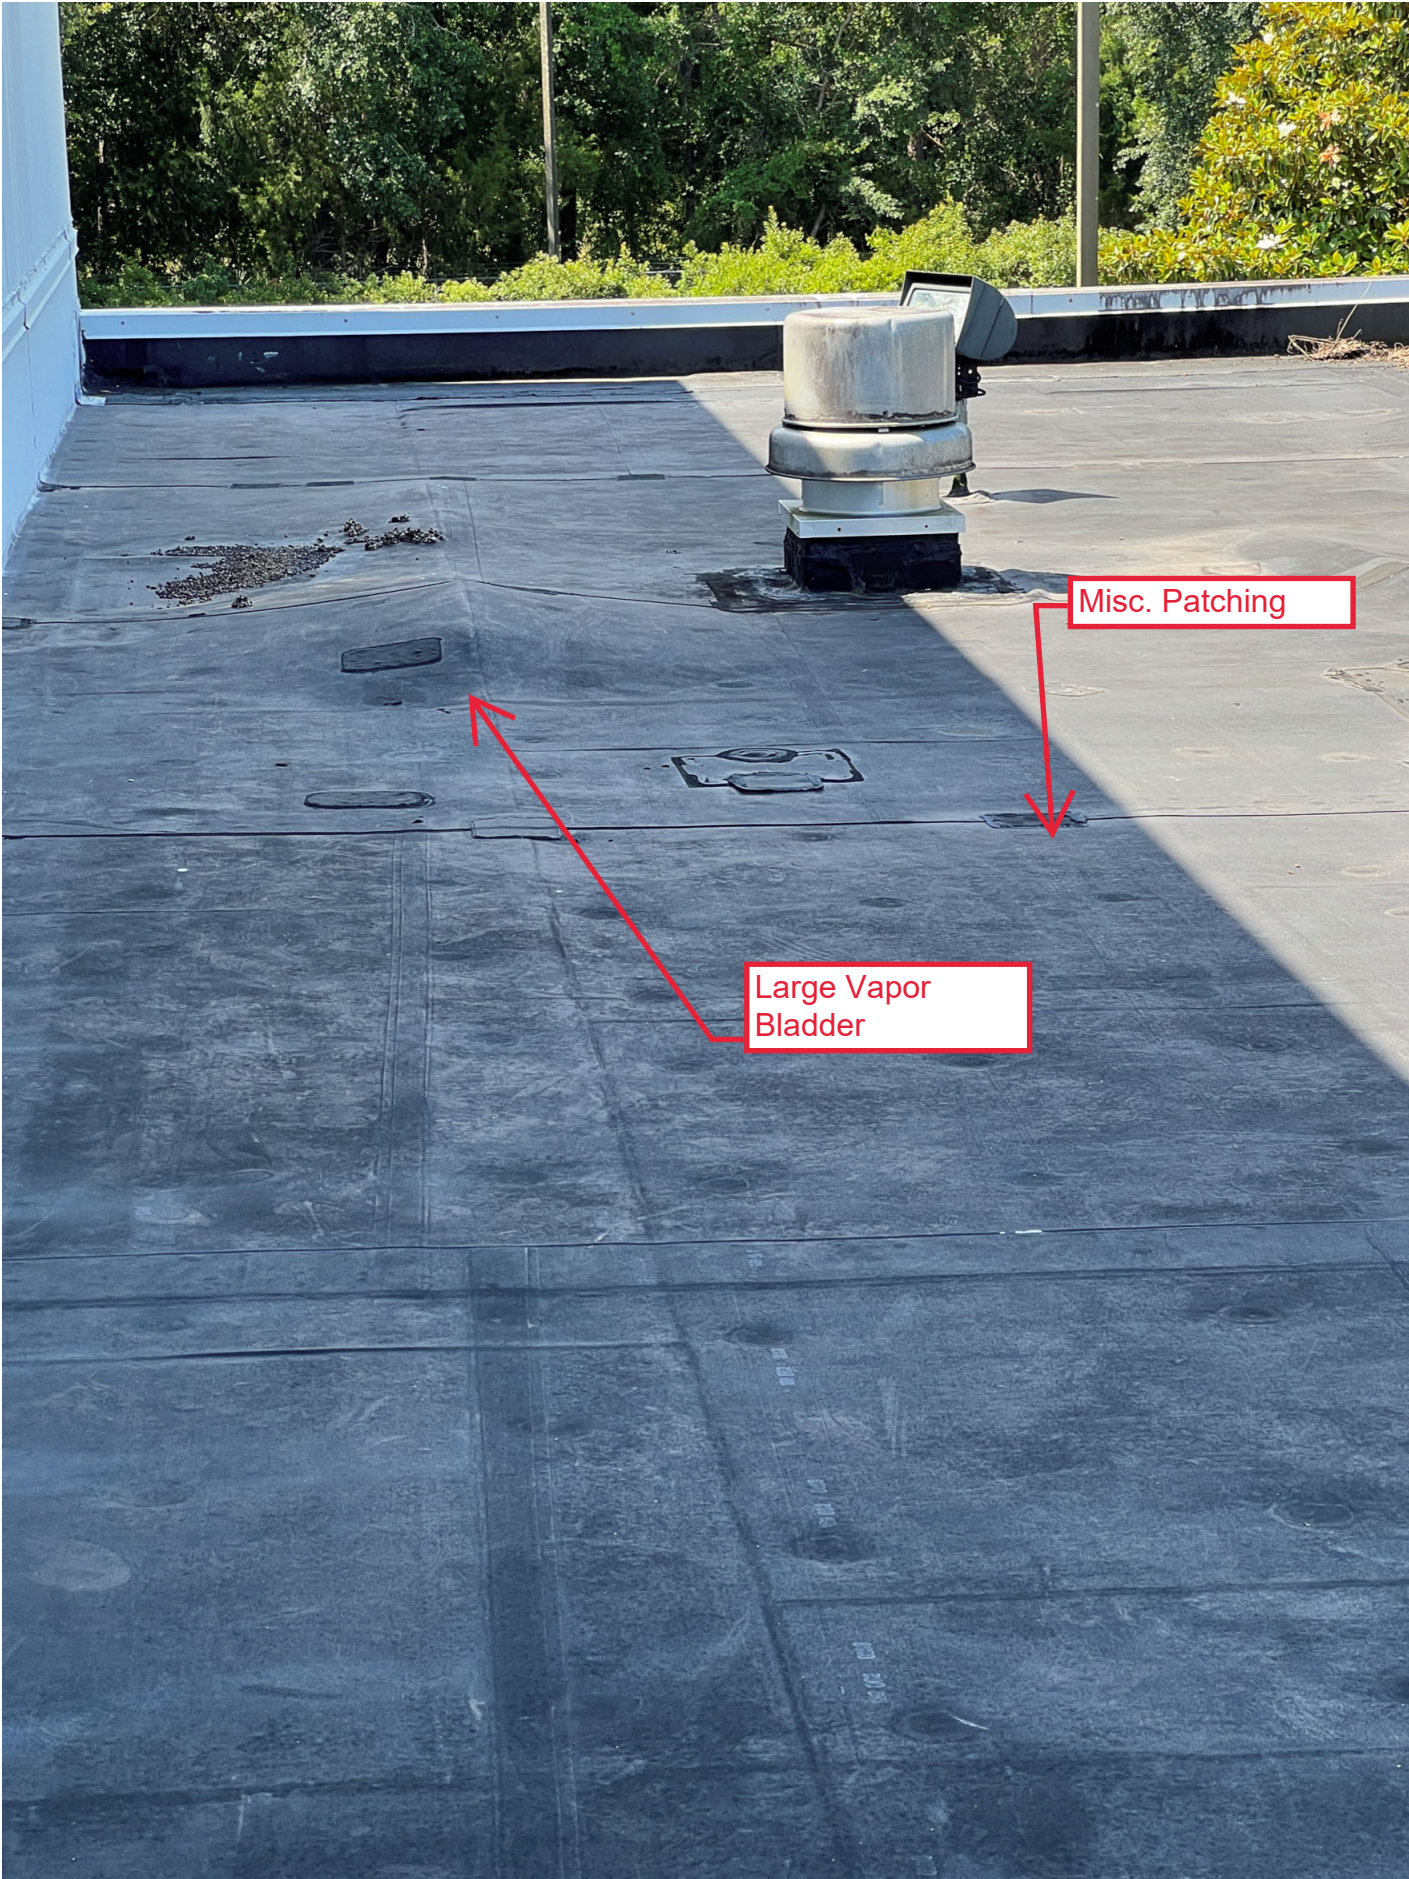
Misc. Patching

Large Vapor Bladder

Lower admin roof viewing south

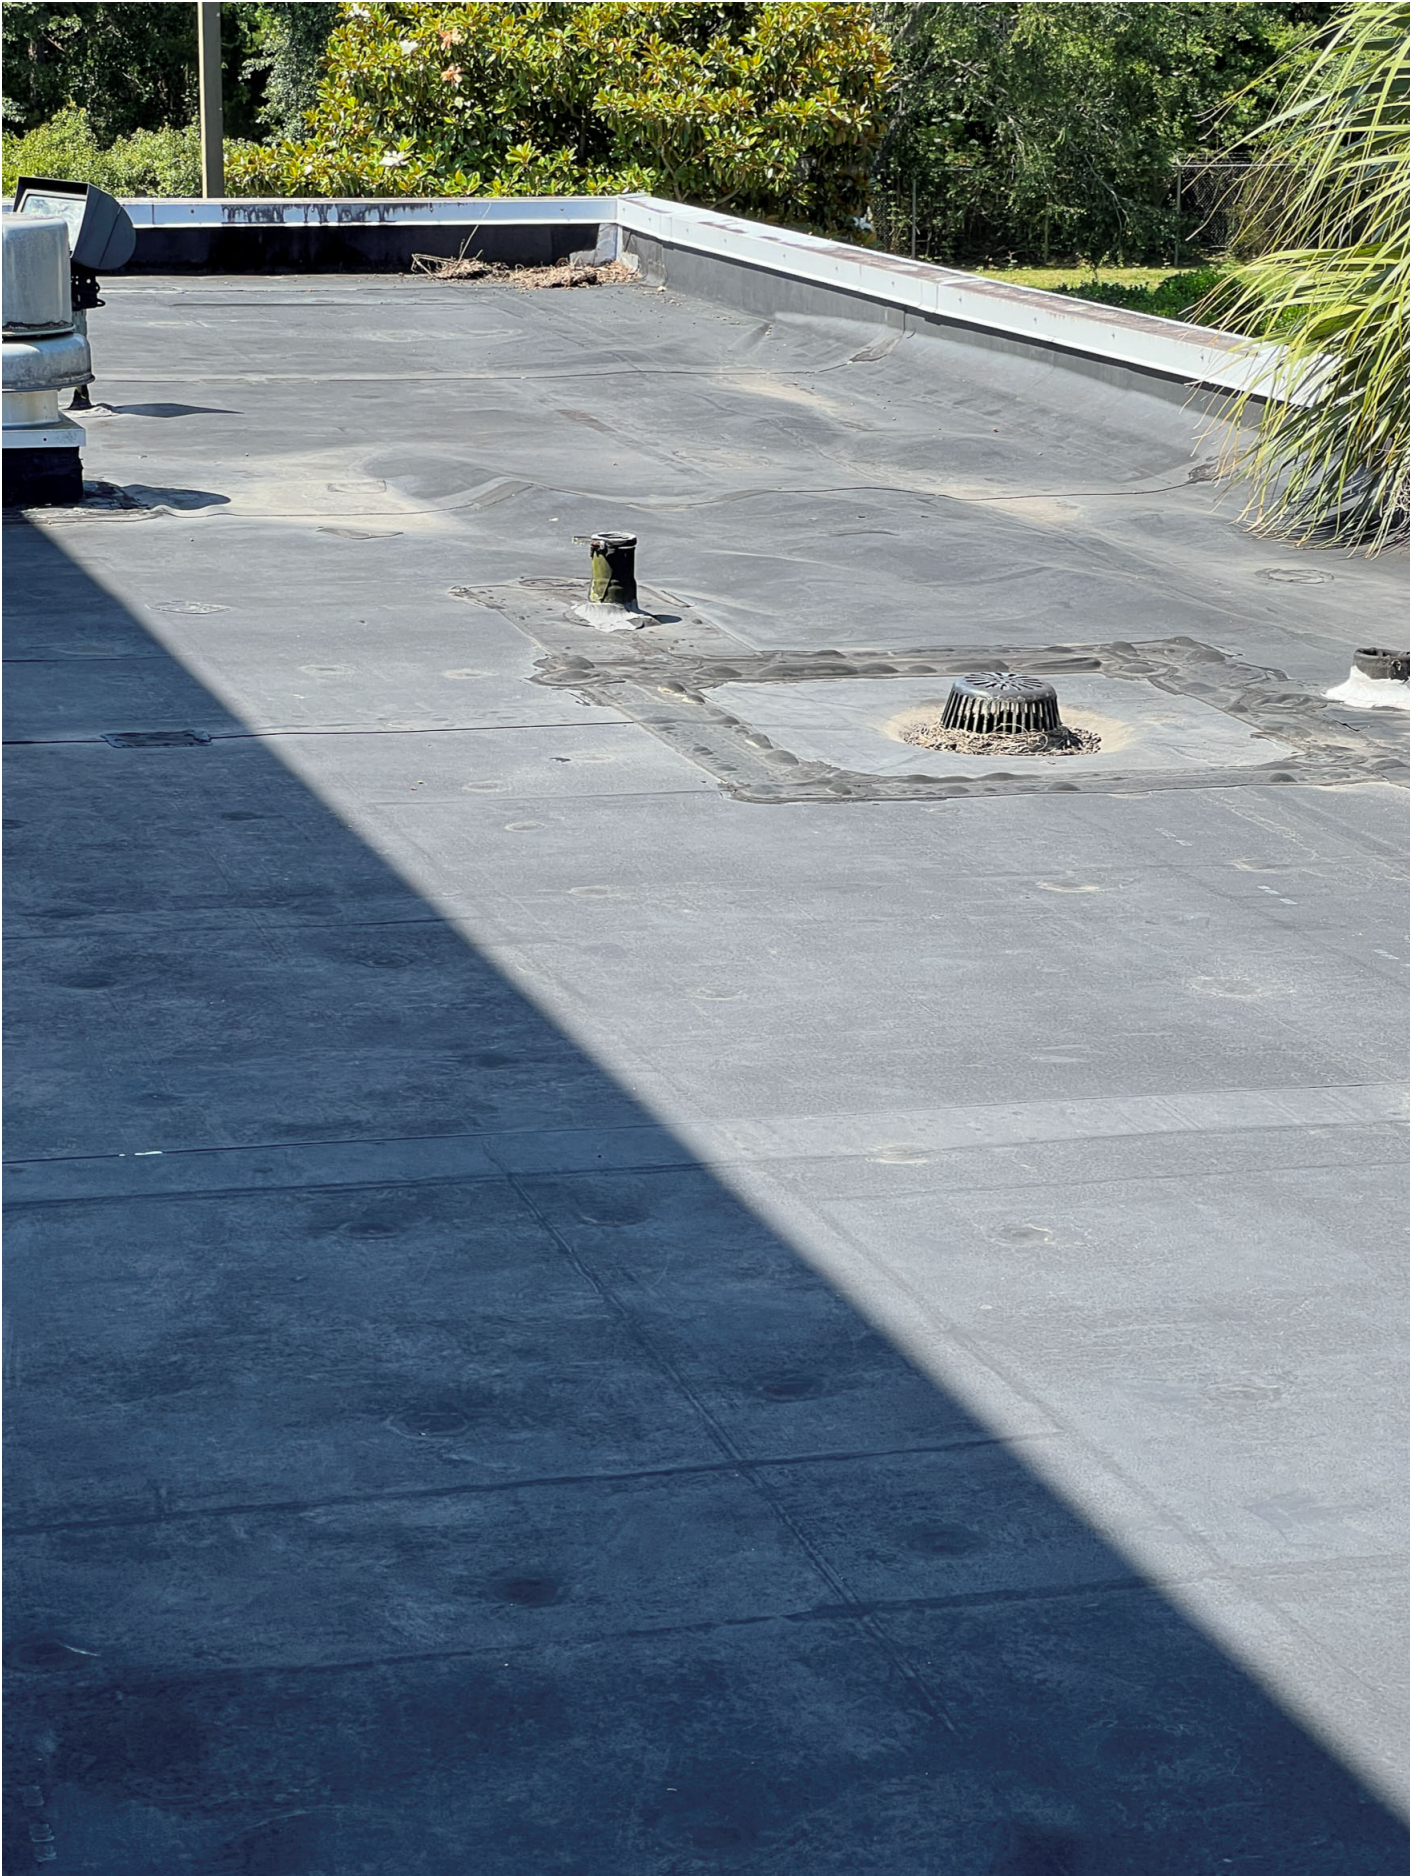
Lower admin roof viewing south large vapor bladders & patching

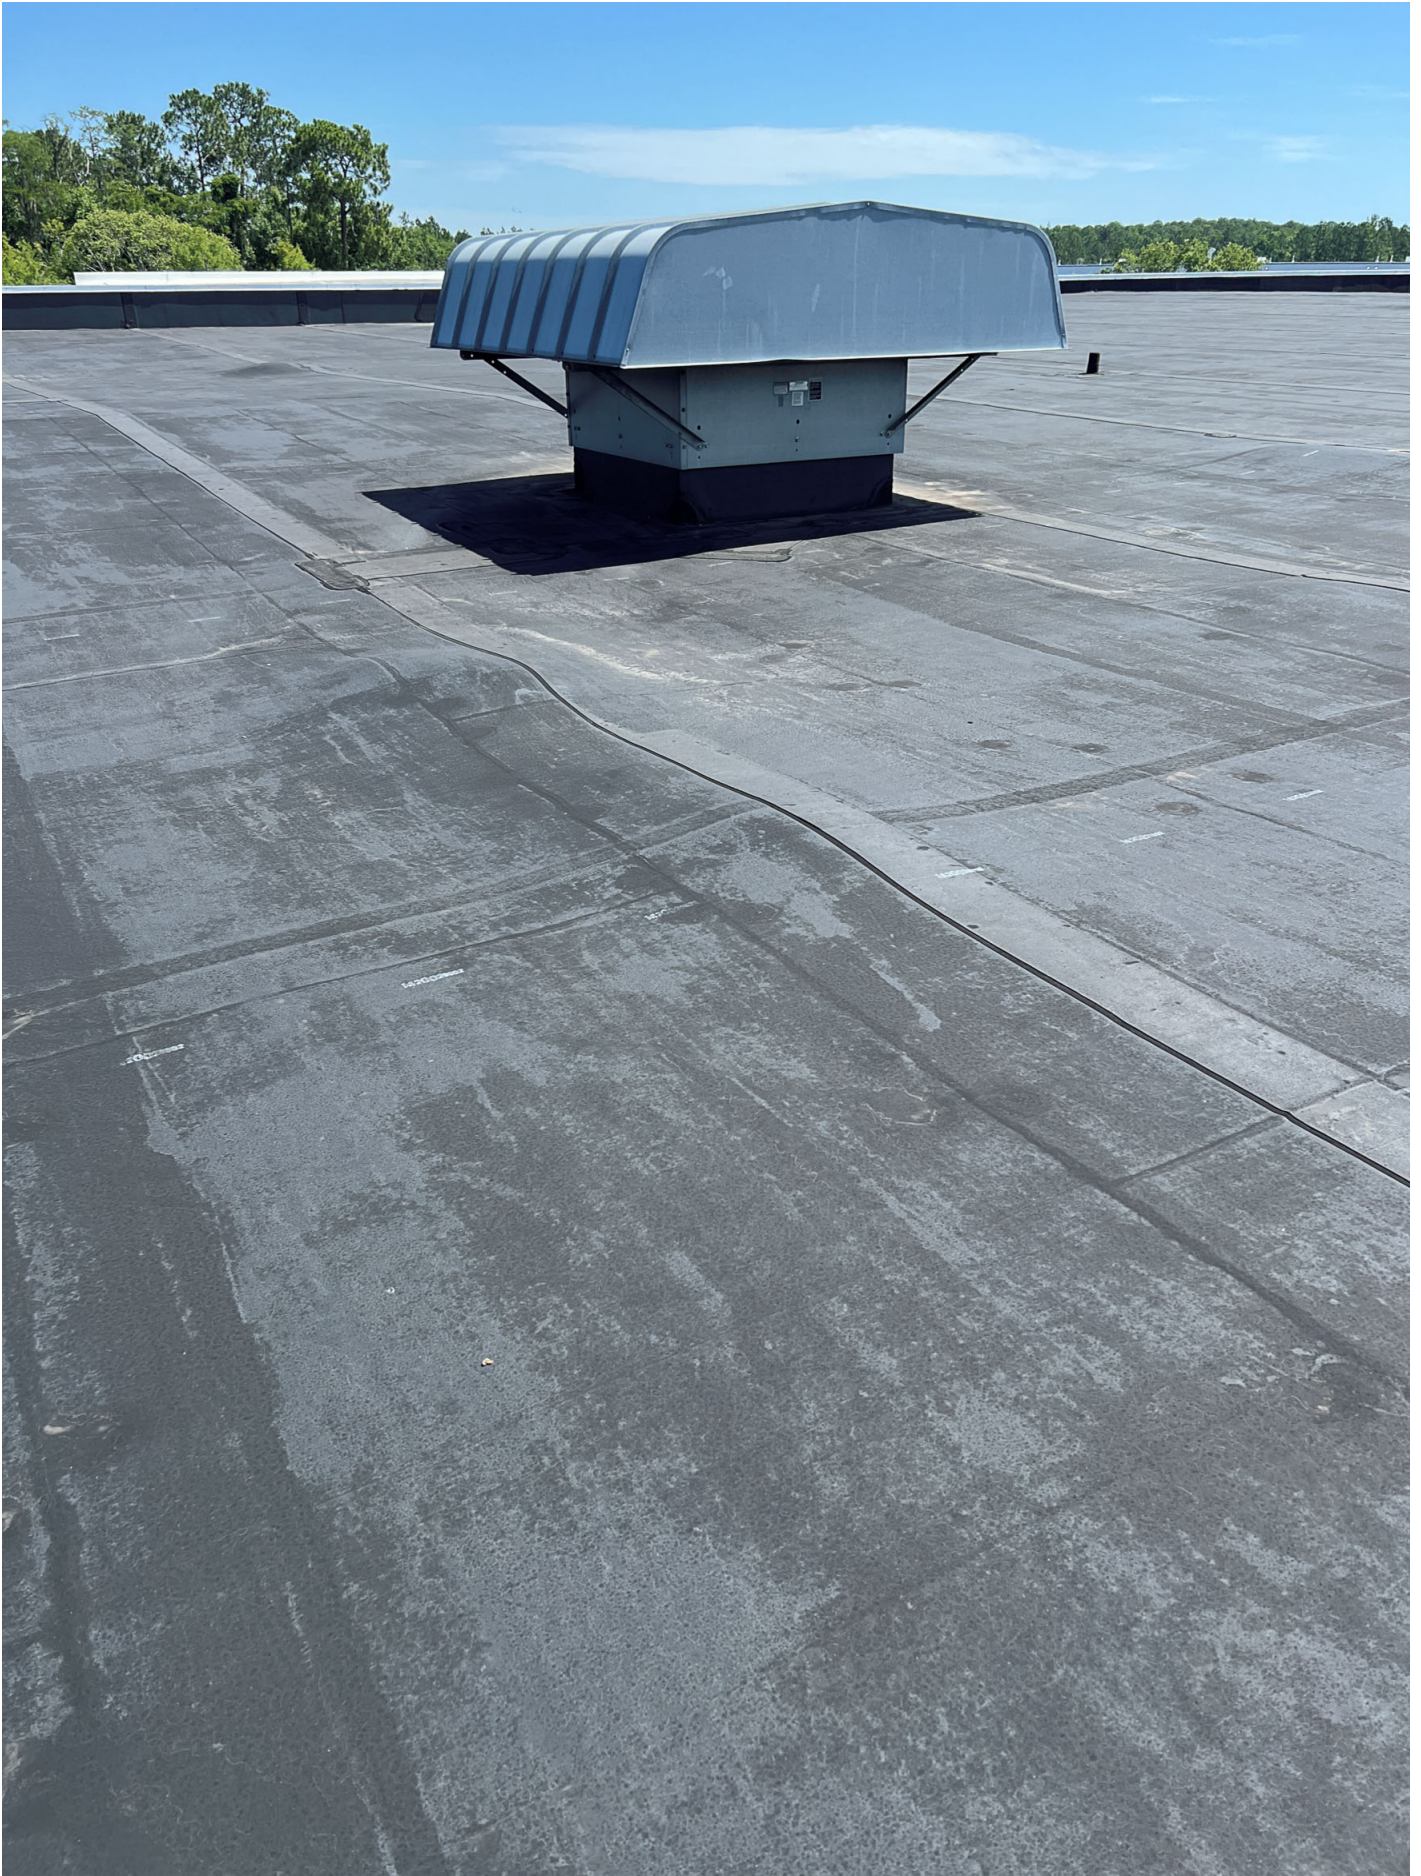
Large vapor bladders under the EPDM single-ply roof membrane

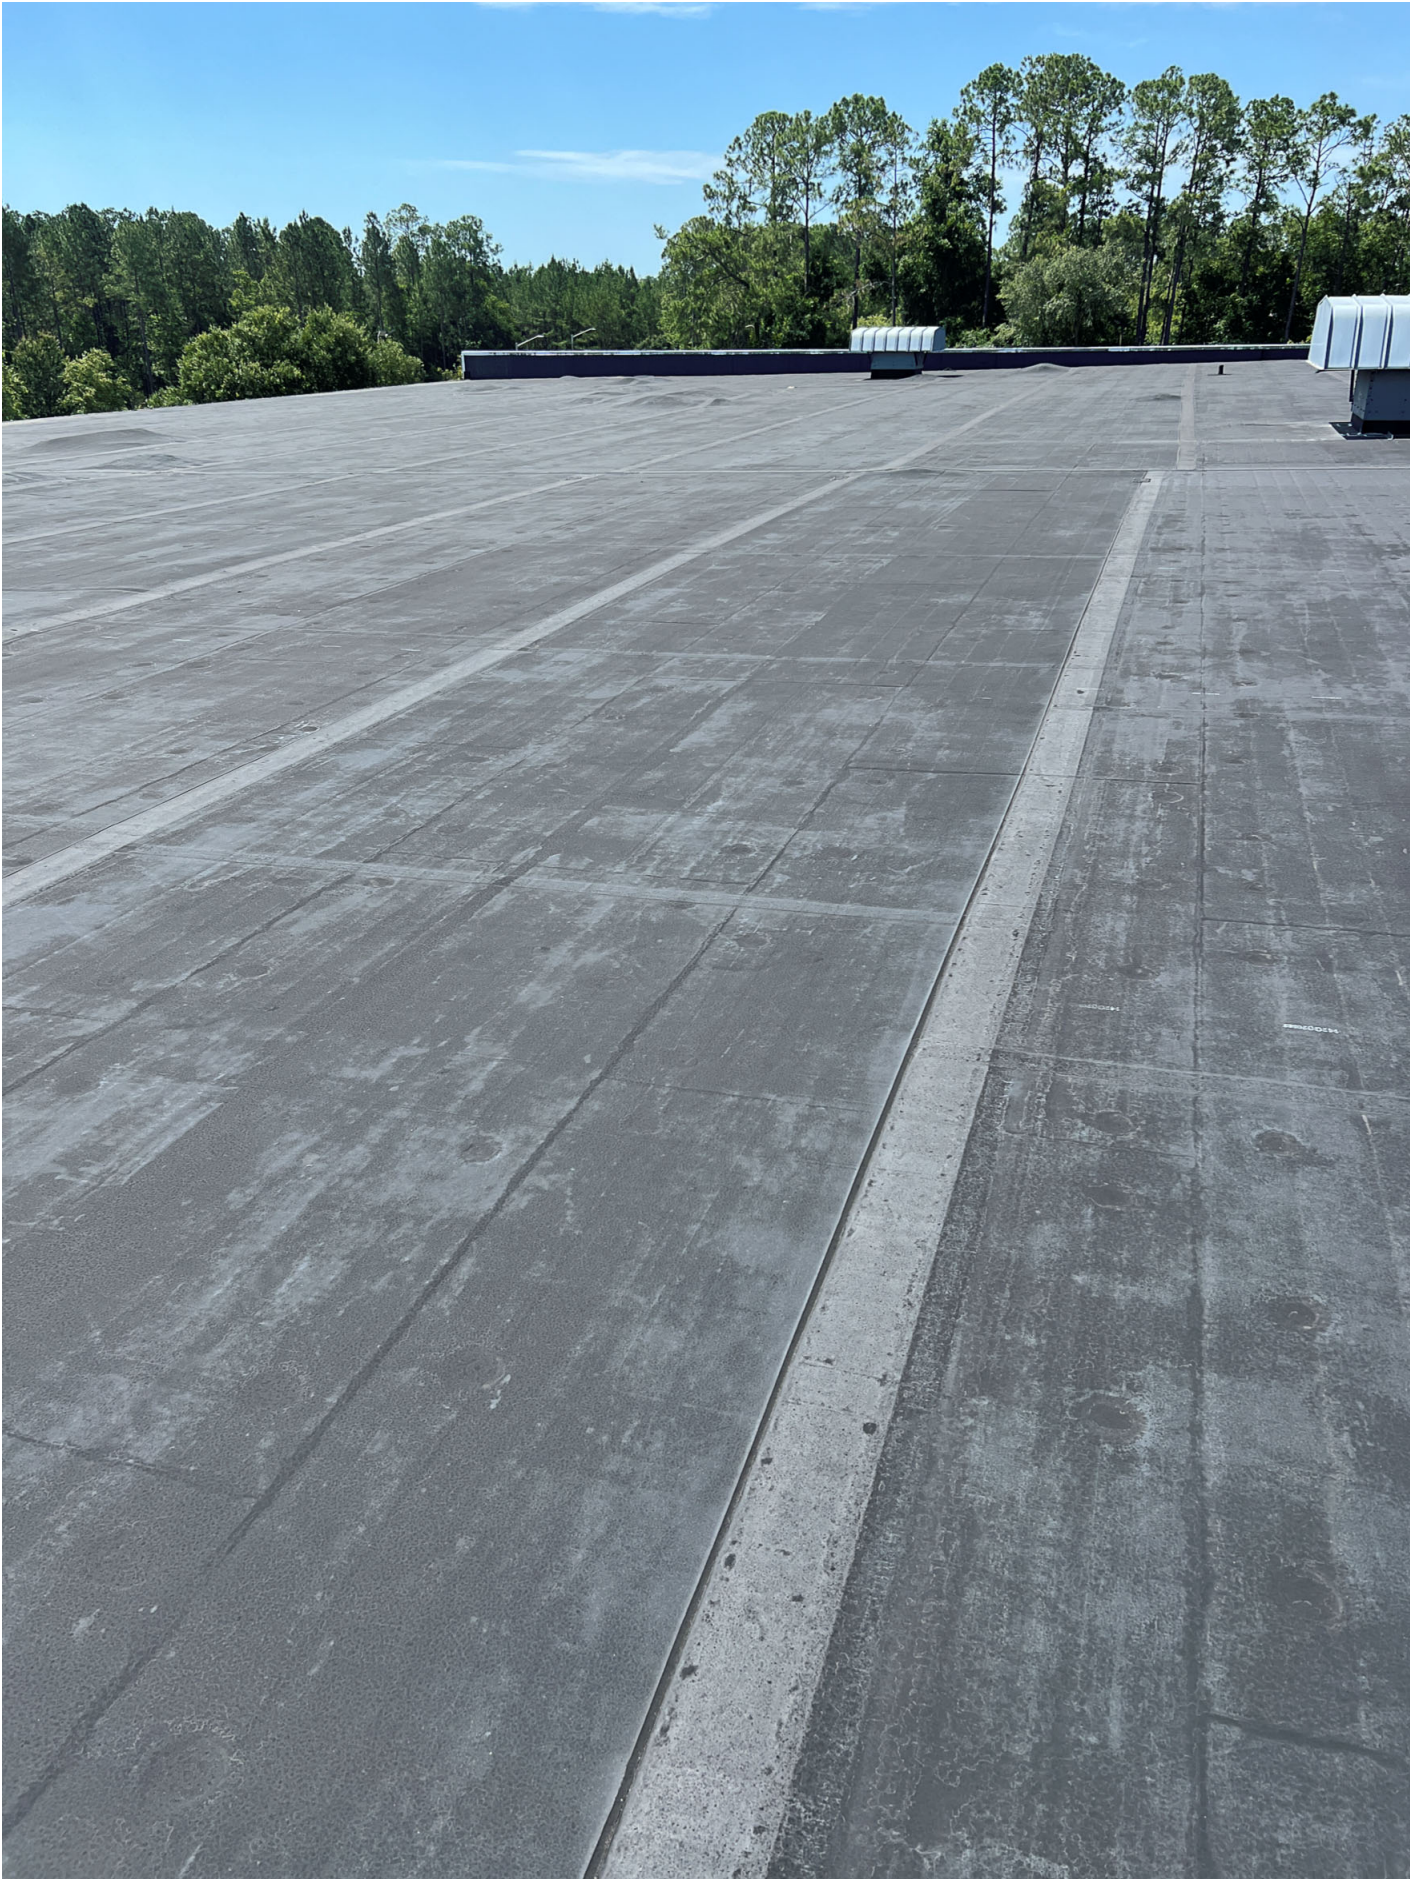
2000 warehouse roof open roof area with large vapor bladders plaguing the roof area

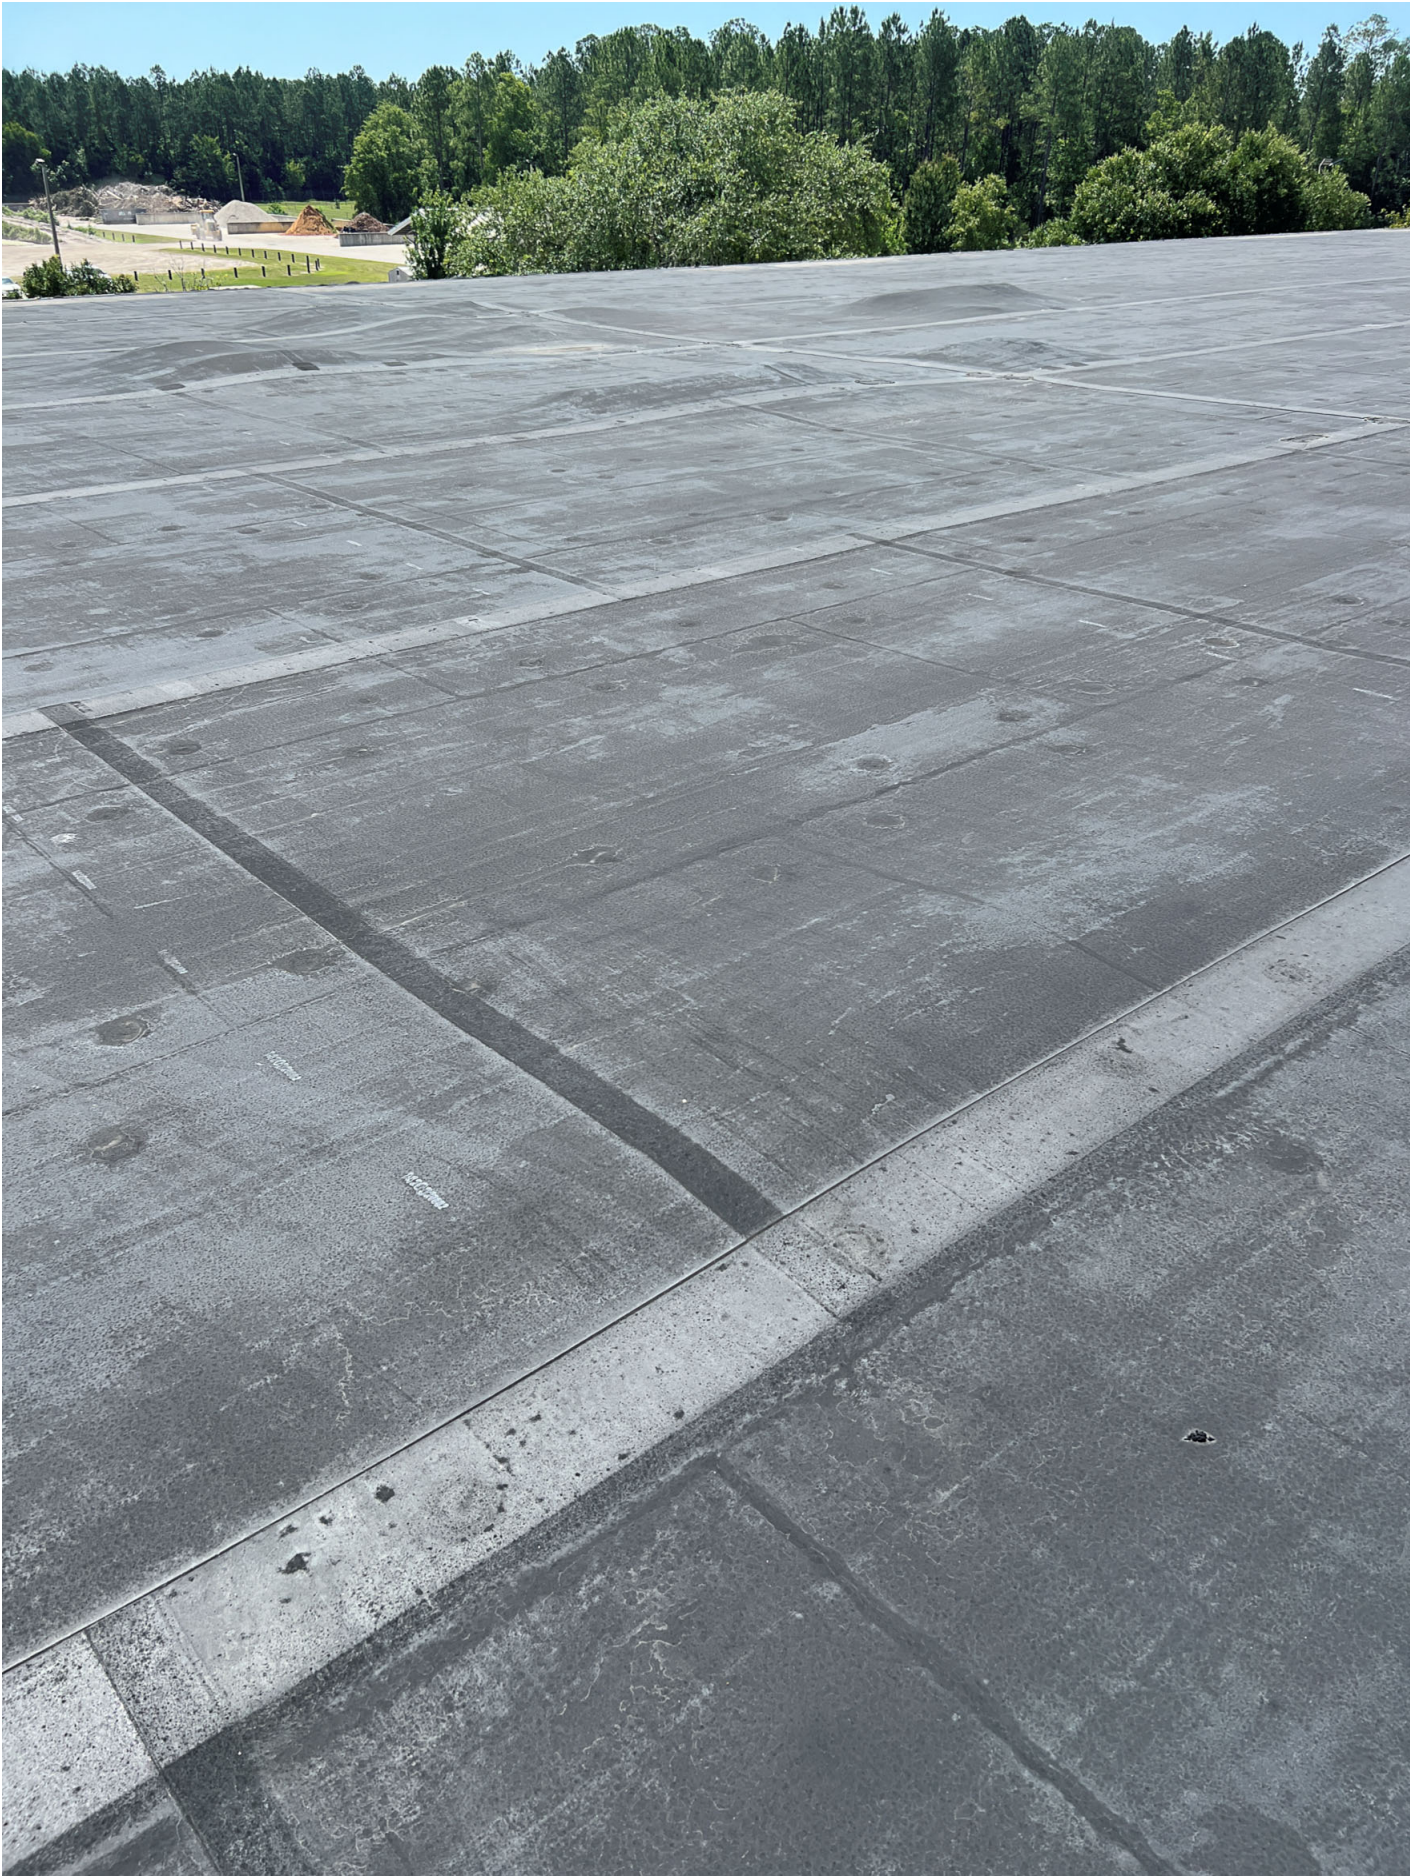
2000 warehouse roof open roof area with large vapor bladders plaguing the roof area

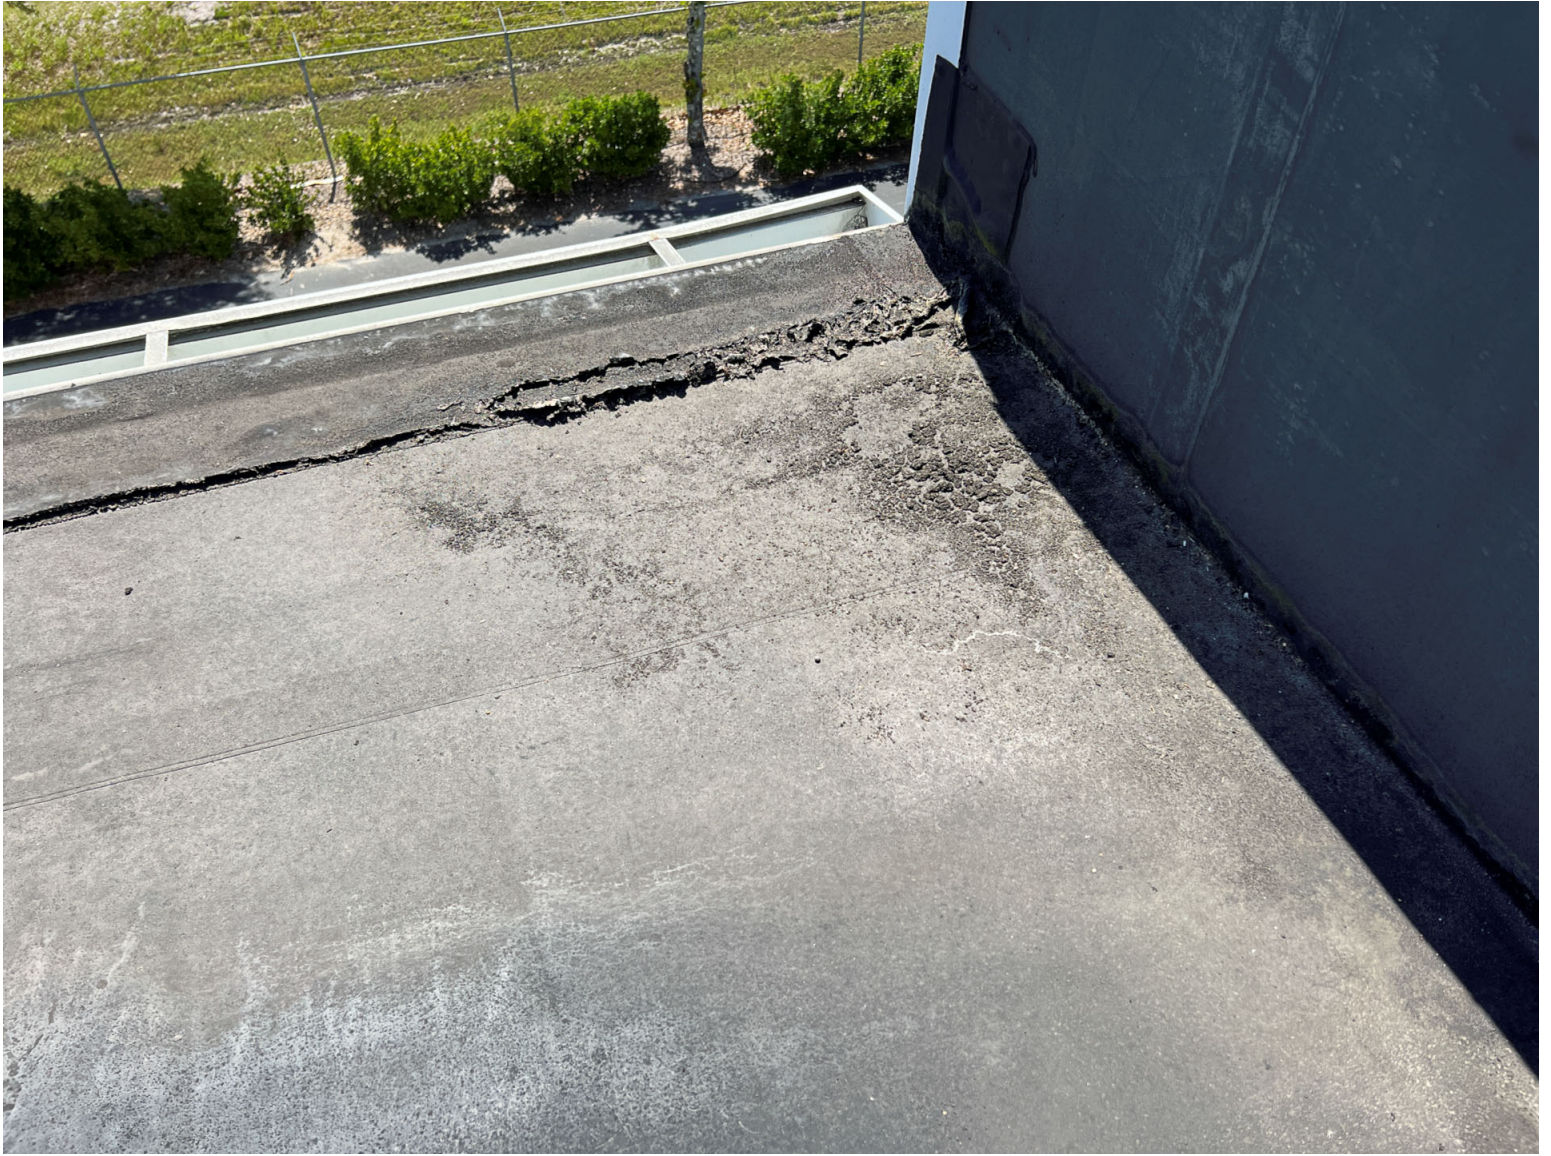
2000 warehouse east roof edge deterioration / gutters & downspouts along east edge of the

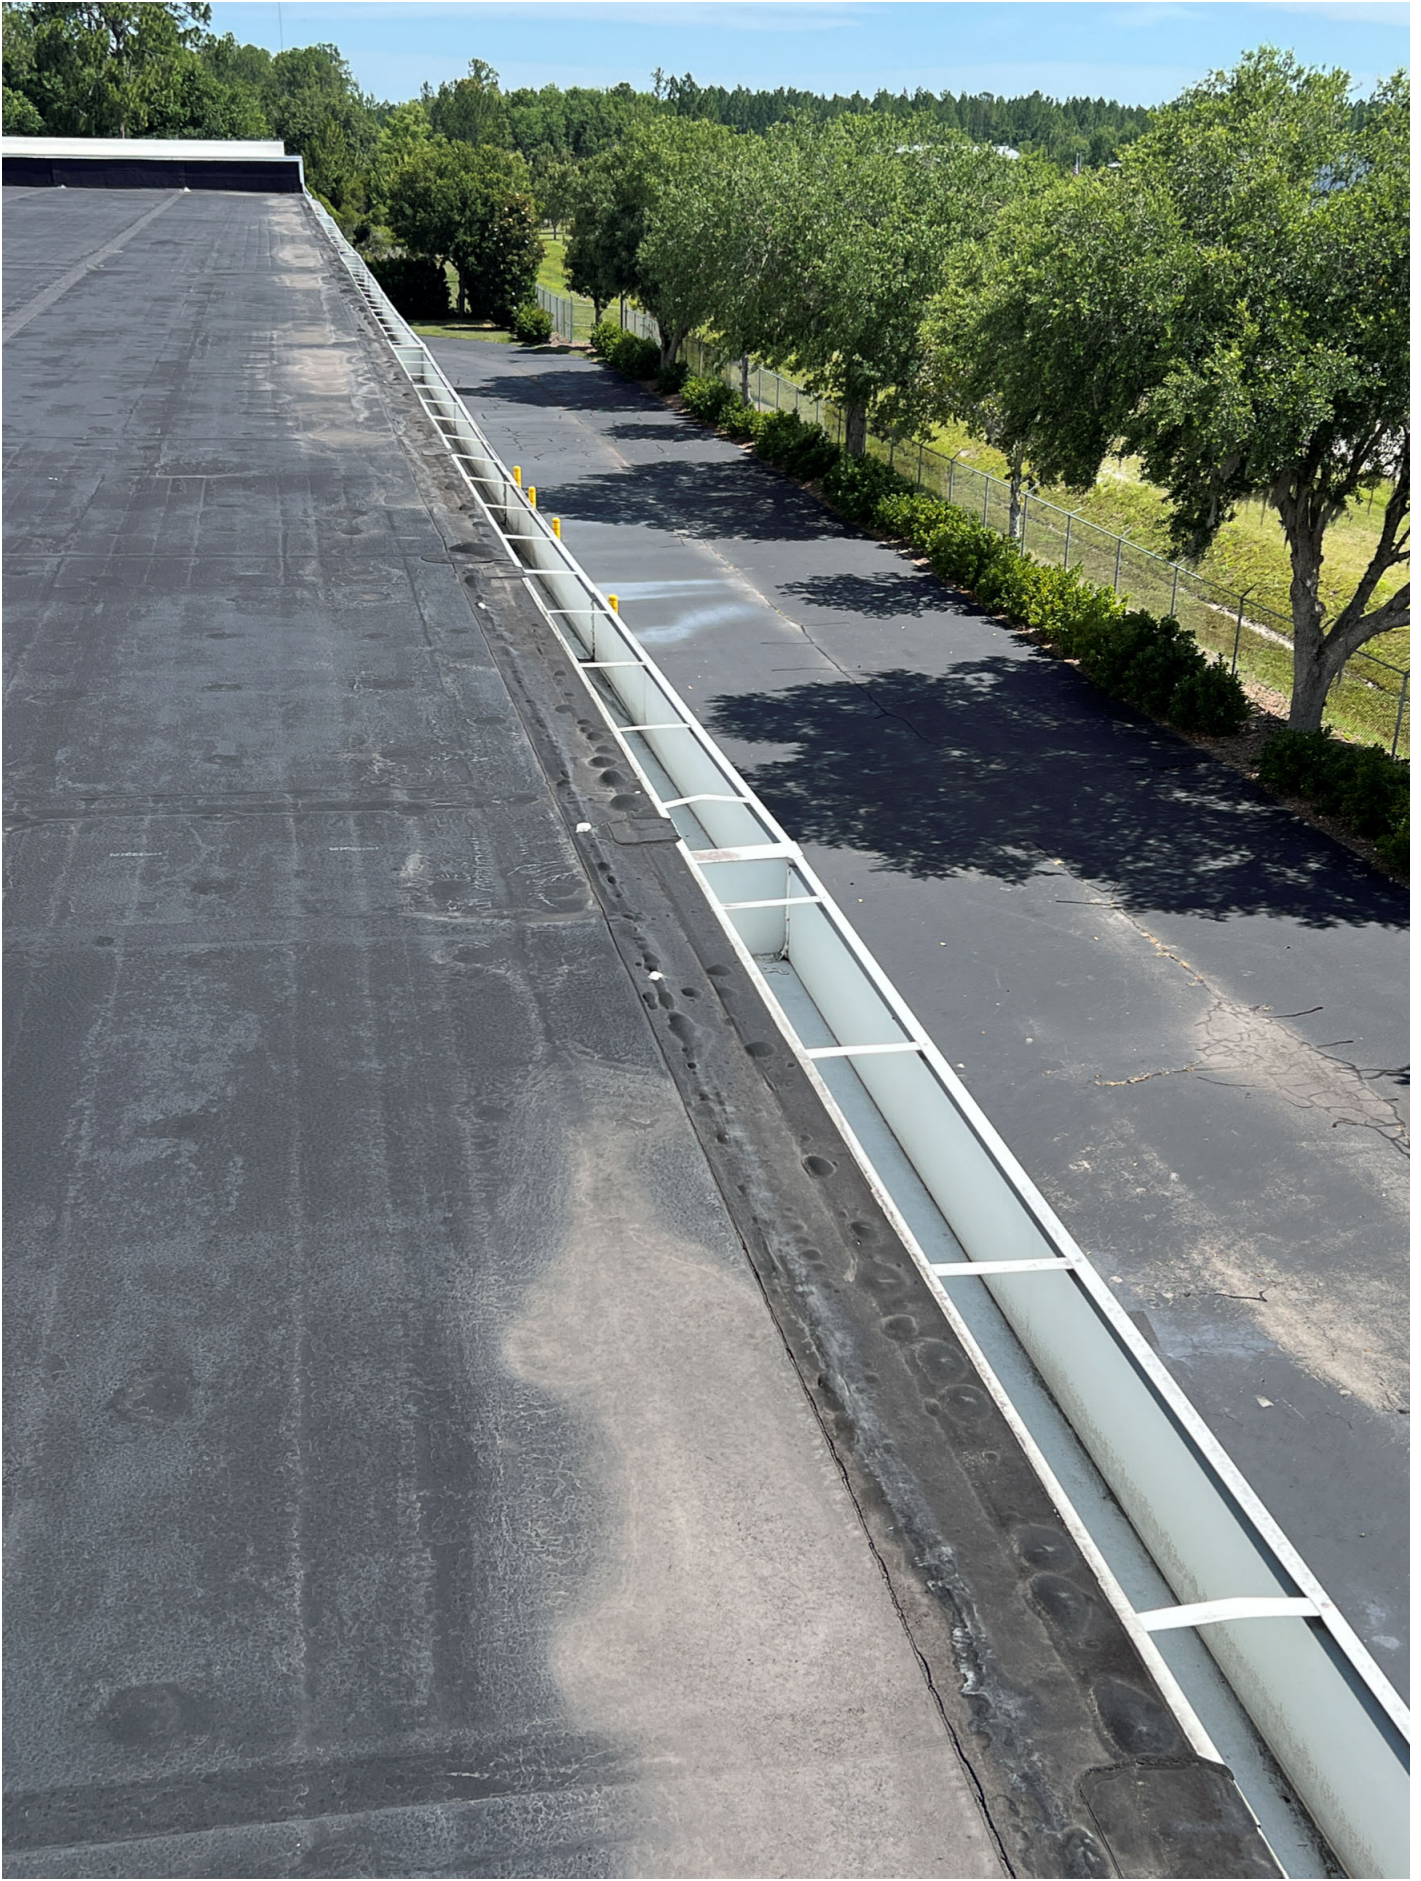
2000 warehouse east roof edge with gutters & downspouts / roof membrane deterioration

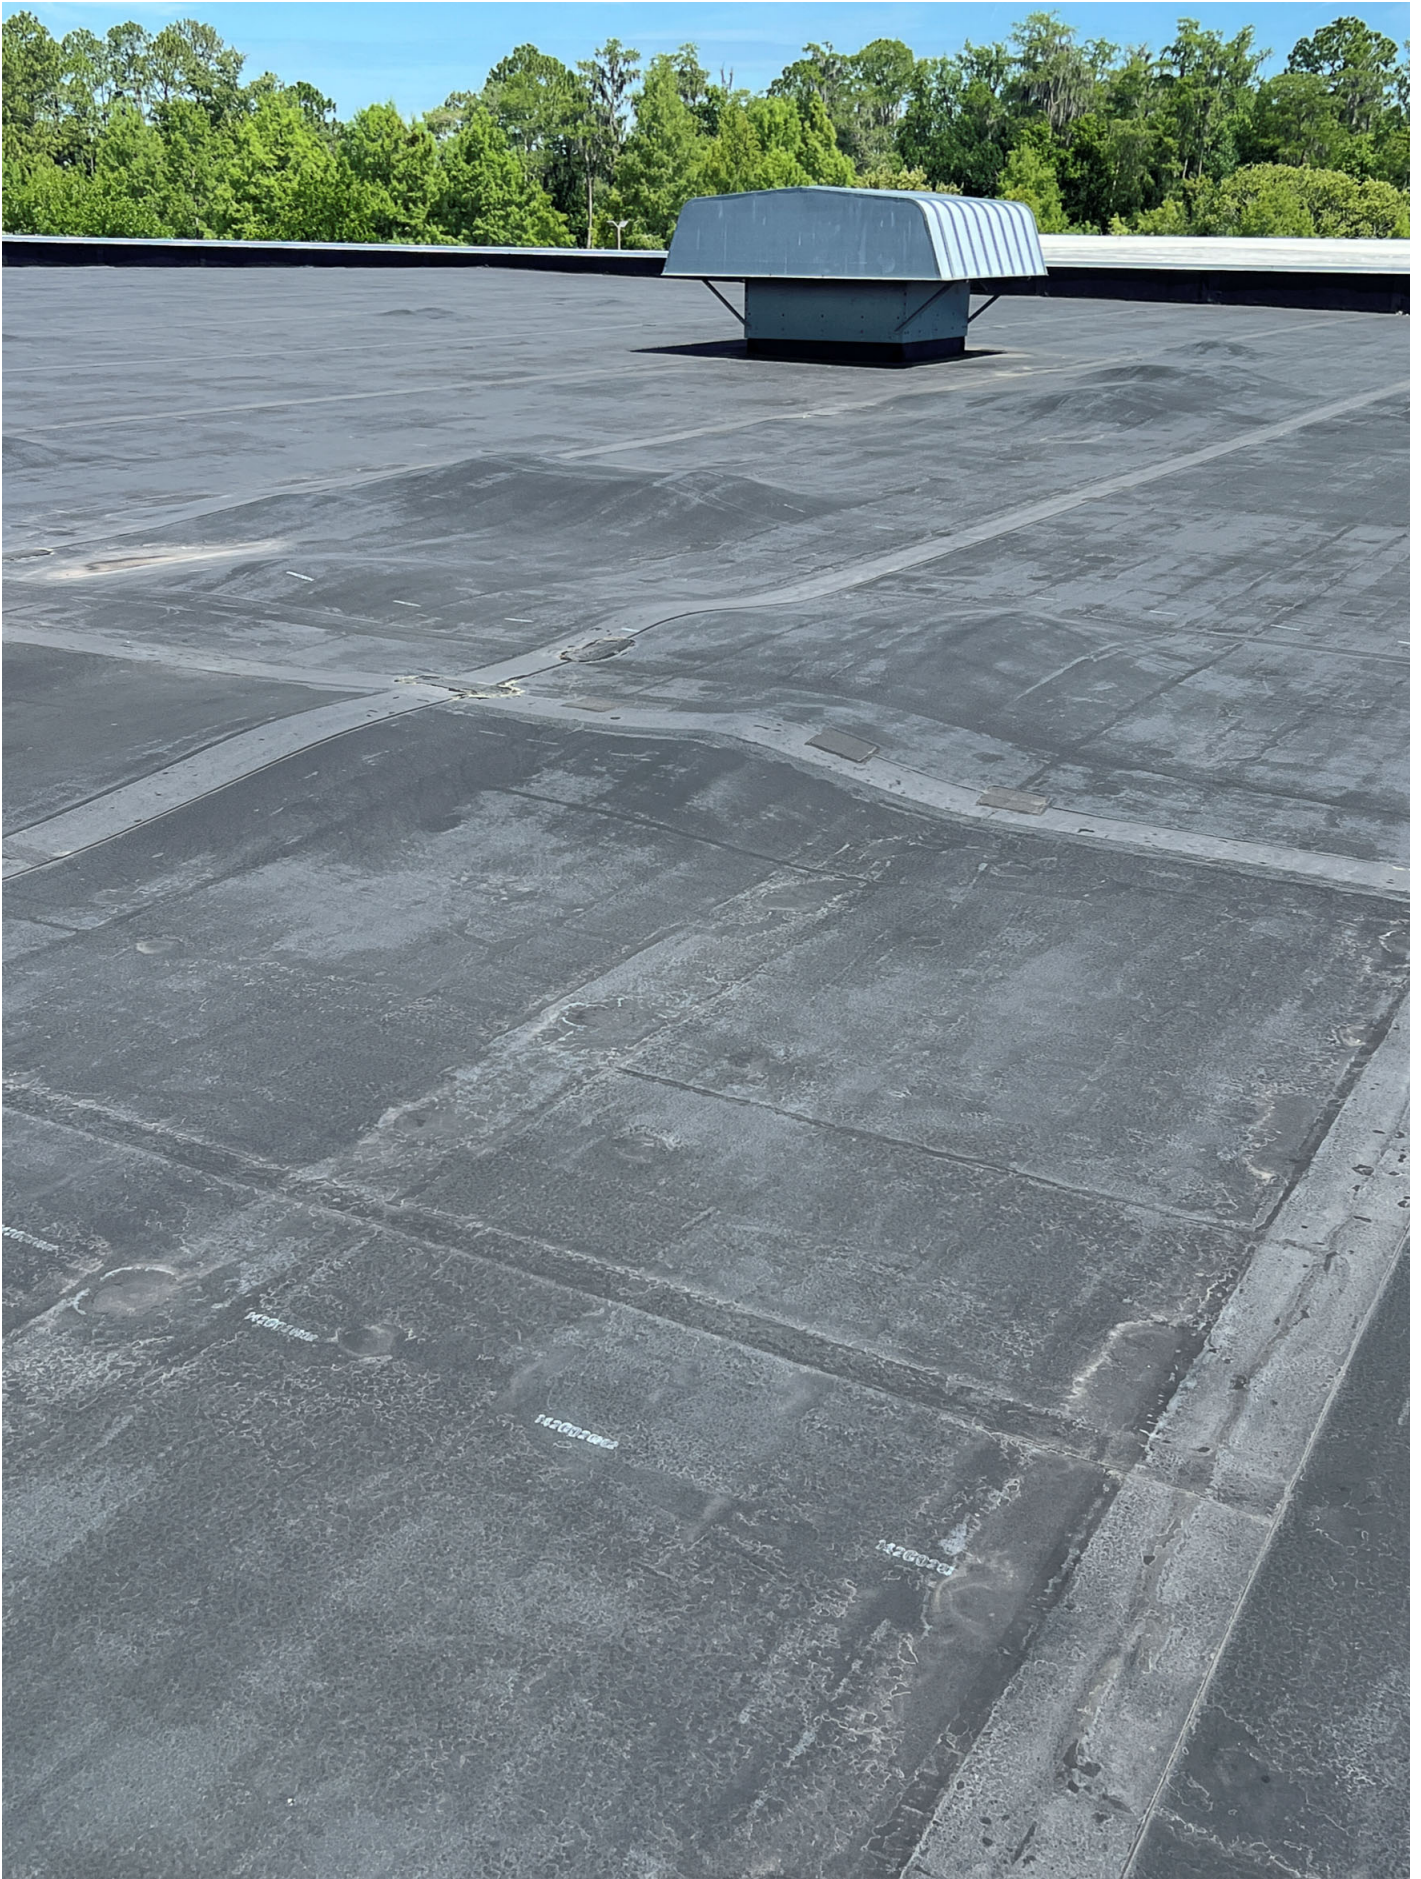
2000 warehouse roof large vapor bladder across the roof area
