RE: Due Diligence Report – Burkhardt Sales & Service

As part of the County's due diligence efforts to evaluate the conditions of the existing commercial industrial warehouse building (Burkhardt Sales & Service) located at 6125 NW 18<sup>th</sup> Drive, Gainesville, FL 32653, Paul Stresing Associates (PSA) was tasked with conducting an inspection of the facility to evaluate its condition prior to entering into a full purchase agreement to its purchase. On May 30, 2024, I was accompanied by KPI Engineering (KPI) where we walked the roof and interior of the facility with Mr. Matt Fultz of the Alachua County Facilities Department and Mr. Daniel Burkhardt, representing the seller where we gained access to the site and buildings to begin our evaluation efforts.

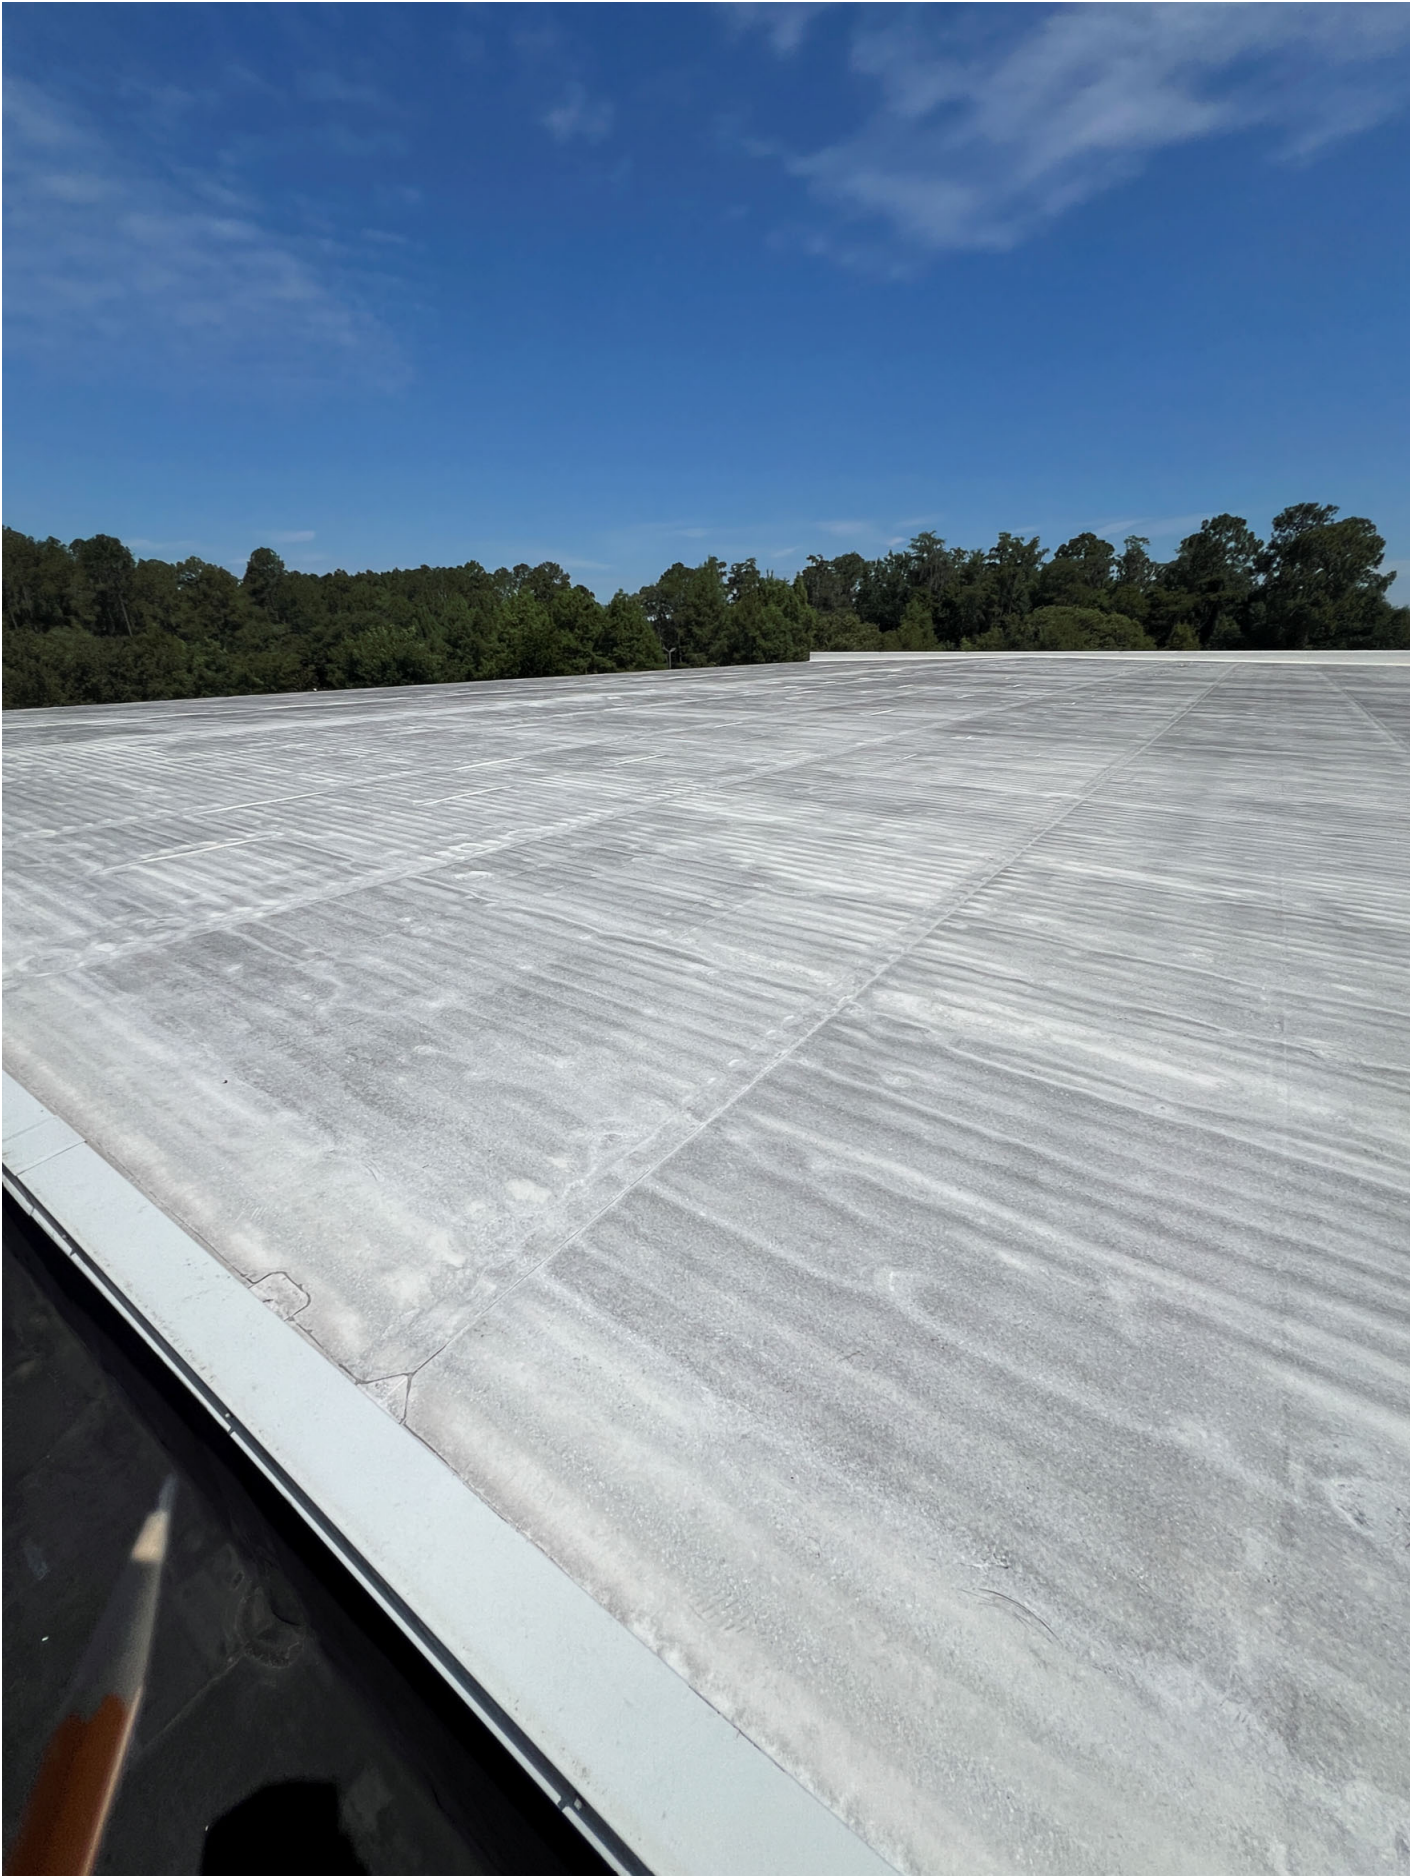
2011 warehouse addition with whole PTO single-ply roof membrane reasonable condition

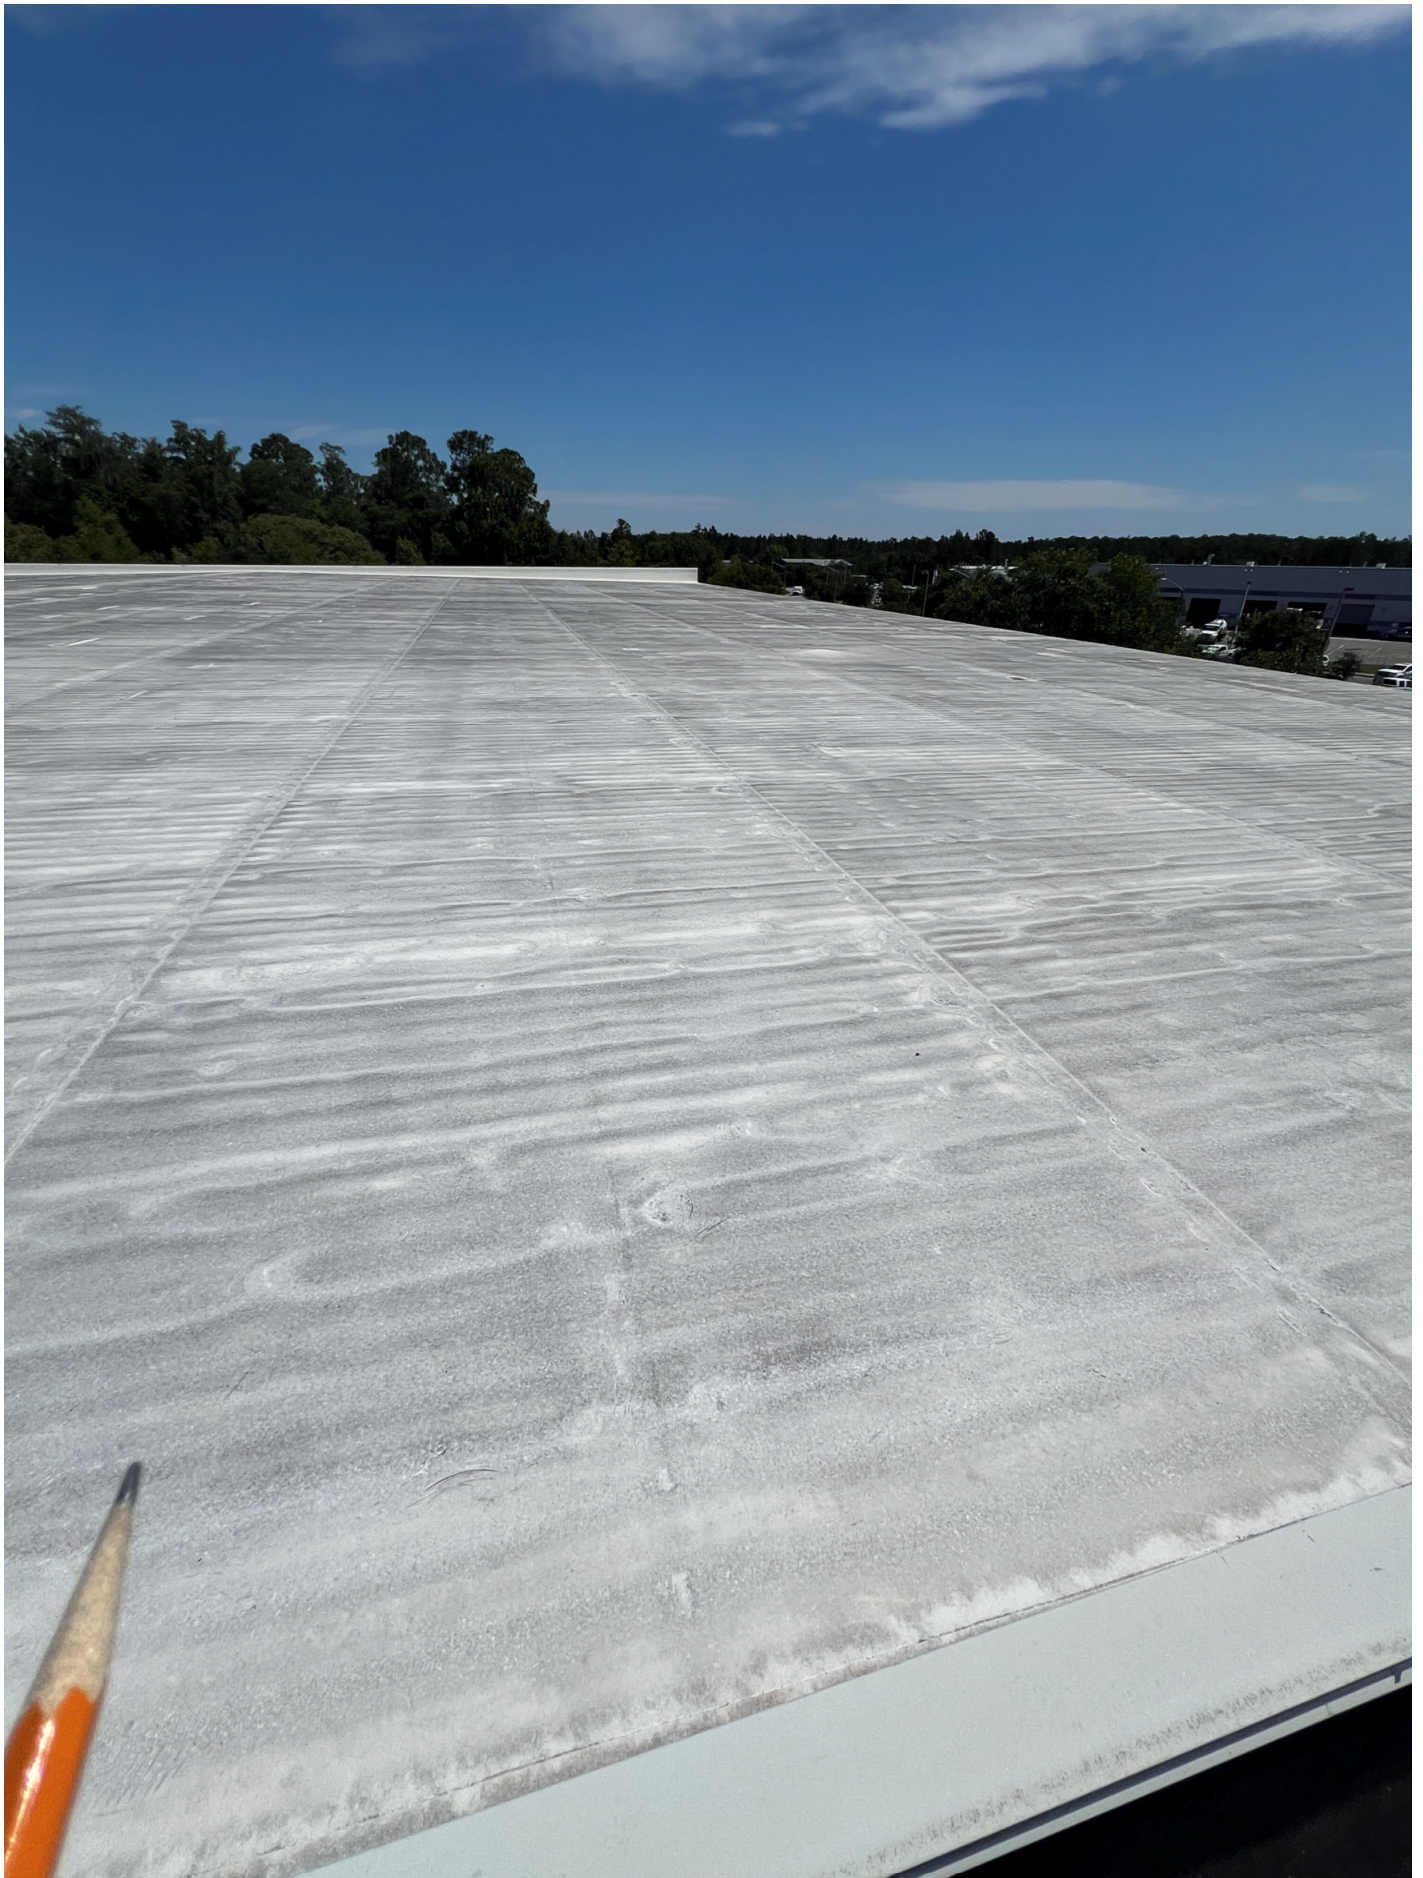
2011 warehouse addition single-ply PTO roof membrane, a few small vapor bladders

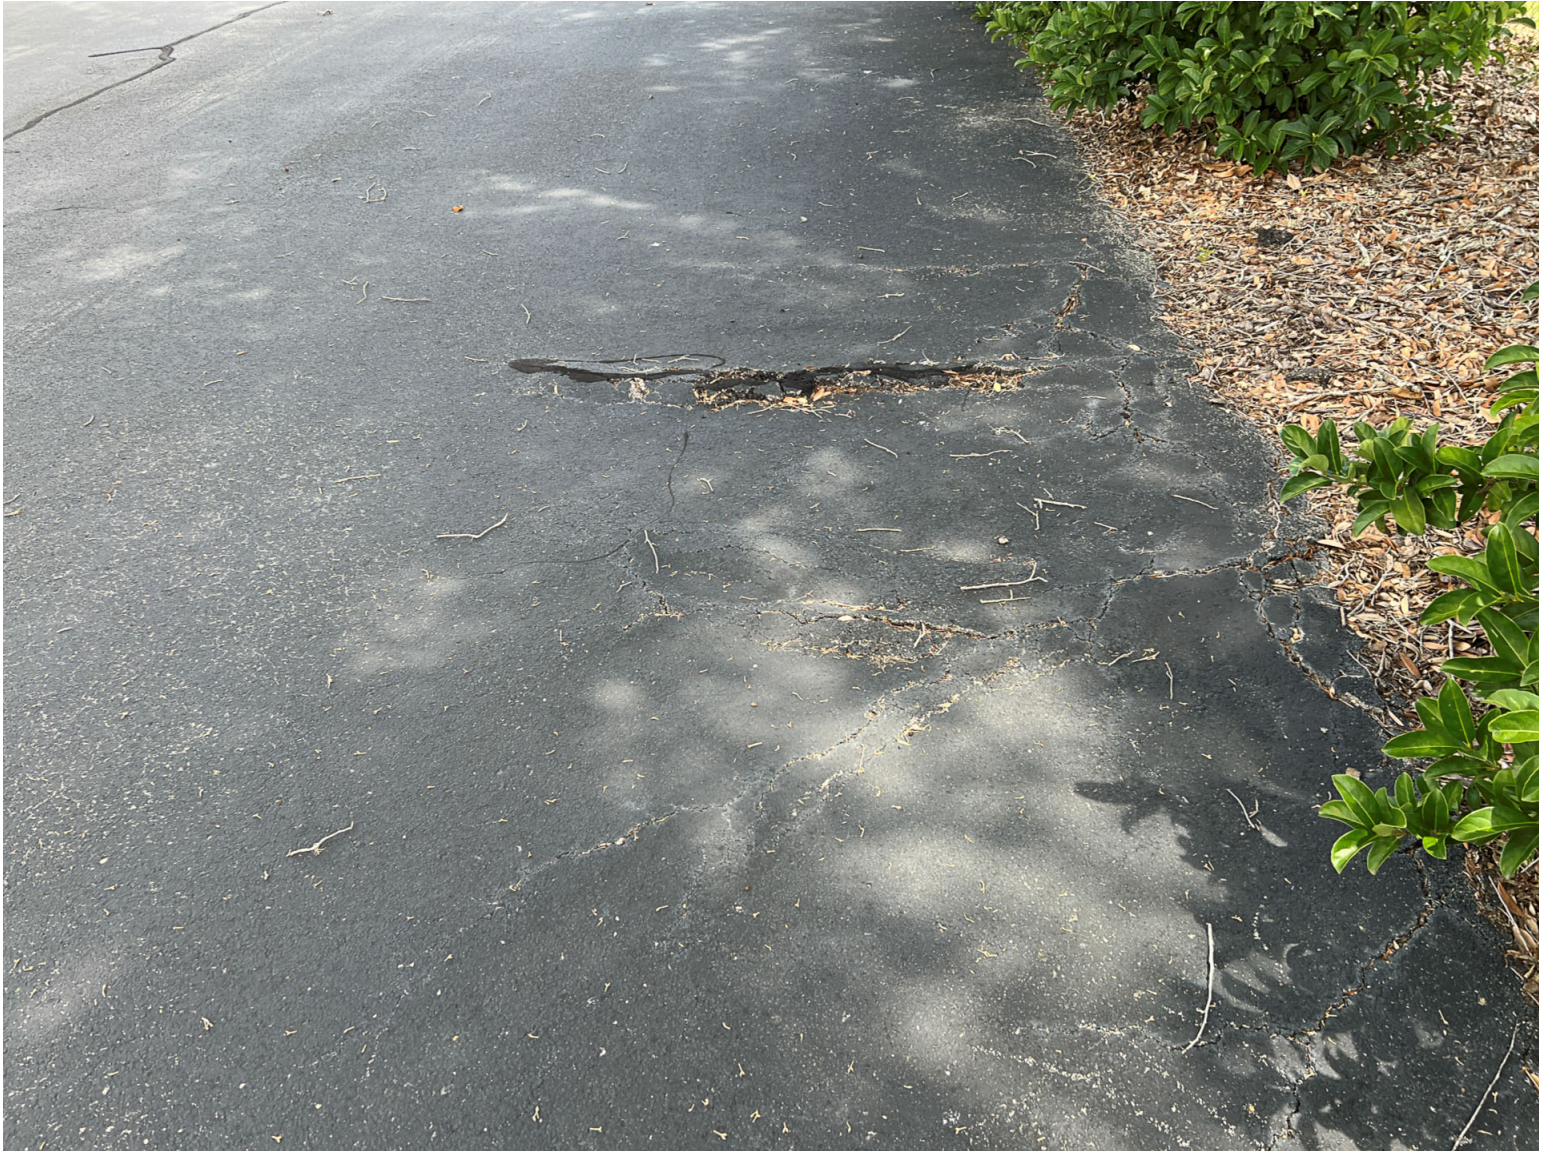
East drive along the west side of the 2000 warehouse, asphalt paving deterioration

In conclusion, the building is in very good general shape and there are no signs of structural concerns or compromises, three items do need to be addressed within the near future, the replacement of two of the A/C units on the lower administration roof will be required in the near future, the re-roofing of the original 2000 building should be considered to preserve the condition of the insulation and metal roof framing and interior finishes. Because of the amount of roof top equipment located on the lower roof area I would recommend a two-ply roof system to minimize exposure to tears and punctures. The upper roof of the warehouse does have exhaust fans which do not really require the maintenance that A/C equipment does so the exposure to damage is lessened, and you could go back with a white fleece back PTO product. The 2011 warehouse addition is capped with a single-ply TPO type membrane and was found to be in reasonably good shape and has a number of additional years of performance in it so this area could wait a few years before being re-roofed or you could decide to simply use this time to re-roof the entire building and get a single building roof warranty. The asphalt heavy duty truck paving requires maintenance that I would do immediately to ensure the subgrade and paving base do not become compromised.

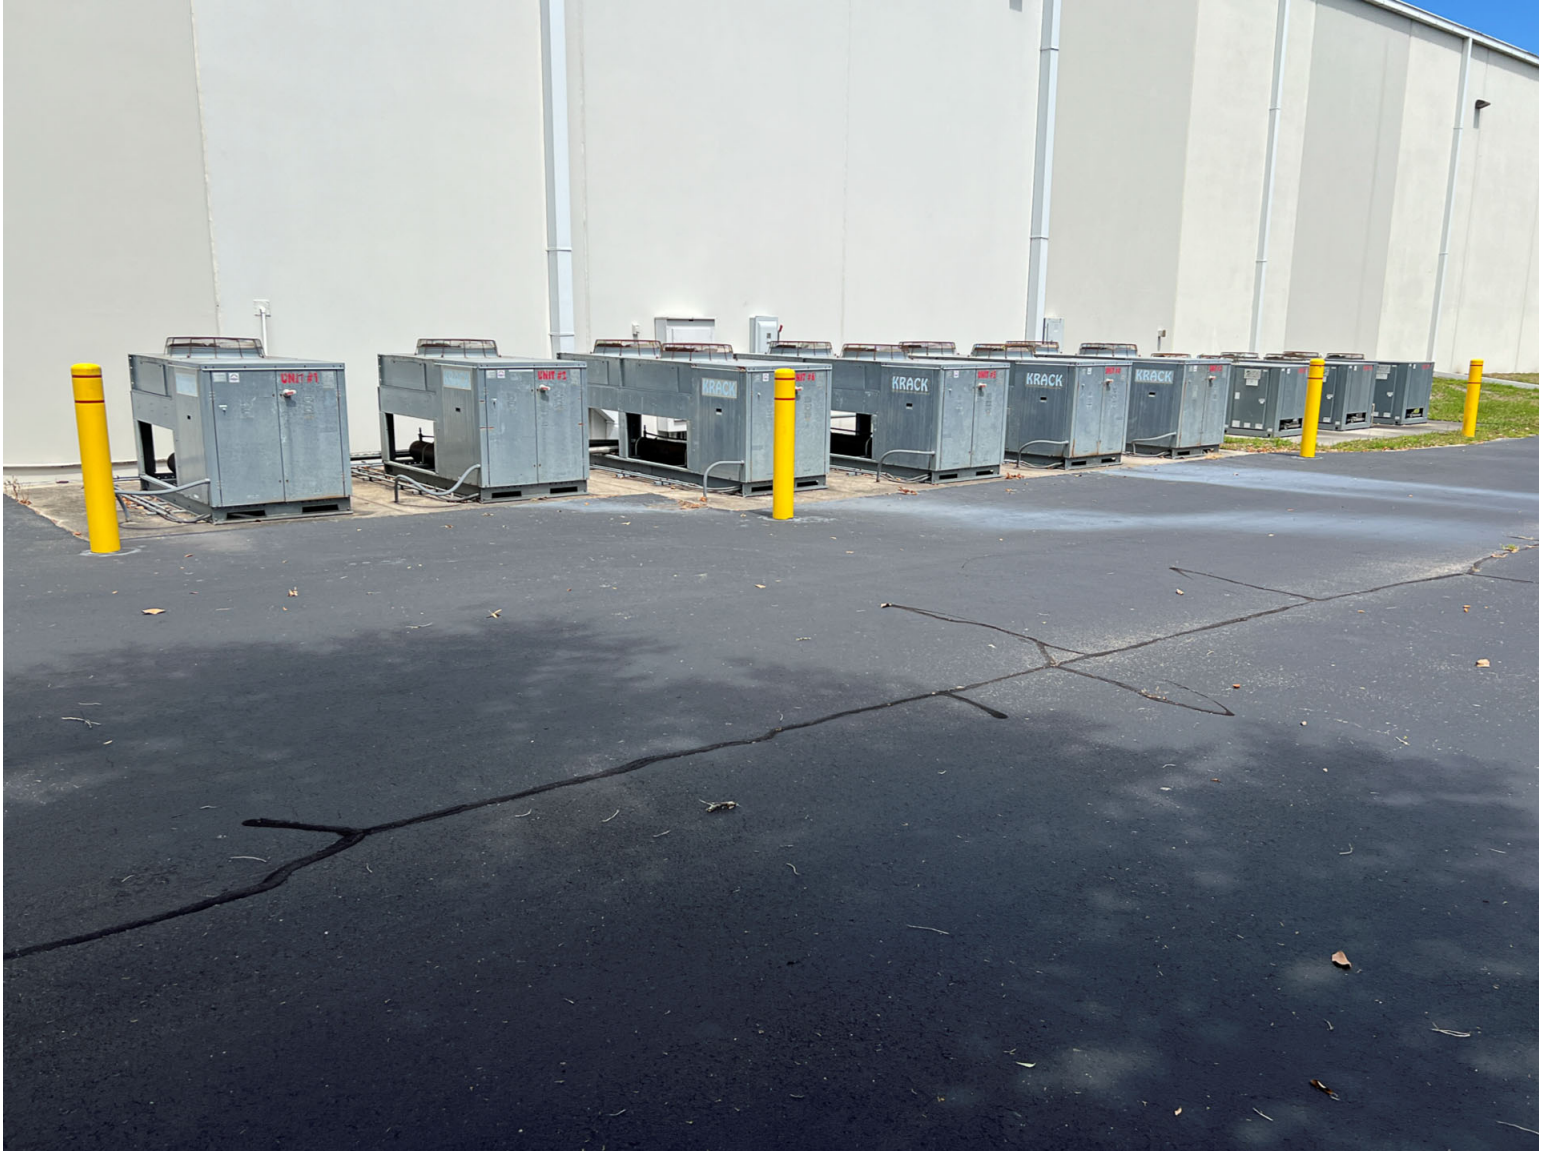
East drive along the west side of the 2000 warehouse, asphalt paving deterioration / east elevation A/C equipment

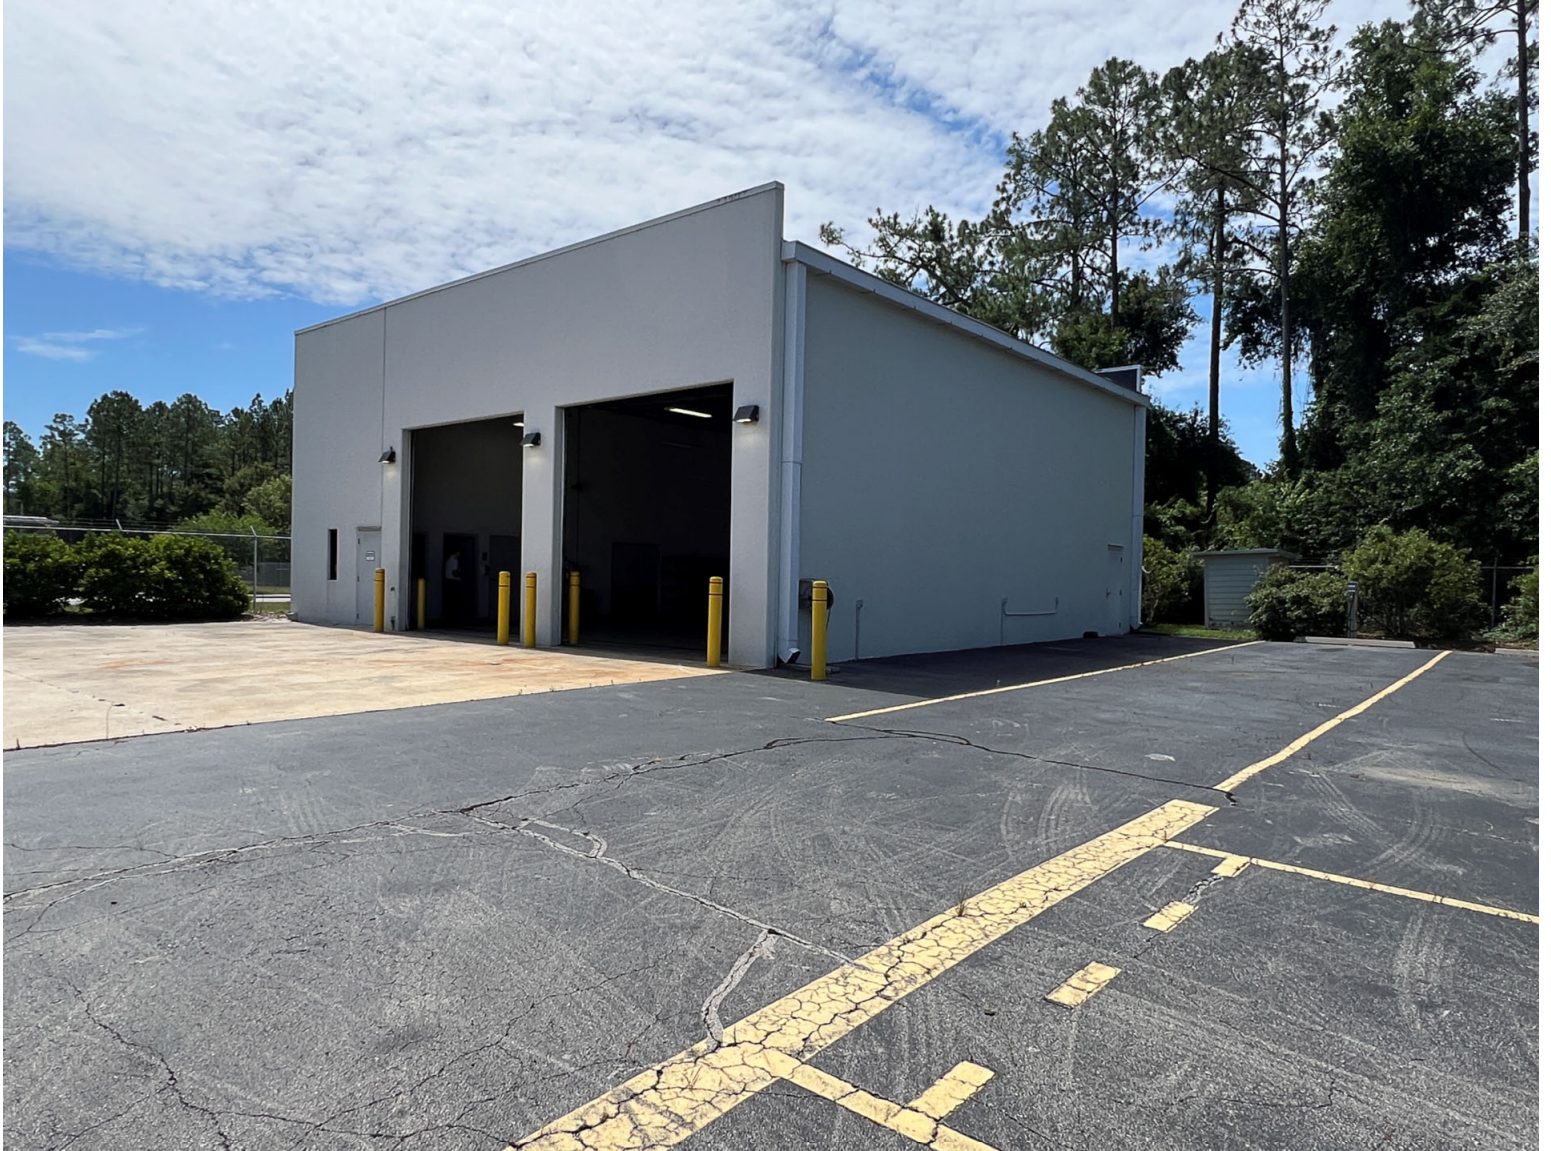
Out building / maintenance building southeast corner of site asphalt shows signs of wear & tear

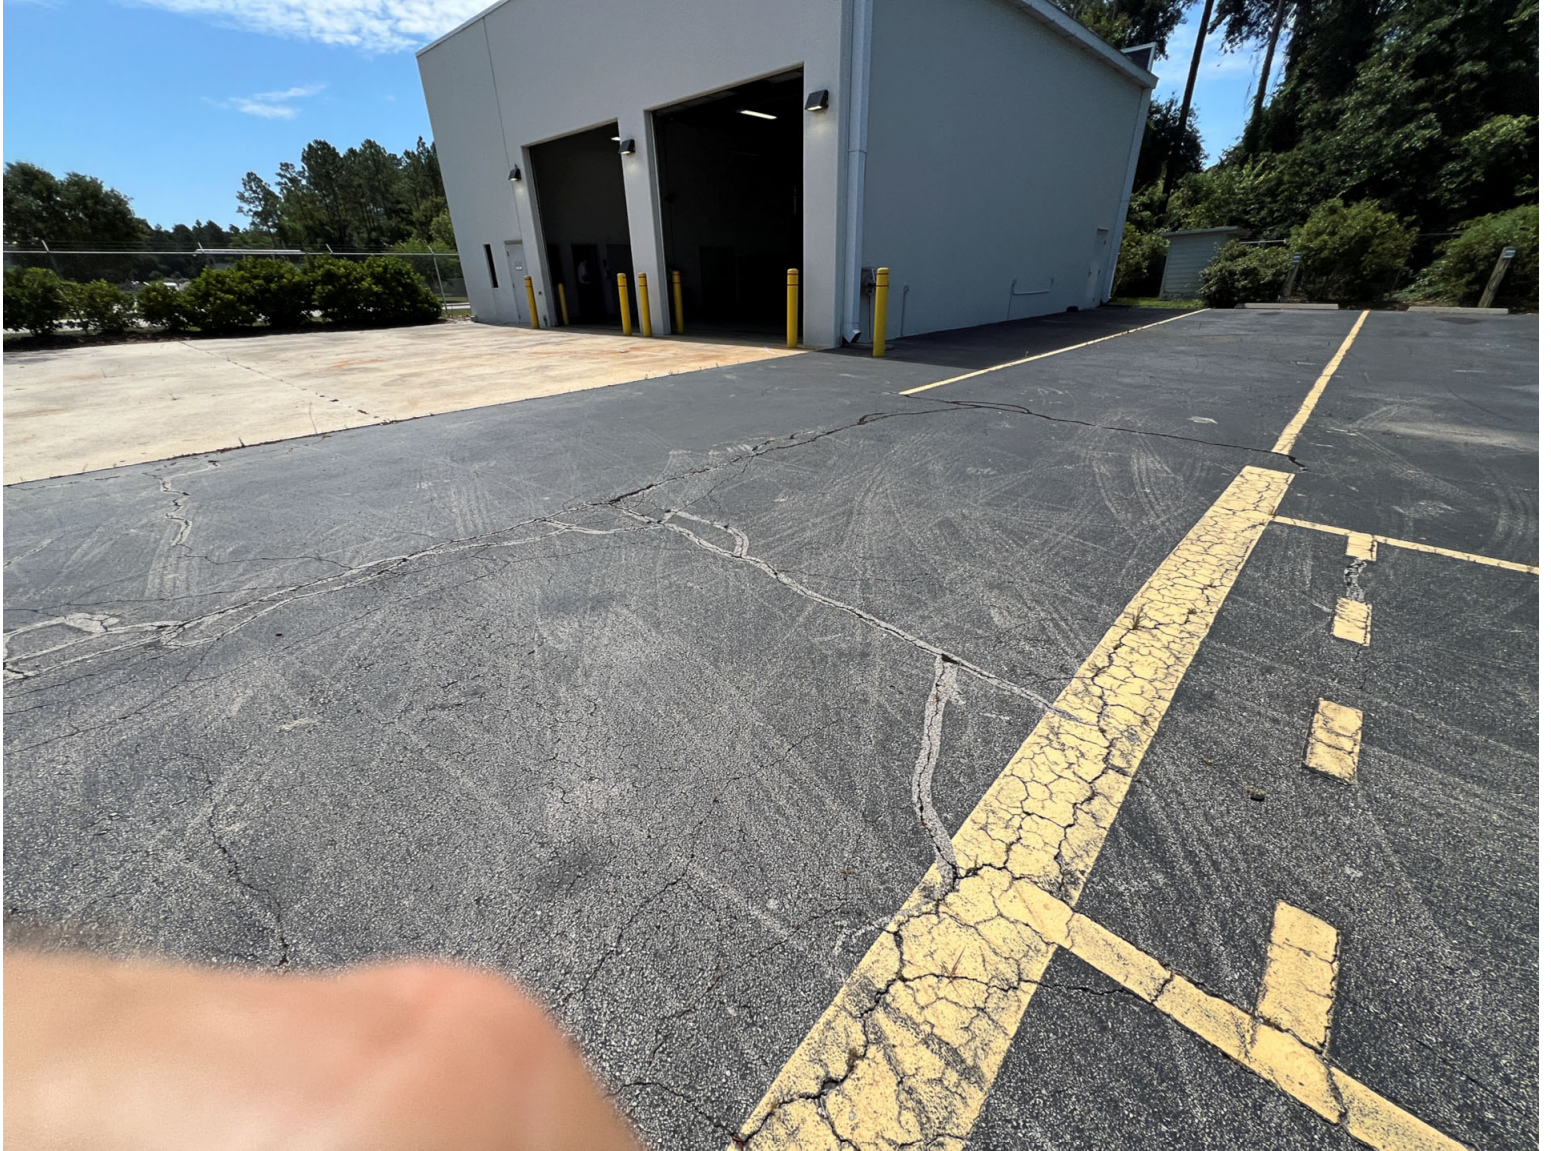
Out building / maintenance building southeast corner of site asphalt shows signs of wear & tear
