PHASE I ENVIRONMENTAL SITE ASSESSMENT

**FORMER BURKHARDT DISTRIBUTION CENTER
GAINESVILLE, ALACHUA COUNTY, FLORIDA**

GSE PROJECT No. 16505

JULY 2024

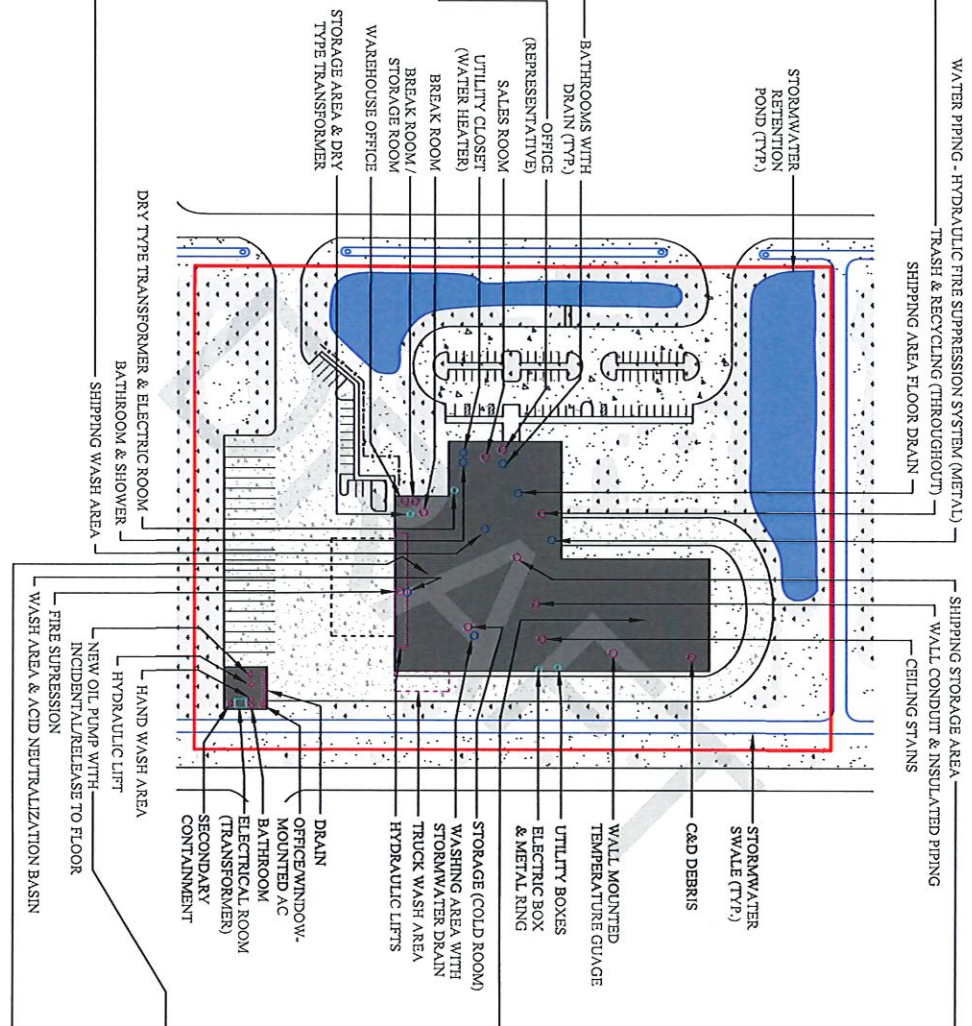
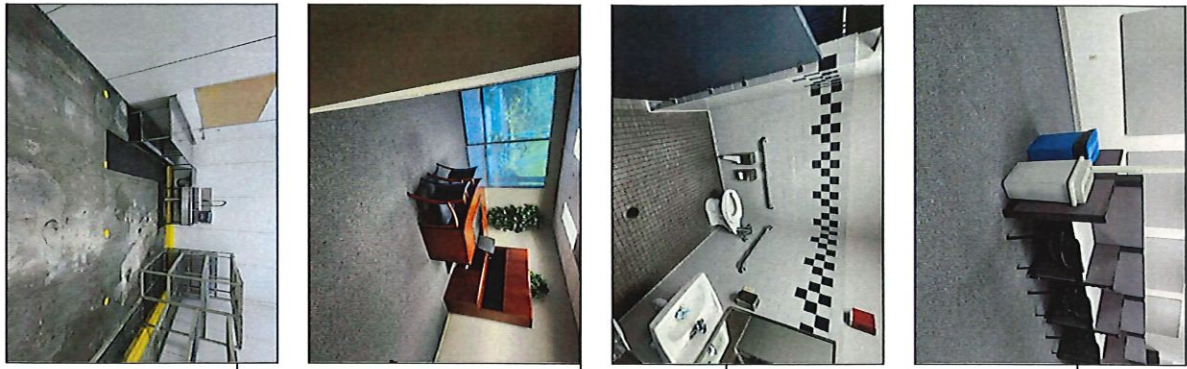
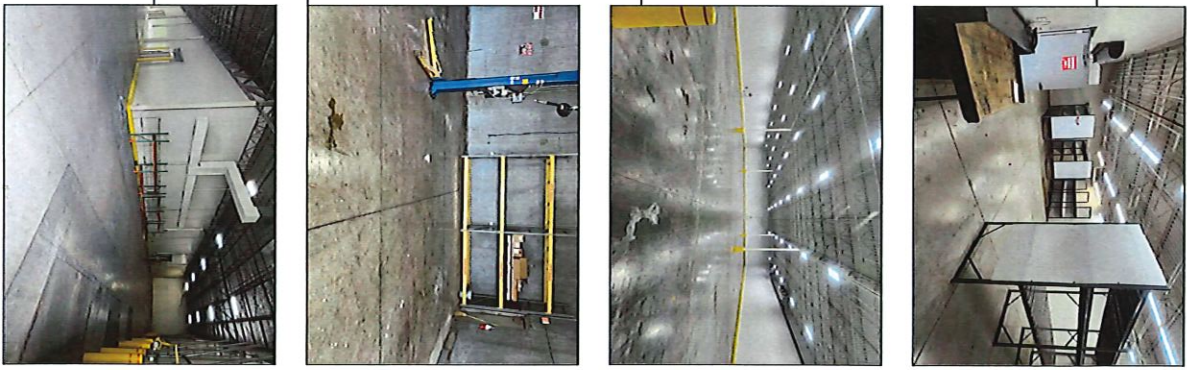
FIGURE
 2B-1

SITE PLAN WITH REPRESENTATIVE PHOTOGRAPHS - INTERIOR
