June 26, 2024

Subject: Summary Report of a Limited Structural Assessment  
**Sunrise Residence Inn**  
Gainesville, Alachua County, Florida  
GSE Project No. 16612

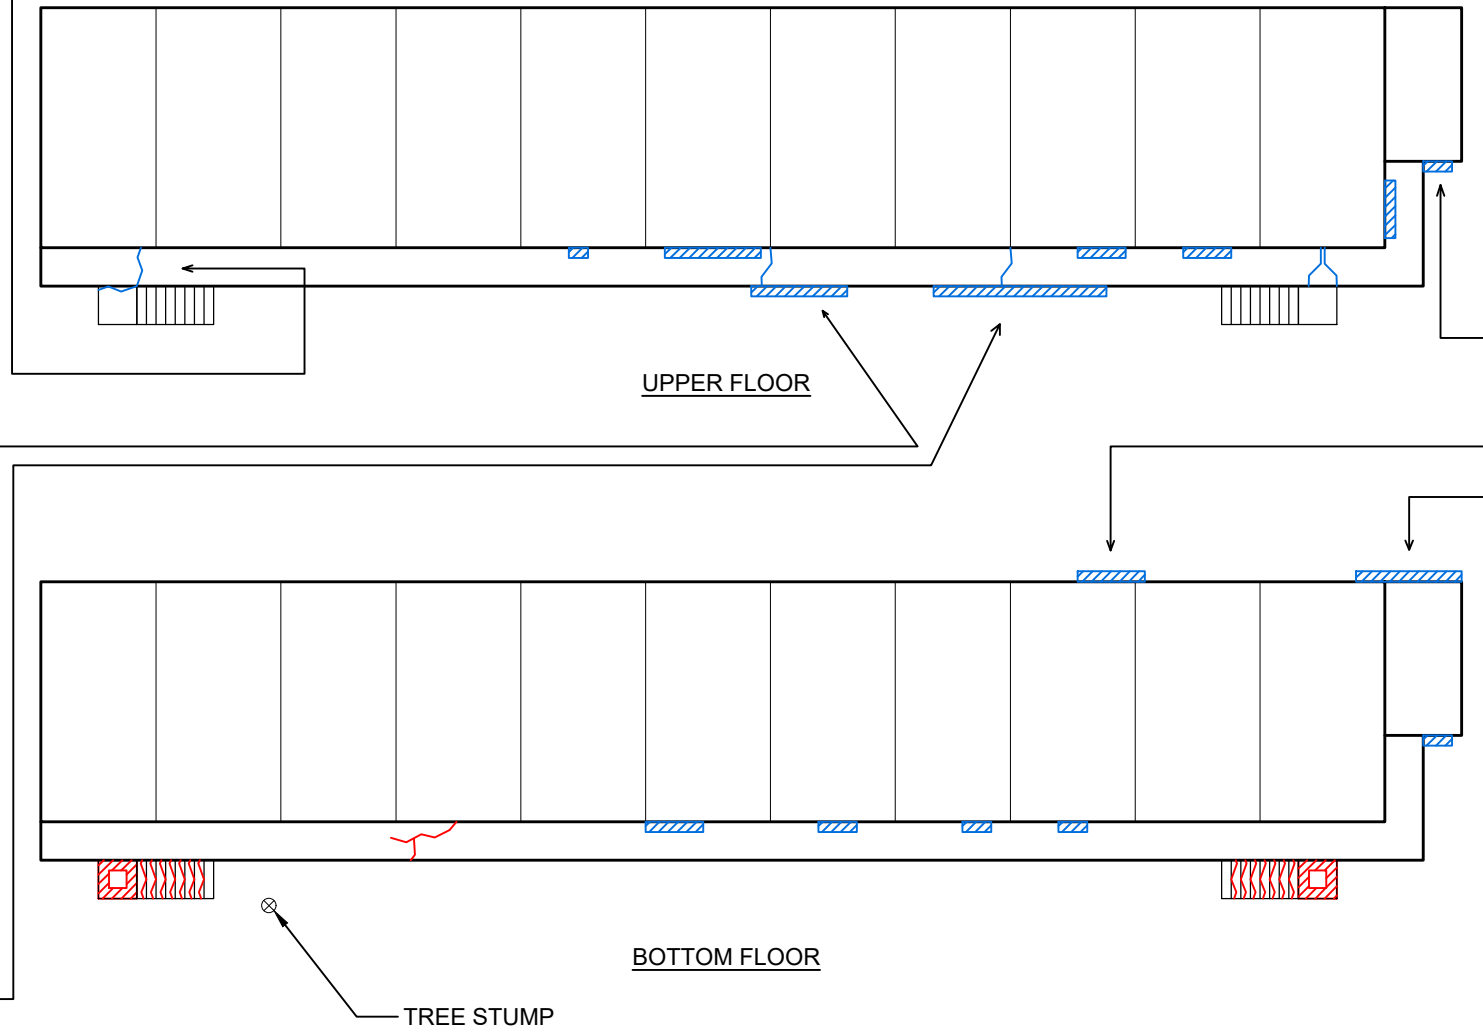
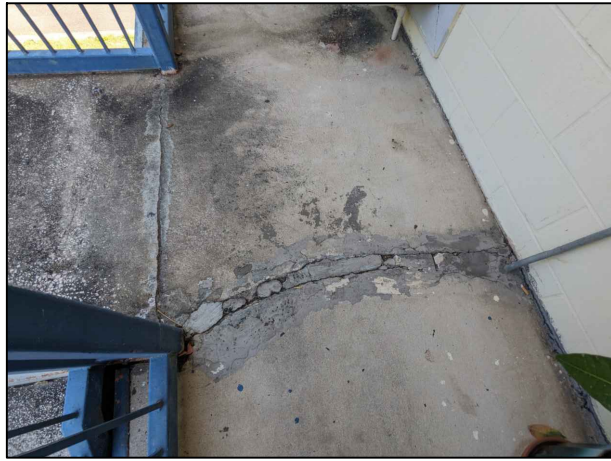
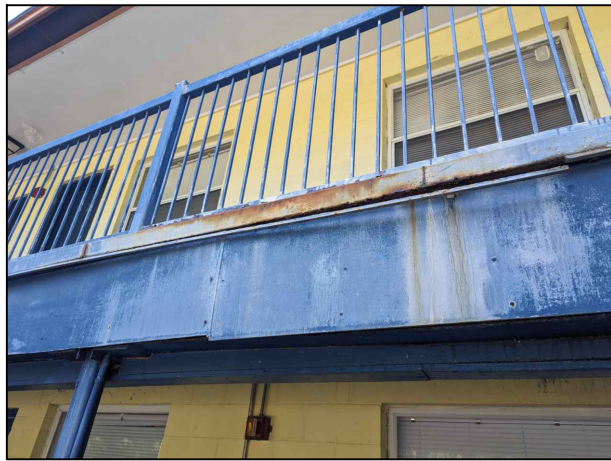
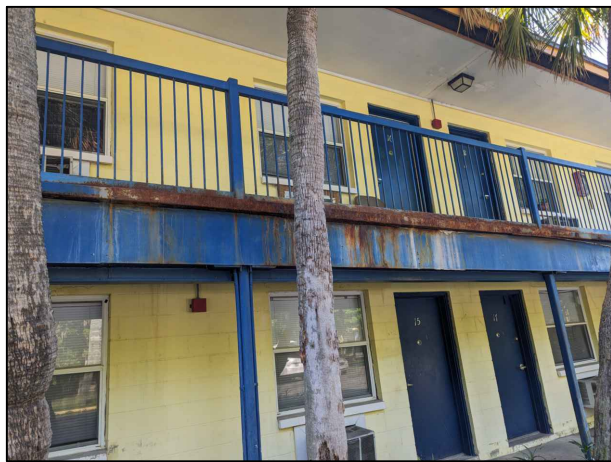
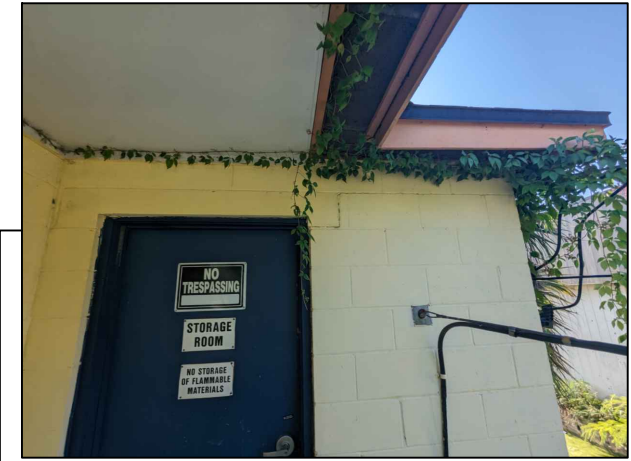
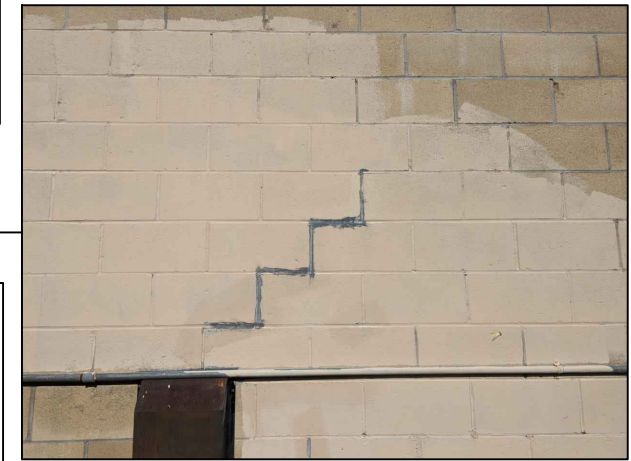
FIGURE  
 2A

Separation and cracking were identified in the CMU walls at many locations throughout the exterior walls of both structures. The observed CMU wall cracks were hairline to 1/8 inches in width. At Building 1, two locations of CMU cracking damage appear to have been repaired. A Hilti PS-35 ferro-detector was used to attempt to locate the spacing and orientation of reinforcing within portions of the CMU walls. Vertical reinforcing was only able to be confirmed within the corners of the structure. Ladder reinforcing appears to be installed horizontally within the mortar joints at 2 feet O.C.

There are walkways along the front of each structure which are supported by 3"x3" steel columns, perimeter beams and what appears to be metal pan walkways filled with concrete. The front edge beams were covered with wood-like sheathing, and access holes showed wood framing near the columns. Oxidation and rusting damage of metal was observed in many locations throughout the walkway structures of the apartment buildings, including at the base of columns. The worst oxidation and rusting damage is located along the front edge of the walkway at Building 1 along the top edge of the metal pan that supports the concrete walkway. Additionally, concrete cracking was identified in many areas of the walkway slabs. Each walkway has two sets of stairs, one at each end. These stairs have steel stringers with steel pans and concrete treads. Rusting and oxidation was observed throughout the stair treads and top landings. At Building 2, the stairs at the north end of the building show signs of a car running into the handrail. Mr. Vaughn confirmed this theory. The eastern bottom post of the handrail has sheared at the base of the post where the column had significant corrosion, and the entire handrail has shifted halfway into the stair walk path.

GSE entered the interior of many of the units to inspect the structural supporting members. None of the interior CMU walls showed signs of damage. The walls appear to have been painted recently in many of the units. The CMU walls extend from the ground floor to the second floor ceiling height. The roof structure is pre-engineered wood trusses spaced at approximately 2 feet O.C. and bear on the top of the CMU walls. The second story floor system is 2x6 wood joists spaced at 16 inches O.C. and hang on the side of the CMU walls with hangers. These joists have wood x-bracing made of 1x4s.

It is GSE's opinion that the CMU walls overall are in good condition. Cracking damage observed in the exterior CMU walls of both structures is not a structural concern. Most of the cracks in the exterior CMU walls are attributed to differential movement resulting from long-term post-construction settlement of the soils supporting the foundation. The differential settlement is consistent with foundation settlement that is within an expected range for the type and age of construction. Various factors influence actual post-construction differential settlement including lack of adequate compaction, disturbance of the foundation supporting soils during construction, surface water diversion, foundation embedment, and erosion. GSE recommends patching/filling all cracks larger than 1/16 inch and repainting the exterior CMU walls with an elastomeric paint system.

The oxidation, rusting, and cracking damage observed within the walkways is a structural concern. At the time of the assessment, much of the support framing for the walkways and the underside of the concrete slabs were covered and could not be properly inspected. It is GSE's professional opinion that all framing and the underside of walkway slabs be uncovered, all oxidation/rust removed, and members cleaned to determine the extent of damage to the walkway support framing and concrete slab. This should be done immediately, or shoring added mid-way between columns prior to a full inspection.

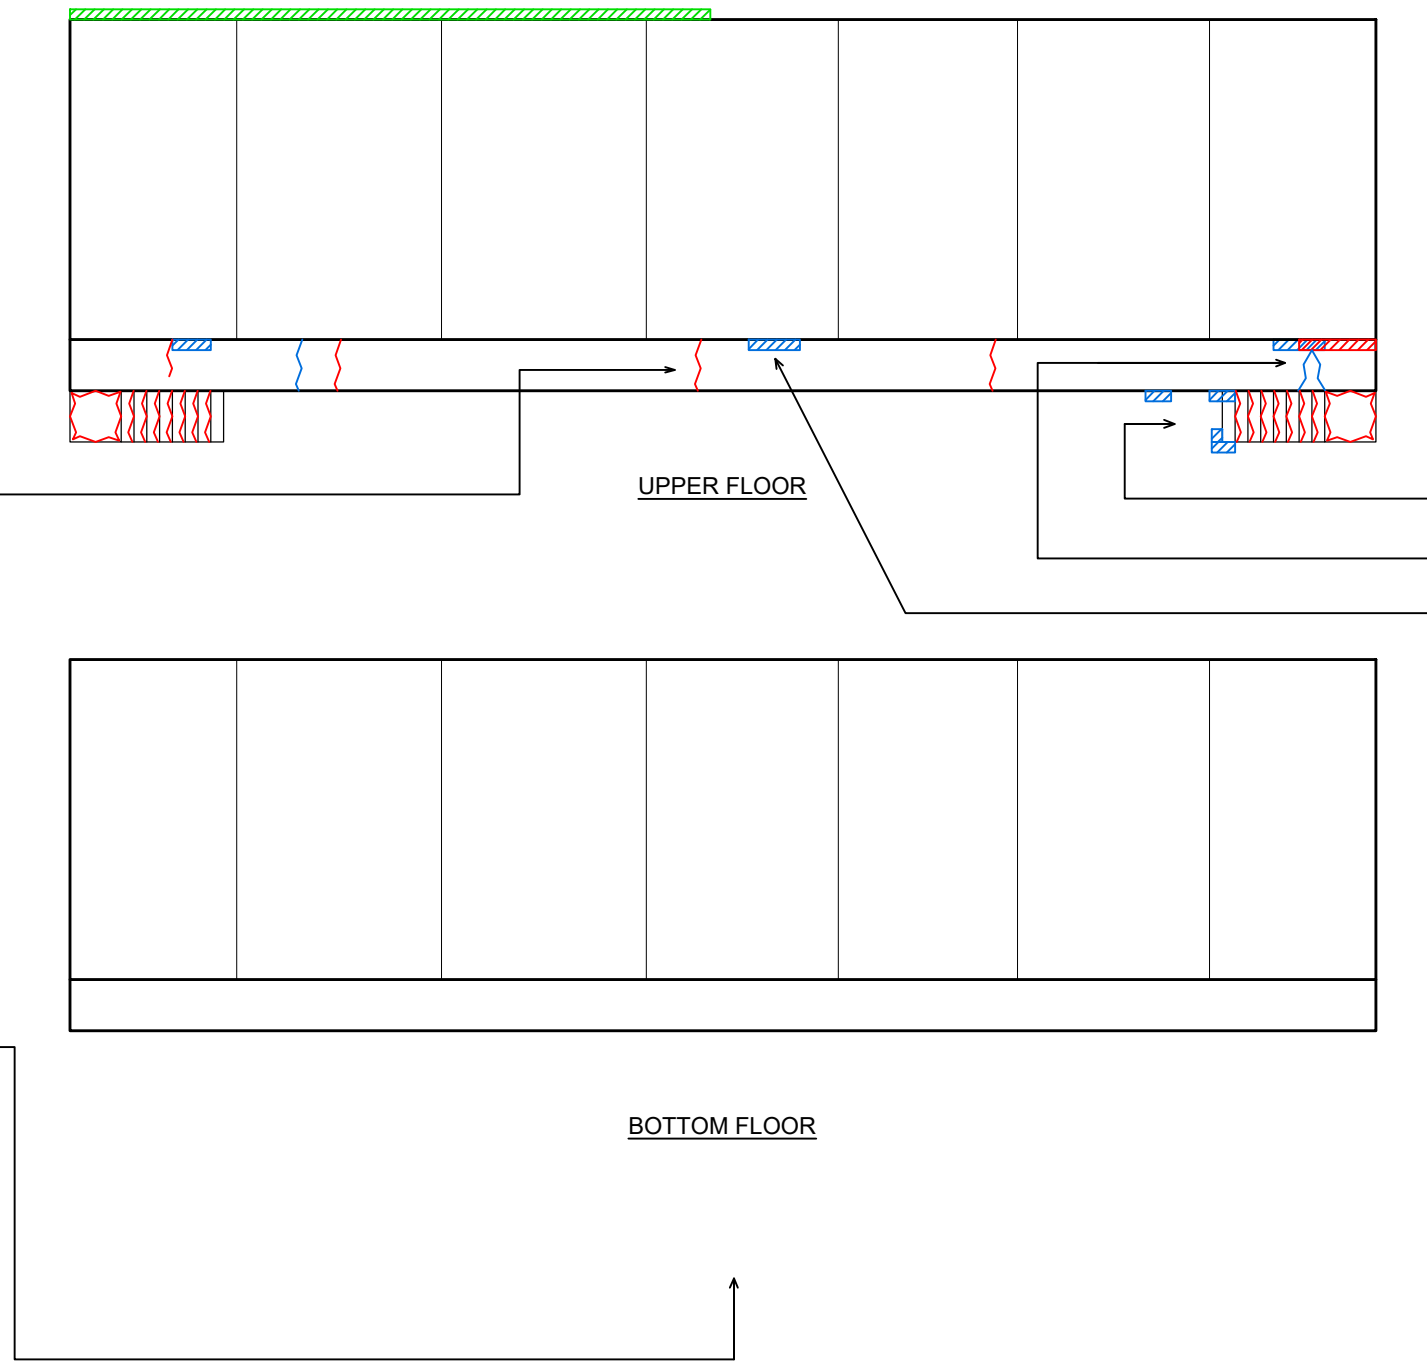
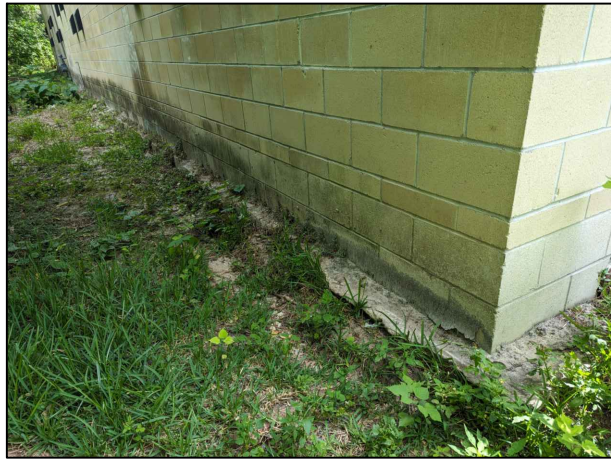
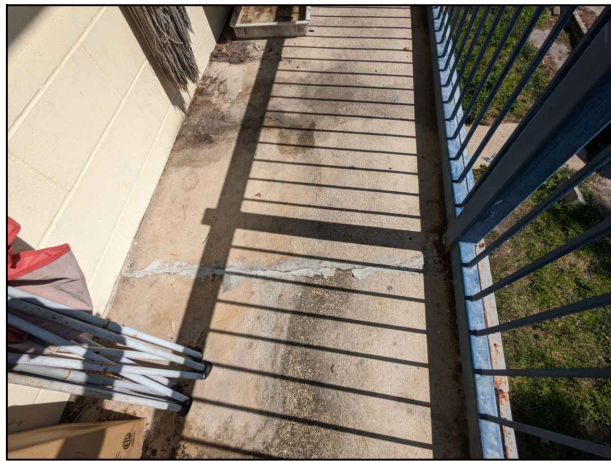
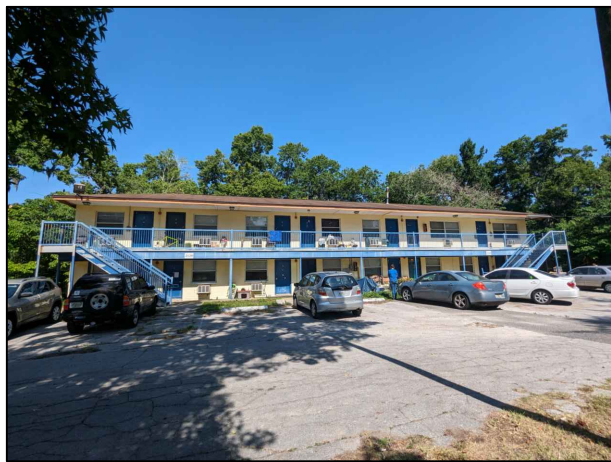
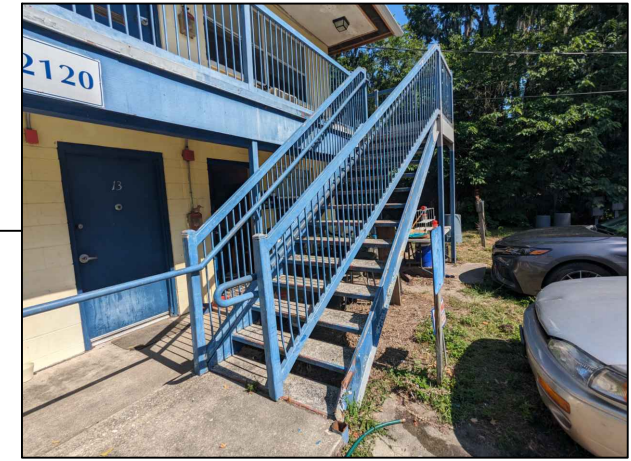
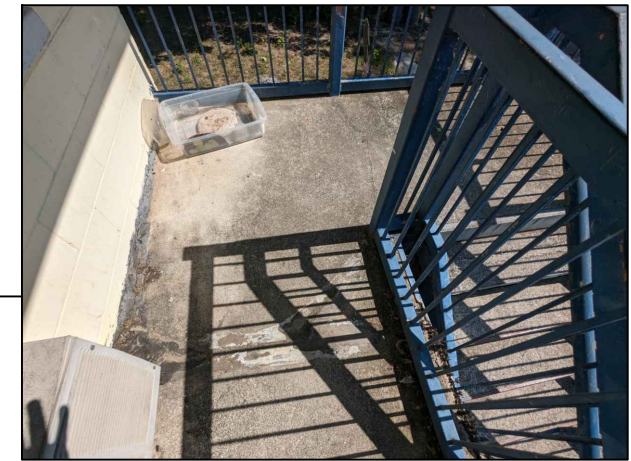
FIGURE  
 2B

At the southwest corner of Building 2, the foundation shows signs of erosion and undermining of the foundation for approximately half of the length of the rear exterior wall (approximately 50 feet long). This undermining is exposing approximately 6 inches of the 12-inch-thick foundation. Within 10 to 20 feet of the building, there is a steep drop-off that drops into a creek.

It is GSE's opinion that the erosion along the back of Building 2 can be attributed to stormwater erosion. Neither structure has gutters installed to help collect the stormwater runoff and divert the water away from the foundations of the structures. GSE recommends that stormwater controls be implemented for both structures including the installation of gutters and grading the soils surrounding the structures to slope away from the foundations. Both buildings would benefit from the installation of erosion protection including erosion preventative vegetation, but this is strongly recommended along the back of Building 2.

One of the handrails for the stairs at Building 2 has been hit by a car and sheared off at the base of the bottom post nearest the parking lot. It is our opinion that this railing be repaired immediately and that the base of all columns be exposed to properly inspect and determine the amount of corrosion present. This should be part of the overall inspections recommended in the paragraph above.
