# The Scottish Inns

## Existing Conditions Assessment

Prepared for **Alachua County Public Works**

**October 16, 2023**

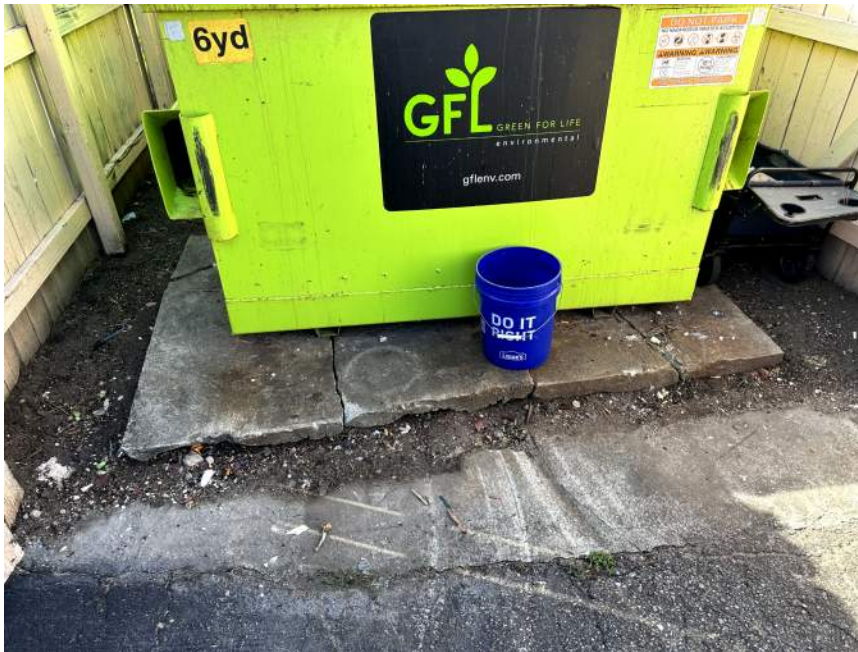
Condition: Dumpster pad is broken, no turndown edge, no protection bollards

Recommendation: Pour new concrete dumpster pad on compacted structural grade fill. Install concrete filled galvanized steel pipe bollards at back of pad to prevent dumpster from being pushed into fence enclosure.

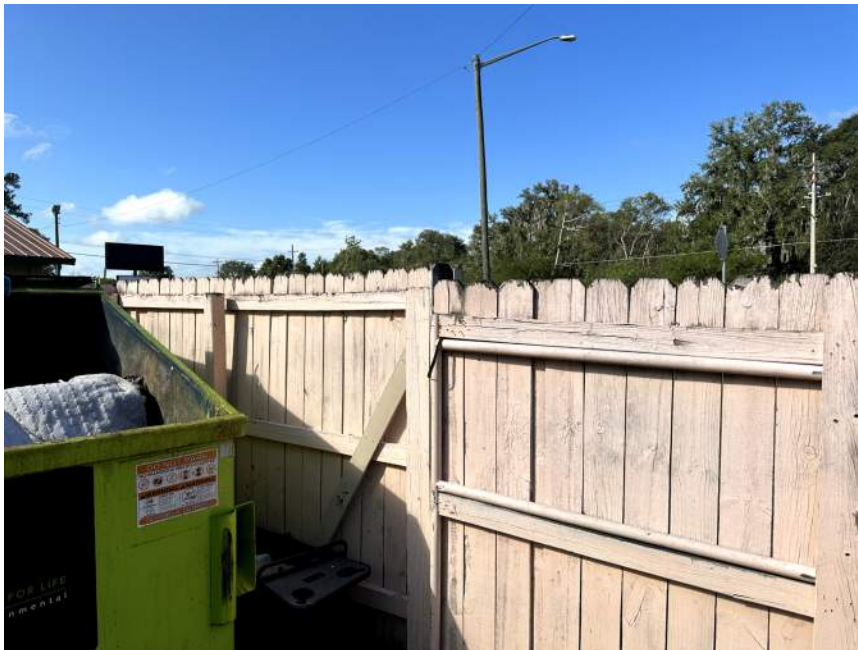
Condition: Dumpster enclosure fence is rotting along tops of fence boards.

Recommendation: Rebuild enclosure using PVC fencing and gates.

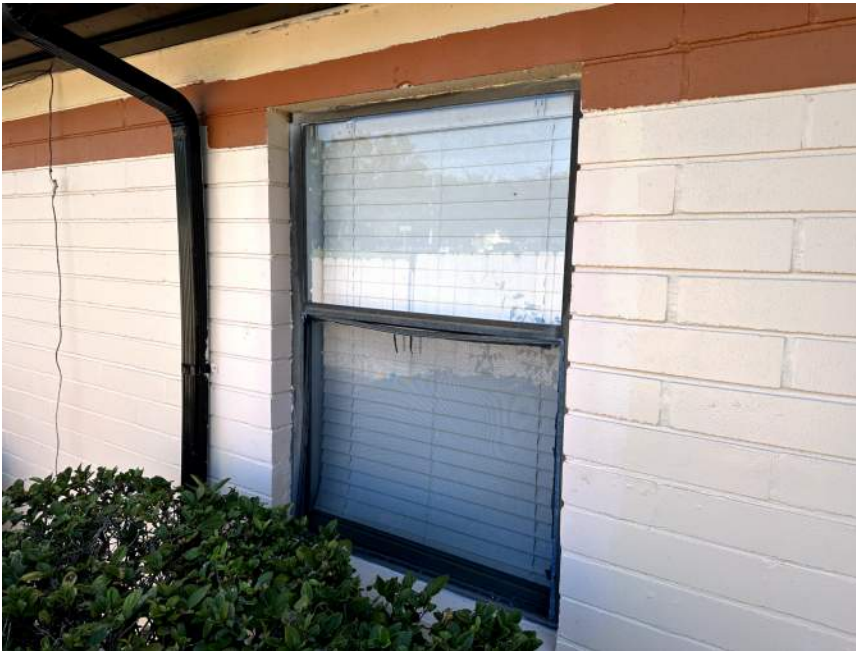
Condition: Window screen is damaged, bent frame.

Recommendation: Replace all damaged or missing window screens with new screens to prevent insect intrusion.

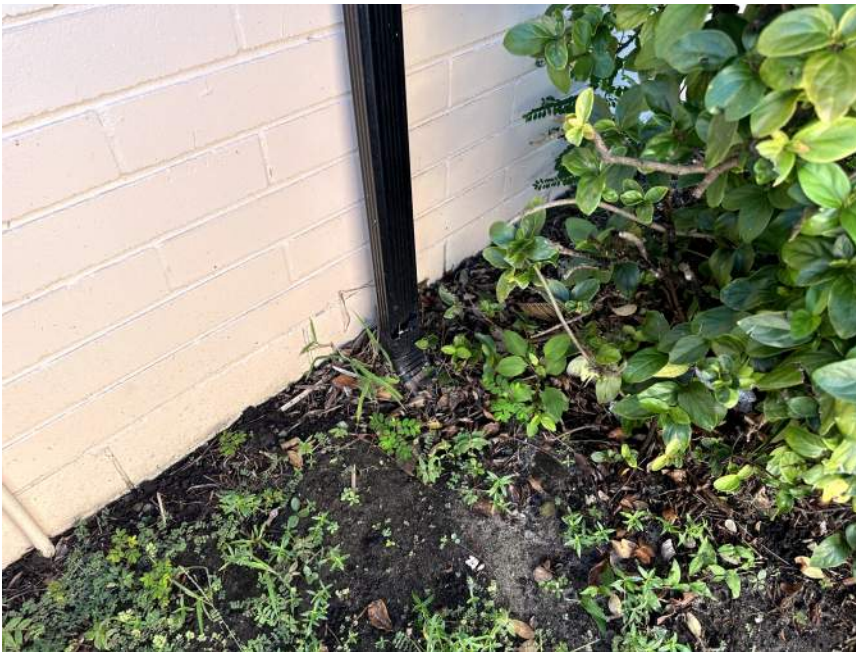
Condition: Several downspouts are damaged from weed trimmer or other abuse. Condition of connections to underground storm water collection system are not visible or do not appear to be sealed. Type of material used for underground collection piping could not be verified.

Recommendation: Repair downspouts where needed. Verify material and condition of below grade storm water collection piping. Adjust connection points to be above grade to avoid seepage of soil into storm system.

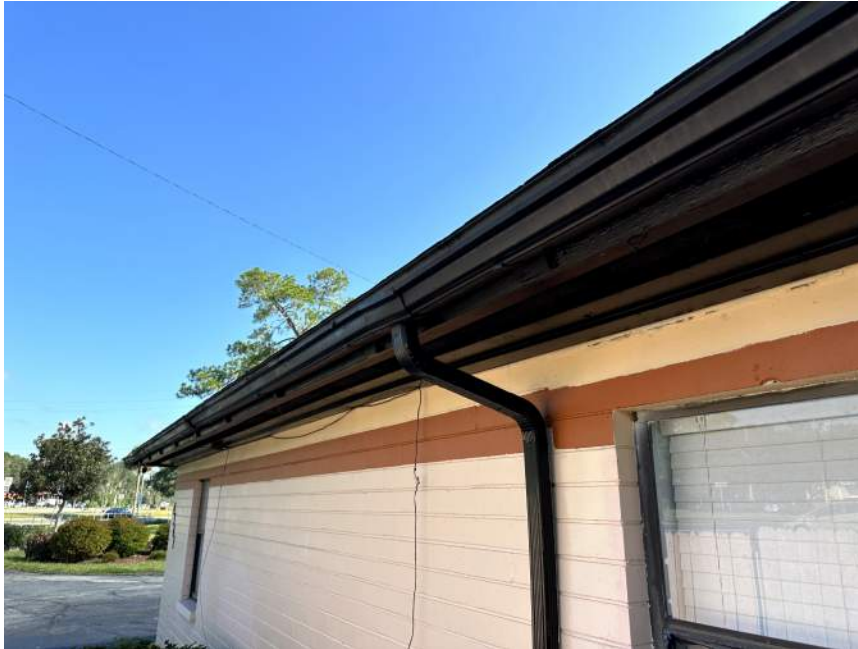
Condition: Roof gutters have a few damaged areas and many patched locations which may leak during rain events.

Recommendation: Monitor gutter performance throughout building and repair or replace sections as needed. Poor gutter performance can cause erosion around base of building.

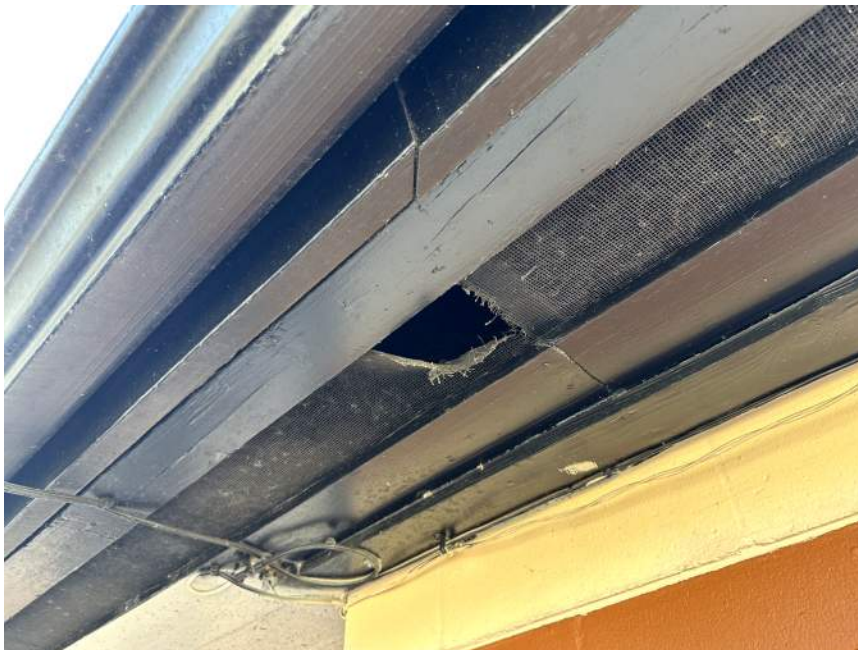
Condition: Soffit vent screens are torn in multiple locations.

Recommendation: Repair soffit screens or replace with rigid vinyl vent channels to prevent pest intrusion into attics.

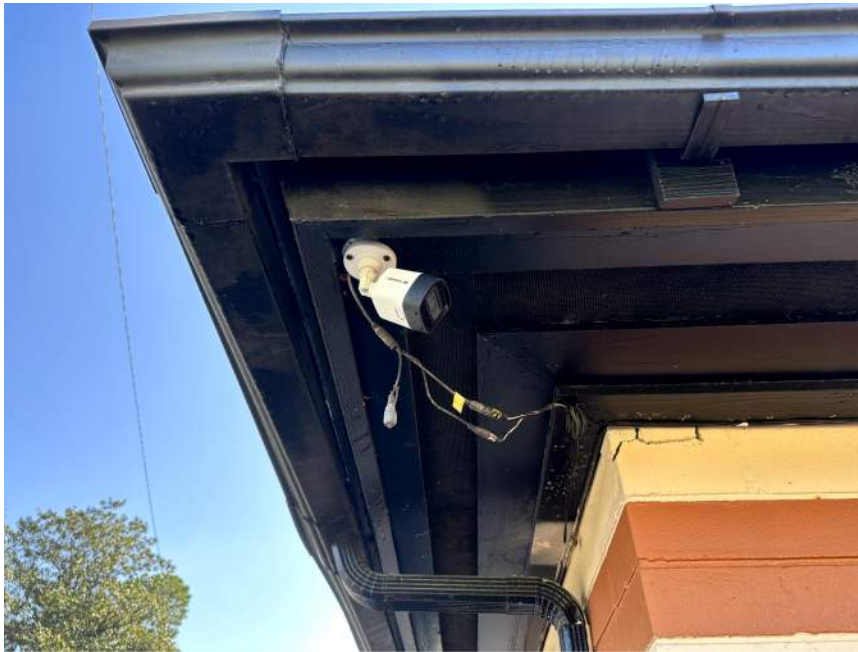
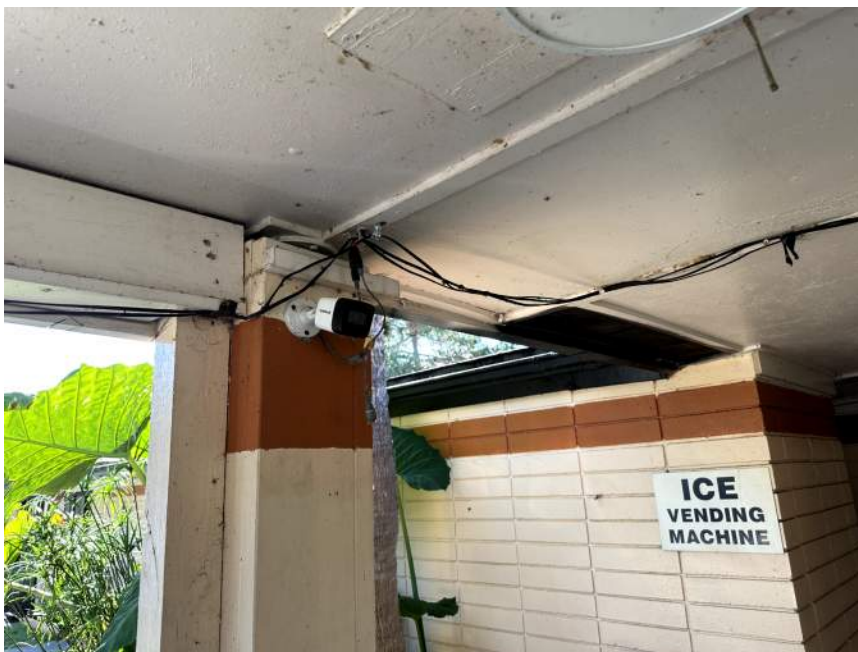
Condition: Security camera wiring is exposed and vulnerable to damage or vandalism in multiple locations..  
Recommendation: Relocate wiring into rigid conduit and extend into attic to protect.

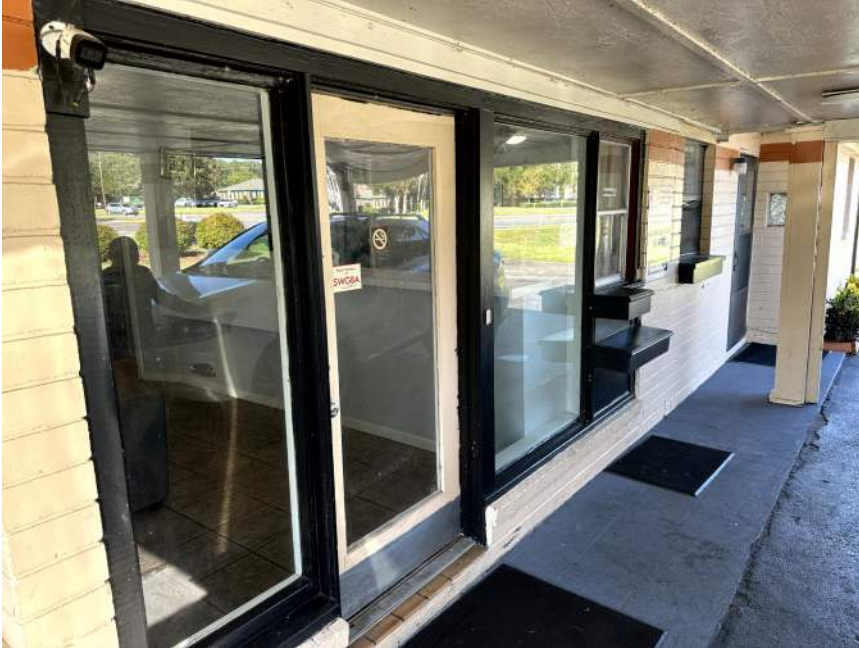
Condition: Front office entry door is not ADA accessible for the public.  
Recommendation: Install new concrete ramp and ADA compliant door hardware.

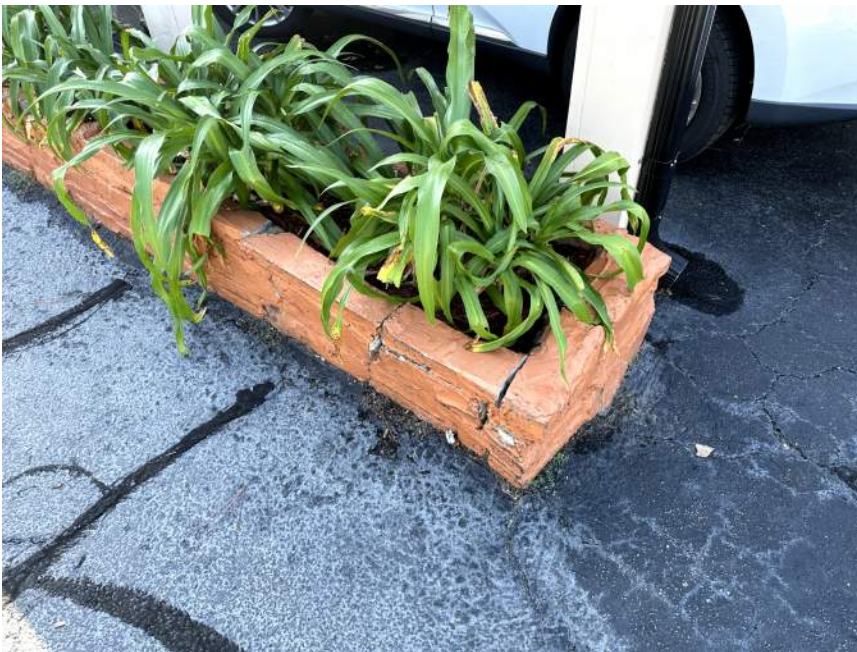
Condition: Planter at covered check-in is damaged from vehicle strikes. Columns supporting roof are not protected by bollards.  
Recommendation: Repair planter and install galvanized steel pipe bollards to protect planter and columns.

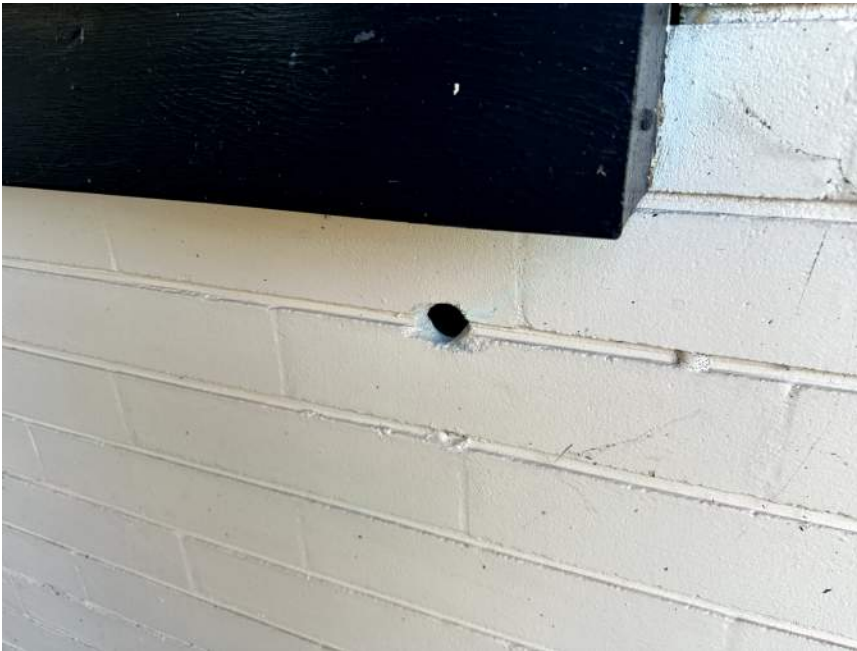
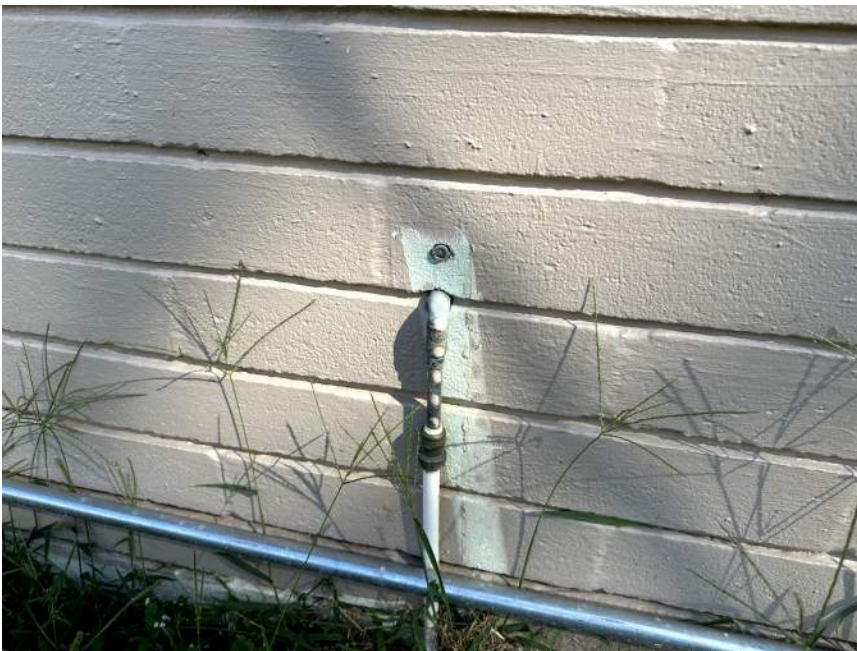
Condition: Multiple abandoned holes and conduit penetrations through exterior walls.  
Recommendation: Seal and paint all holes and penetrations to prevent insect intrusion and energy loss.

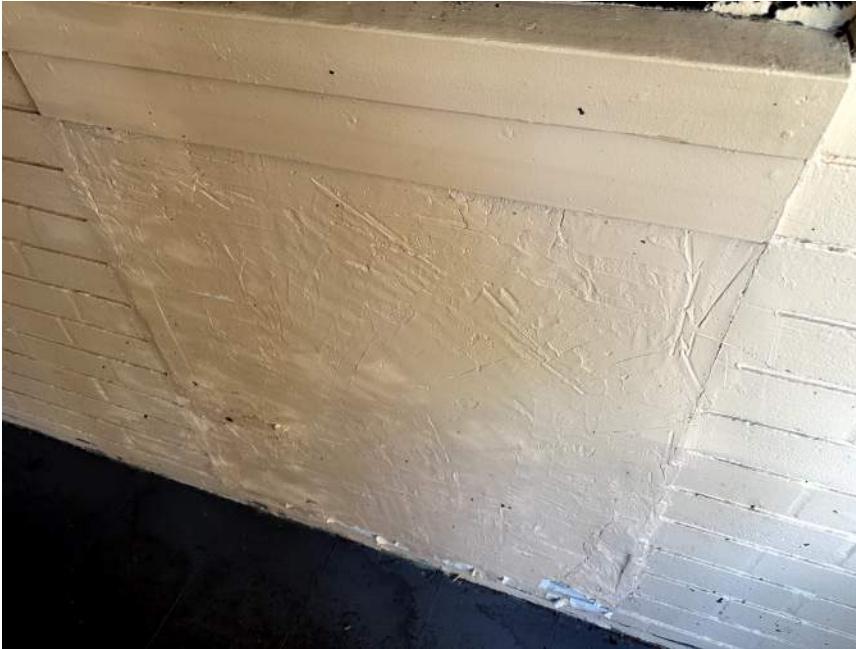
Condition: Paint peeling off of plaster infill. Texture resembles drywall mud.

Recommendation: Verify plaster used is suitable for exterior application. If not, replace with suitable exterior grade cement plaster. If plaster is suitable for exterior application, re-prime and paint plaster in accordance with paint manufacturer's preparation requirements to maintain adhesion. Unprotected plaster can chalk, crack and chip more easily.

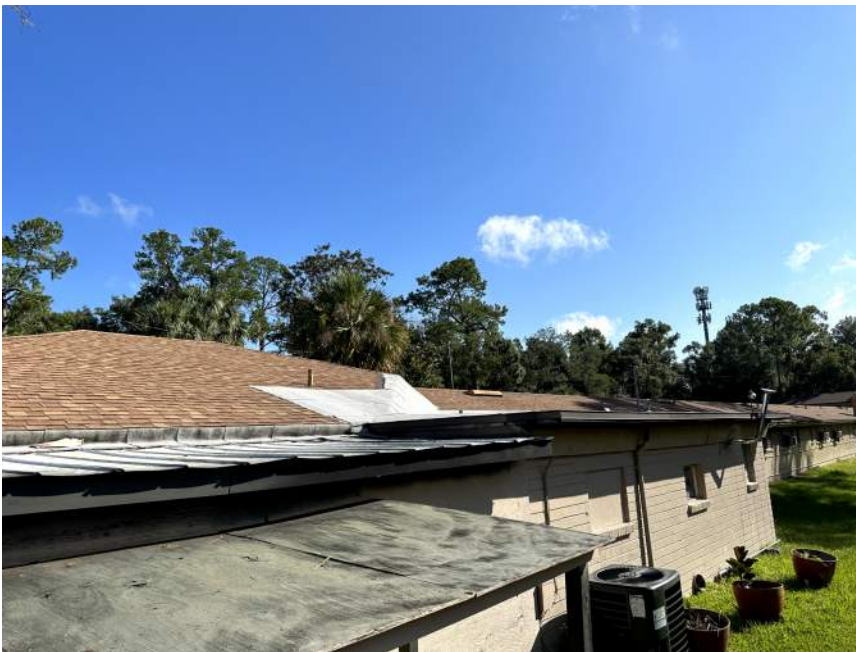
Condition: Asphalt shingle roof appears to have been patched using asphalt sheet. Not apparent if weather lapping of roofing materials and compatible roofing sealants were used.

Recommendation: Roofing contractor should verify the installation meets current Florida building code requirements and that proper installation techniques were followed.

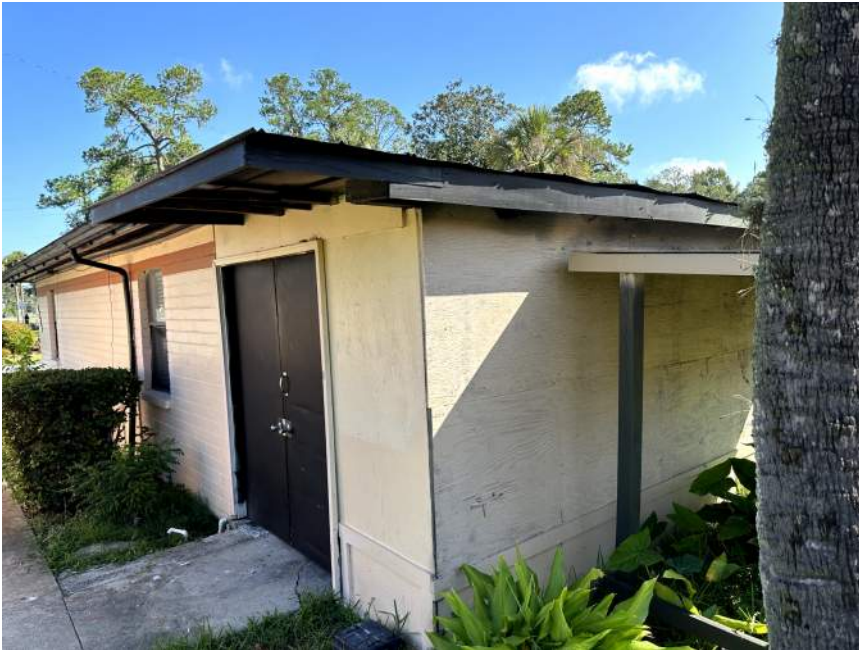
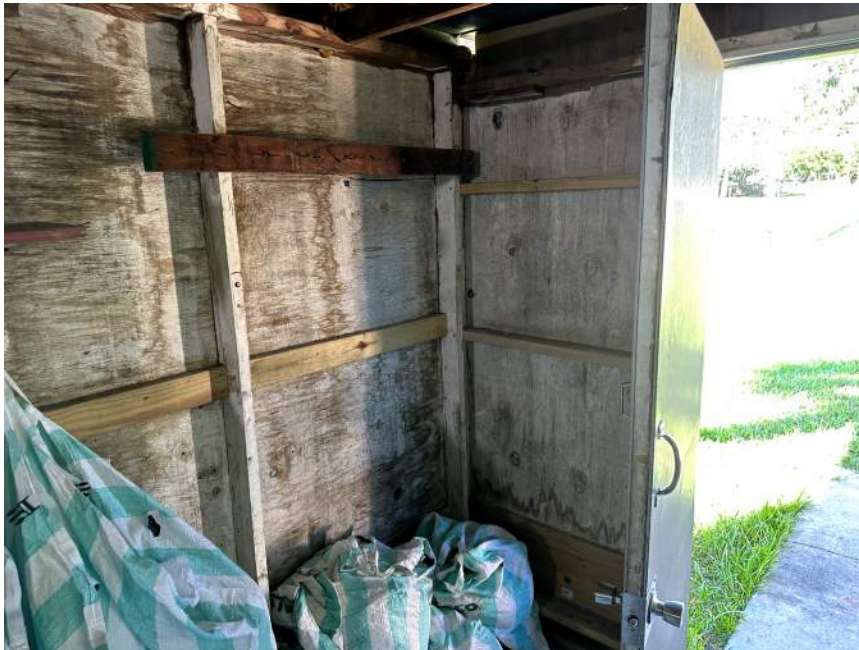
Condition: Painted plywood sheathing on utility room addition is not weather proofed, not insulated and not framed using a structural stud spacing.

Recommendation: Confirm addition is constructed to meet Florida Building Code. Install weather barrier and new exterior finish over exterior walls.

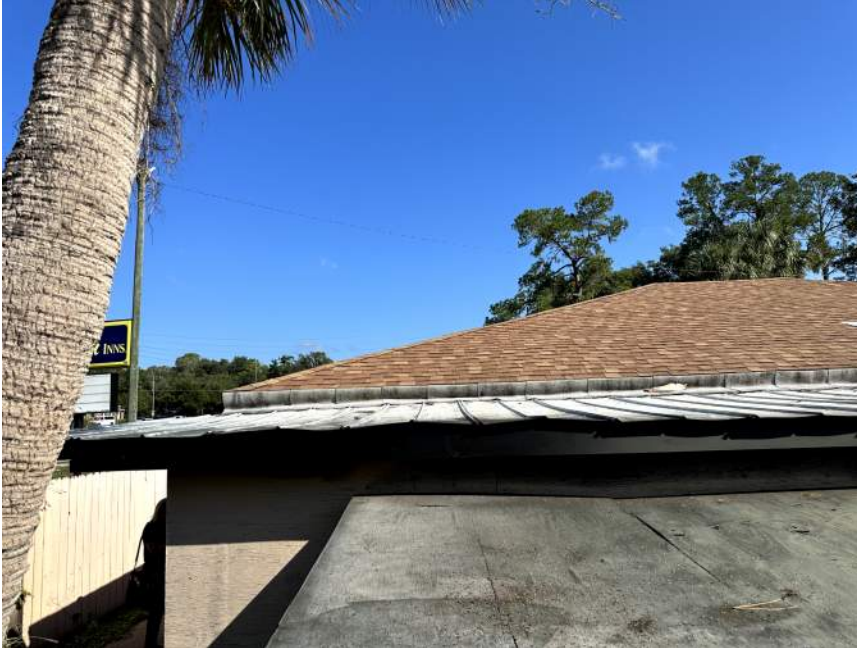
Condition: V-crimp metal roofing on utility room addition is installed at less than 3:12 pitch. Edge of roofing metal is not secured to fascia. Metal is warping. Flashing at asphalt shingle roof is achieved using asphalt sheet. Recommendation: Rebuild roof and flashing over utility room to meet Florida Building Code. Increase pitch of roof and flash into existing asphalt shingle roof using metal flashing transitions. Install fascia board and secure metal roofing to structure per Florida Product Approvals.

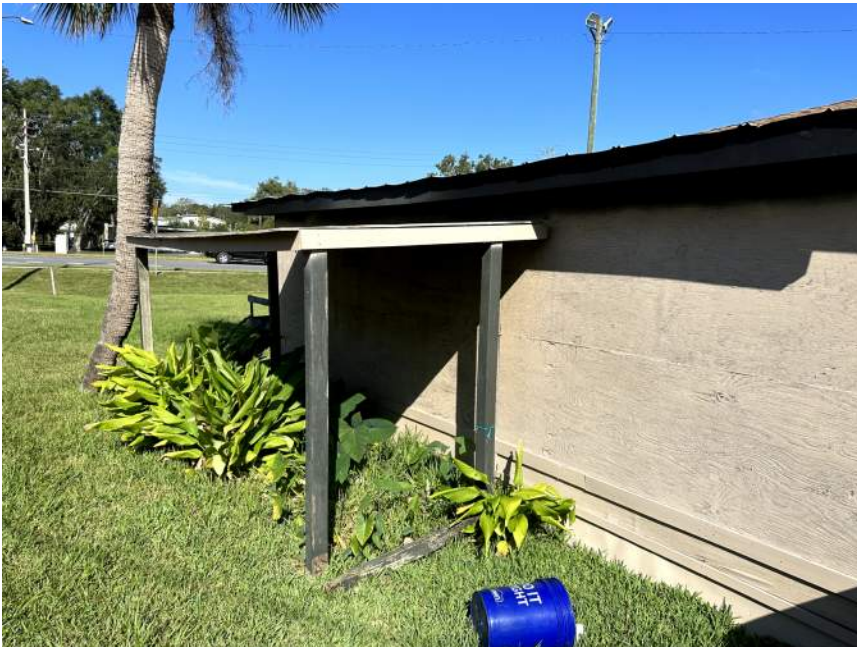
Condition: Wood framed cover has exposed plywood roof, inadequate cross bracing, and sagging joists. Does not appear to serve any purpose. Recommendation: Remove unutilized wood cover to prevent potential flying debris during storm event.

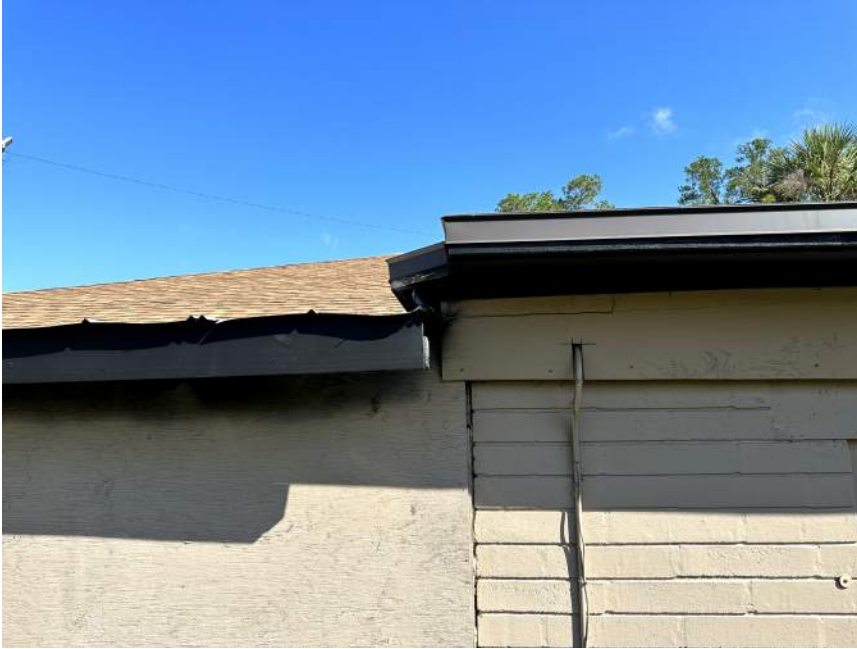
Condition: Many unsealed gaps, cracks and penetrations around exterior of building.  
Recommendation: Seal all gaps, cracks and penetrations using approved exterior grade sealant and backer rod where required.

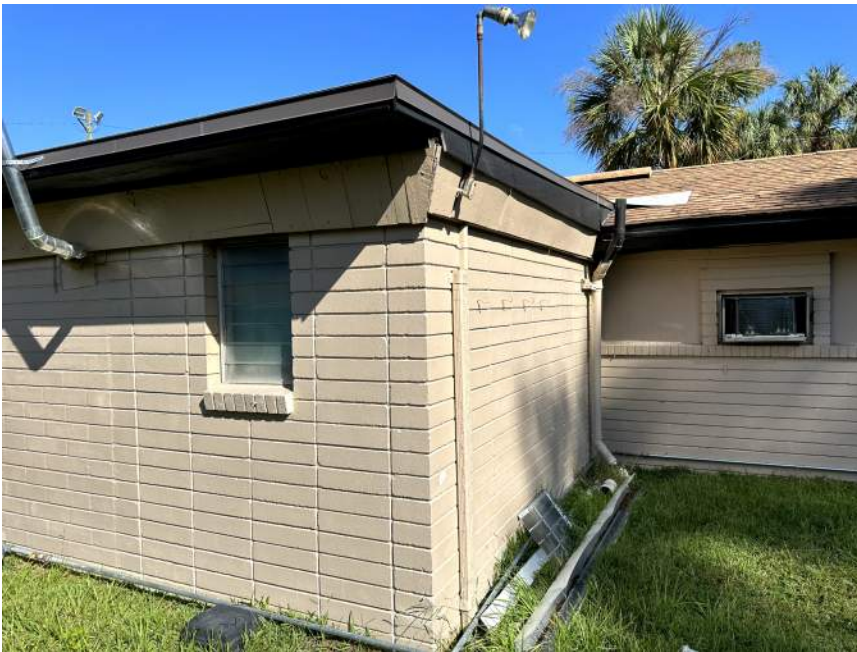
Condition: Wood soffit trim is poorly installed, cracking and showing signs of rot in some locations.  
Recommendation: Rebuild soffit trim and closure panels using cementitious fiber paneling to prolong life and prevent rot.

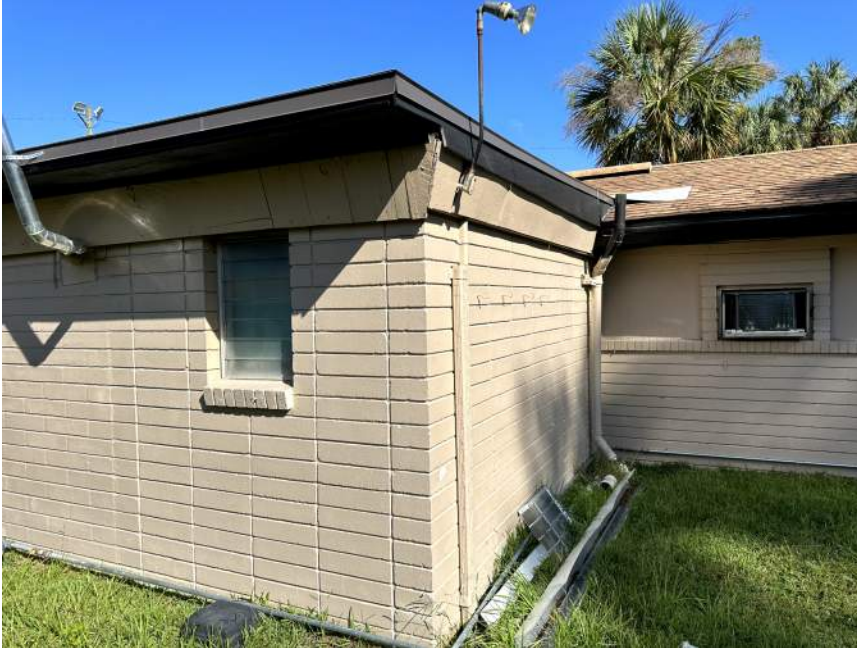
Condition: Jalousie window does not provide proper seal to conserve energy and is security concern.  
Recommendation: Replace window with new insulated single hung or casement style window unit.

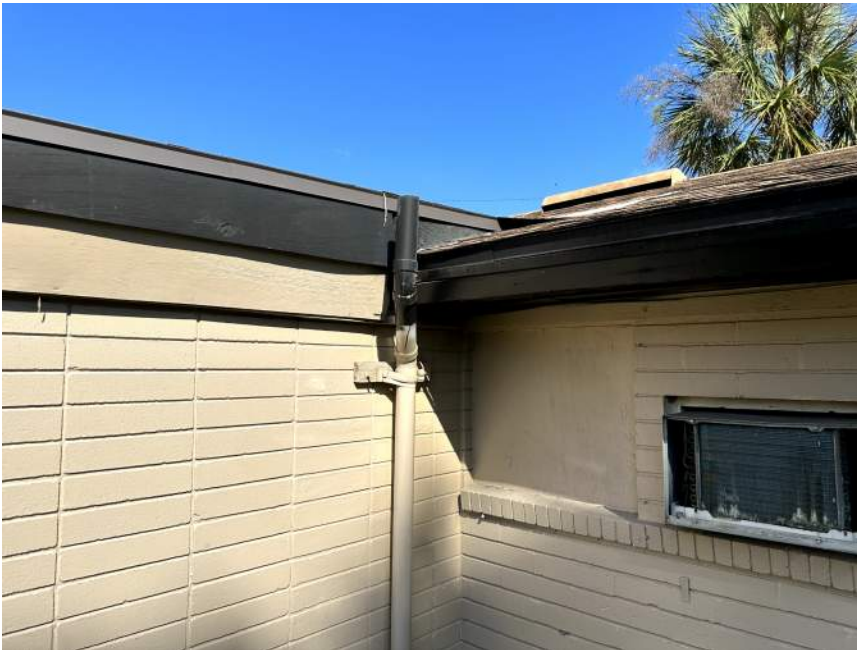
Condition: Painted particle board used at roof edge fascia transition. Asphalt roof membrane is unsupported at intersection of two roof planes. PVC vent pipe is secured to exposed wood blocking.  
Recommendation: Rebuild fascia using pressure treated lumber and metal flashing components to prolong life and reduce likelihood of leaks. Install substrate and blocking to support roofing membrane. Remove wood blocking and secure pipe to wall using stainless steel or galvanized metal strapping.

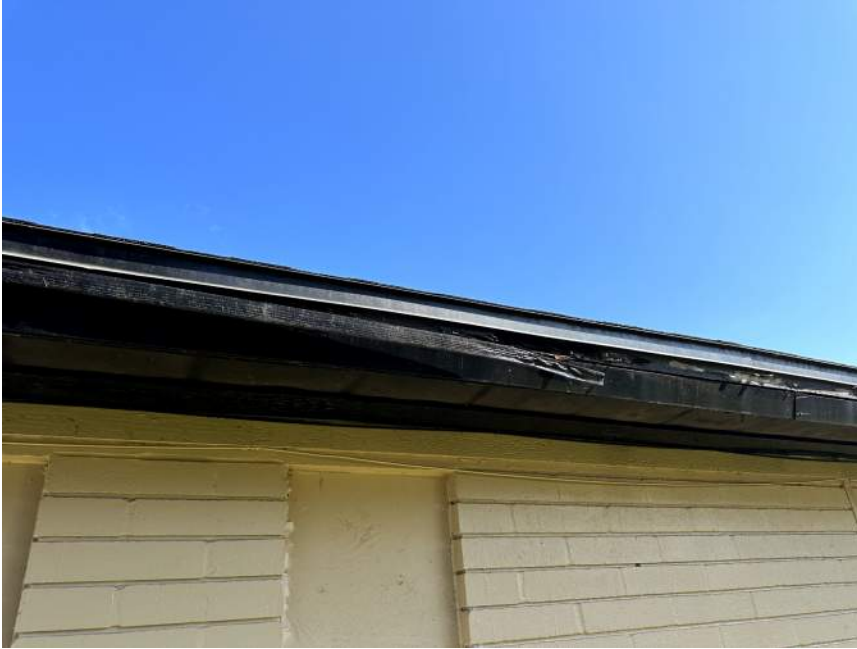
Condition: Wood fascia is rotting and falling apart in multiple locations  
Recommendation: Rebuild fascias using pressure treated lumber and cement fiber trim or brake metal fascia covers to prolong life.

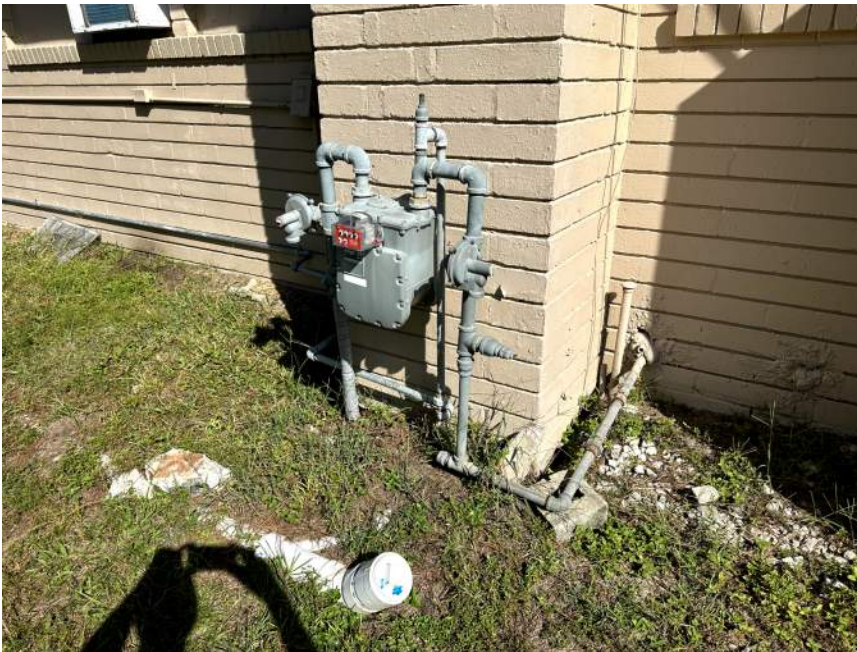
Condition: Piping conduits on ground and sanitary piping cleanouts unprotected.  
Recommendation: Install landscape buffer to help reduce risk of lawn equipment hitting gas and plumbing pipes exposed at grade.

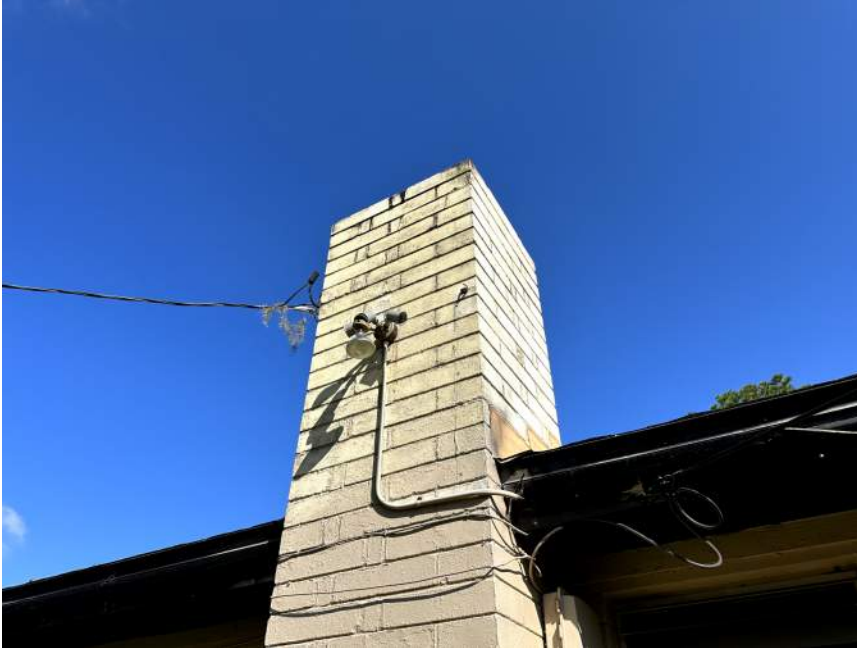
Condition: Chimney cap flashing does not overhang edge of chimney chase. It is not apparent that cap flashing exists.

Recommendation: Verify condition of existing chimney cap flashing and repair or replace with new stainless steel tapered cap flashing as needed to maintain weather tightness.

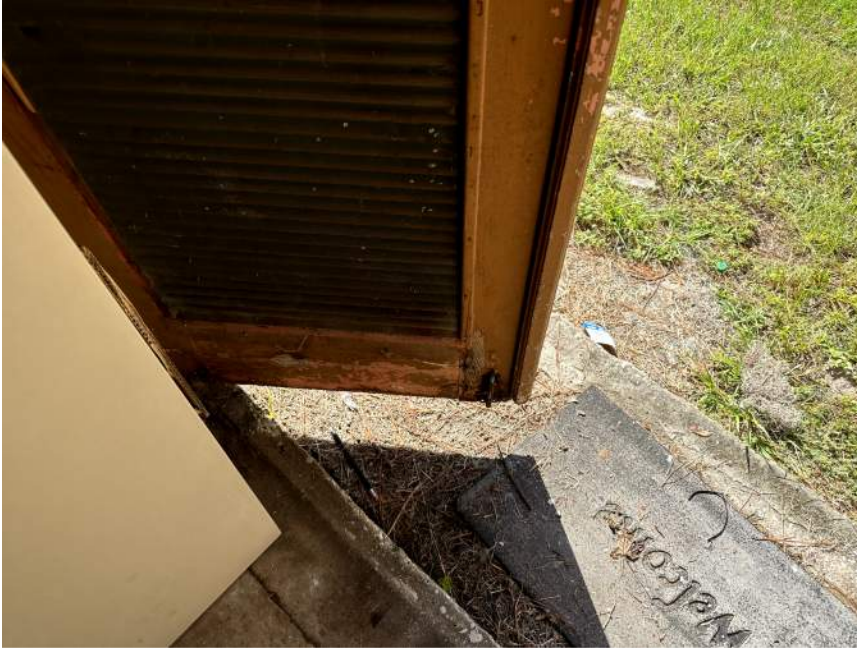
Condition: Top door bolt missing from utility room door leaf. Nail is being used to secure door. Bottom door bolt is undersized. No threshold and no seals. Multiple doors throughout building have insufficient or make-shift hardware and seals.

Recommendation: Evaluate each opening. Replace all exterior door hardware and seals with appropriate hardware designed to maintain building security and prevent energy loss or water intrusion.

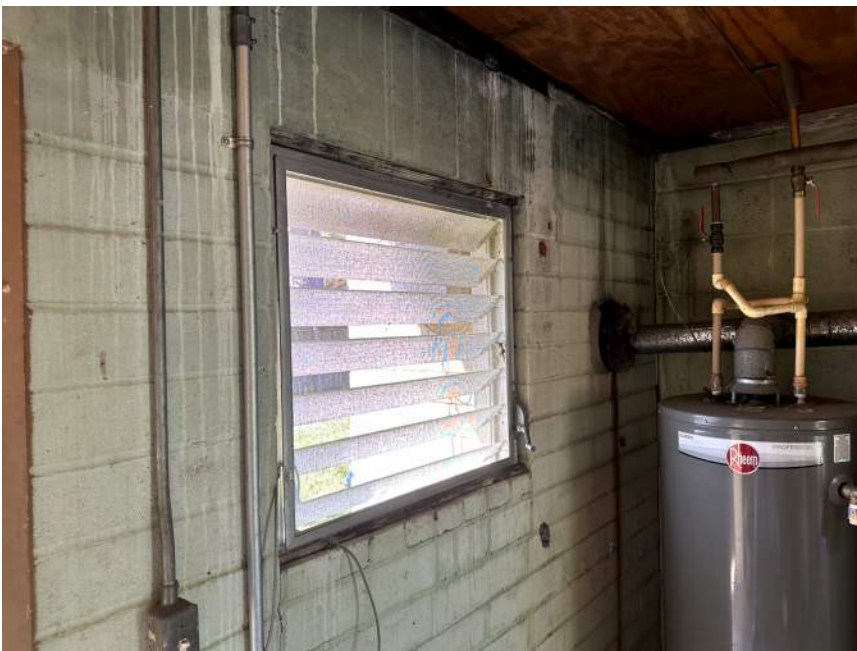
Condition: Evidence of leaks along outside wall. Jalousie windows are less secure and allow for moisture intrusion.

Recommendation: Inspect all exterior walls for leaks throughout building. Replace all Jalousie windows with insulated operable or non-operable windows to improve thermal performance of building and mitigate moisture intrusion.

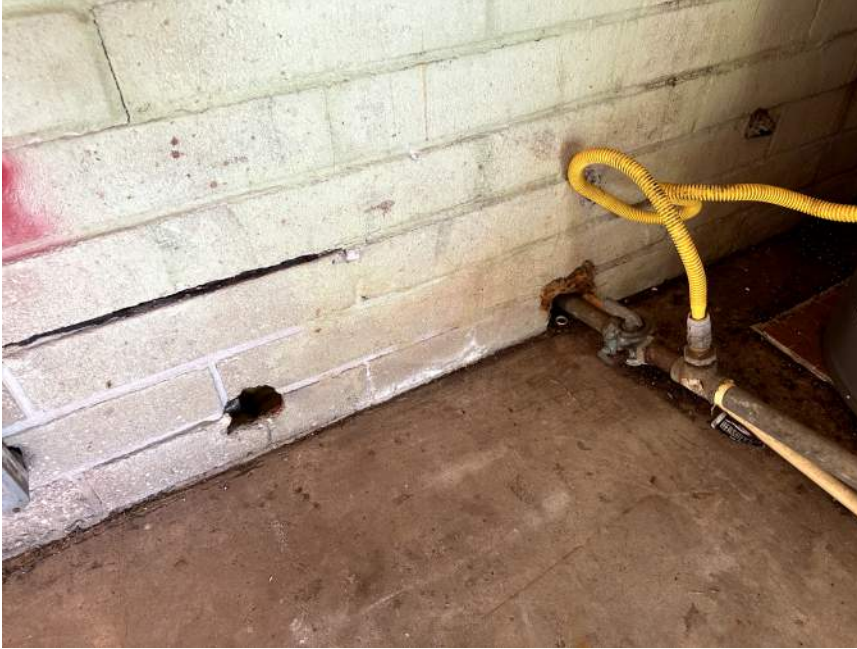
Condition: Hole in exterior wall CMU.  
Recommendation: Grout hole solid.

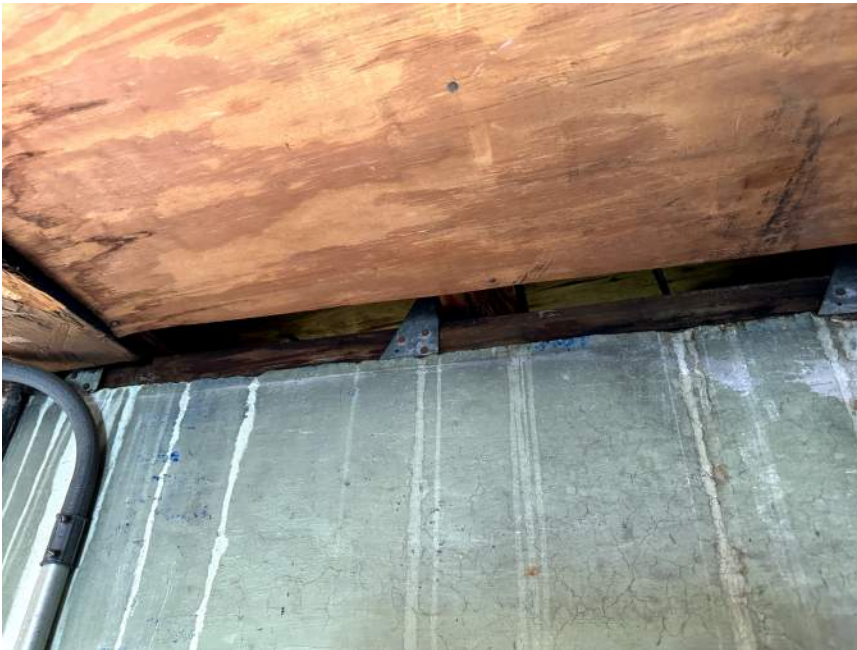
Condition: Evidence of moisture damage to truss sill plate. Plywood used for ceiling board has been damaged by water.  
Recommendation: Inspect all attic spaces for water damage and repair active leaks.

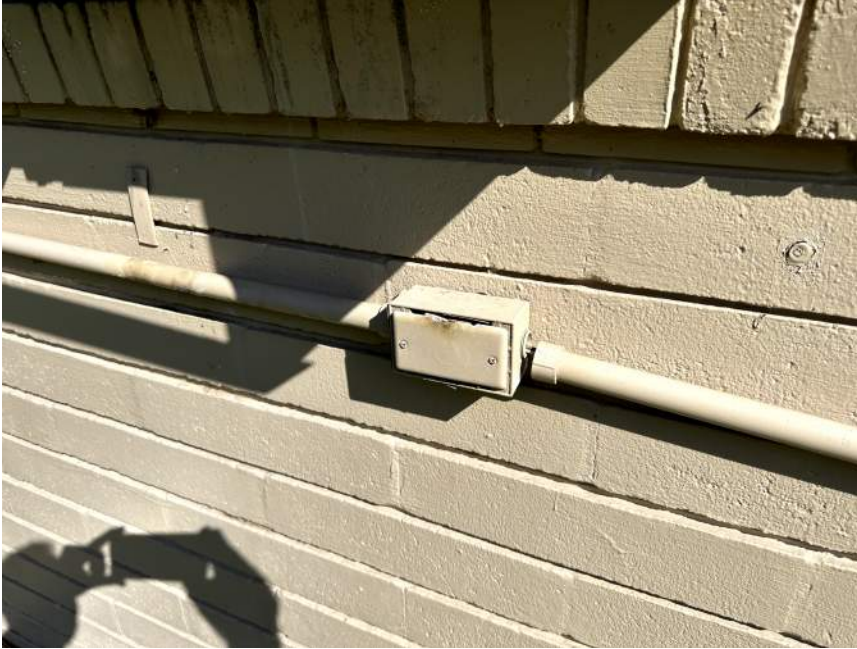
Condition: Junction box cover is undersized for box, not weather resistant. Conduit not secured to box, placing stress on wiring.

Recommendation: Replace junction box with weather resistant box and secure conduit. Inspect entirety of exteriors and address each instance.

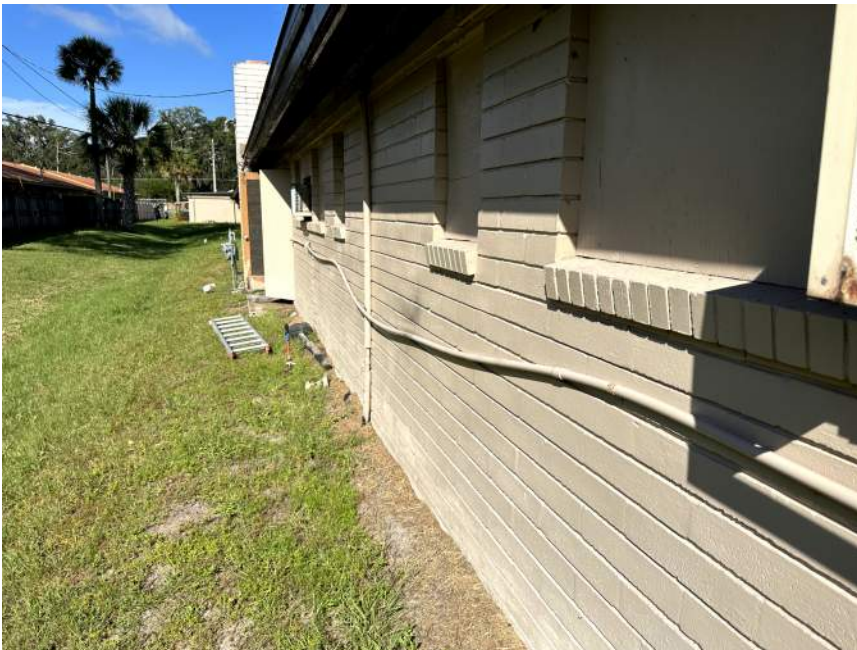
Condition: Conduit routed along wall of building is not adequately supported.

Recommendation: Provide necessary support.

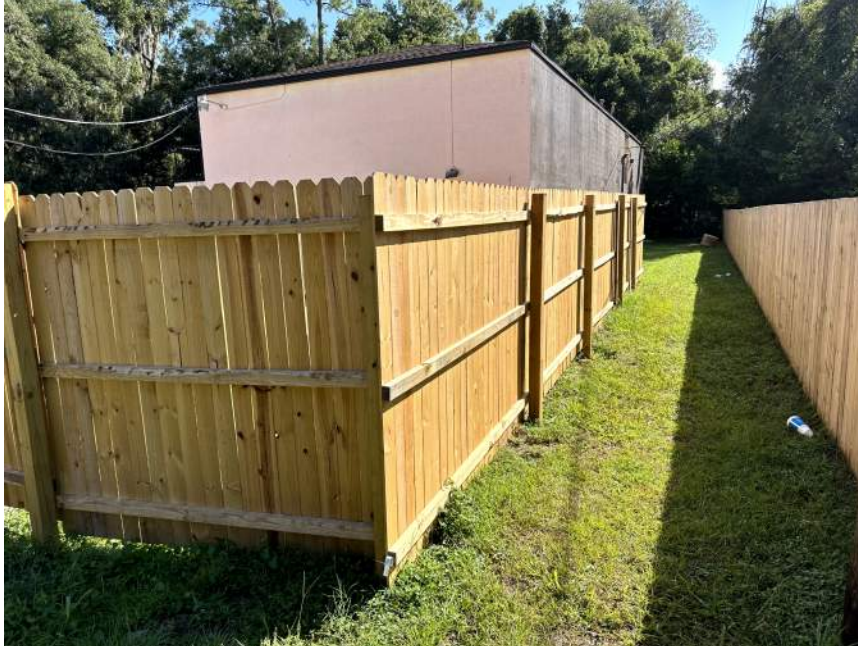
Condition: Exterior wood fence not yet painted.

Recommendation: After proper amount of drying time, paint all bare wood exposed to the elements with an exterior grade wood paint and primer to prolong life of wood.

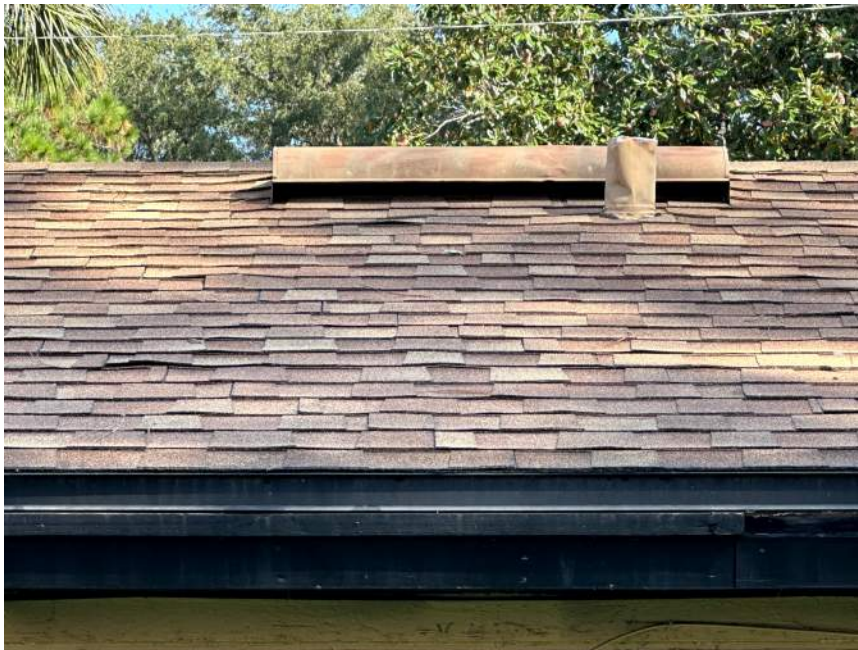
Condition: Waviness observed in asphalt shingles near attic vent may be evidence of moisture damage to roof sheathing below.

Recommendation: Inspect roof sheathing through attic and repair sheathing if needed.

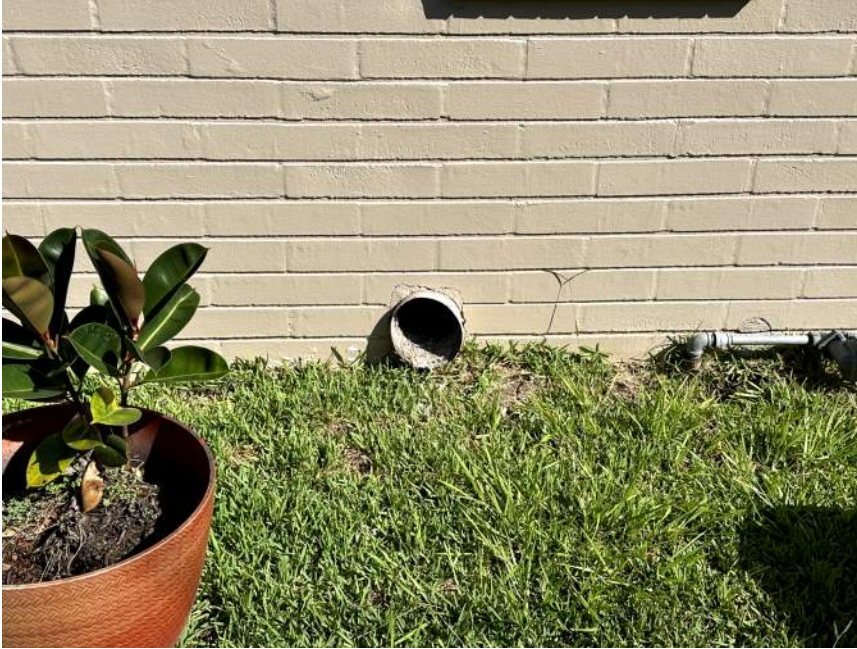
Condition: Vent pipe without damper, very close to finished grade may allow pest or water intrusion.  
Recommendation: If vent is abandoned, remove pipe and grout hole solid. If vent is still in use, consider opportunities to reroute vent to higher elevation and add weather resistant damper.

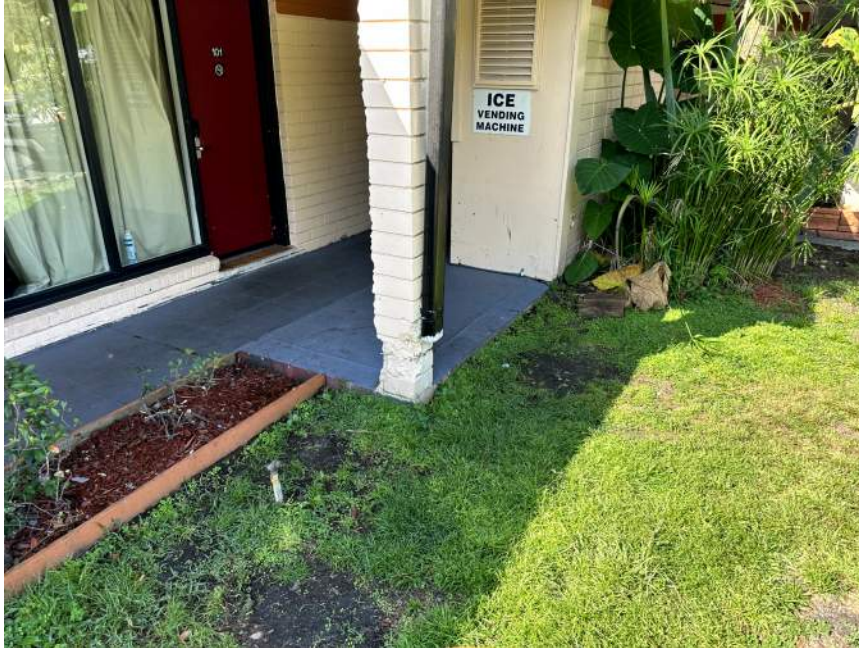
Condition: Downspout not connected to storm system. No splash block provided.

Recommendation: Extend downspout to connect to stormwater system below grade, or install diverter at base of downspout with splash block to prevent erosion around column base.

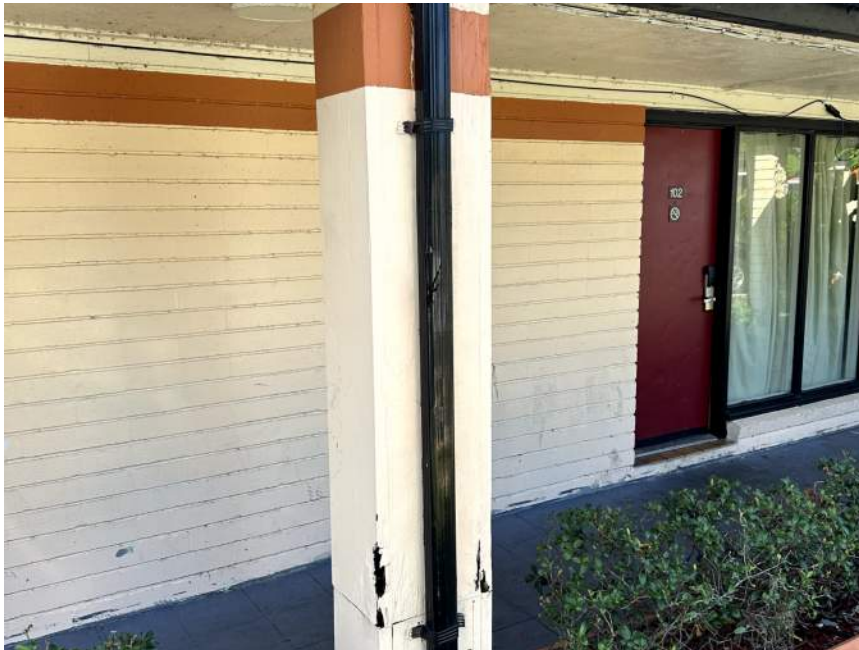
Condition: Significant water damage to wood column enclosures along walkway.

Recommendation: Replace covers with new PVC or Cement fiber column wrap to improve appearance and durability.

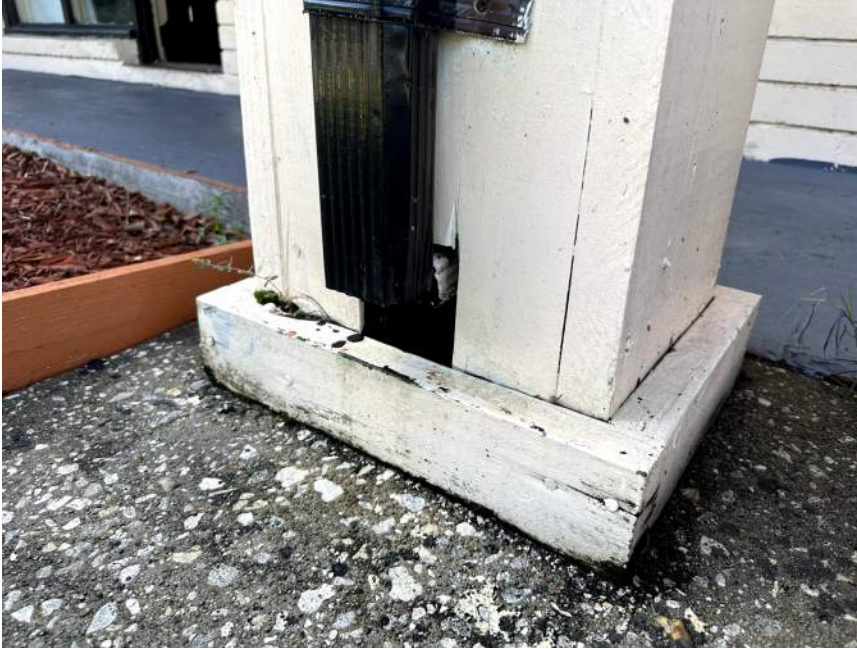
Condition: Downspout appears to divert water into base of wood column enclosure.  
Recommendation: Reconfigure downspout to discharge water outside of enclosure.
