# The Scottish Inns

## Existing Conditions Assessment

Prepared for **Alachua County Public Works**

**October 16, 2023**

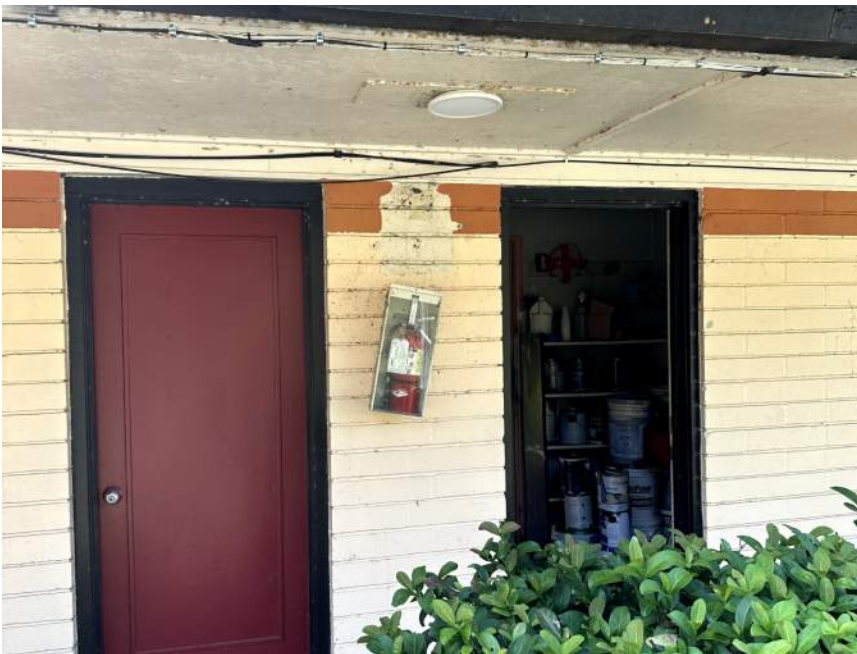
Condition: Fire extinguisher cabinets protrude into walkway more than 4" and are mounted above ADA accessibility height.  
Recommendation: Relocate cabinet to be at an ADA accessible height and in a location that permits 4" projection without obstructing walkway.

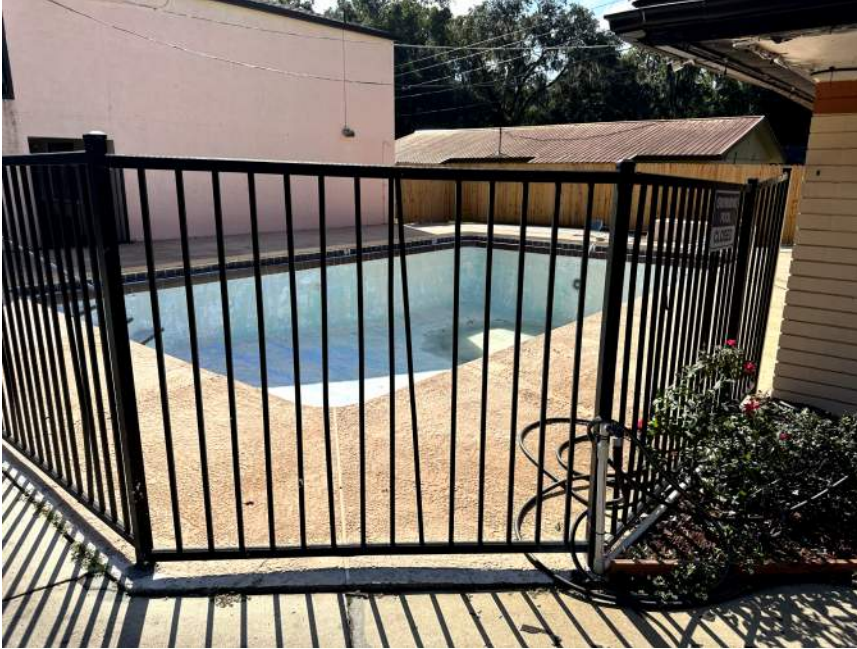
Condition: Damaged picket in pool fence could allow unauthorized access.

Recommendation: Repair picket and ensure all fence segments are secure, and do not provide a clear opening greater than 3  $\frac{7}{8}$ " wide.

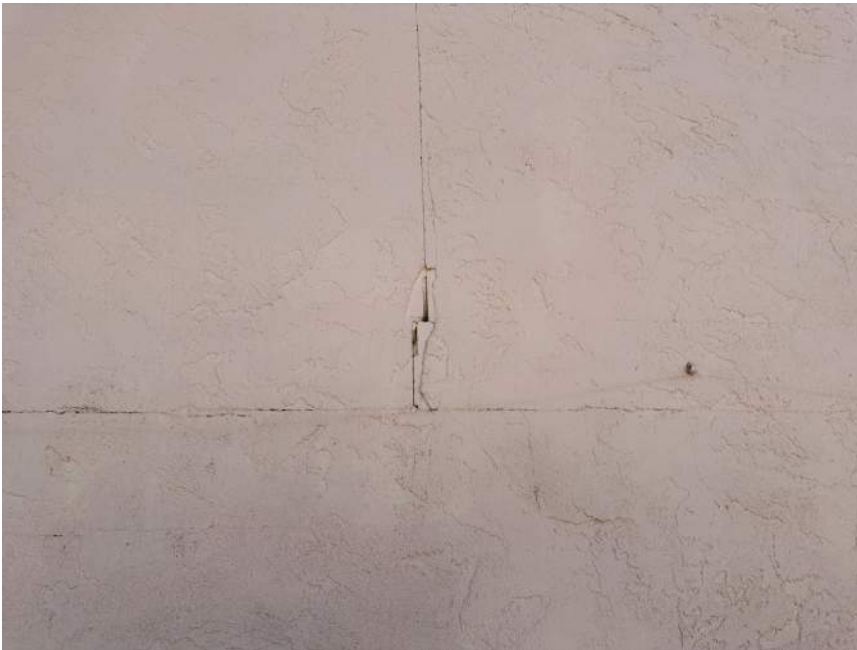
Condition: Cracking in stucco finish on two-story structure.

Recommendation: Repair and seal cracks to prevent further decay of stucco finish.

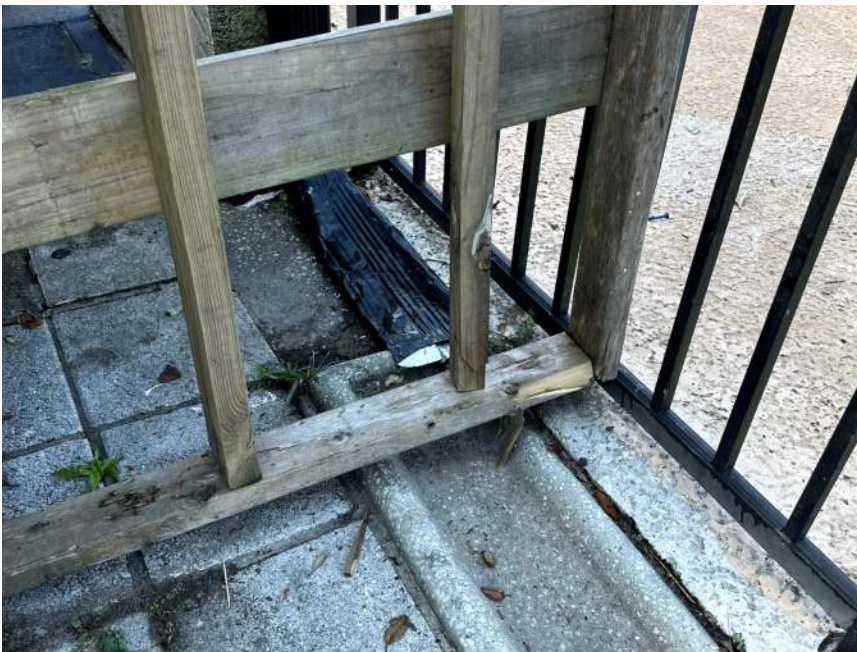
Condition: Downspout extension has been flattened.  
Recommendation: Replace extension.

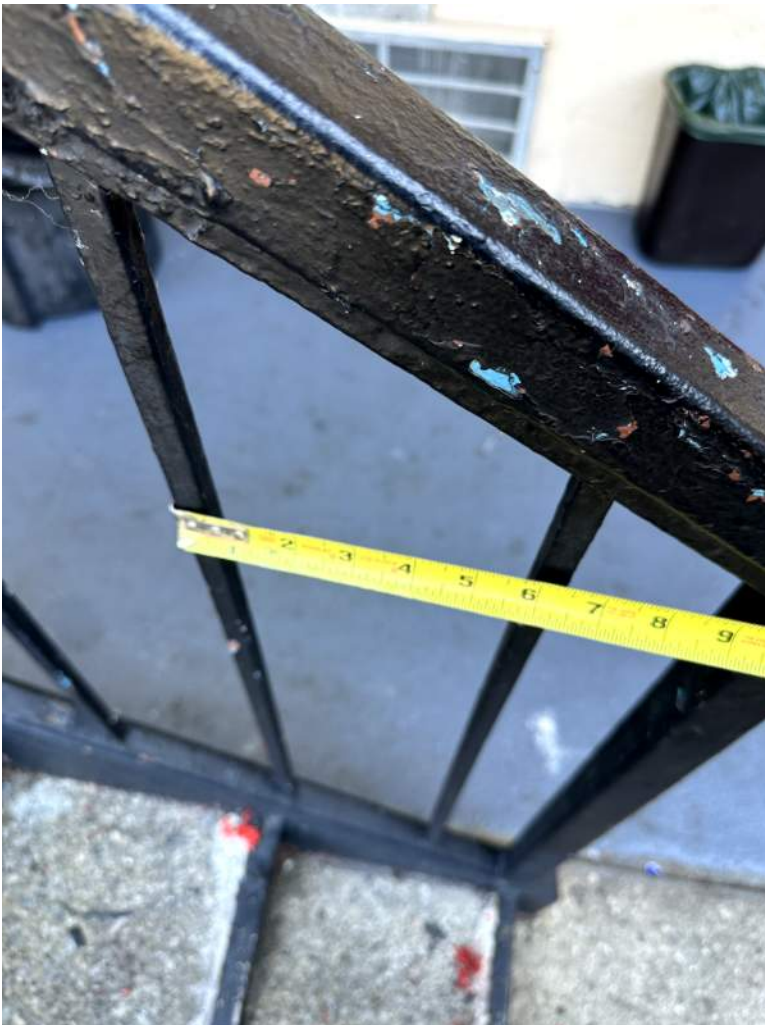
Condition: Guardrail height on exterior staircases and picket spacing do not meet current building code.  
Recommendation: Replace railings to be code compliant.

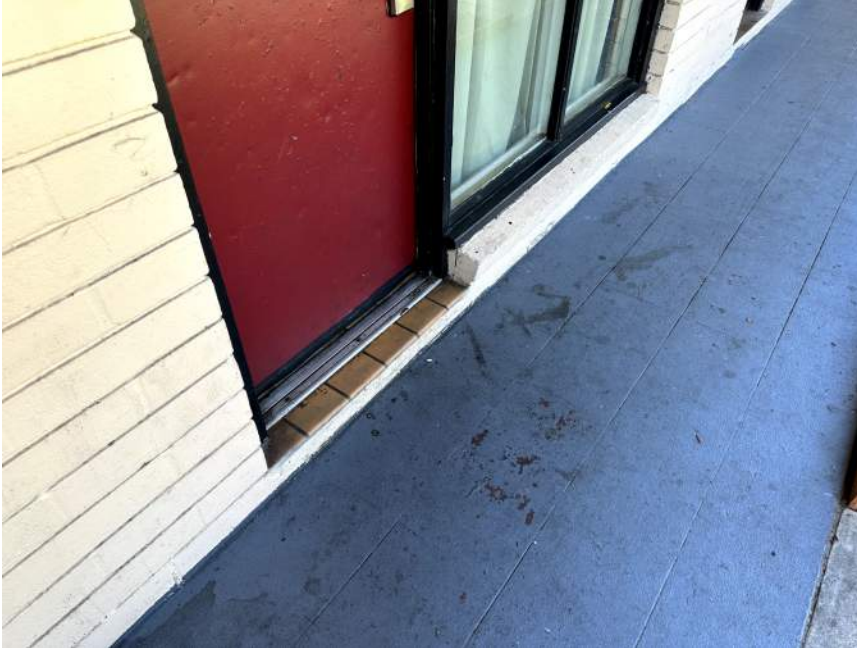
Condition: Step up at sleeping room doorways do not meet ADA for accessibility.

Recommendation: Designate 5% of rooms to be accessible and modify thresholds as required to meet ADA requirements.

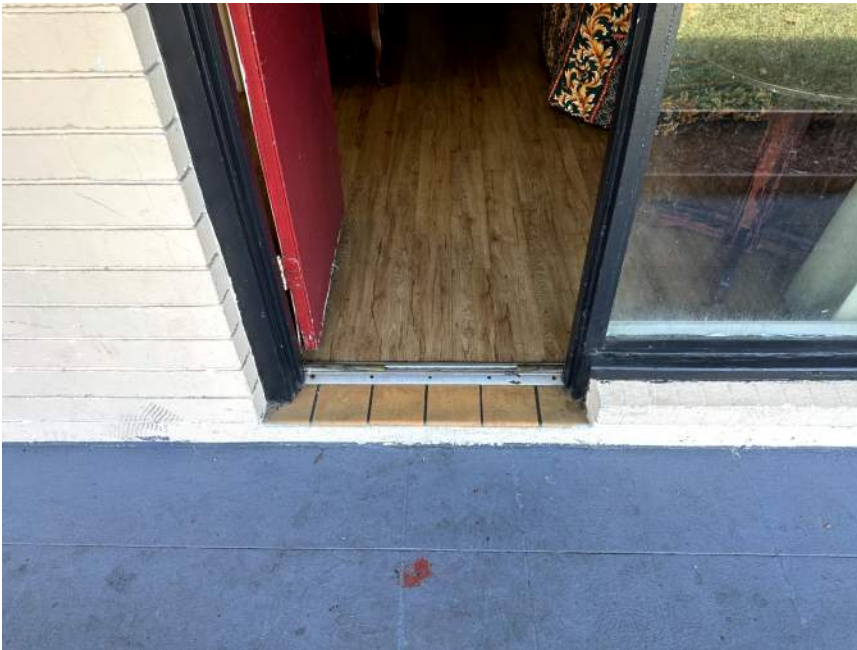
Condition: Damaged door threshold seal.

Recommendation: Inspect all door seals at all exterior openings and repair/replace as needed.

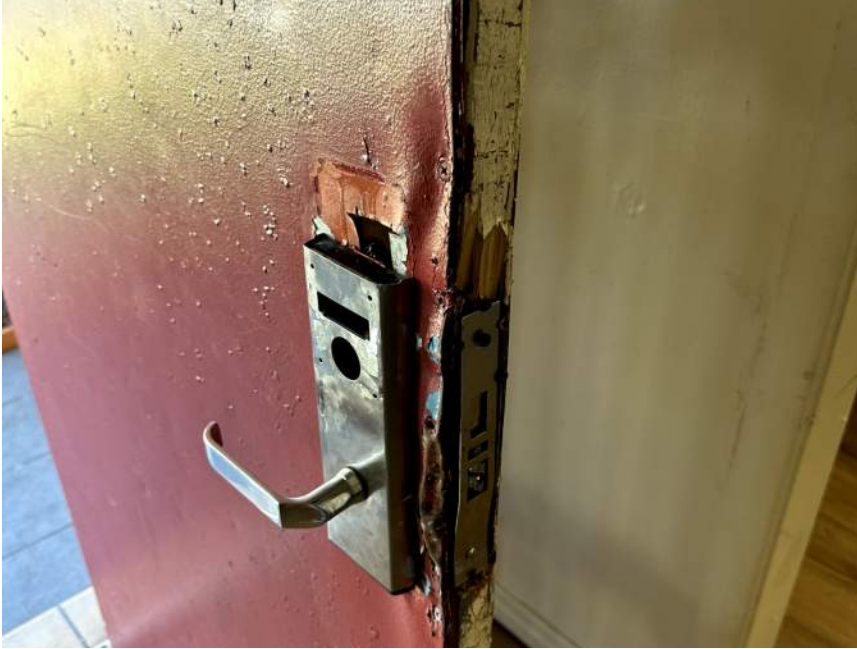
Condition: Door leaf and hardware damaged from vandalism.

Recommendation: Inspect all door leaves and hardware for damage. Replace with new door, door hardware and frame where needed.

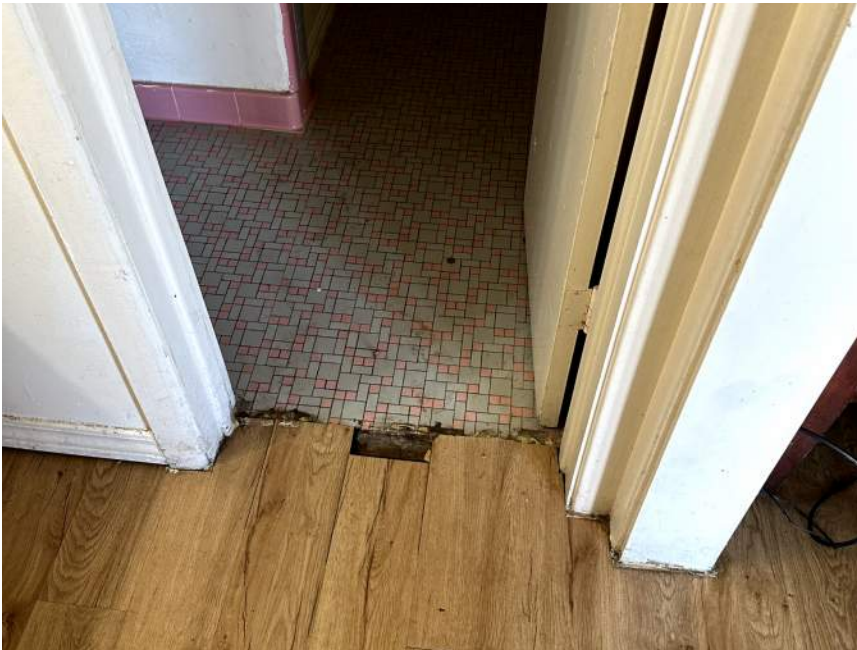
Condition: No transition strip used between tile and laminate flooring.

Recommendation: Inspect all units and Install transition strips where needed to protect flooring.

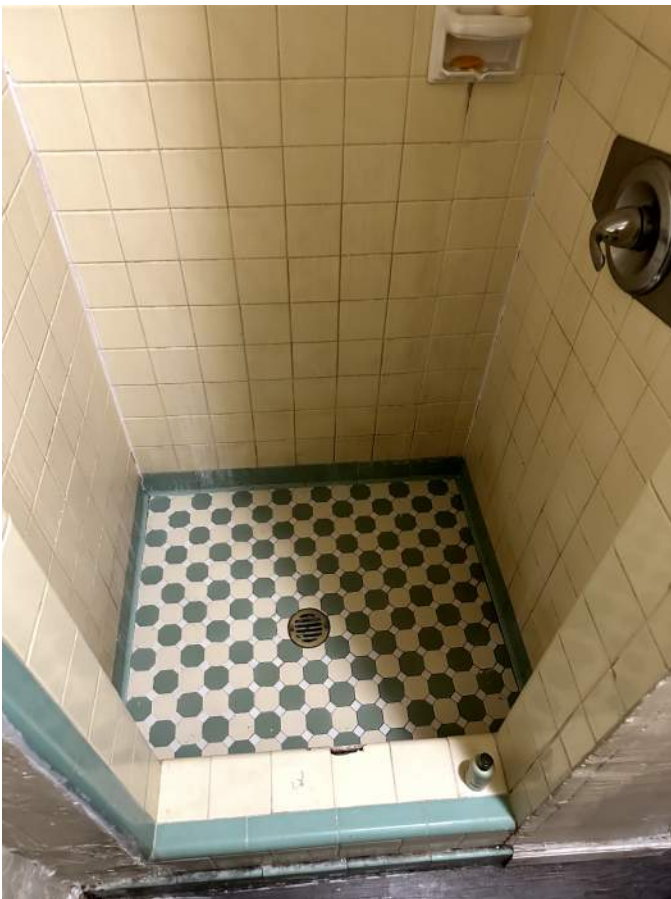
Condition: Broken tile at shower threshold.

Recommendation: Inspect all showers and replace tiles as needed throughout building.

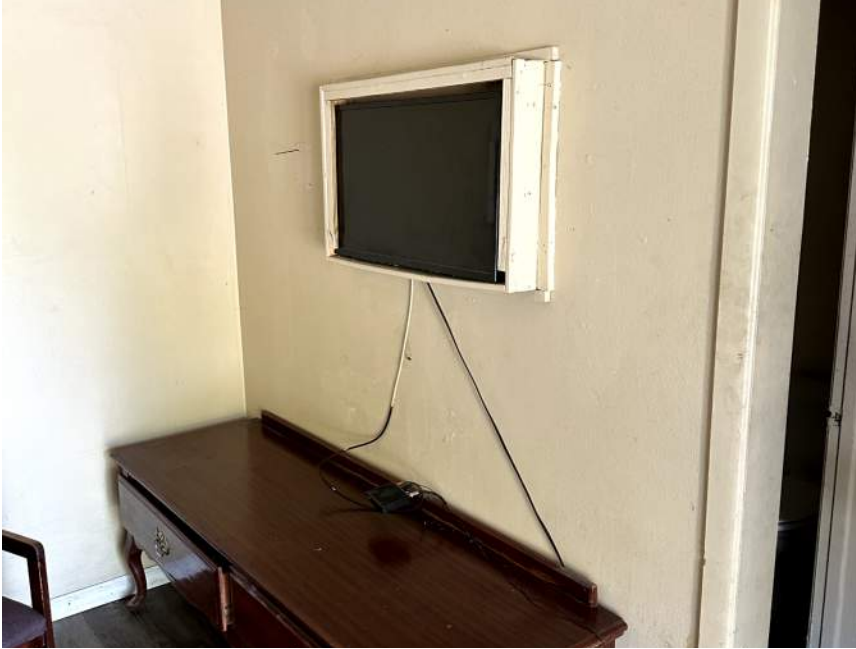
Condition: Television boxed in using combustible materials.

Recommendation: Remove wood boxes and mount TVs on wall brackets. Install new power and data outlets at TV elevation to avoid having exposed cords on wall, which is a safety concern for small children.

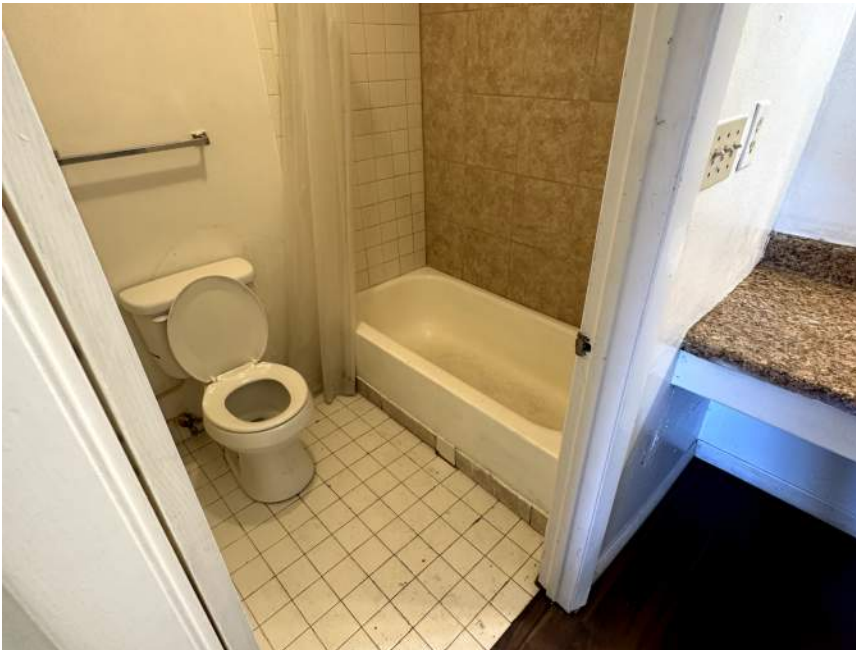
Condition: Restrooms are not configured for ADA accessibility.

Recommendation: Consider full renovation of 5% of restrooms on ground floors to allow for accessibility.

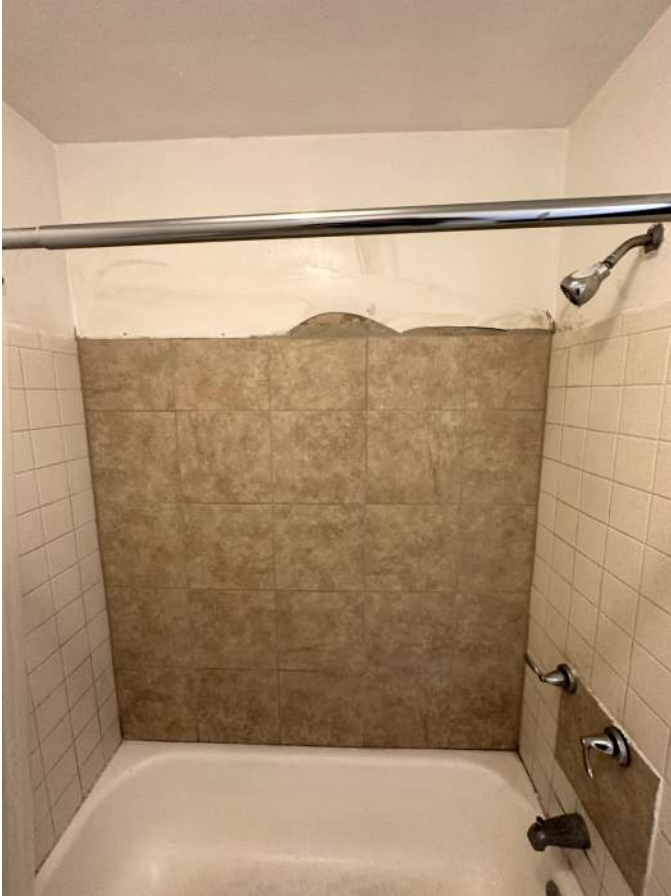
Condition: Moisture damage to painted surfaces adjacent to shower.

Recommendation: Inspect all showers throughout building to ensure wall board used in wet locations is approved for contact with moisture. Replace where needed.

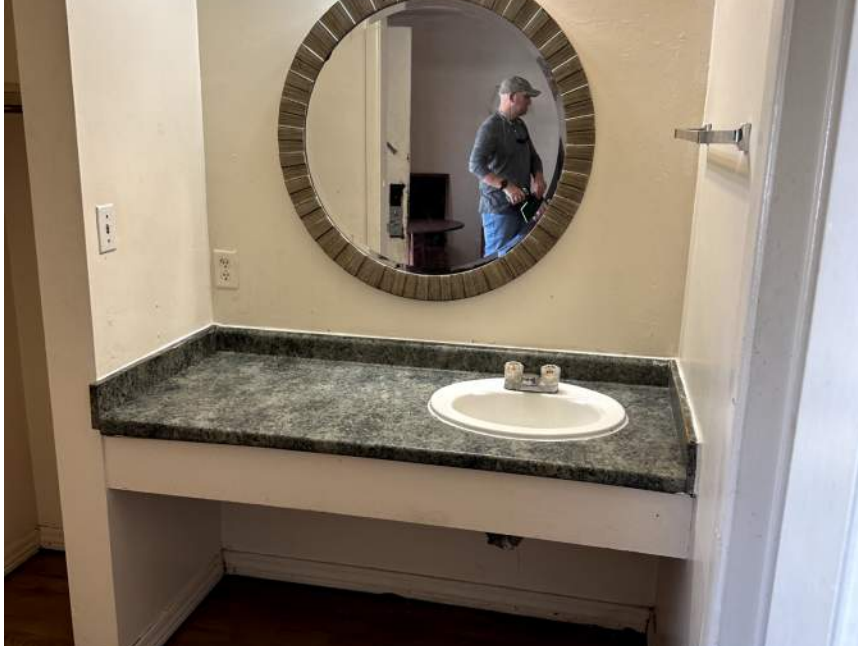
Condition: Vanity faucets and countertops are not ADA accessible.

Recommendation: Install accessible counters and faucets in at least 5% of ground floor units to provide accessible options for residents with disabilities.

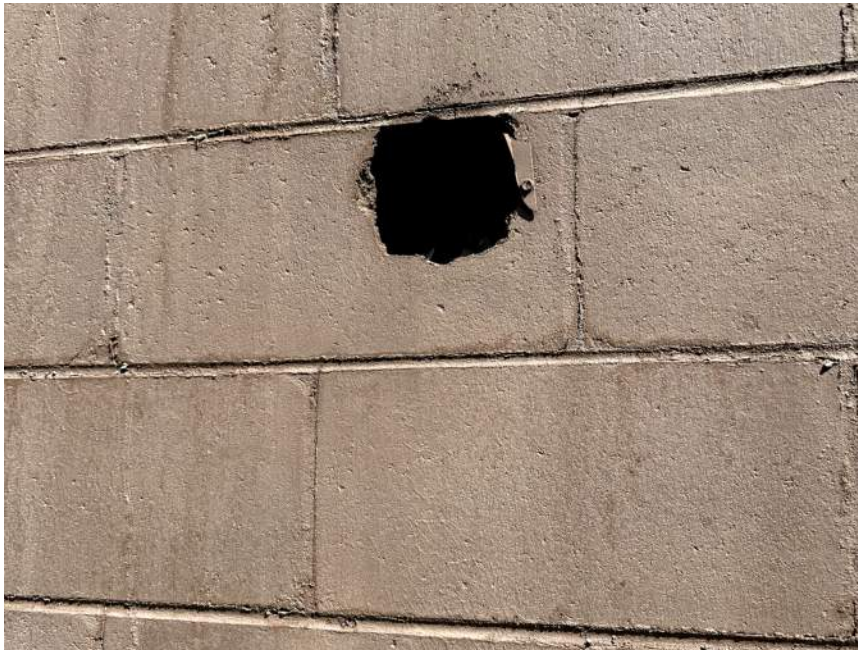
Condition: Many holes in exterior CMU walls, both abandoned and at penetrations

Recommendation: Grout abandoned holes solid and seal penetration holes to prevent pest and moisture intrusion.

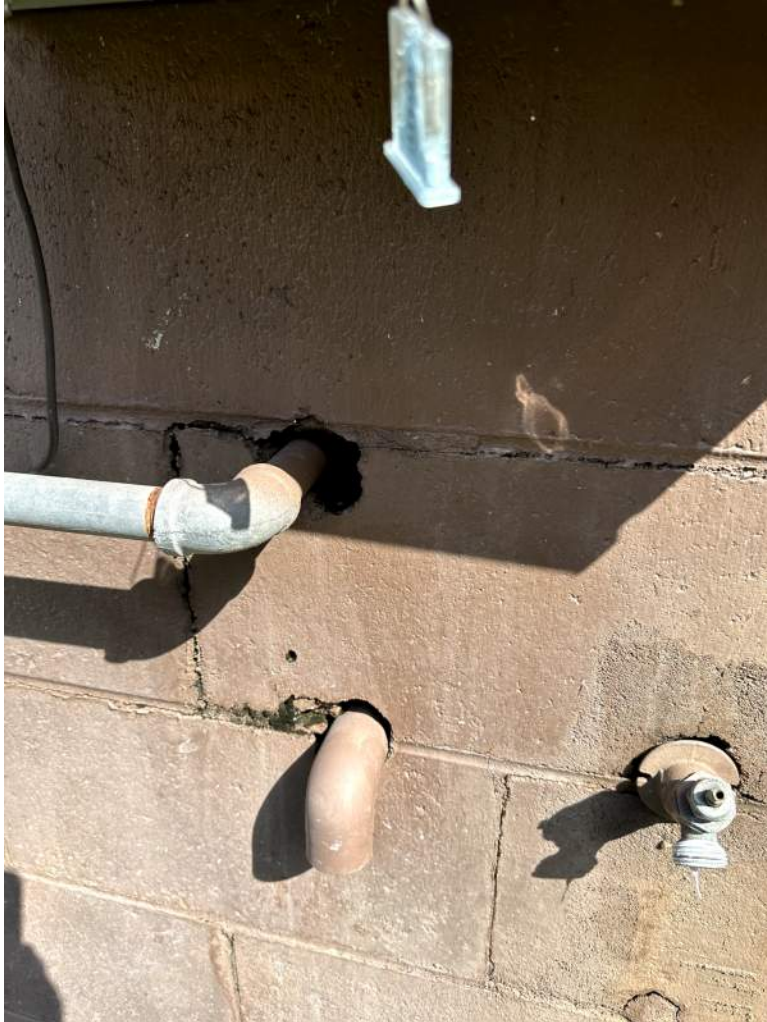
Condition: Many holes in exterior CMU walls, both abandoned and at penetrations

Recommendation: Grout abandoned holes solid and seal penetration holes to prevent pest and moisture intrusion.

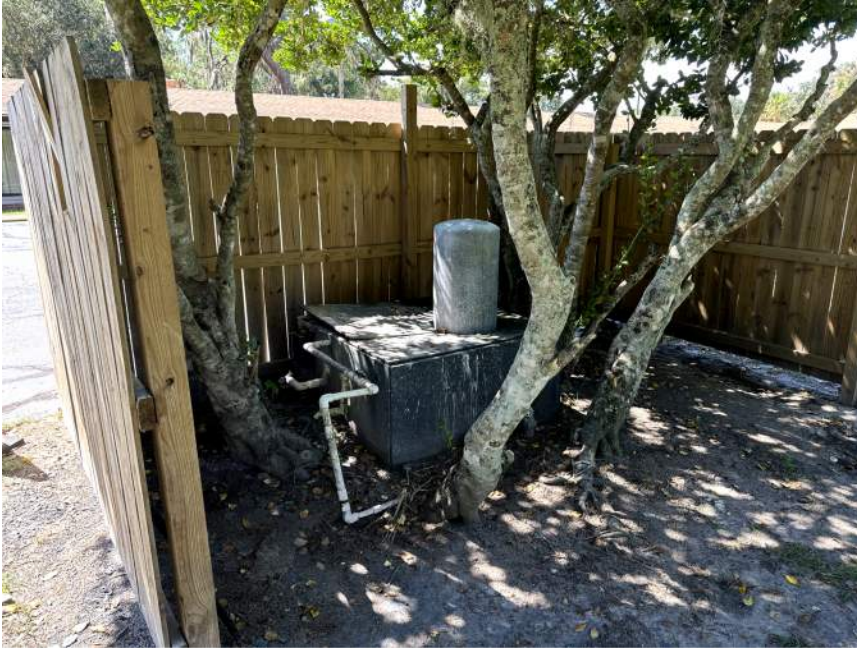
Condition: Trees growing in close proximity to well. Fence not painted.

Recommendation: Trees could impede the ability to service the well pump, and roots could interfere with well operation. Consider removing or transplanting trees to new location. Paint fence with exterior grade wood paint and primer to prolong life of wood.

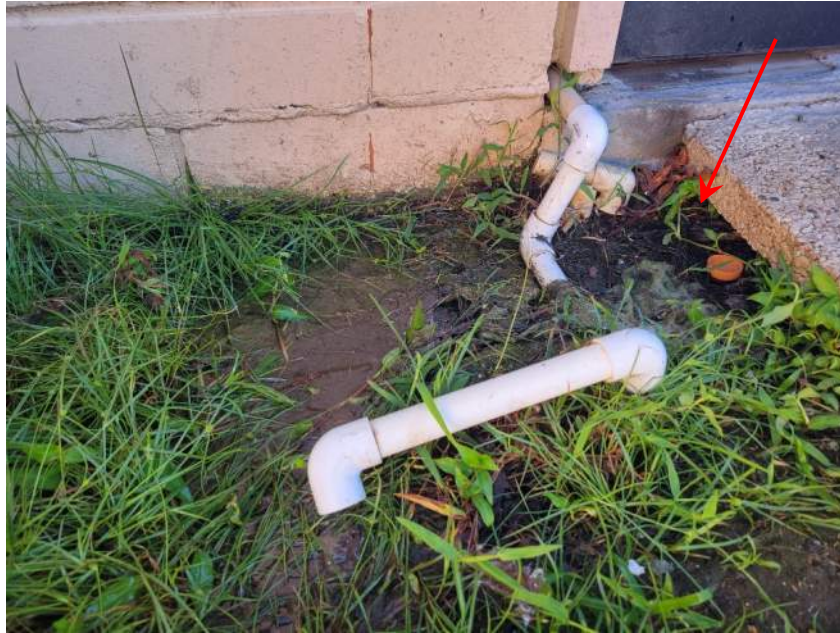
- Erosion/Ponding of Water and Organic Growth
  - Water is collecting at column bases with no downspout extensions (see Photo 7)
  - Water is collecting and causing erosion at foundation at areas of broken downspouts (Photo 8 & 9)

**Photo 9: Erosion at exterior slab on grade**

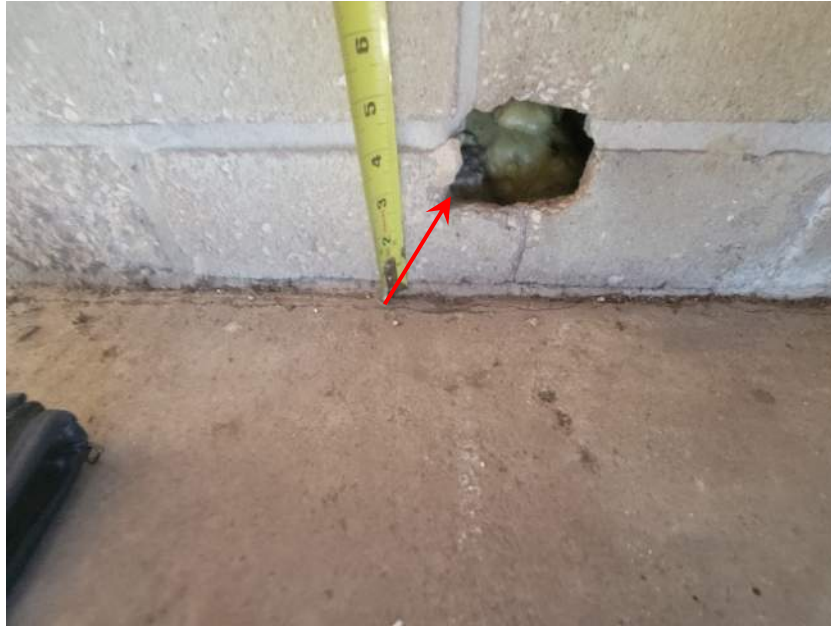
- Unsealed holes in exterior mechanical room CMU wall (see Photo 14 & 15)
  - Damage to CMU pilaster column at exterior walkway with exposed/corroded column reinforcing and ties (see Photo 16).

**Photo 15: Unsealed holes in mechanical room wall**

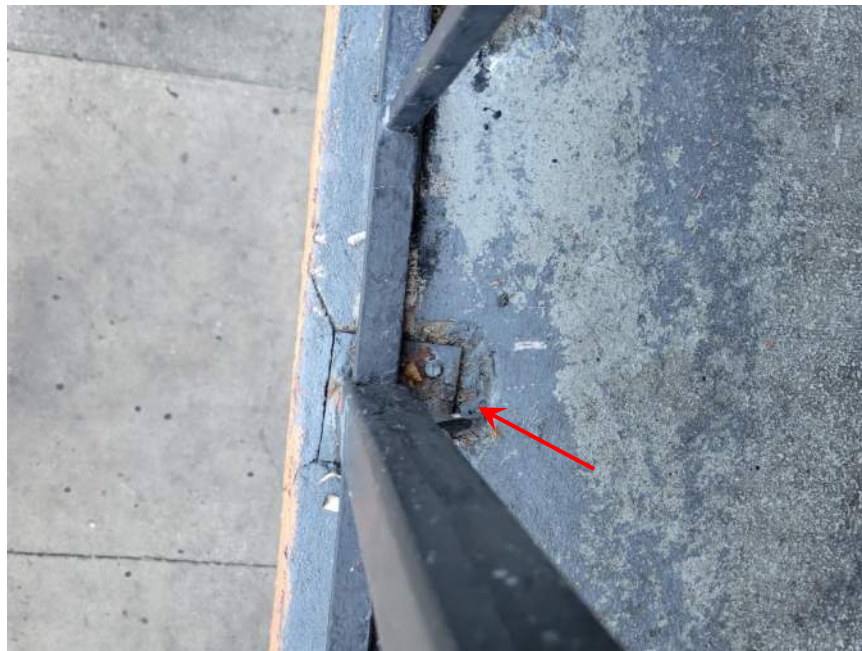
- Exterior Concrete Walkways and Steel Handrails/Guardrails
  - Concrete spalling at handrail/guardrail post base connection at 2<sup>nd</sup> floor (see Photo 30)

**Photo 30: Concrete Spalling at Handrail Post Base**

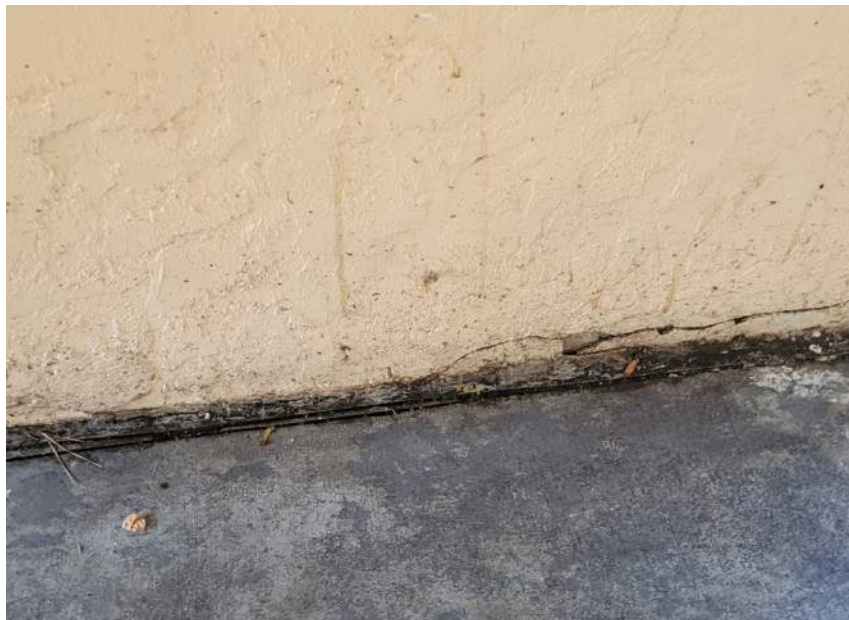
- Large concrete joint at 2<sup>nd</sup> floor exterior walkway (see Photo 33)
  - Failed joint sealants at 2<sup>nd</sup> floor exterior walkway (see Photo 34)

**Photo 34: Failed Joint Sealant**

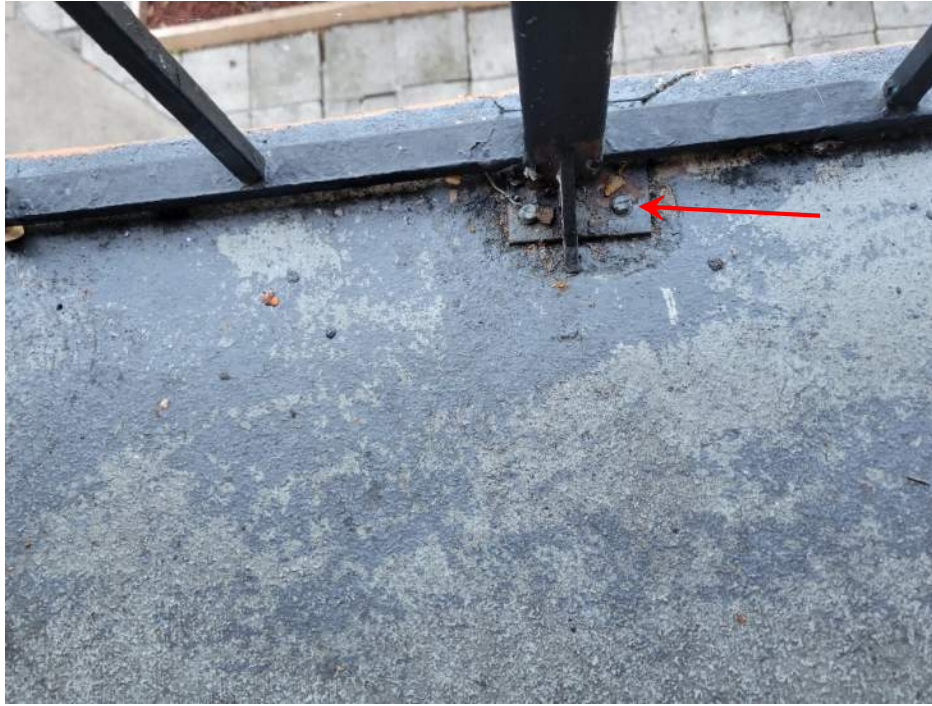
- Corrosion of handrails/guardrails and post base anchors at 2<sup>nd</sup> floor exterior walkway (see Photo 35)
- Exterior Steel Stairs
  - Corrosion of exterior steel framing (posts, stringers, metal pan landings, treads, risers, handrails, and all connectors) (See photos 36 & 37)

**Photo 35: Corrosion at Guardrail Post Base Plate Anchors**

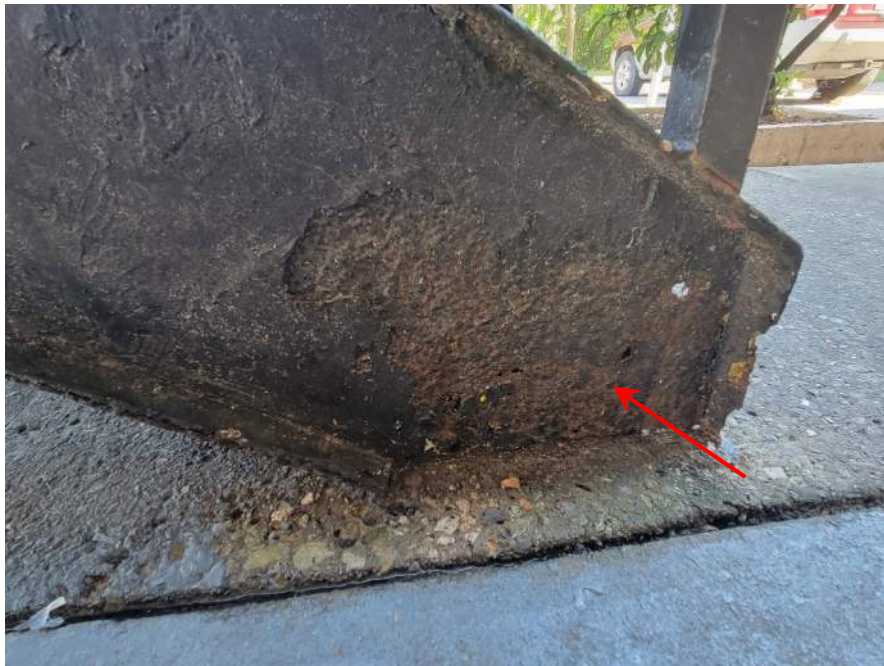
**Photo 36: Corrosion of Exterior Steel Framing - Stair Stringer**

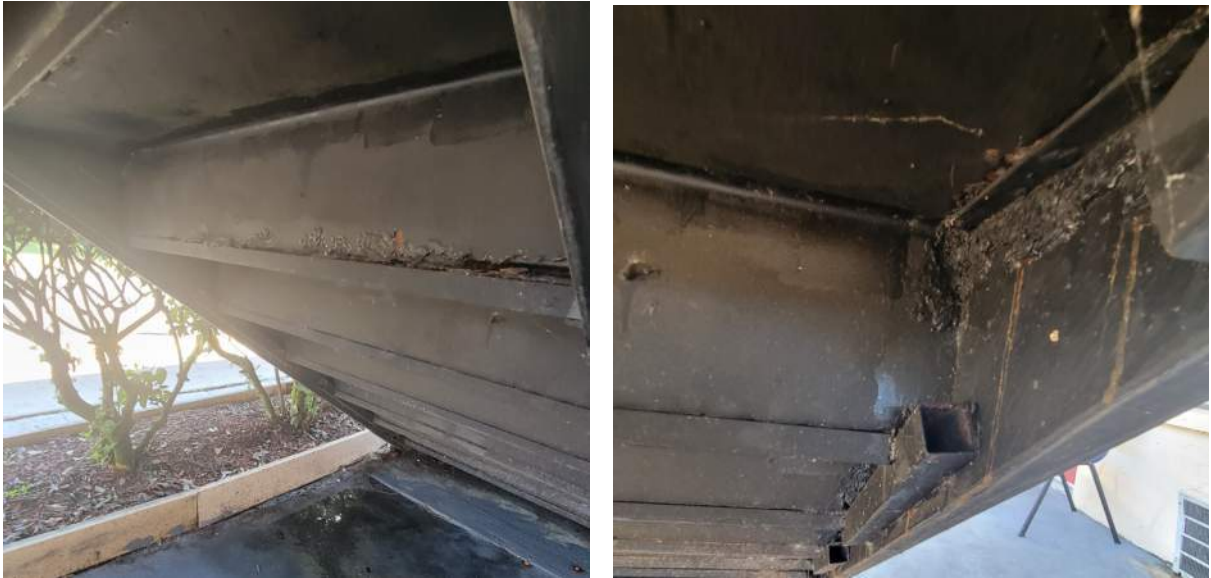
**Photo 37: Corrosion of Exterior Steel Framing**

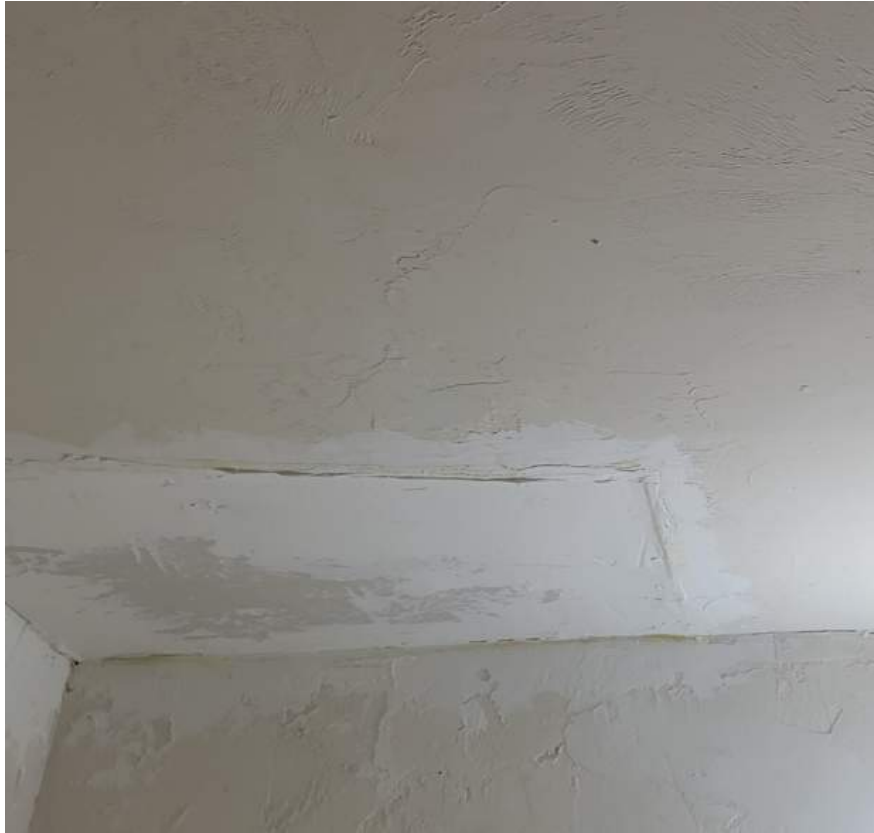
- Mildew/Organic Growth:
  - Mildew/organic growth was observed at second floor exterior beams joints. This may suggest water intrusion from 2<sup>nd</sup> floor or roof above (see Photo 40)
- Miscellaneous
  - Sagging of previous repair of plaster ceiling at roof. This may be an indication of previous or current water intrusion from roof above (see Photo 41)

**Photo 41: Sagging Plaster Ceiling at Roof**

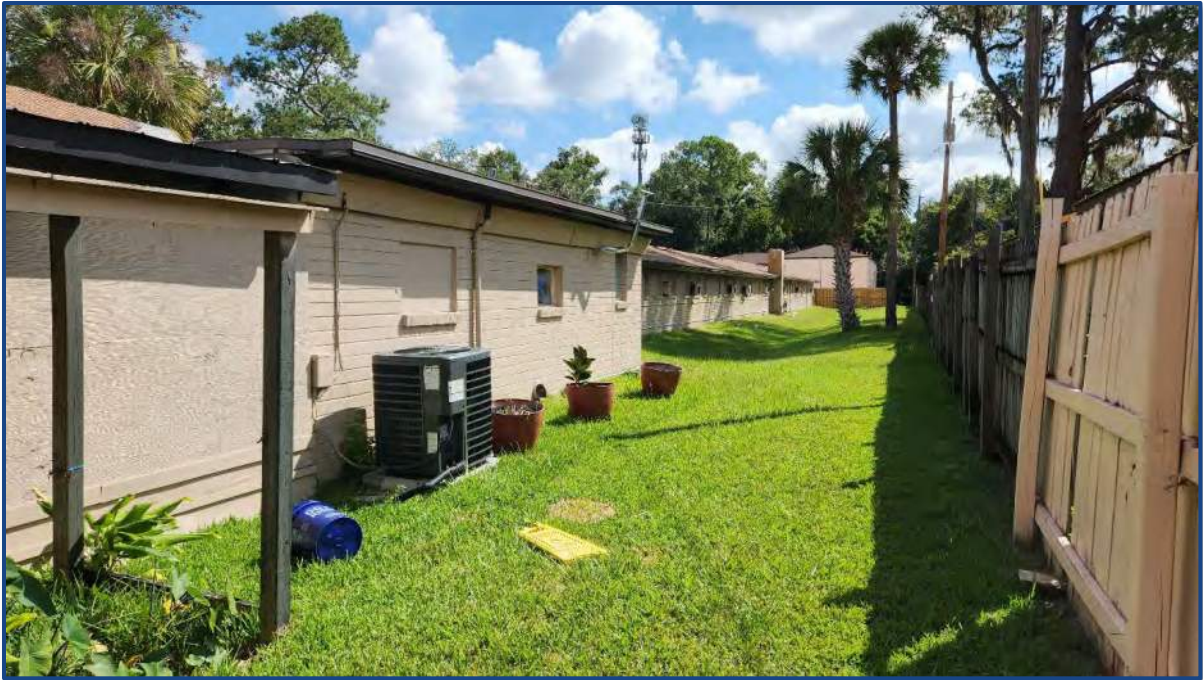
Photograph No. 9: View of the subject property, facing east. Pad mounted air-conditioning unit for the office and manager's apartment is apparent in the center. Window-mounted air conditioning units for the individual motel rooms are apparent in the background.
