**SINKHOLE SUSCEPTIBILITY STUDY AND NEAR SURFACE
GEOTECHNICAL EXPLORATION**

**GRU 63 ACRE WETLAND SITE
ALACHUA COUNTY, FLORIDA**

GSE PROJECT NO. 14588

NOVEMBER 2020

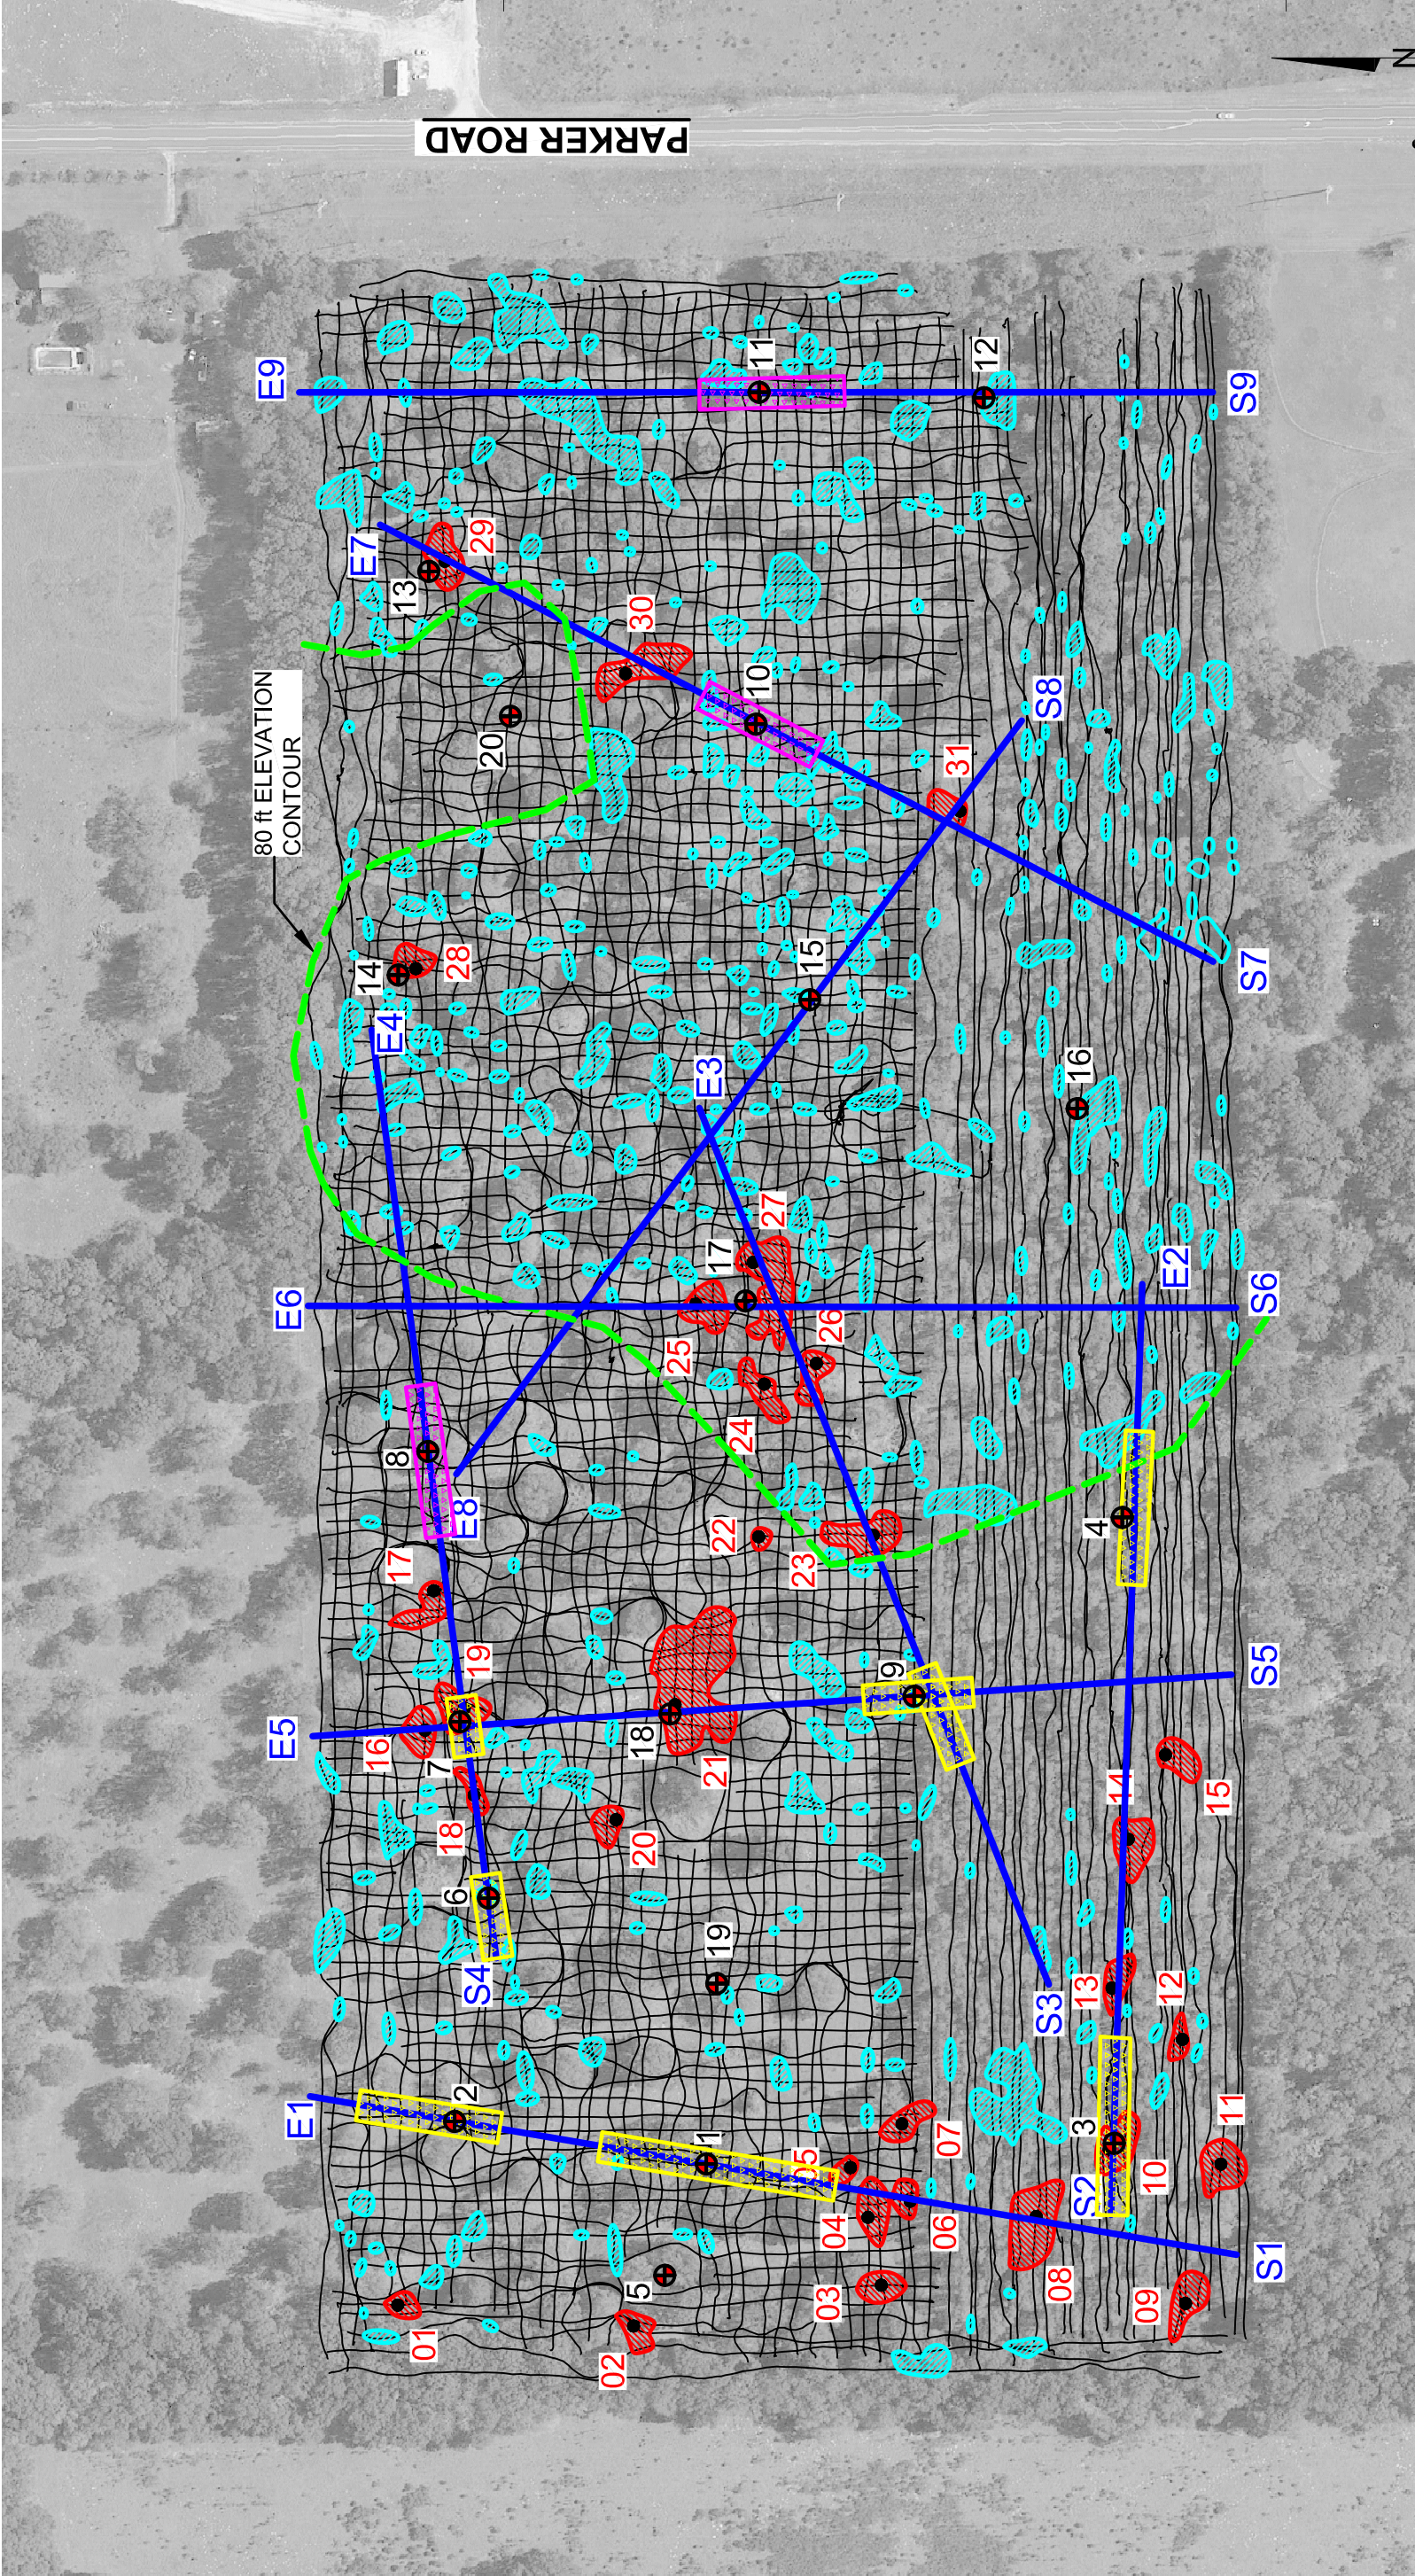
- GPR TRANSECTS
- TYPE (A) GPR ANOMALIES (MOST SIGNIFICANT)
 - TYPE (A) APPARENT CENTER OF ANOMALY WITH DESIGNATION
 - TYPE (B) GPR ANOMALIES (LEAST SIGNIFICANT)

The GPR data observed a high degree of variability in the depth of the reflector set. This variability is characteristic of a highly weathered epi-karst terrain common to this area. The majority of the variability in epi-karst terrain can be attributed to surficial erosion of the limestone surface rather than settlement due to an underlying void or cavity.

The Level A anomalies were characterized by a downwarping of approximately 5 to 10 feet toward a common center. In addition, a localized increase in the depth of the penetration and/or amplitude of the GPR signal response is observed. These represent the more pronounced GPR features identified.

The Level B anomalies were characterized by a moderate downwarping of 1 to 5 feet toward a common center and/or a localized increase in the depth of the penetration and/or amplitude of the GPR signal response is observed. Type B anomalies were observed in the upper 5 to 10 feet of the soils and do not appear to continue with depth. These anomalies are more likely associated with surficial weathering or erosional activities characteristic of epi-karst terrain rather than sinkhole activity.

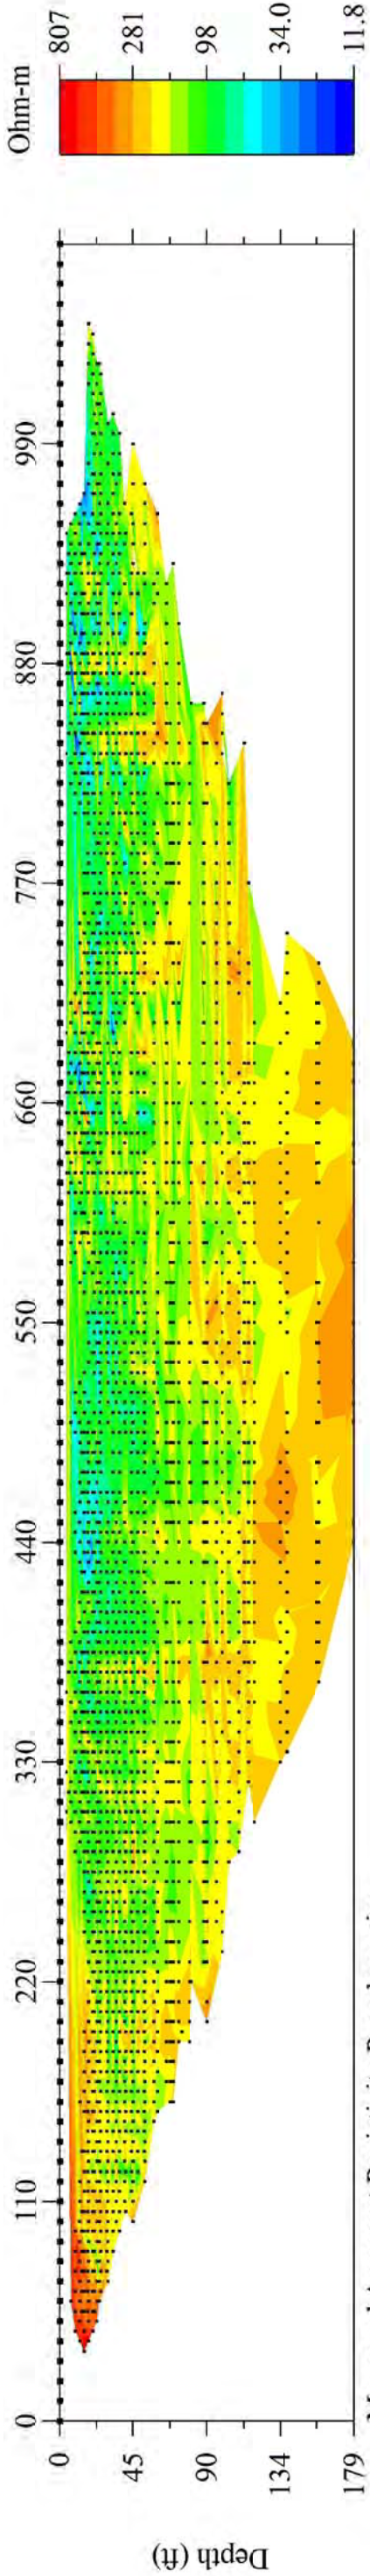
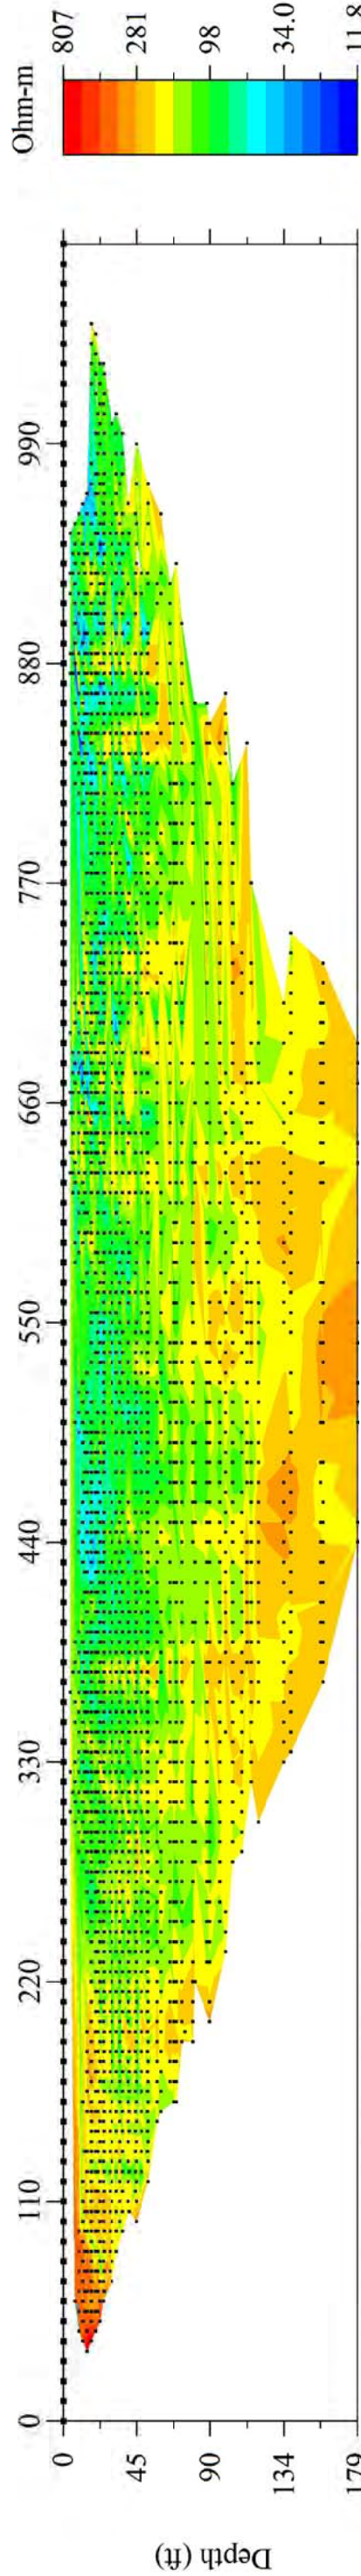
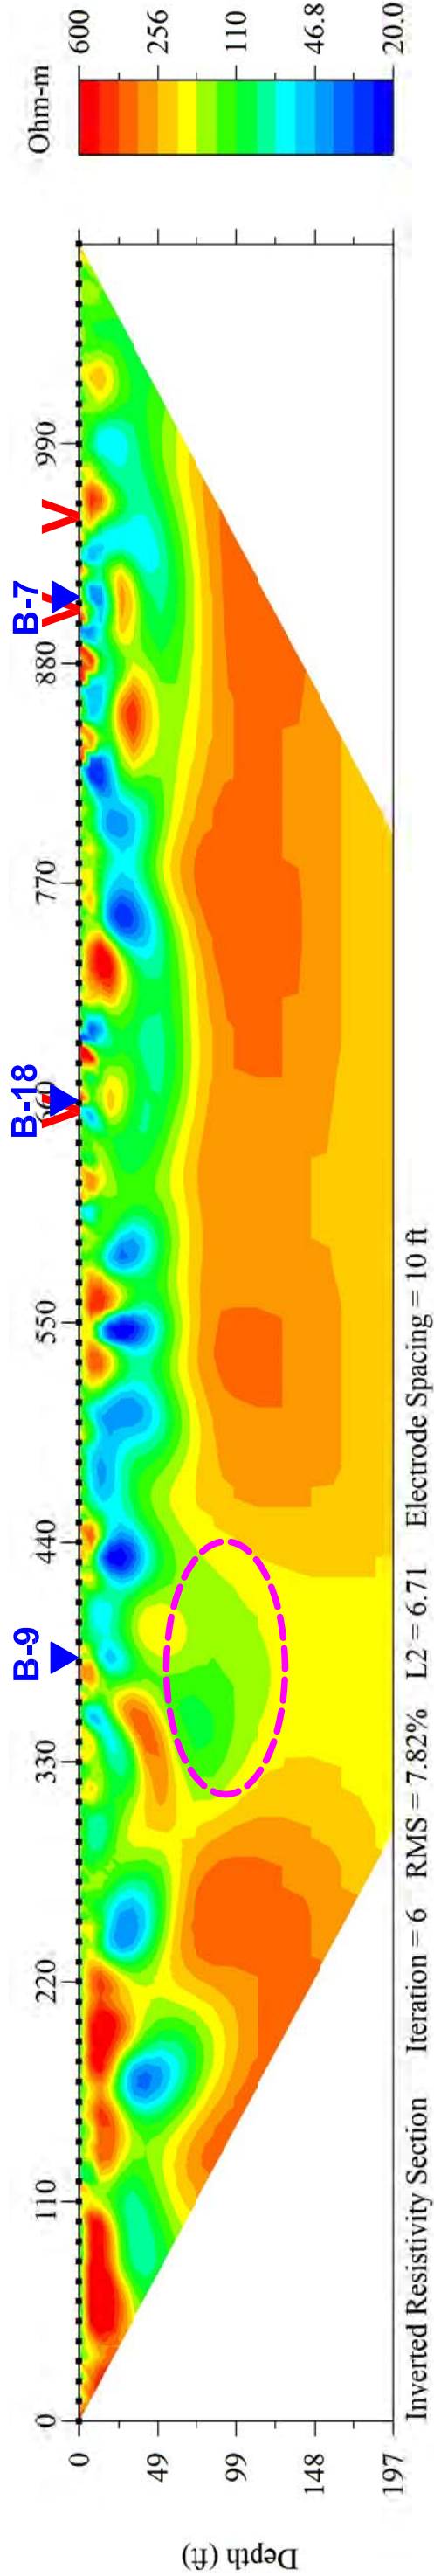
FIGURE 8	ERI TRANSECT 5	GRU-PARKER ROAD RECHARGE WETLAND SITE ALACHUA COUNTY, FLORIDA	
			GSE ENGINEERING & CONSULTING, INC. GAINESVILLE, FLORIDA	PROJECT: 31405 DATE: 05/26/17

Analysis of the ERI transects indicate the presence of a mixture of high to low resistivity earth materials to an approximate depth range of 40 to 60 feet bls (represented in blue to red on the ERI transects). This mixed resistivity layer is most likely associated epikarst conditions where the relative percentages of sand, clays, weathered limestone and competent limestone are both vertically and horizontally highly variable. This mixed resistivity layer is underlain by a moderate to high resistivity layer (represented in yellow to red) to the maximum depth of the ERI results. This moderate to high resistivity layer is most likely associated with competent limestone.

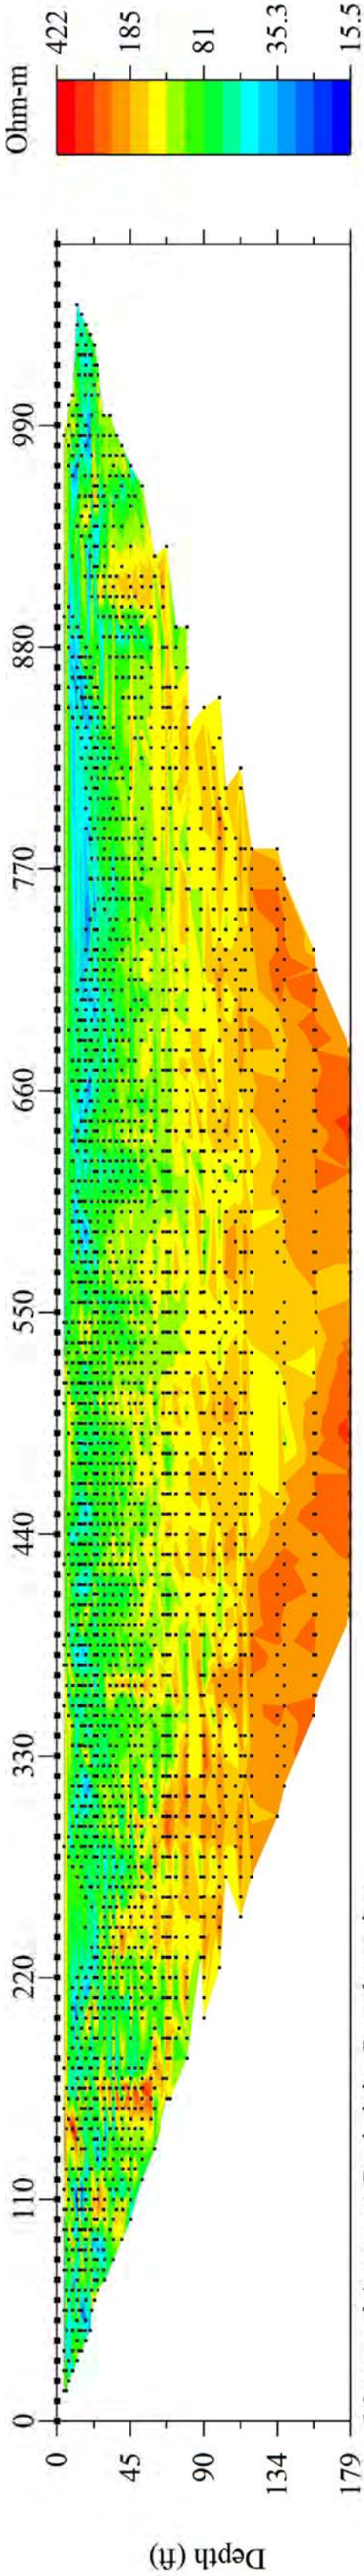
ERI TRANSECT 9

Measured Apparent Resistivity Pseudosection

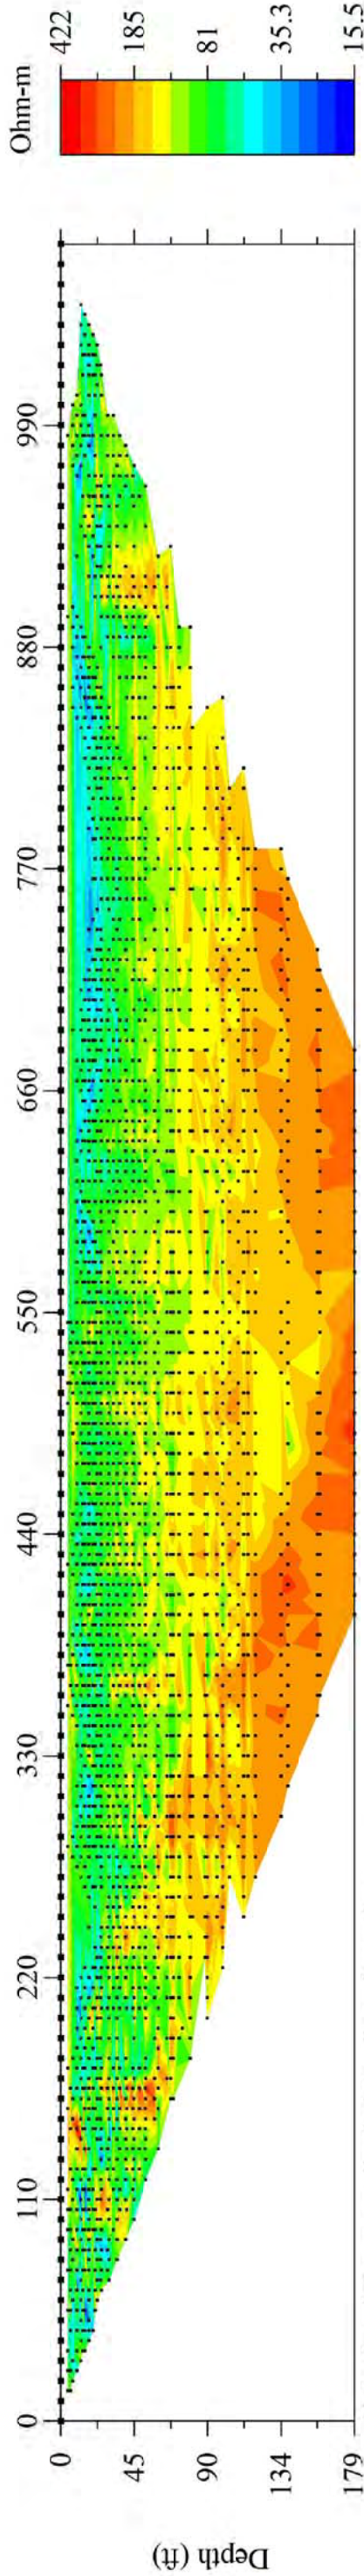
Calculated Apparent Resistivity Pseudosection

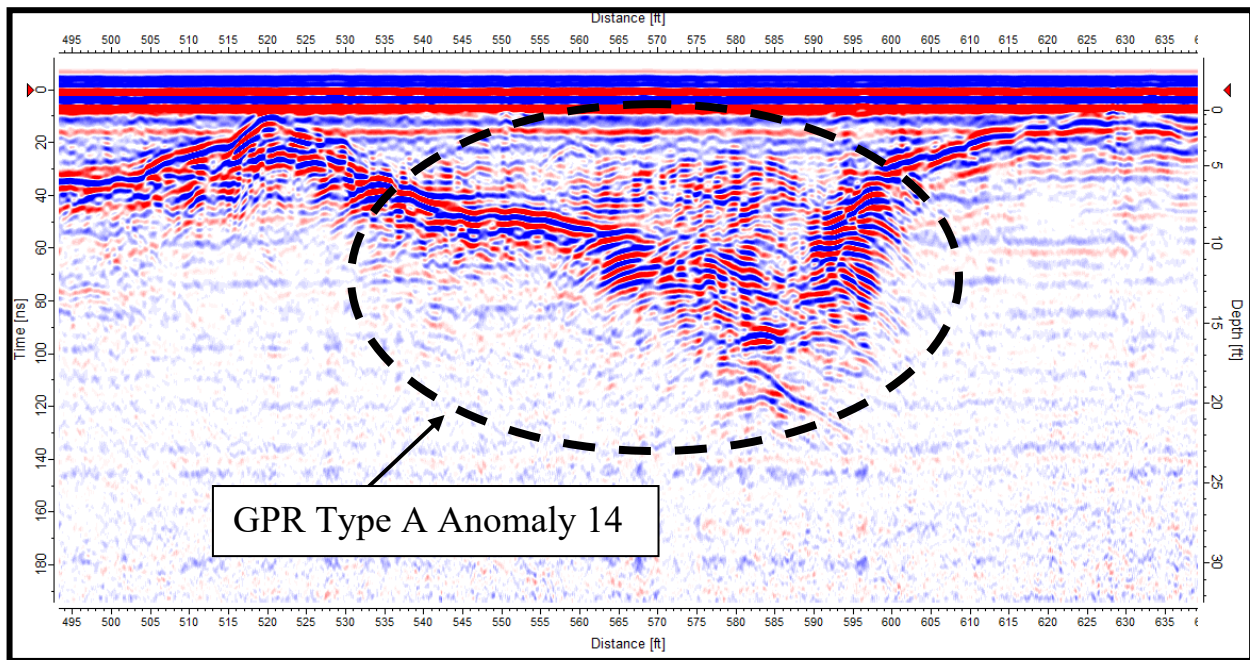
GPR Transect Showing Example of GPR Type A Anomaly 14

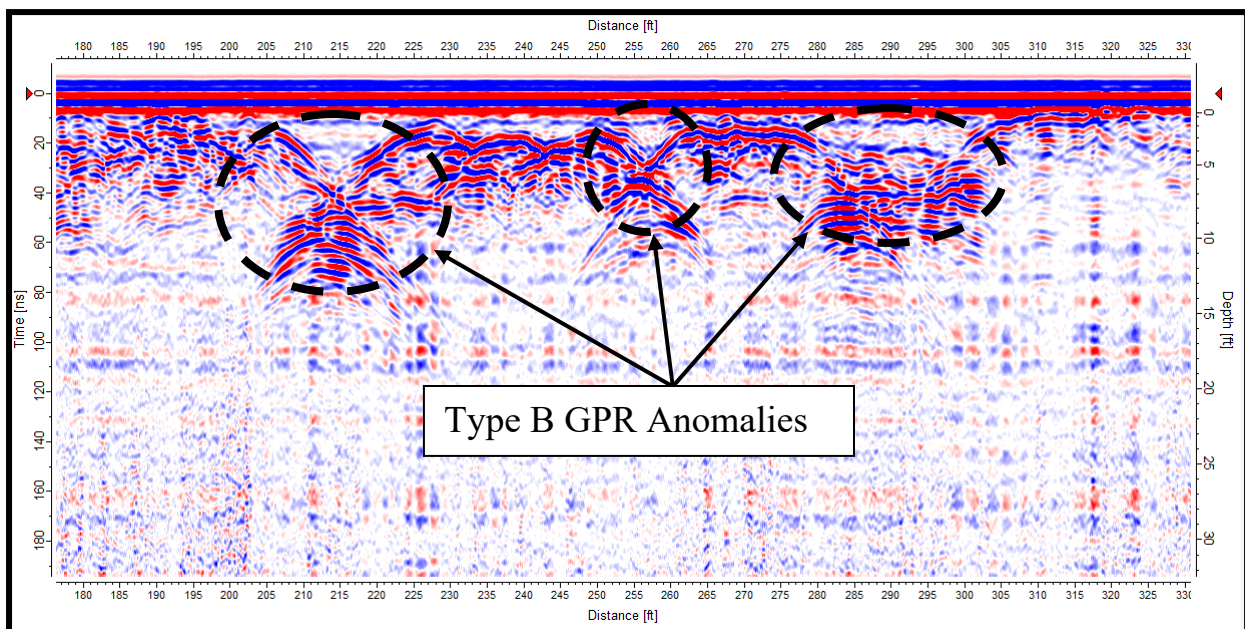
Type B GPR Anomalies

GPR Transect Showing Examples of GPR Type B Anomalies
