RE: Origis Energy Solar Facility

The Applicant proposes a modification to the existing transmission substation, known as Parker Substation, located on the southwest corner of SW 122nd Street (Parker Rd) and Hwy 24 (Archer Rd). The parcel is owned by the City of Gainesville; the substation is owned and operated by the Gainesville Regional Utility (GRU). The approximately 20-acre parcel is zoned Agricultural, with a future land use designation of Institutional. The substation was permitted in May 1972 by Special Exception [SUP-72-1161] issued by the BOCC.

Both the Applicant and GRU plan to add high-voltage equipment inside the existing substation fence to accommodate the connection of the Applicant's solar energy generating facility (see application DR23-000032). The equipment to be added, owned, and maintained by the Applicant will include, for example, high voltage circuit breakers and switches; meters; steel framing; a step-up transformer; a small control enclosure; a capacitor; communication equipment; underground cables; and an above-ground conductor. The equipment to be added, owned, and maintained by GRU will include, for example, high voltage circuit breakers and switches;

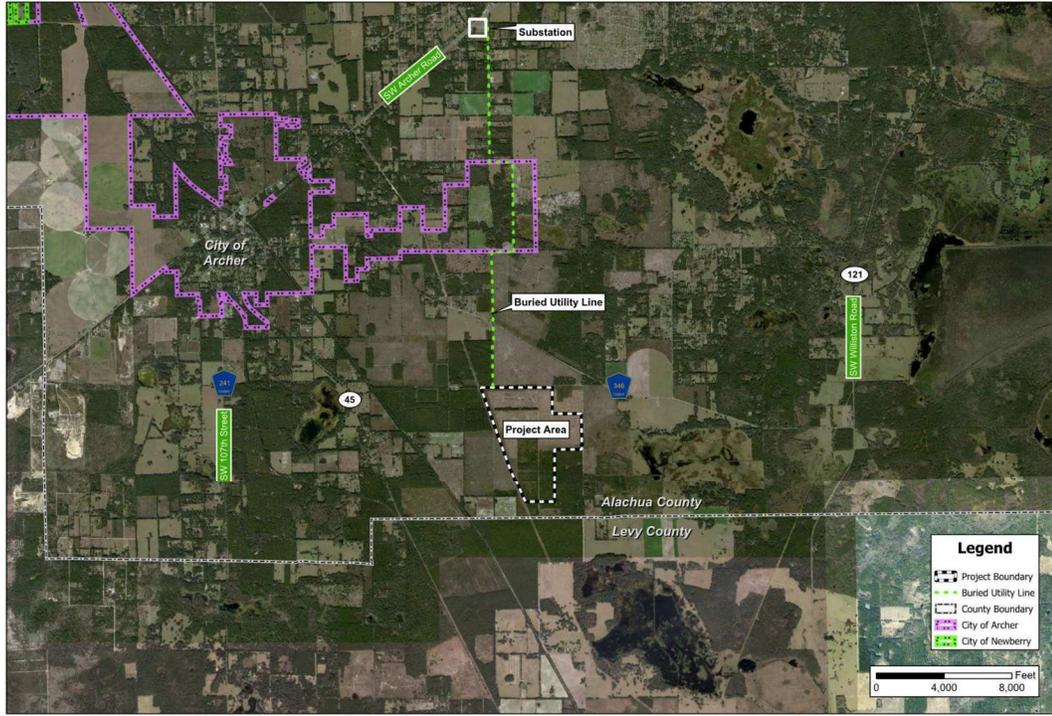
ILLUSTRATION 1A:  
CONTEXT MAP

Context Area Map

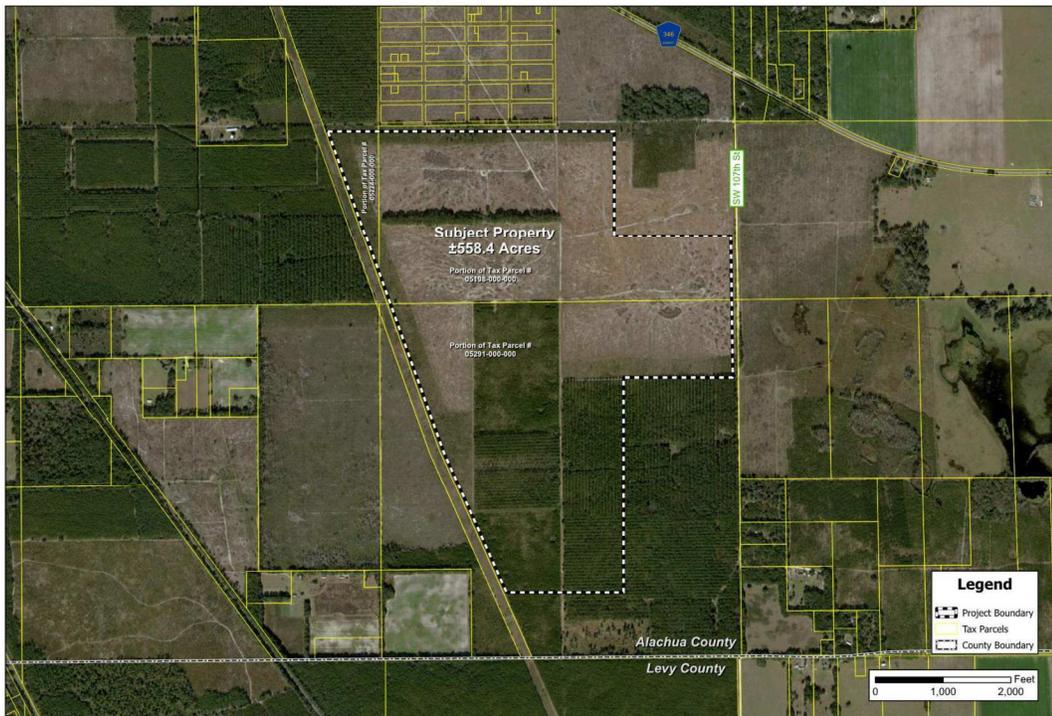
ILLUSTRATION 1B:  
AERIAL MAP

Context Aerial Map

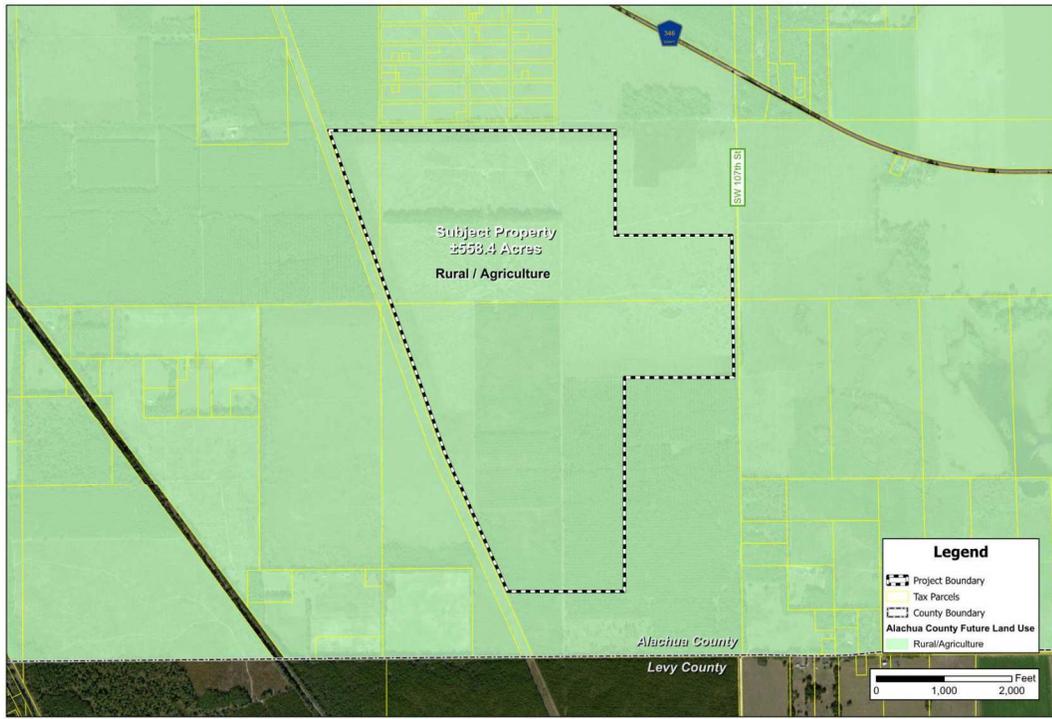
ILLUSTRATION 2A:  
FLU MAP

Existing Future Land Use Map

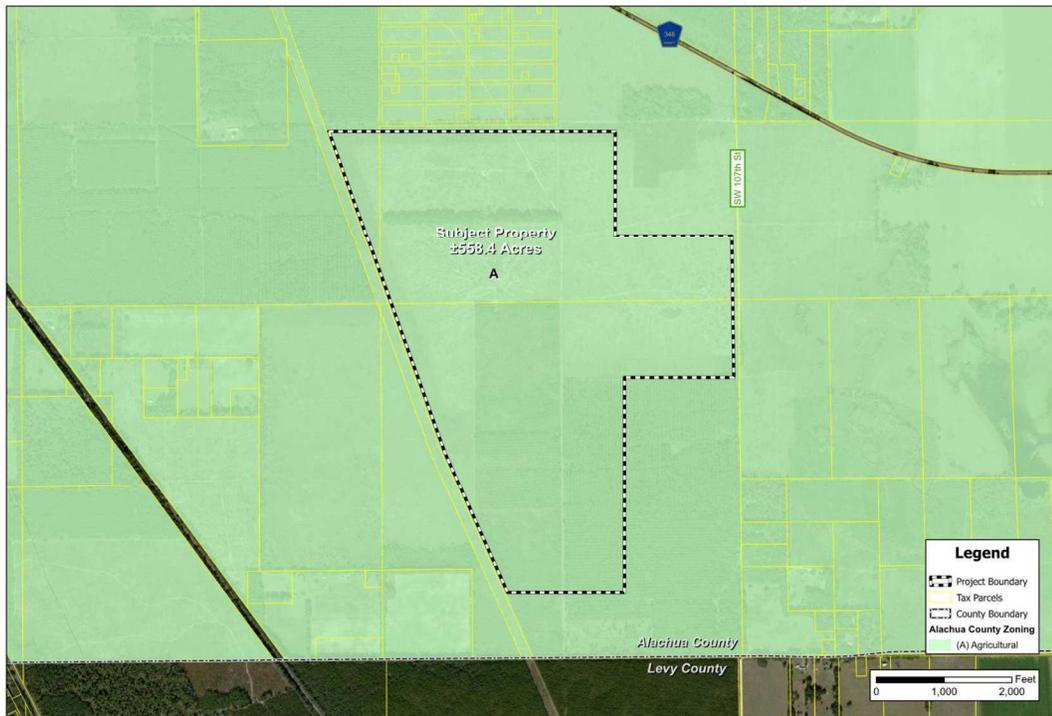
ILLUSTRATION 2A:  
ZON MAP

Existing Zoning Map

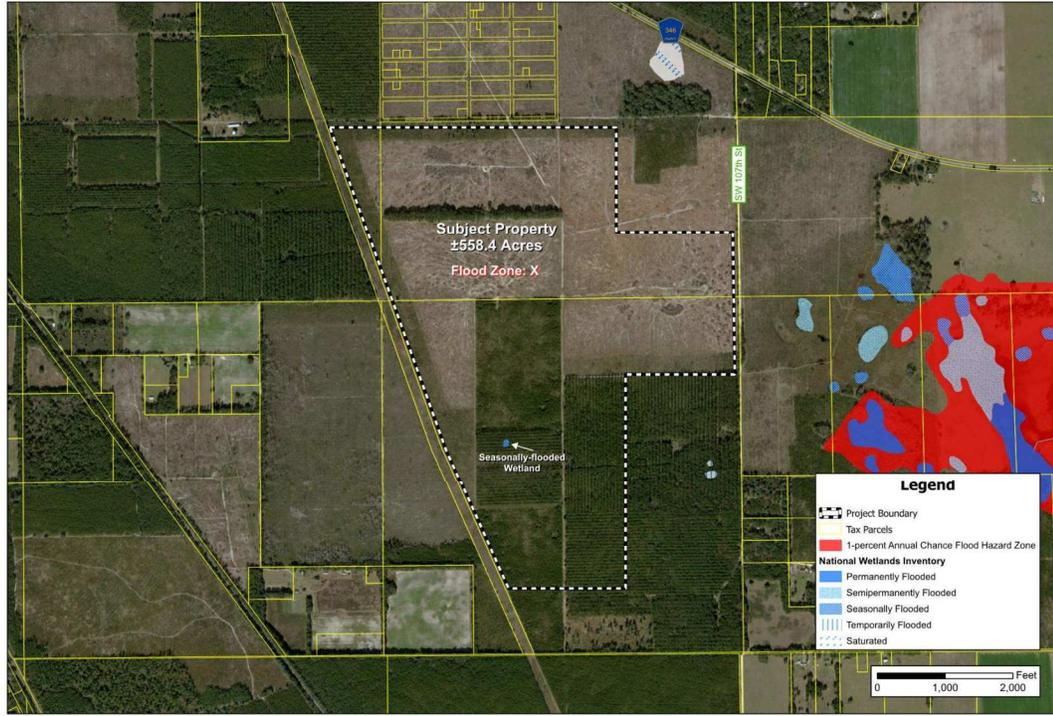
ILLUSTRATION 4  
ENV MAP

Env Map

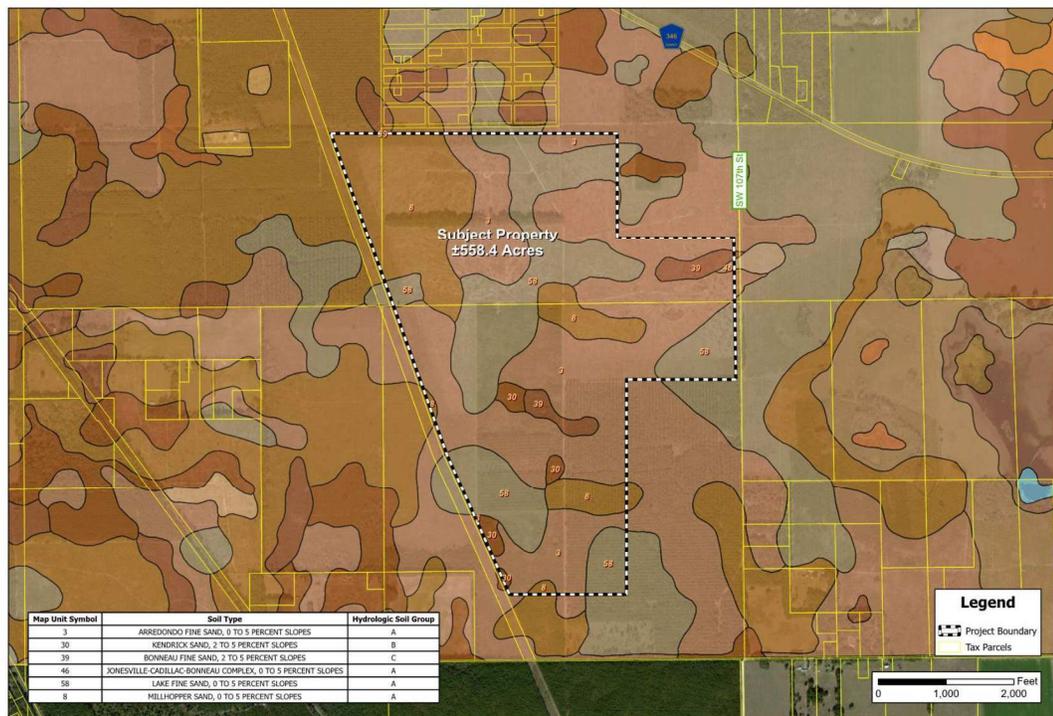
ILLUSTRATION 5  
SOILS MAP

Existing Topography & Floodplains

Map Unit Symbol	Soil Type	Hydrologic Soil Group
3	ARRONDON FINE SAND, 0 TO 5 PERCENT SLOPES	A
30	KENDRICK SAND, 2 TO 5 PERCENT SLOPES	B
39	BONNEAU FINE SAND, 2 TO 5 PERCENT SLOPES	C
46	JONESVILLE-CADILLAC-BONNEAU COMPLEX, 0 TO 5 PERCENT SLOPES	A
58	LAKE FINE SAND, 0 TO 5 PERCENT SLOPES	A
8	MILL HOPPER SAND, 0 TO 5 PERCENT SLOPES	A

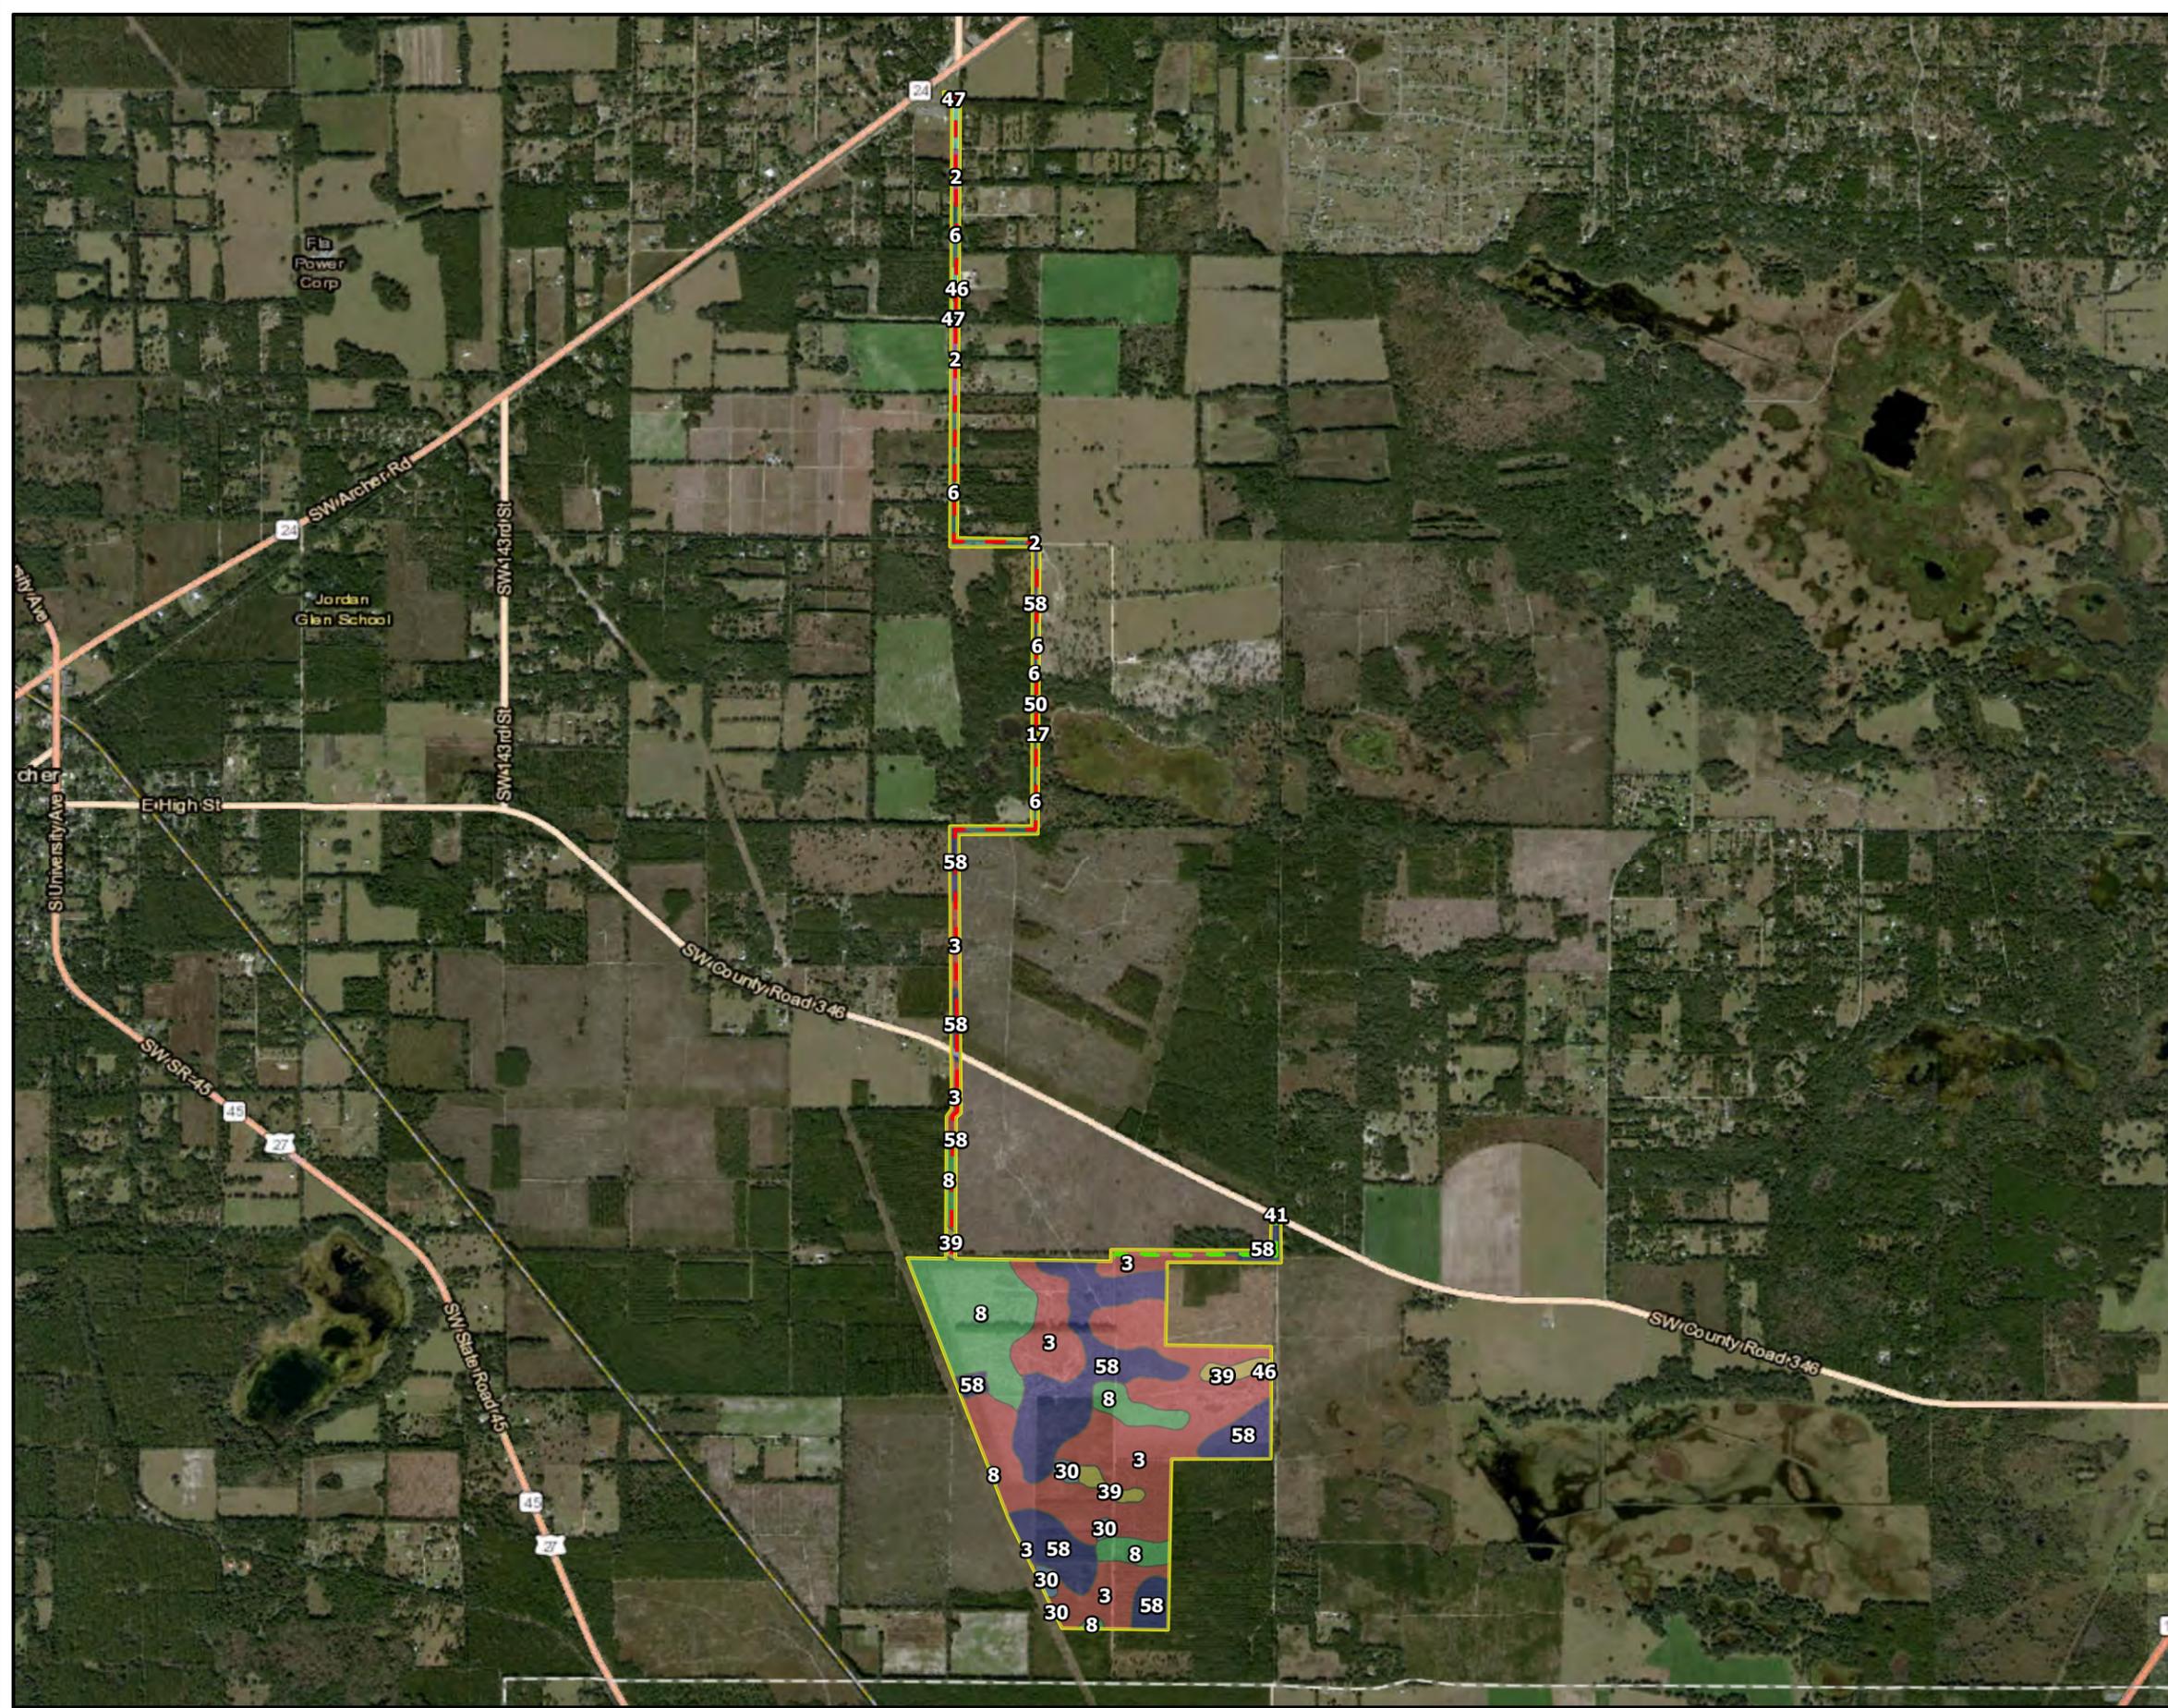
**Sand Bluff Solar Site  
Alachua County, Florida  
B-3 NRCS Soils Data Map**

- Legend**
- Project Area
  - Access Road
  - MV Connector Bore Path
- NRCS Soil Types**
- 17 - Wachula sand
  - 2 - Candler fine sand, 0 to 5 percent slopes
  - 3 - Arredondo fine sand, 0 to 5 percent slopes
  - 30 - Kendrick sand, 2 to 5 percent slopes
  - 39 - Bonneau fine sand, 2 to 5 percent slopes
  - 41 - Pedro fine sand, 0 to 5 percent slopes
  - 46 - Jonesville-Cadillac-Bonneau complex, 0 to 5 percent slopes
  - 47 - Candler-Apopka complex, 0 to 5 percent slopes
  - 50 - Sparr fine sand
  - 58 - Lake fine sand, 0 to 5 percent slopes
  - 6 - Apopka sand, 0 to 5 percent slopes
  - 8 - Millhopper sand, 0 to 5 percent slopes

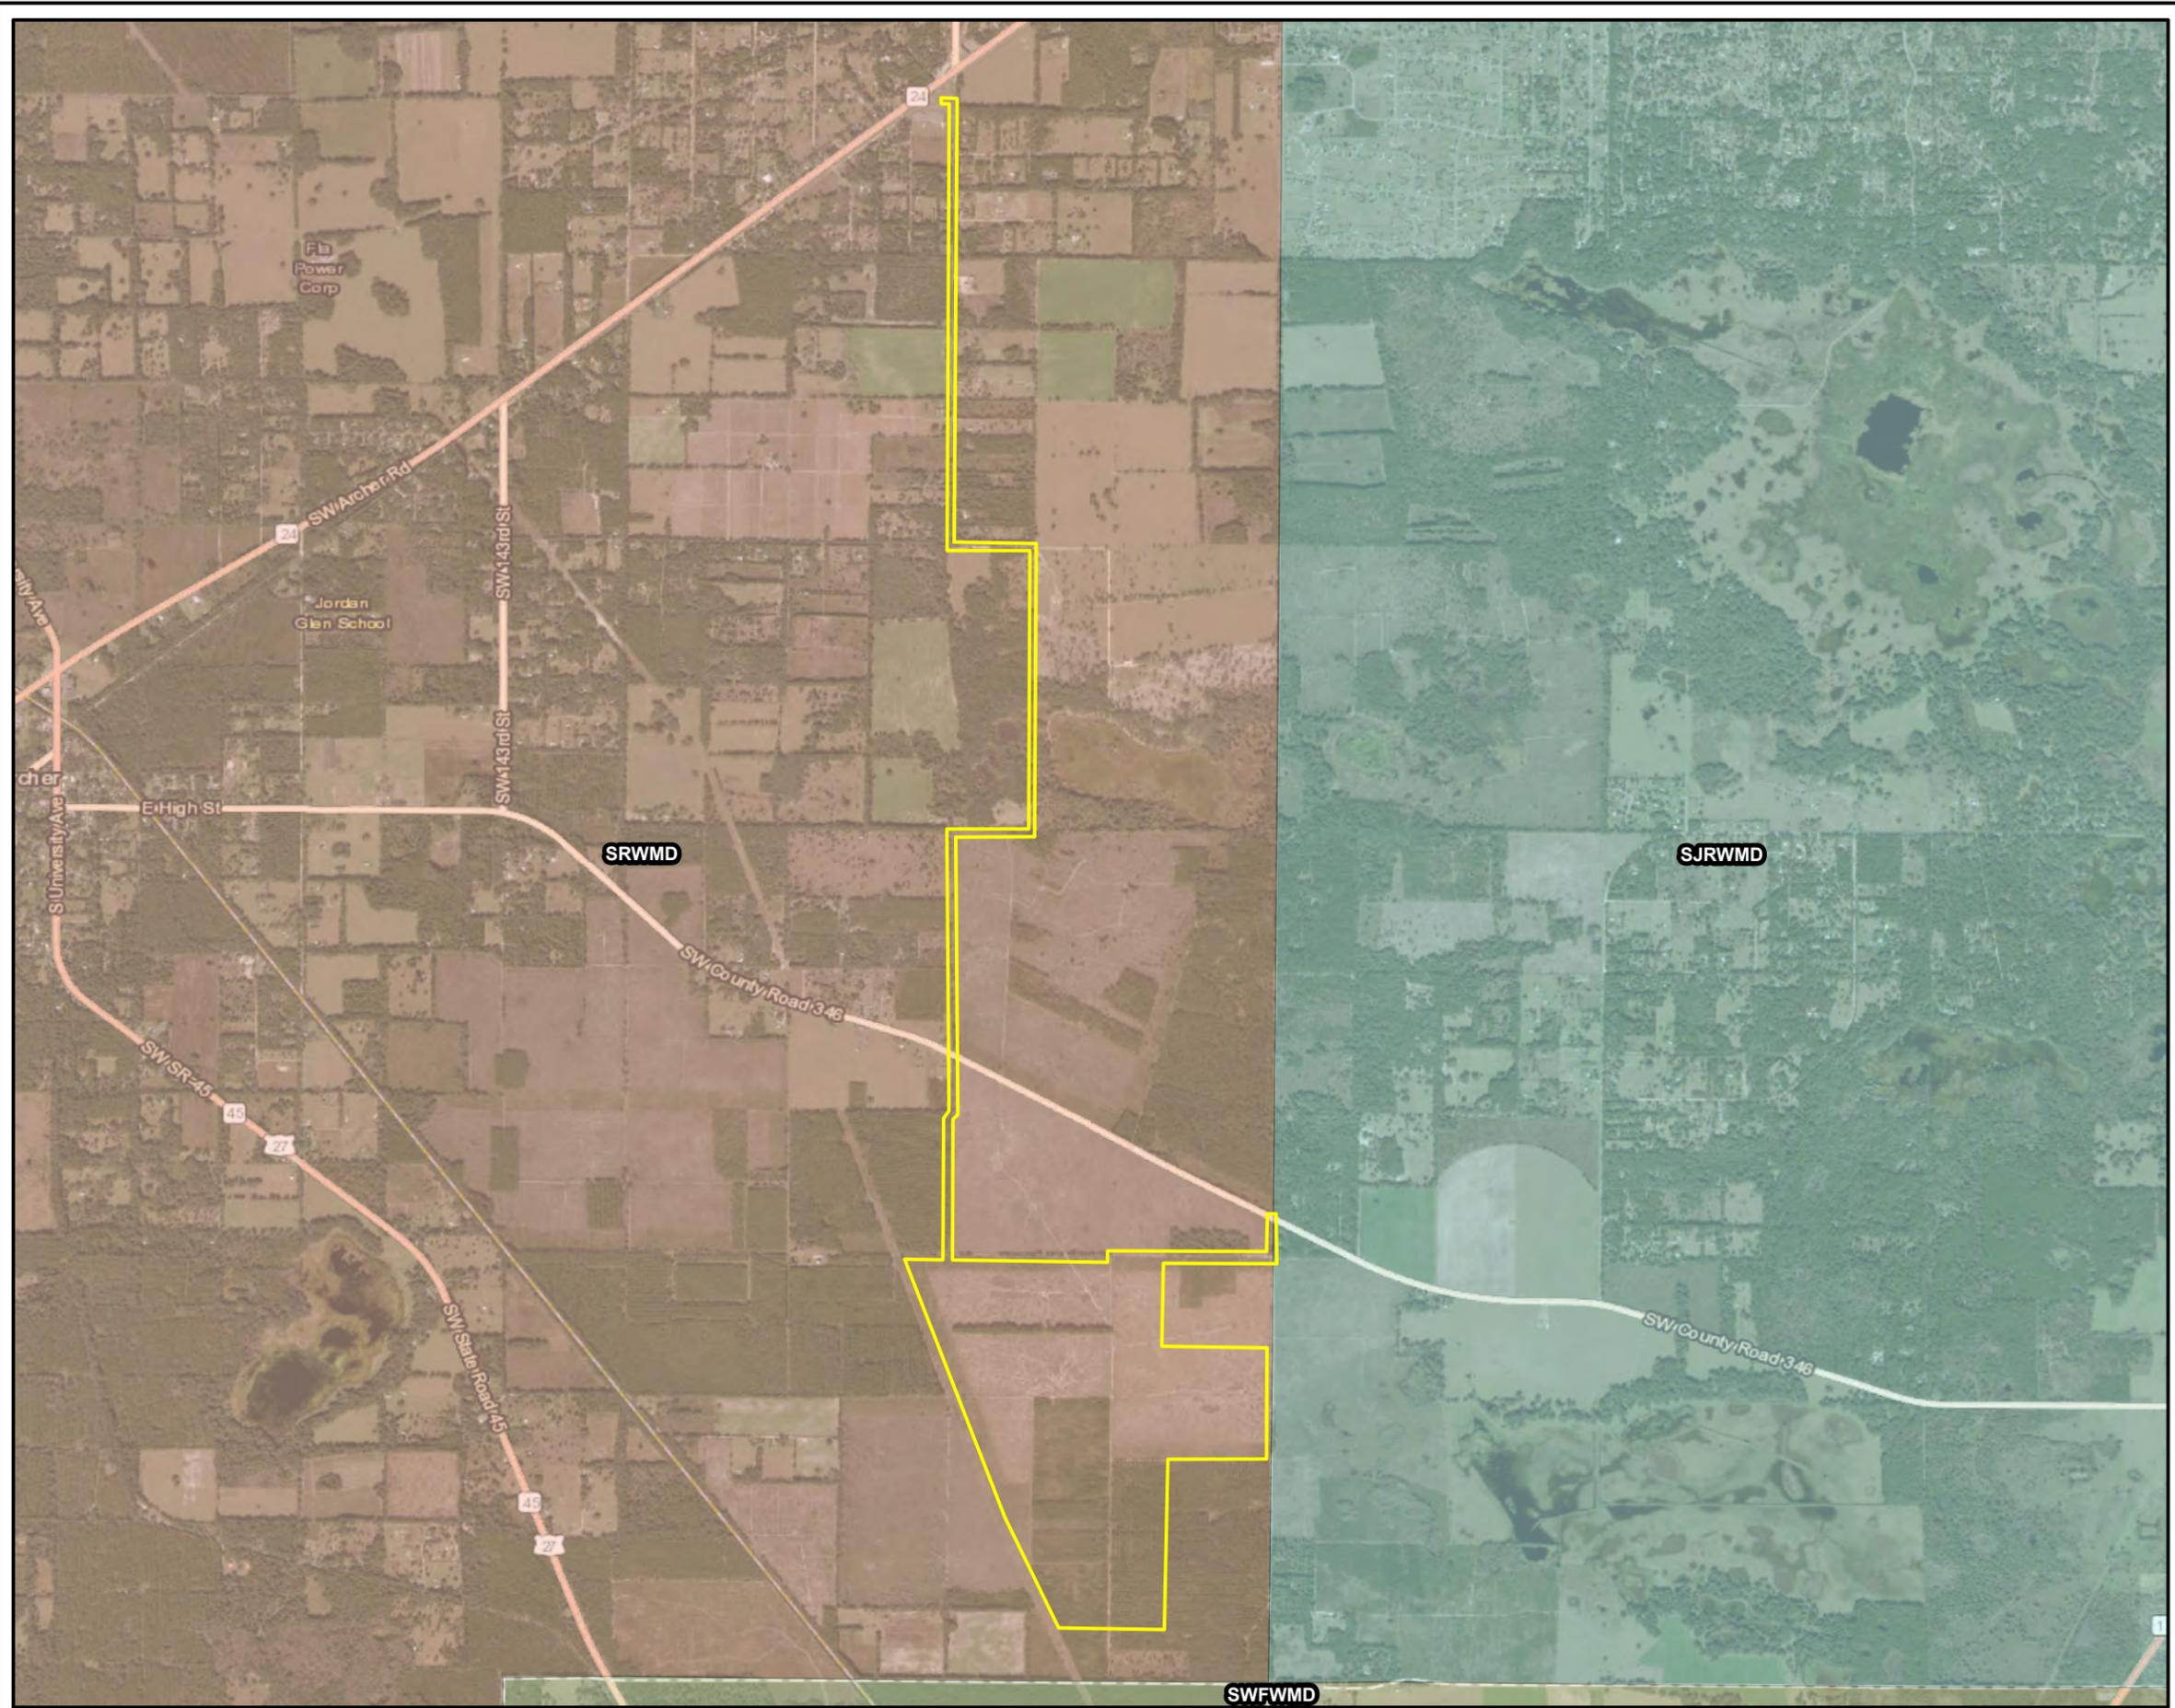
**Sand Bluff Solar Site  
Alachua County, Florida  
B-5 Water Management District Boundaries**

**Water Management District Boundaries**

- SJRWMD
- SRWMD
- SWFWMD

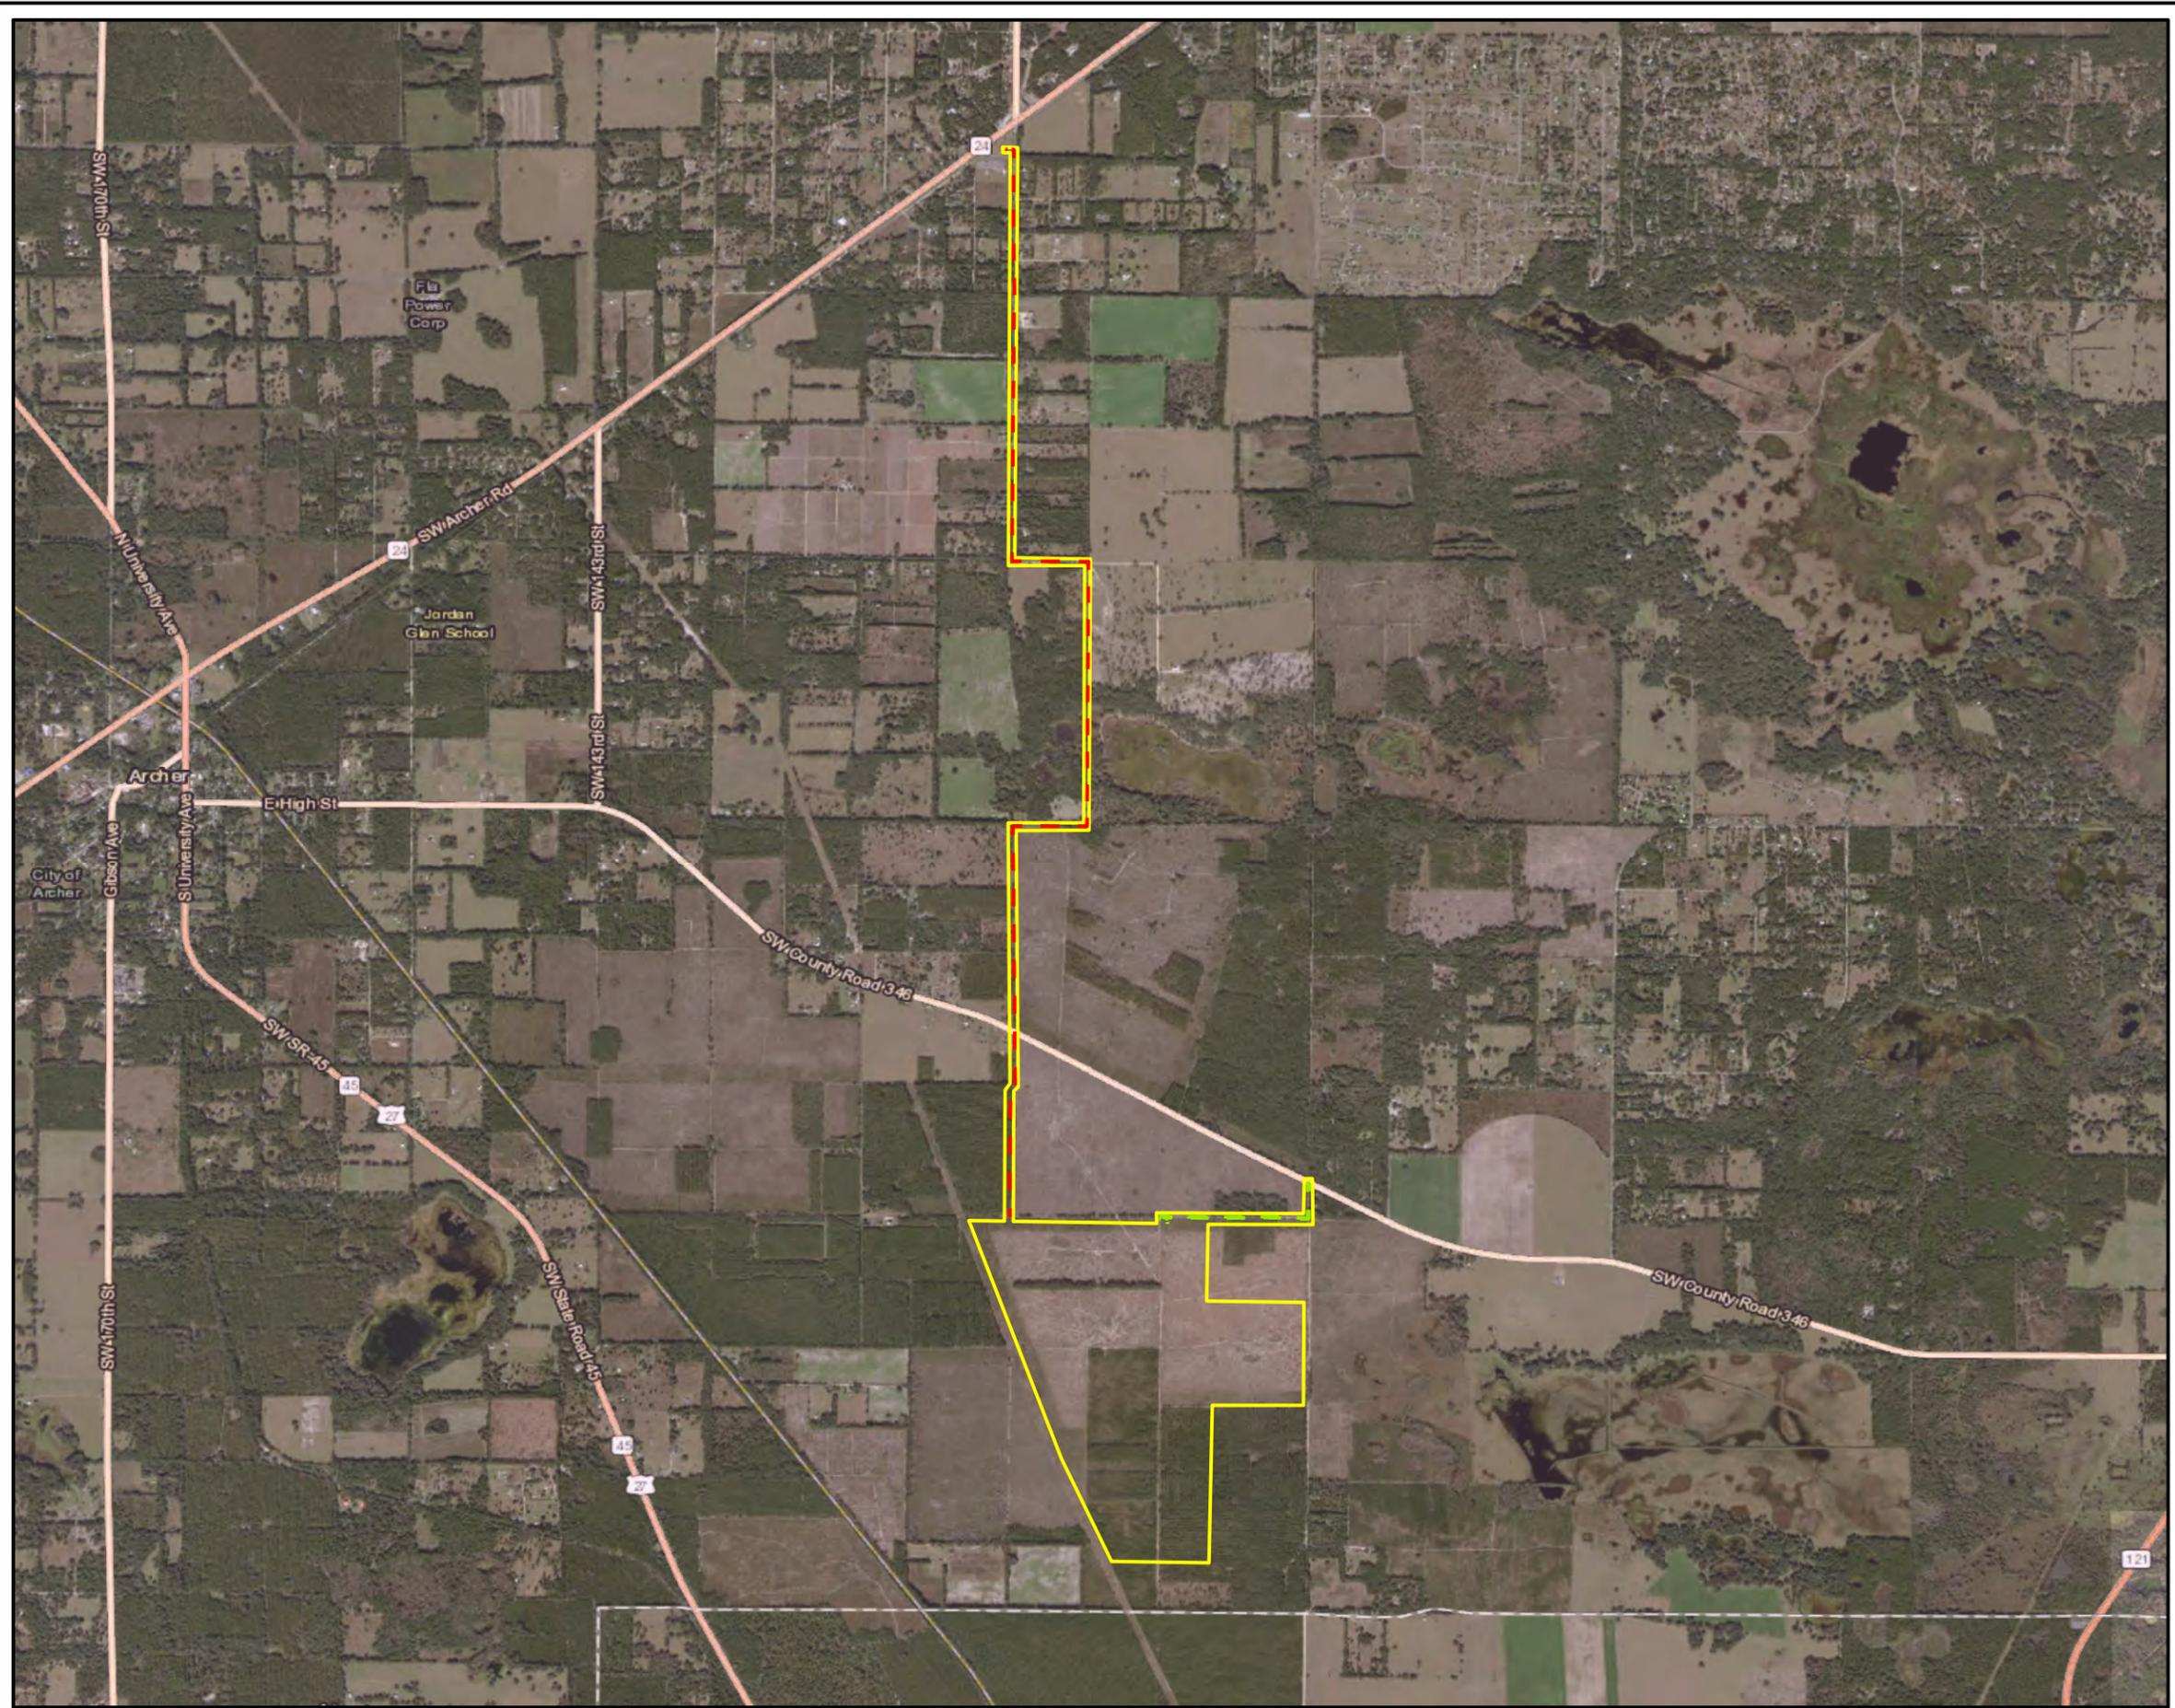
**Sand Bluff Solar Site  
Alachua County, Florida  
B-8 Protected Species Consultation Area  
Map**

- Legend**
- Project Area
  - Access Road
  - MV Connector Bore Path
- Listed Species Consultation Areas**
- Eastern Indigo Snake Range 2001

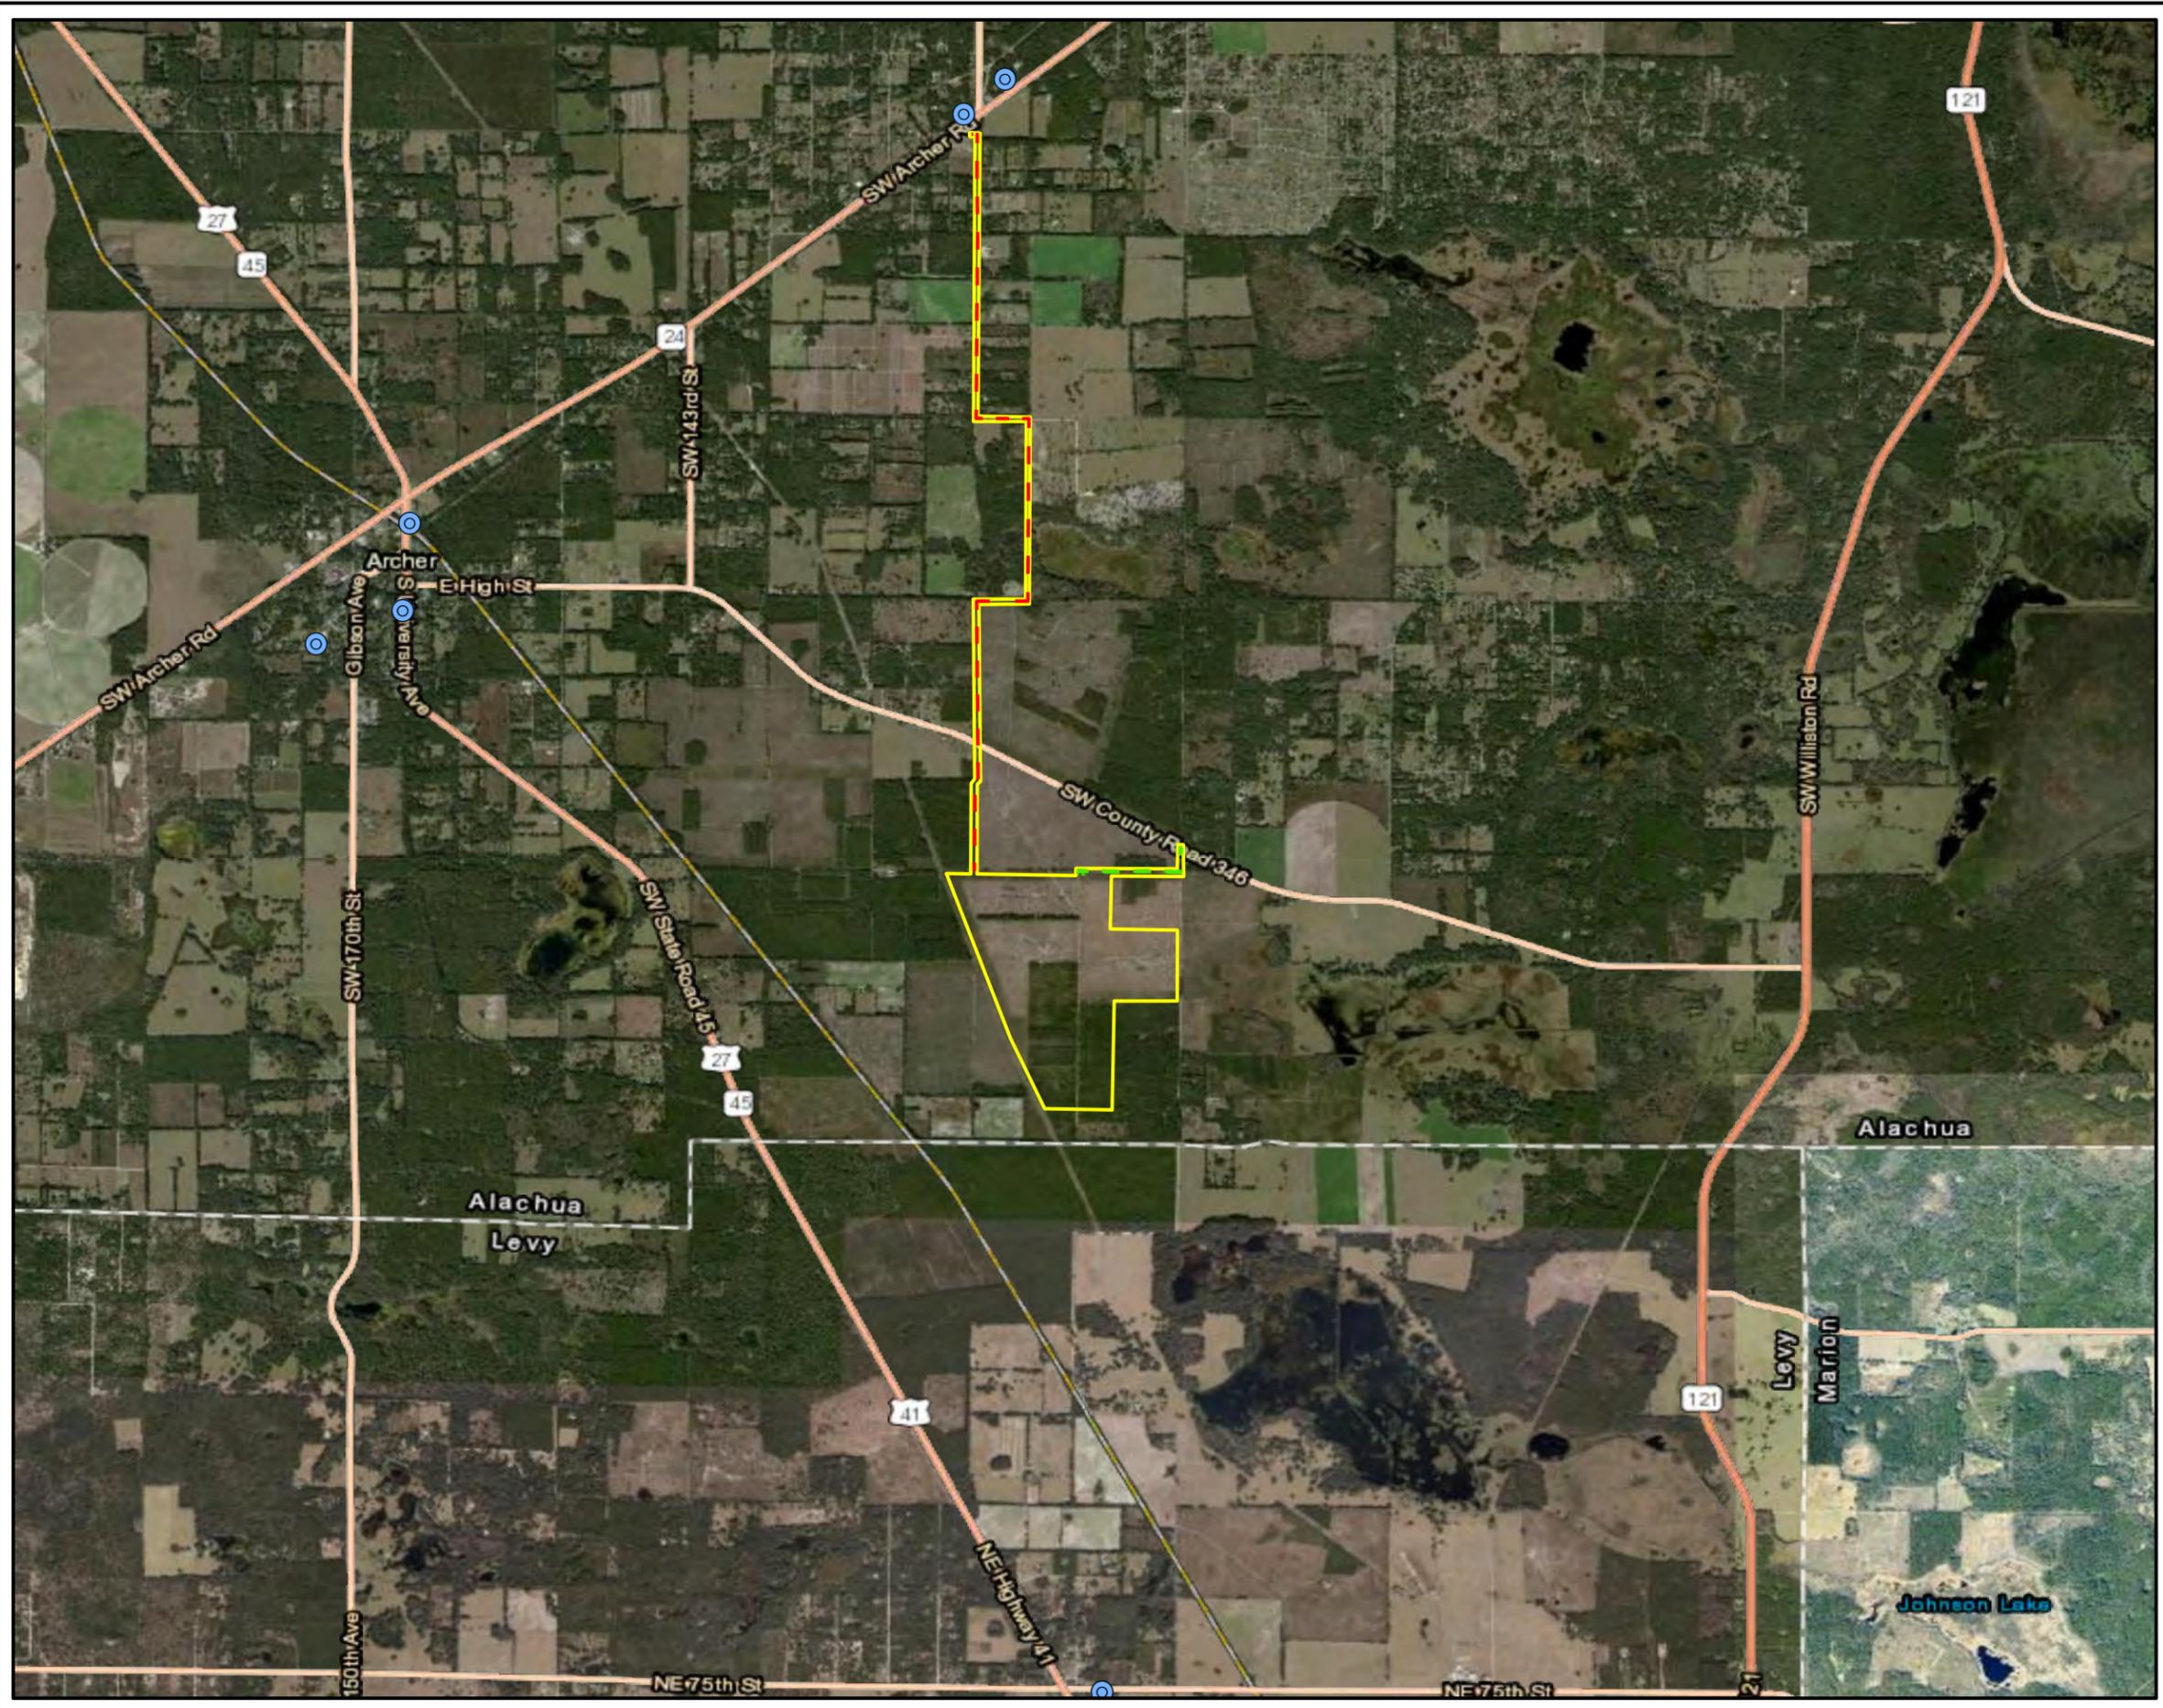
**Sand Bluff Solar Site  
Alachua County, Florida  
B-11 Public Water Supply  
Wellheads Map**

- Legend**
- Public Water Supply Wells (Non Federal)
  - Project Area
  - MV Connector Bore Path
  - Access Road
