RE: Origis Energy Solar Facility

The Applicant proposes a modification to the existing transmission substation, known as Parker Substation, located on the southwest corner of SW 122nd Street (Parker Rd) and Hwy 24 (Archer Rd). The parcel is owned by the City of Gainesville; the substation is owned and operated by the Gainesville Regional Utility (GRU). The approximately 20-acre parcel is zoned Agricultural, with a future land use designation of Institutional. The substation was permitted in May 1972 by Special Exception [SUP-72-1161] issued by the BOCC.

Both the Applicant and GRU plan to add high-voltage equipment inside the existing substation fence to accommodate the connection of the Applicant's solar energy generating facility (see application DR23-000032). The equipment to be added, owned, and maintained by the Applicant will include, for example, high voltage circuit breakers and switches; meters; steel framing; a step-up transformer; a small control enclosure; a capacitor; communication equipment; underground cables; and an above-ground conductor. The equipment to be added, owned, and maintained by GRU will include, for example, high voltage circuit breakers and switches;

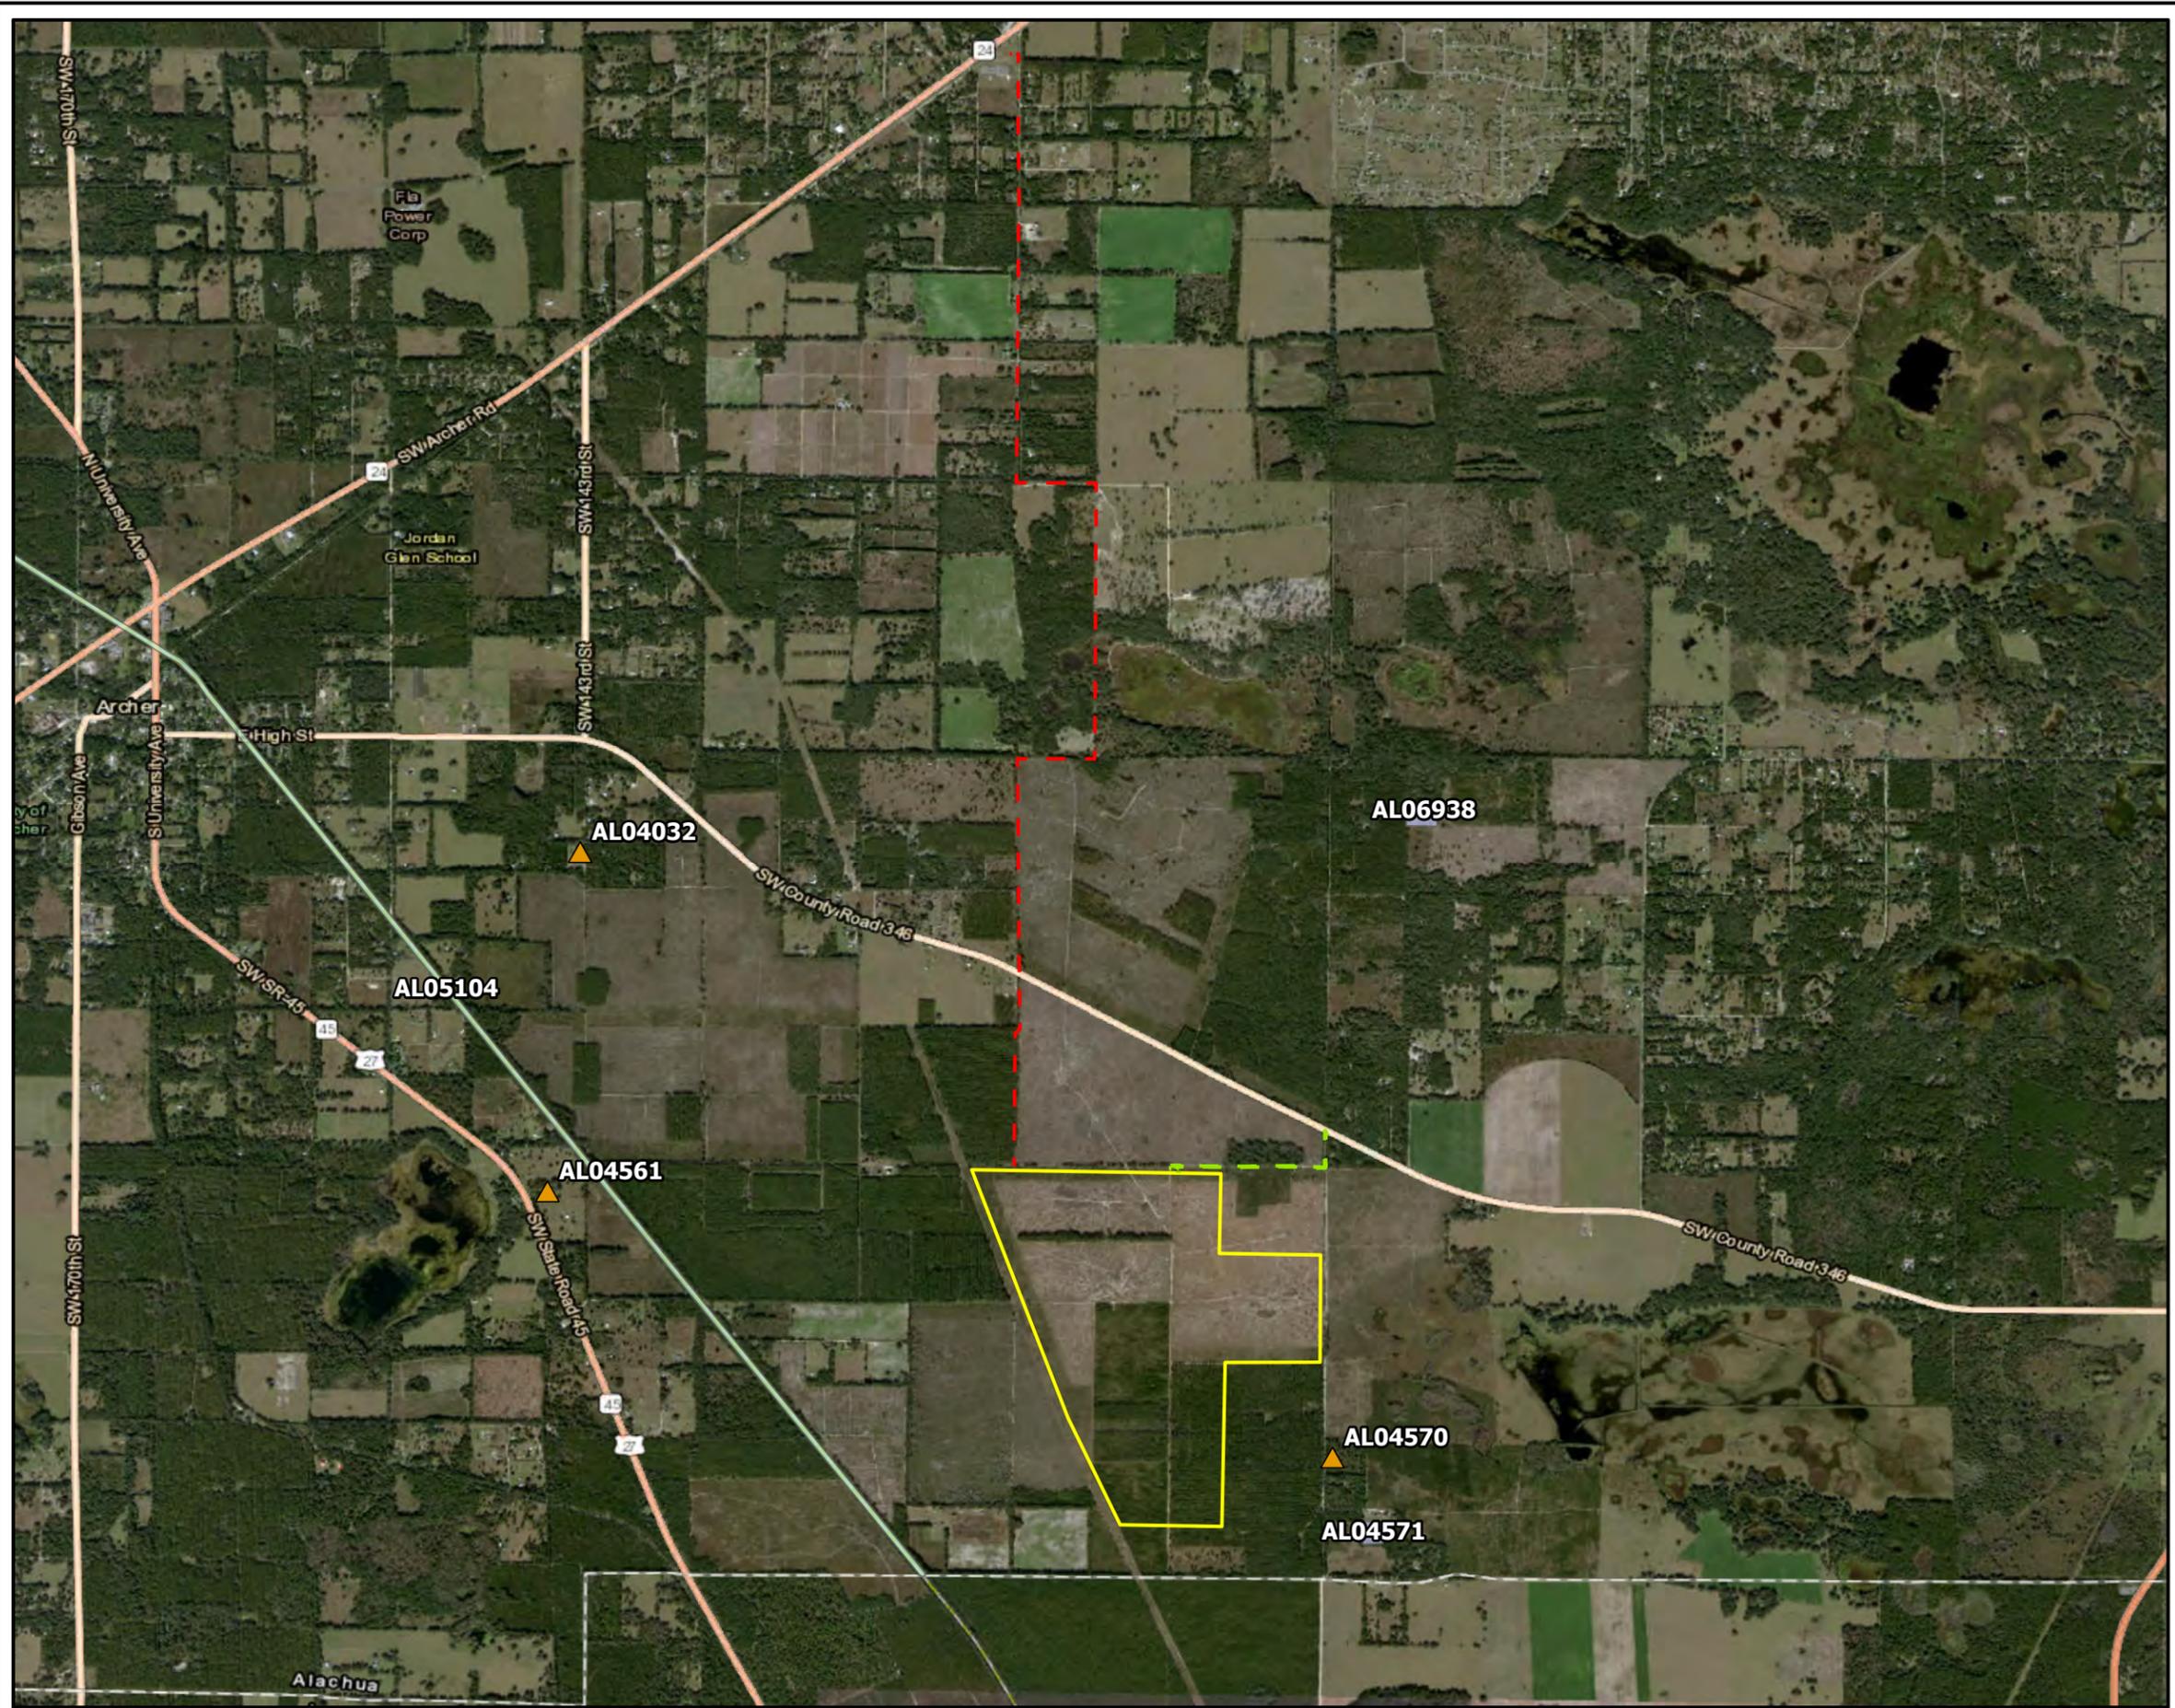
**Sand Bluff Solar Site Alachua County, Florida  
B-14 Historical Resources Map**

Florida Historical Resources

- Historic Cemetary
- Historic Structure
- Historic Railroad

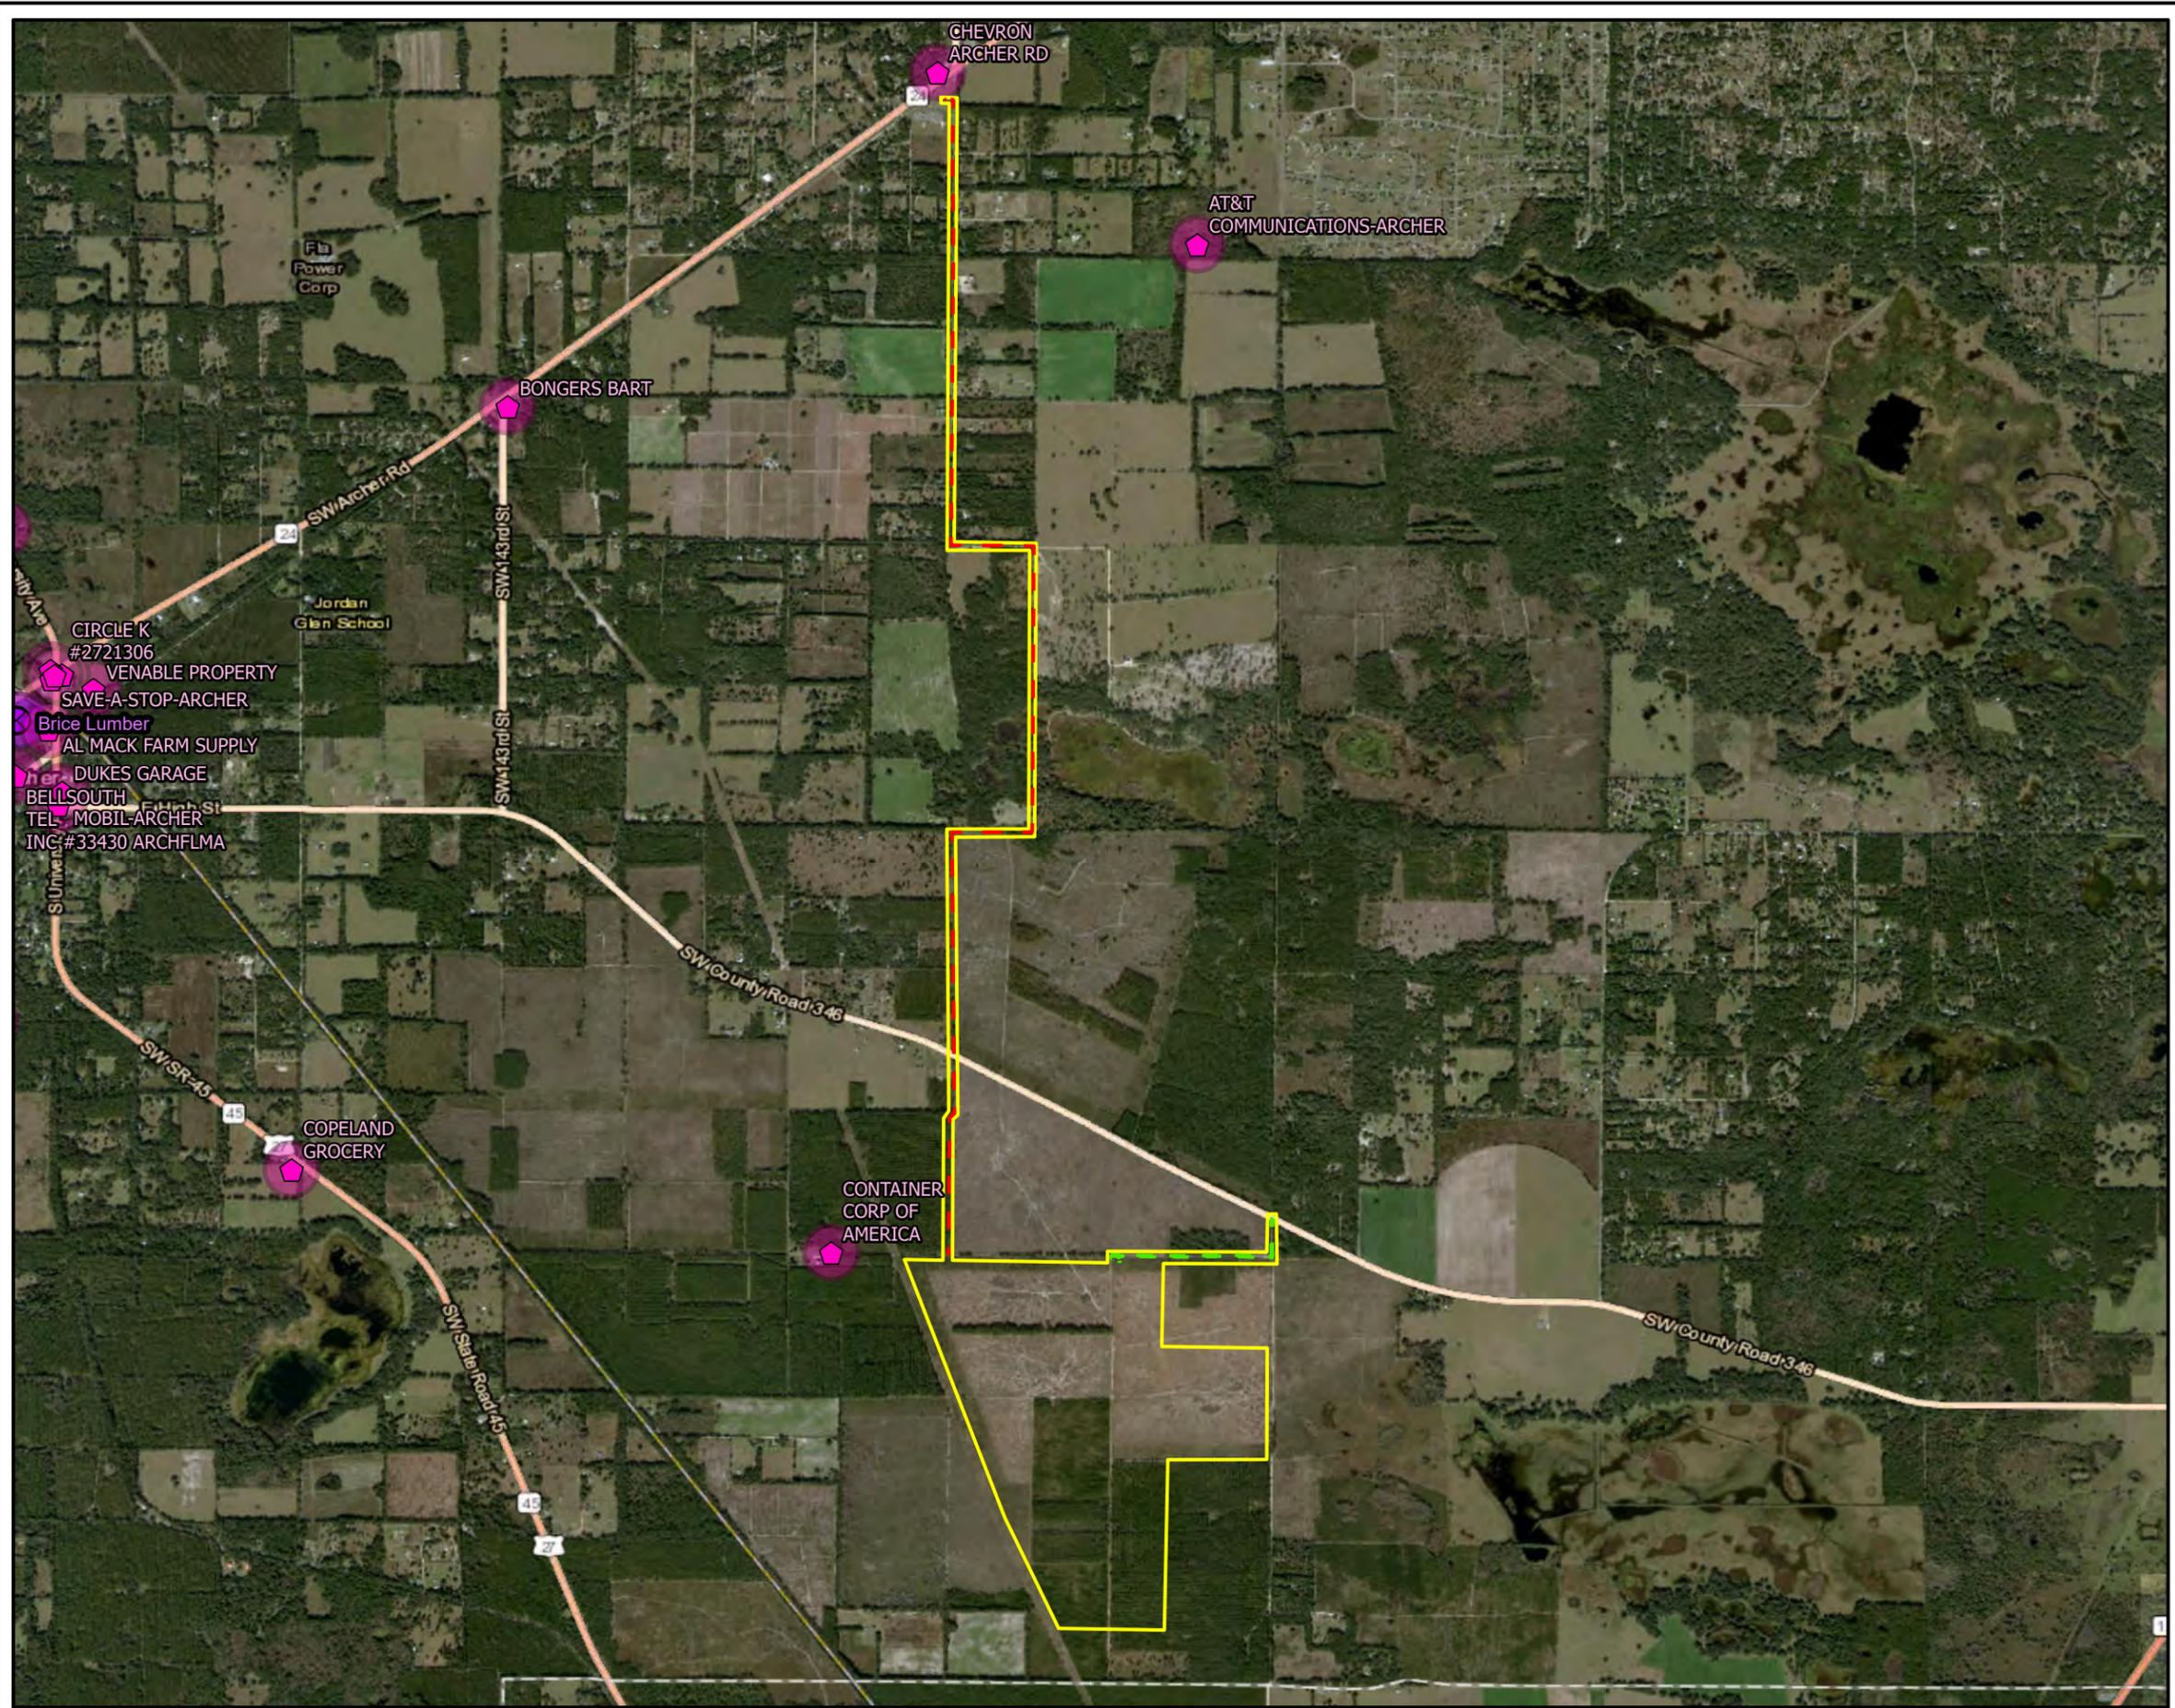
**Sand Bluff Solar Site  
Alachua County, Florida  
B-15 Contaminated Sites Map**

- Legend**
- Project Area
  - Access Road
  - MV Connector Bore Path
  - ◆ Storage Tank Contamination Monitoring (STCM)
  - STCM 500ft Buffer
  - ⊗ FDEP Clean-up Sites
  - FDEP Clean-up Sites 500ft Buffer

condition of the Project area. Figure B-15, in **Appendix B** provides an overview of contaminated sites in proximity to the Project area.

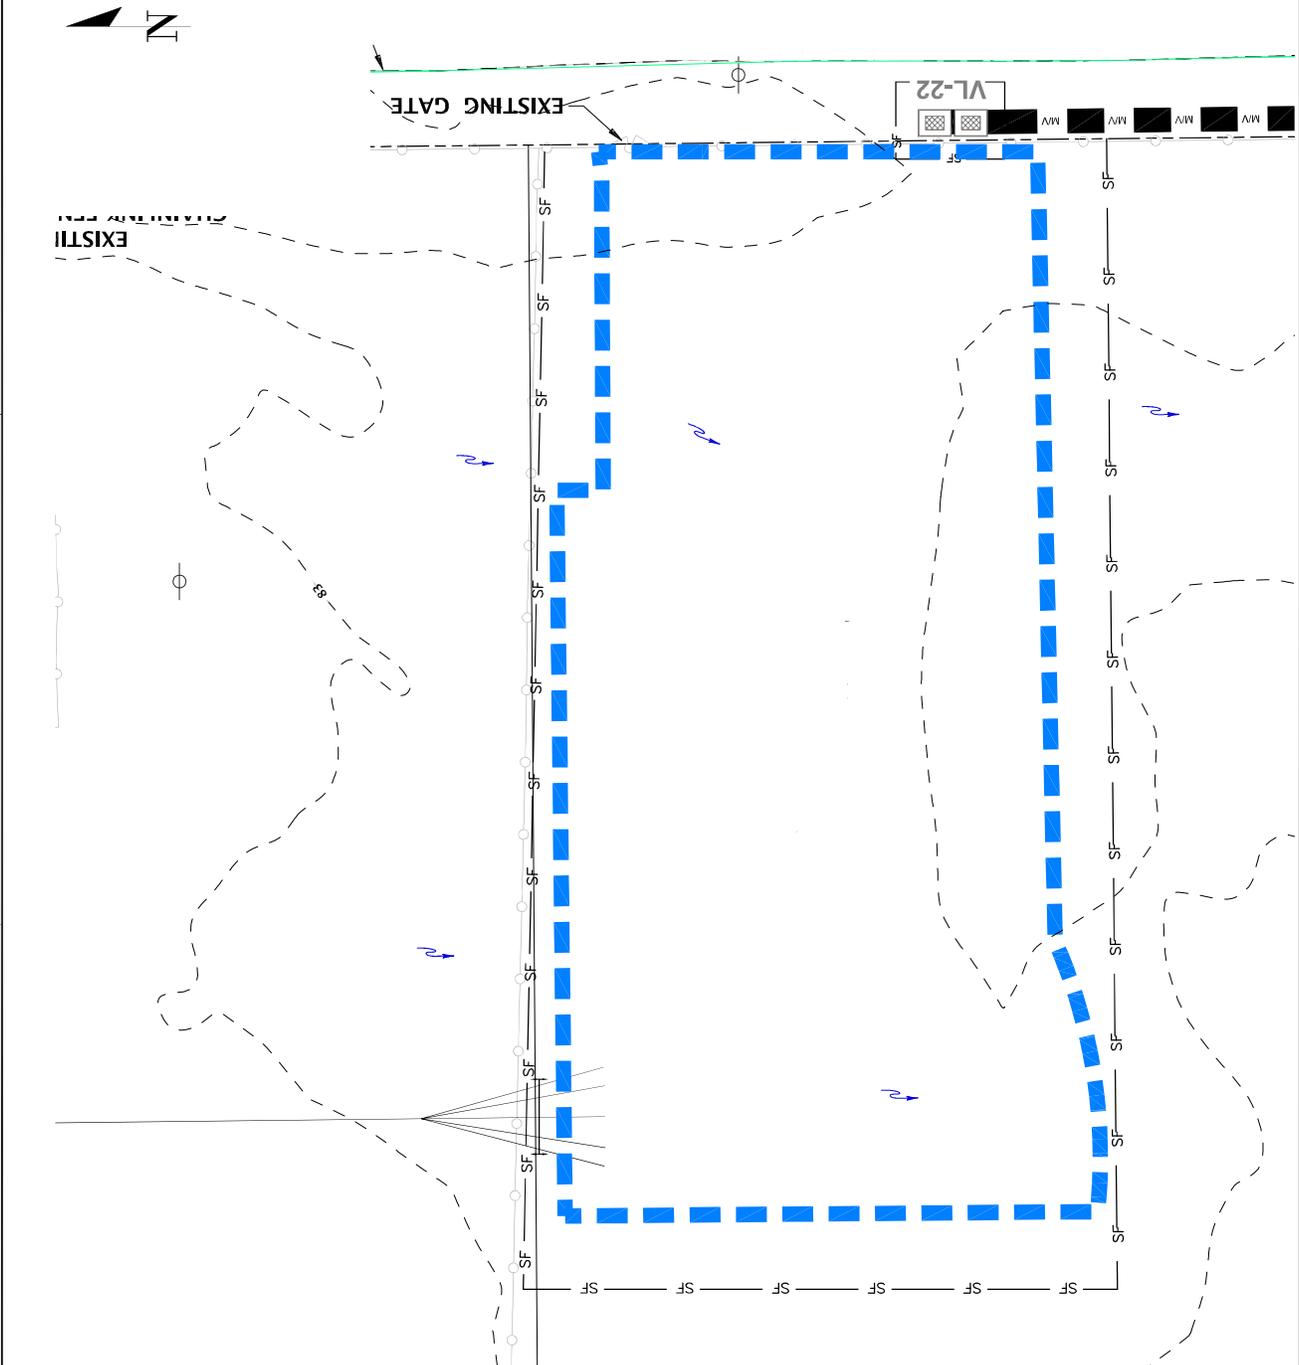
**NOTE: ALL SOILS ARE TYPE 'A' UNLESS OTHERWISE NOTED**
