RE: Tree Report for Proposed Gainesville Cottages, Alachua County, FL

<i>Project Name</i>	Gainesville Cottages
<i>Consultant Project Number</i>	22-007 Manley Design
<i>Project Location</i>	Northwest corner of NW 143 rd Street and Newberry Road
<i>Project Tax Parcel Number</i>	04306-002-000 and 04306-001-001
<i>Site Zoning</i>	'BR' and 'AP' / Business, Retail Sales, and Service; Administrative and Professional
<i>Site Area</i>	Approx. 22 Acres
<i>Site Status</i>	Undeveloped, Planted pine and native tree cover
<i>Date of Pre-Design Onsite Mtg</i>	February 24, 2022

PRELIMINARY TREE REPORT TREE LOCATION MAP

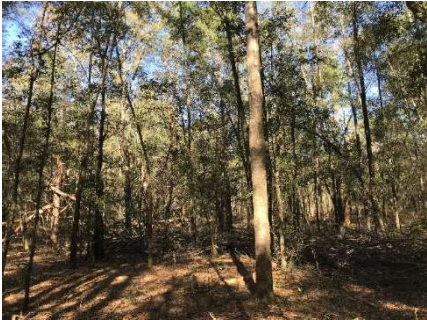
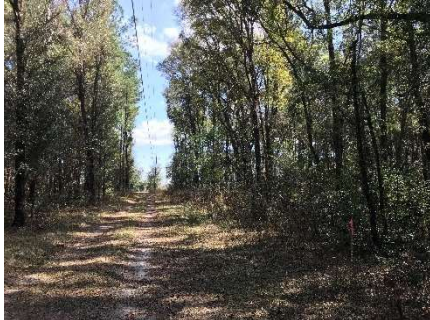
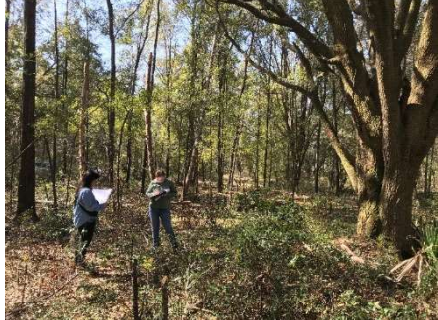
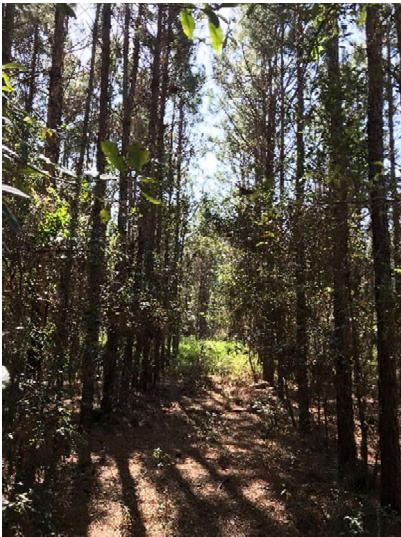
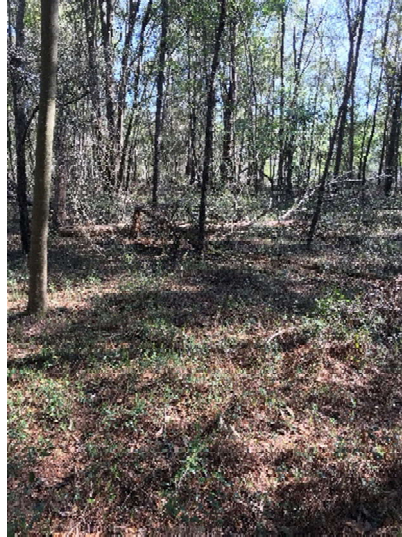
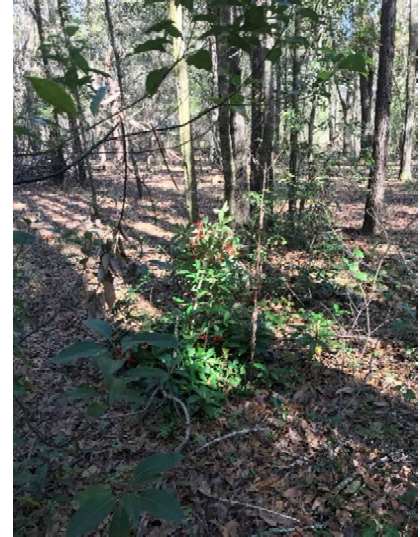
Typical Existing Conditions

This site includes primarily mixed hardwood forest (laurel and live oaks, pine, black cherry, hackberry) in the northern area (north of the existing dirt road/utility easement), and along the site perimeters. The southern portion of the site has an existing dry stormwater pond with a large live oak (tree 750) on the northern edge. The central area of the site has planted pine mixed with species such as live and laurel oaks and black cherry. Site adjacencies include wooded parcels of the same zoning and a Domino’s Pizza/Shell Gas Station to the east, West Newberry Road/SR 26 to the South, Brookside Apartments (zoned ‘R-2’) and an undeveloped parcel zoned ‘R-1B’ to the west, and Forest Meadows Cemetery-West and West Hills Memorial Gardens (zoned ‘A’) to the north. There was some Coral Ardisia throughout the site that should be removed during development.

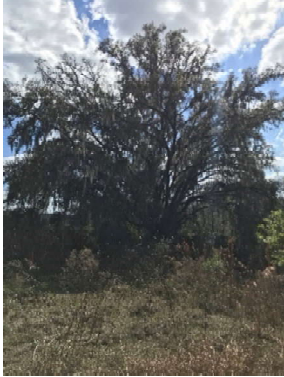
Tag No.	Scientific Name Common Name	Representative Photo	Diameter Breast Height	Tree Rating Provided by County Arborist	Remain or Remove	Mitigation, If Required
750	<i>Quercus virginiana</i> Live Oak

55"	5	Remain	Mitigation not Required. If future plans change, mitigation would be Inch:Inch 92" Replacement Inches $29" + (1.5 * 10) + (3 * 16) = 92"$

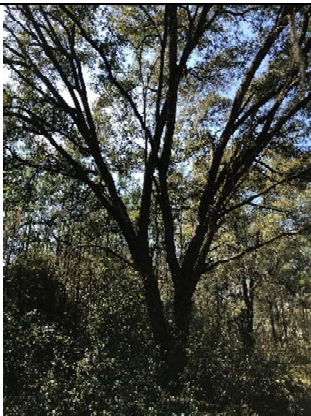
Tag No.	Scientific Name Common Name	Representative Photo	Diameter Breast Height	Tree Rating Provided by County Arborist	Remain or Remove	Mitigation, If Required
1052	<i>Quercus virginiana</i> Live Oak

33"	4	Remain	Mitigation not Required. If future plans change, mitigation would be Inch:Inch 35" Replacement Inches Replacement Inches 29" + (1.5 * 4) = 35"
1053	<i>Quercus virginiana</i> Live Oak

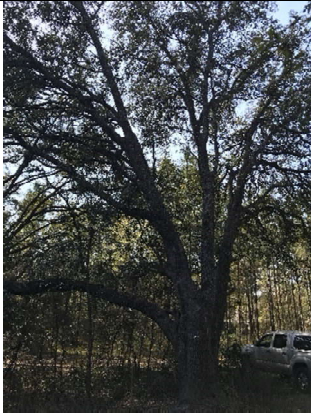
20", 32"	4	Remain	Mitigation not Required. If future plans change, mitigation would be Inch:Inch 83" Replacement Inches Replacement Inches 29" + (1.5 * 10) + (3 * 13) = 83"
1072	<i>Quercus virginiana</i> Live Oak	No photo requested	23"	3	Remove	Inch:Inch 23" Replacement Inches
1089	<i>Quercus virginiana</i> Live Oak

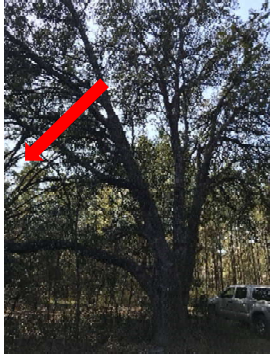
19", 22", 17"	5	Remain	Mitigation not Required. If future plans change, mitigation would be Inch:Inch 101" Replacement Inches Replacement Inches 29" + (1.5 * 10) + (3 * 19) = 101"
1185	<i>Quercus virginiana</i> Live Oak

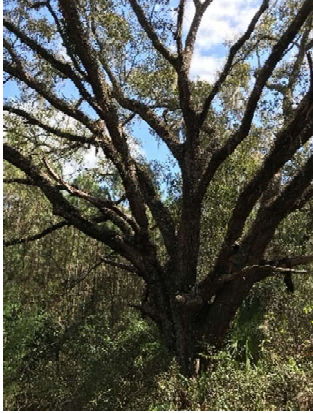
54"	3	Remain	Mitigation not Required. If future plans change, mitigation would be Inch:Inch 89" Replacement Inches 29" + (1.5 * 10) + (3 * 15) = 89"

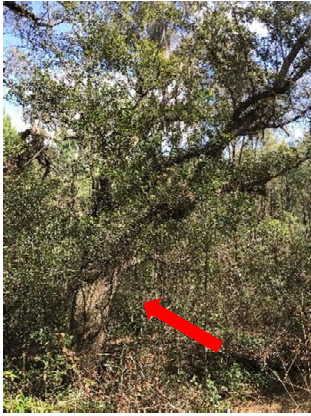
Tag No.	Scientific Name Common Name	Representative Photo	Diameter Breast Height	Tree Rating Provided by County Arborist	Remain or Remove	Mitigation, If Required
1186	<i>Quercus virginiana</i> Live Oak

30"	4	Remain	Mitigation not Required. If future plans change, mitigation would be Inch:Inch 30.5" Replacement Inches 29" + (1.5 * 1) = 30.5"
1259	<i>Quercus virginiana</i> Live Oak	No photo requested	20"	3	Remove	Inch:Inch 20" Replacement Inches
1296	<i>Celtis laevigata</i> Hackberry	No photo requested	21"	3	Remov	Inch:Inch 21" Replacement Inches
1307	<i>Quercus virginiana</i> Live Oak

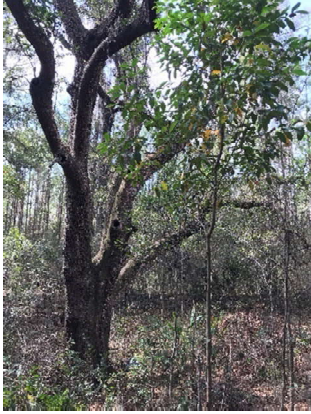
42"	3	Remove	Inch:Inch 53" Replacement Inches Replacement Inches 29" + (1.5 * 10) + (3 * 3) = 53"
1332	<i>Quercus virginiana</i> Live Oak

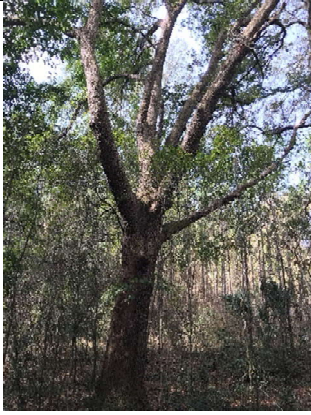
26"	3	Remove	Inch:Inch 26" Replacement Inches

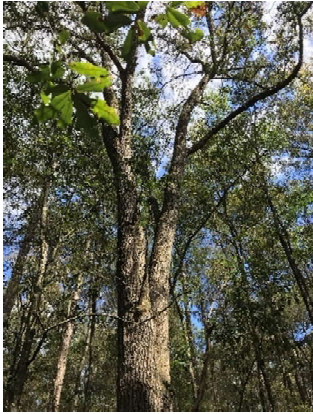
22"	3	Remain	Mitigation not Required. If future plans change, mitigation would be Inch:Inch 22" Replacement Inches
1419	<i>Quercus virginiana</i> Live Oak	No photo requested	22"	3	Remove	Inch:Inch 22" Replacement Inches
1446	<i>Quercus virginiana</i> Live Oak

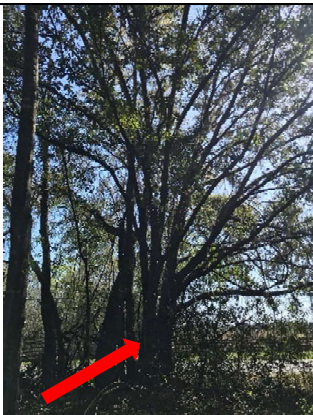
32"	3	Remain	Off property. Mitigation not Required. If future plans change, mitigation would be Inch:Inch 33.5" Replacement Inches 29" + (1.5 * 3) = 33.5"

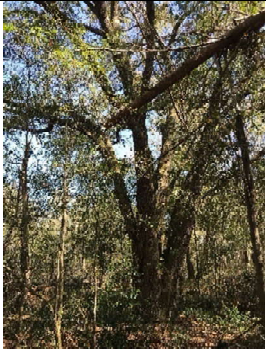
46"	4	Remain	Mitigation not required. If future plans change, mitigation would be Inch:Inch 65" Replacement Inches 29" + (1.5 *10) + (3* 7) = 65"

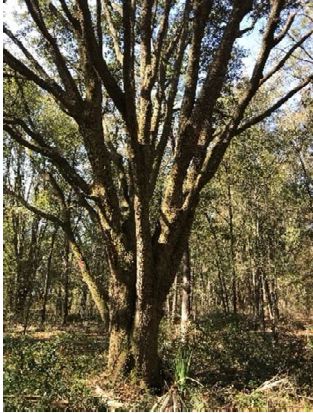
7", 19", 26"	4	Remain	Mitigation not Required. If future plans change, mitigation would be Inch:Inch 83" Replacement Inches $29" + (1.5 * 10) + (3 * 13) = 83"$
2068	<i>Quercus virginiana</i> Live Oak

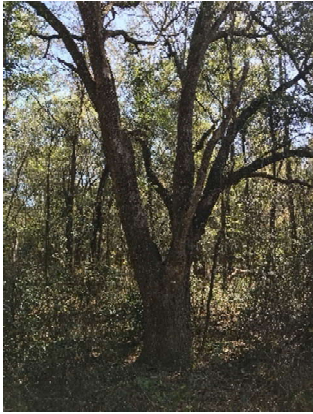
32"	4	Remain	Mitigation not Required. If future plans change, mitigation would be Inch:Inch 33.5" Replacement Inches $29" + (1.5 * 3) = 33.5"$

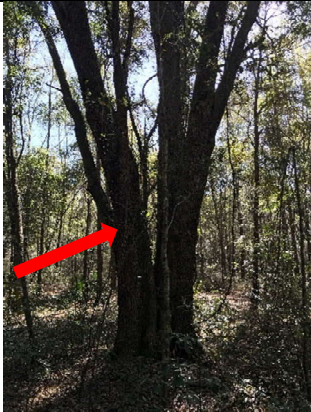
24", 27"	4	Remove	Inch:Inch 80" Replacement Inches $29" + (1.5 * 10) + (3 * 12) = 80"$

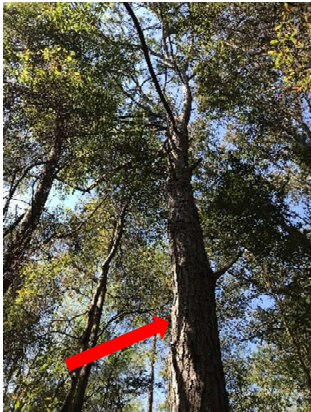
2085	<i>Pinus sp.</i> Pine

26"		Remove	Tree:tree mitigation, 1 mitigation tree required
------	--------------------------	---	-----	--	--------	--
