ENVIRONMENTAL RESOURCES ASSESSMENT CHECKLIST

Re: Listed Species Habitat Assessment and Invasive Plant Survey
Watson C&D Facility
20103 SW Archer Road, Archer, FL 32618
Alachua County Parcel No.: 05104-002-002
Verde Environmental -- Project No. 22-139

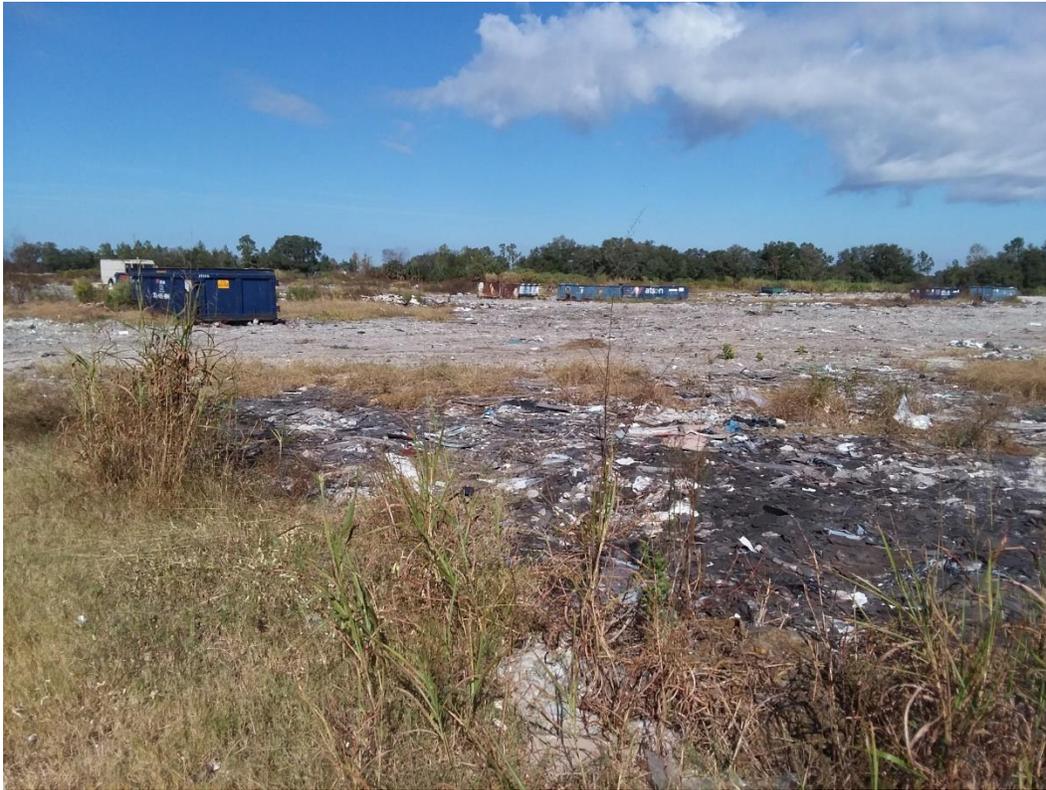
Site Photograph 1: Sparsely vegetated Active landfill in the interior of the property managed, typical.

The majority of the property not actively managed as landfill or haul roads was densely vegetated by ruderal, non-native and invasive herbaceous plant species (Site Photographs 1 and 2). A narrow band of natural forest was observed along the northern boundary (Site Photograph 3), but it too included a moderate non-native plant component. The most prominent non-native plant species encountered onsite are listed below.

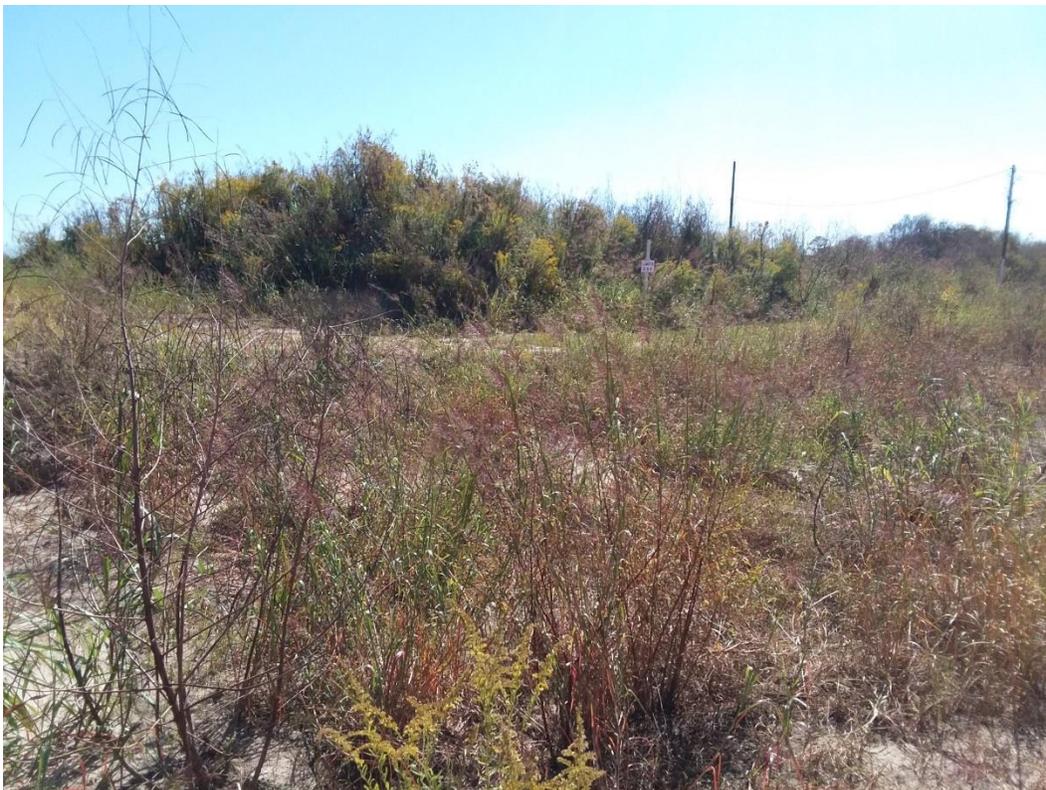
Site Photograph 2: Densely vegetated interior portions of the property, typical.

- Cogon grass (*Imperata cylindrica*) - Scattered patches along the northern property boundary,
- Guinea grass (*Urochloa maxima*) - Frequent, large patches throughout the property,
- Mexican petunia (*Ruellia simplex*) - Scattered individuals throughout the interior of the site,
- Tallow tree (*Triadica sebifera*) - Several individuals in the northern portion of the property and occasionally scattered throughout the site,
- Silk tree (*Albizia julibrissin*) - Multiple individuals in the north and northeast portions of the property,
- Paper mulberry (*Broussonetia papyrifera*) - Scattered individuals in the north and northeast portions of the property,
- Mile a minute vine (*Ipomoea cairica*) - Abundant throughout the property,
- Durban crow foot grass (*Dactyloctenium aegyptium*) - Abundant along haul roads, and
- Harry indigo (*Indigofera hirsuta*) - Abundant throughout the property.

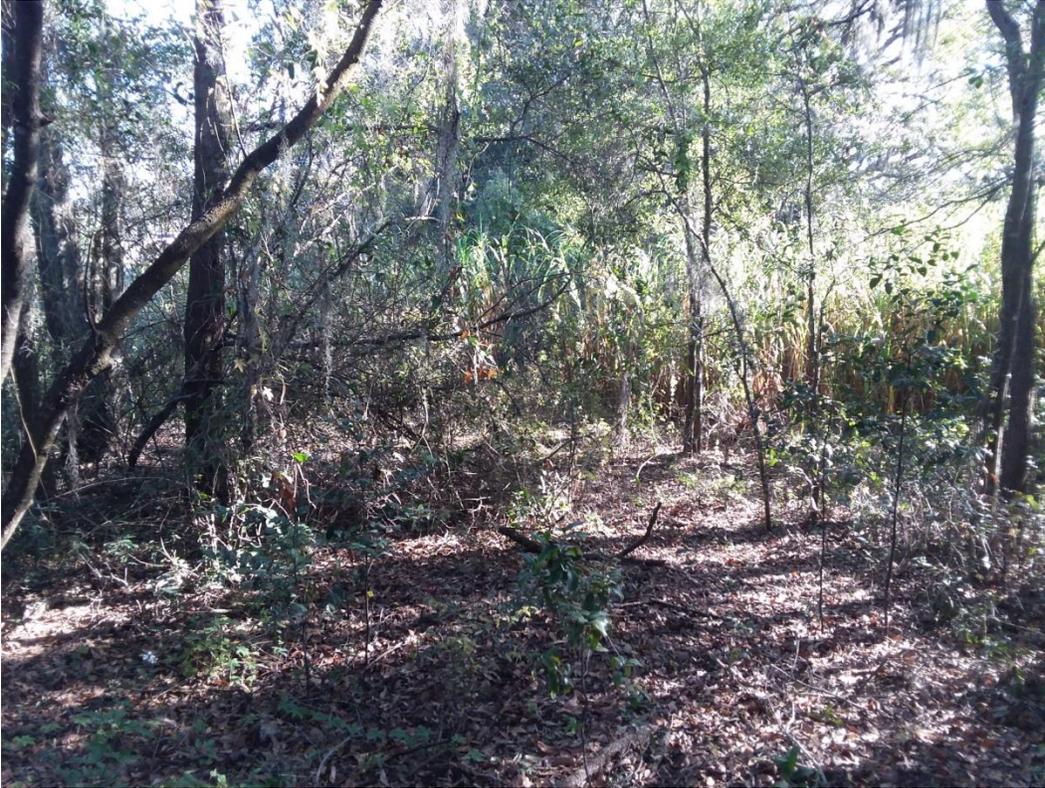
Site Photograph 3: Narrow forested community along the northern boundary, typical.
