TECHNICAL MEMORANDUM

TO: Project File - Cuscowilla Fire Station – AC Zoning Application Z23-000006

SUBJECT: Environmental Resource Assessment (ERA)

Cuscowilla Fire & Rescue Station

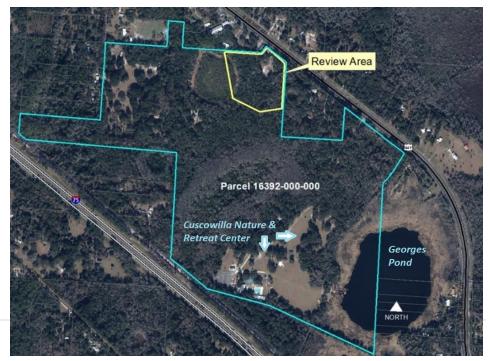
EPD Natural Resource staff members (Emily Rodriguez, Sandy McGee) conducted an on-site evaluation of the depicted review area on June 27th, 2023. The area contains a residential house, 1-acre pasture/old field habitat, upland forest, and the perimeter zones of two wetlands. The residence is a modular mobile home installed in 2023 over an existing homesite, well and septic system. These features are depicted on an aerial (next page).

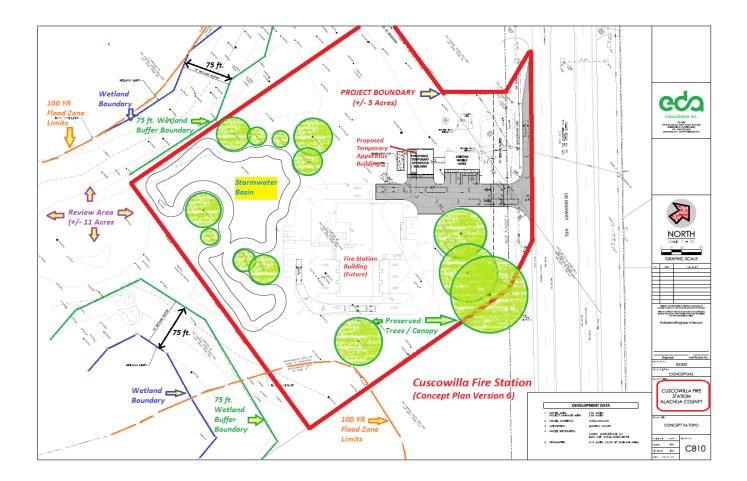
The aerial above depicts the GPS points of the two wetland boundary delineations, locations of adjacent 75 ft. wetland buffer boundaries, and the 100-year floodplain within the11-acre review area. The two wetlands within the review area and the third wetland identified offsite are regulated under Article VI, Chapter 406, ULDC. The wetland boundaries within proximity of the project boundary were delineated by Ms. Rodriguez and Ms. McGee based on the uniform statewide methodology adopted by the Florida Department of Environmental Protection and Water Management Districts to delineate wetlands [FAC Rule 62-340.300]. For the offsite "Sinkhole Pond" wetland, they confirmed during the site evaluation the wetland limits are sufficiently accurate as depicted on GIS to buffer and protect the resource.

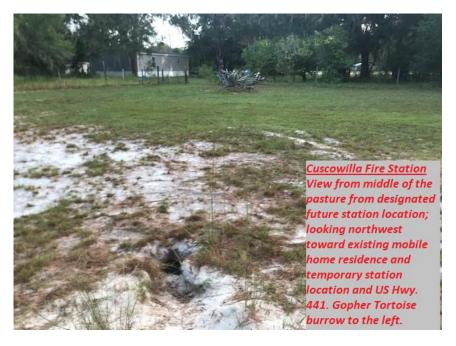
coverage of bahia grass (*Paspalum notatum*) and scattered native grasses and forbs; including broomsedge (*Andropogon spp.*), fleabane (*Erigeron spp.*), and prickly pear cactus (*Opuntia mesacantha*). The location of "*Proposed Temporary Apparatus Building*" and associated parking area (gray highlight on plan sheet) will be adjacent to the existing mobile home. This pasture is also where the permanent "*Fire Station Building* (*Future*)" and associated parking and loop drive will be constructed within the near future (reference photo above).

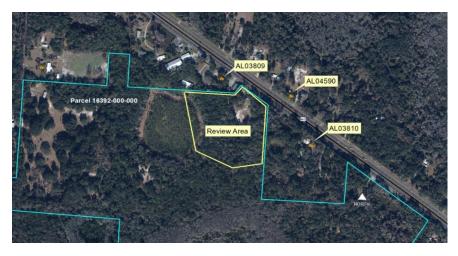
Additionally, the 1966 USGS topographic quadrangle above references two historic-aged structures were at one time present within the review area.

There are no historic structures recorded in the FMSF on the subject property, however there are three such structures adjacent to the review area. These three resources are listed on the following table and associated locations depicted on the aerial (next page).

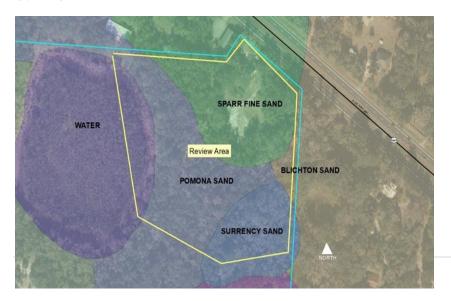
The following NRCS Soil Survey of the review area and associated table summarize the soil drainage classes. Hydric characteristics associated with soil map unit such as Surrency sand and the "water" designation are typically associated with wetlands and/or surface waters.

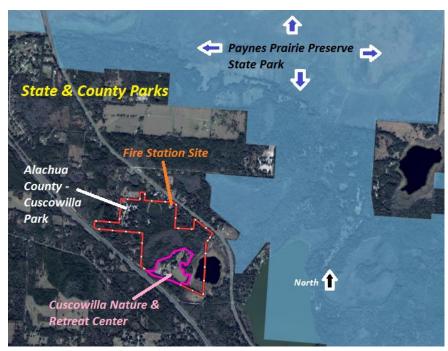
The proposed fire station site is within the northeastern boundary of Alachua County's 211-acre Cuscowilla Park and across US Hwy. 441 from the 21,000-acre Paynes Prairies Preserve State Park. Access to and from the fire station will only be to Hwy. 441, and not near any public access locations into the parks.
