Civil Site Investigation

Parcel 15552-005-002 (2105 SW 14th St)

Wetland Delineation Report

Sunrise Residence Inn

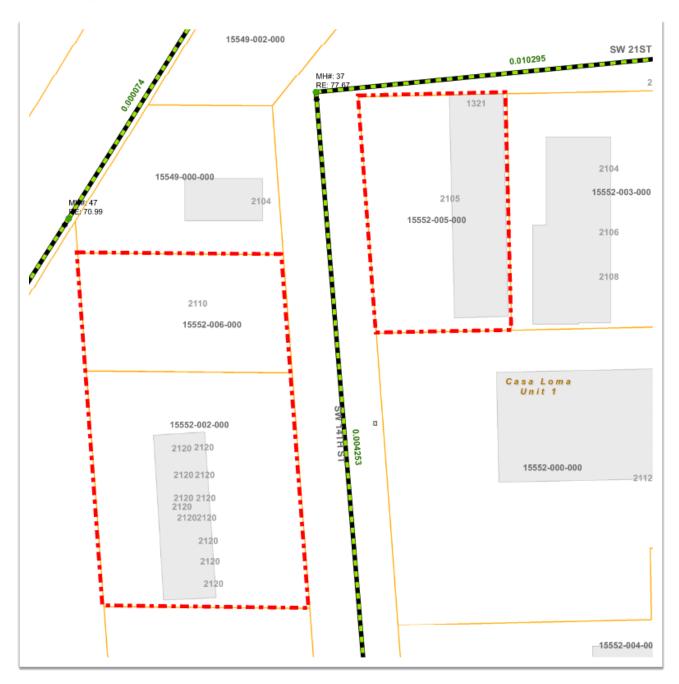
Figure 2 - Sanitary Sewer

- <u>Sanitary Sewer</u> A 8" sanitary sewer gravity main exists along SW 21st Ave and SW 14th St according
 to the sanitary sewer map provided by GRU (Figure 2). Based on the visual presence of assumed
 sanitary sewer cleanouts, Sewer service is provided by a single lateral extending from the western side
 of the building to the sewer main along SW 14th St.

- <u>Sanitary Sewer</u> An 8" sanitary sewer gravity main exists along SW 21st Ave and SW 14th St according
 to the sanitary sewer map provided by GRU (Figure 2). No evidence of a sewer lateral was observed.

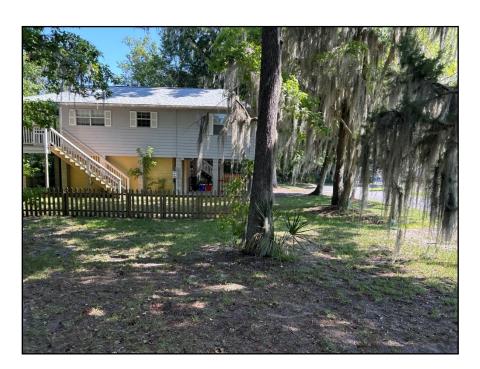
The project area consists of three parcels (Parcel IDs 15552-002-000, 15552-006-000, and 15552-005-000), for an approximate total area of 1.00 acre. The project area is located along the Southwest 14th Street, south of the intersection of US Highway 441 and Southwest 16th Avenue, in Sections 01 and 16 of Township 10 South and Range 20 East, Gainesville, Alachua County, Florida. A location map is attached in *Figure 1*. A portion of the U.S. Geological Service (USGS) 7.5-Minute *Micanopy, Florida* quadrangle map depicting the location of the project area is attached as *Figure 2*. Elevation on-site ranges from approximately 70 – 85 feet.

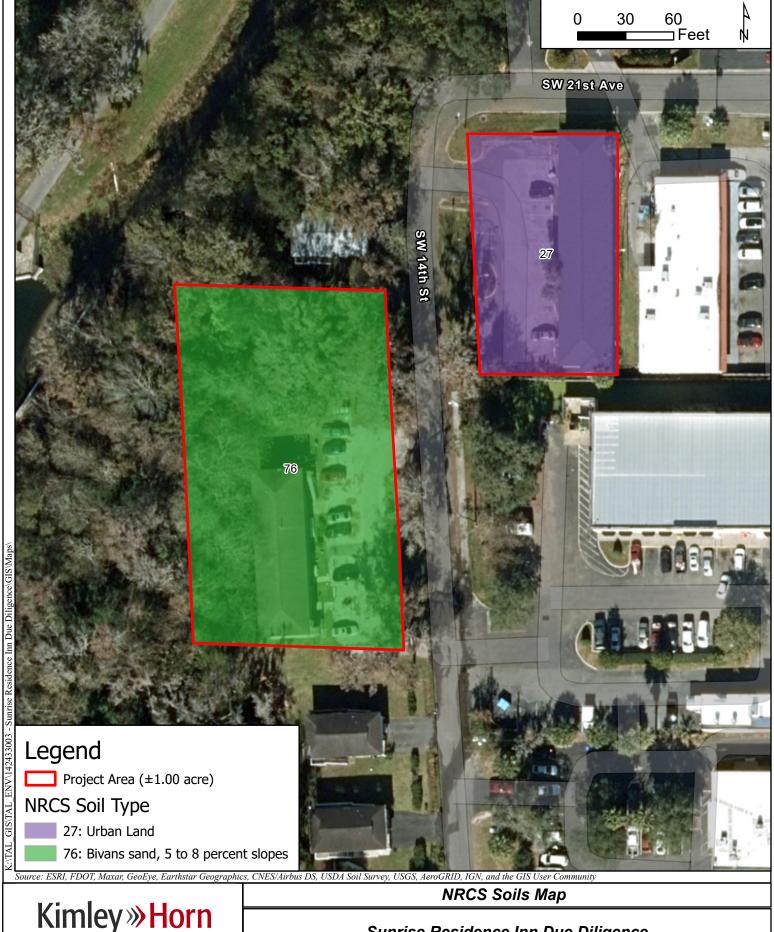
The USDA / NRCS Soil Survey of Alachua County, Florida maps the project area with the following soils: (27) urban land, (76) Bivans sand, 5 to 8 percent slopes. A copy of the digital USDA/NRCS soil data is attached in Figure 3 and details regarding each soil is listed in Table 1.

TABLE 1 - NRCS SOILS IDENTIFIED WITHIN THE PROJECT AREA						
Soil ID Number ¹	Soil Name	Drainage Class	Groundwater Depth	Hydric, Hydric Inclusions , or Non- hydric ²		
27	Urban Land	None specified	None specified	Unranked		
76	Bivans sand, 5 to 8 percent slopes	Poorly drained	12 to 18 inches	Hydric Inclusions

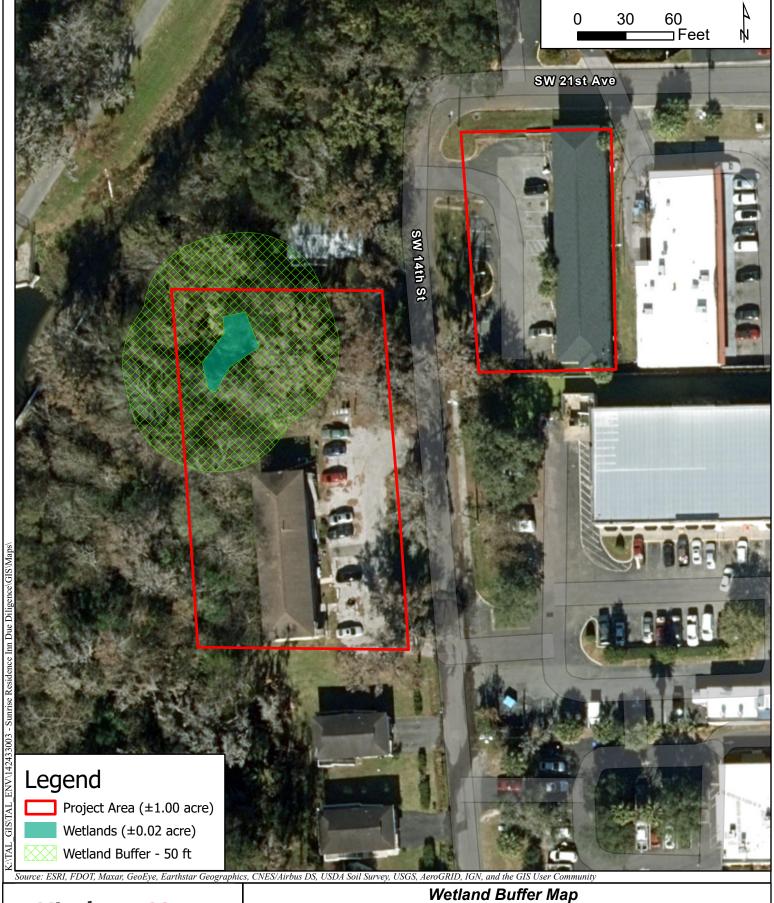
One wetland was observed within the northwestern portion of the project area during field reconnaissance. A map showing on-site wetlands is attached as *Figure 5*.

The northwestern portion of the project area consists of a depressional area at the base of the steep slopes extending down from the adjacent developed parcels and likely receives overland flow from the adjacent areas during storm events.

- Per City of Gainesville Code, a minimum buffer of 35 feet and an average buffer of 50 feet will be required to be maintained around wetland areas.
- The City of Gainesville regulates impacts to floodplains and will require development permits be reviewed by the Floodplain Administrator to issue a floodplain development permit.
