# **Kincaid Loop Trail, SE 27<sup>th</sup> Street**

## **Alternatives Analysis & Preferred Alignment**

# Analysis Alternative Summary

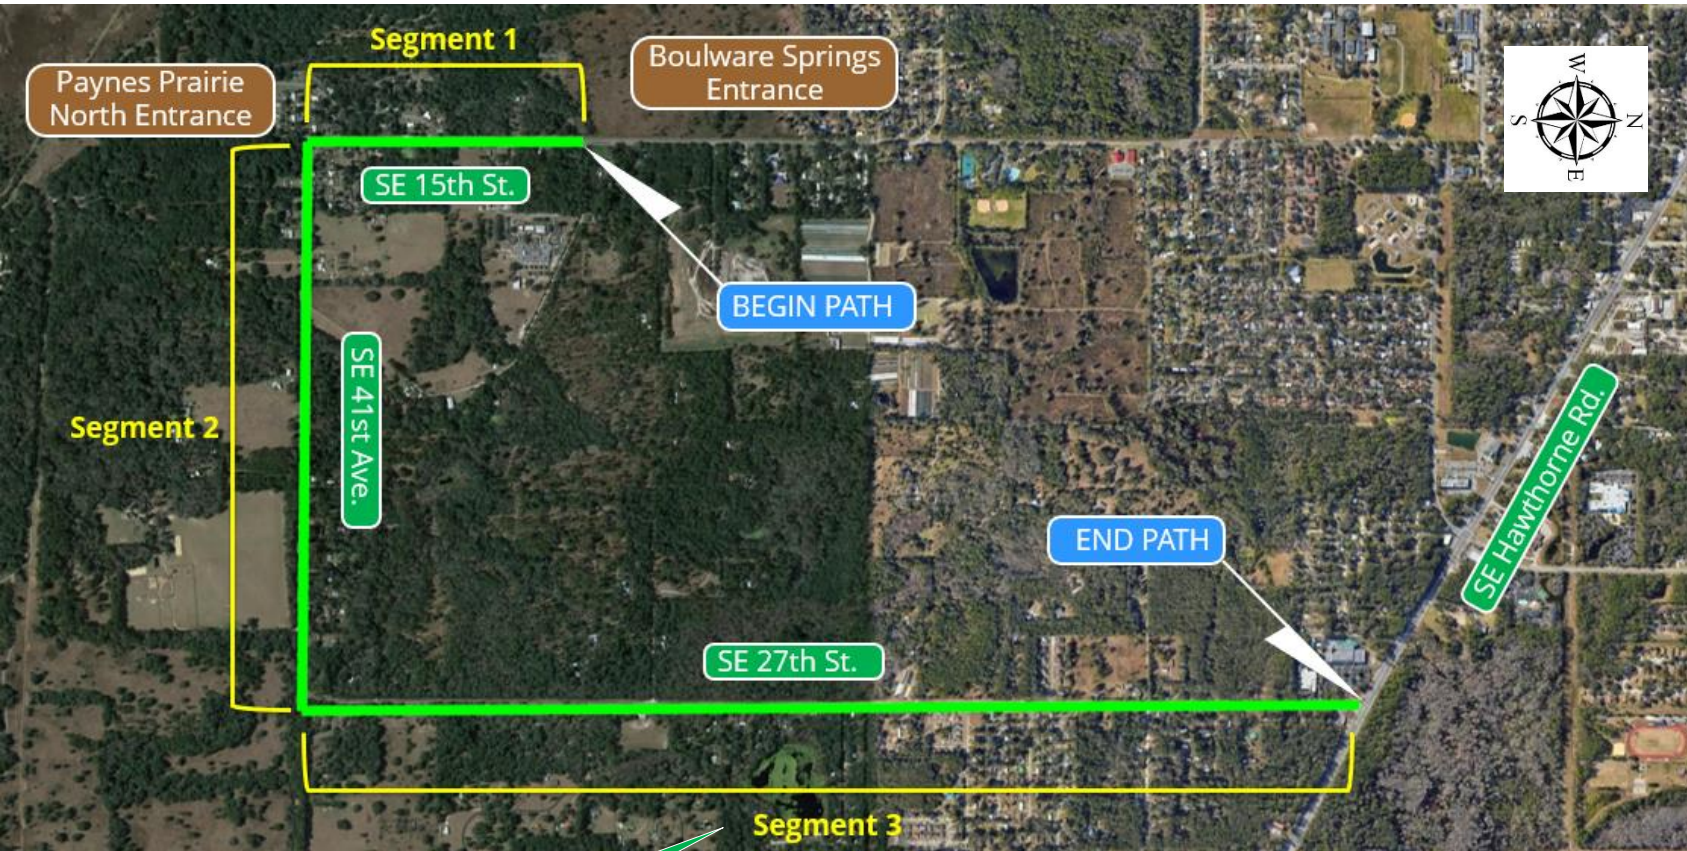
Analysis  
Segment

## **Alternative 1:**

East side of SE 27<sup>th</sup> St.

## **Alternative 2:**

West side of SE 27<sup>th</sup> St.

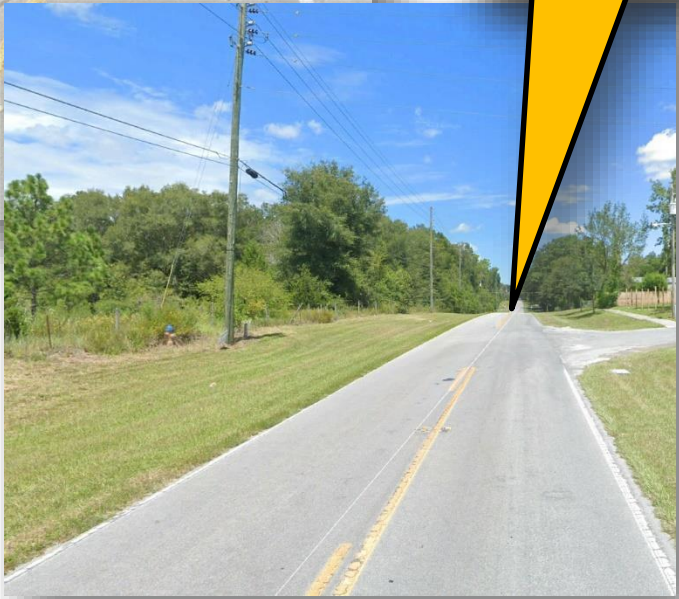
- 80-ft. Total right-of-way width.
- Observed "rolling" terrain restricts potential mid-block crossing locations on SE 27<sup>th</sup> St. (*proposed in Alt. 2*)
  - Vehicular sight-distance
  - ADA (cross-slope) criteria

More utilities on the west side of SE 27<sup>th</sup> St.

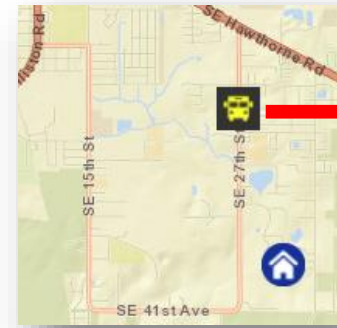
- Services Lake Forest Elementary School, Lincoln Middle School, and Eastside High School.
- **School bus stop is located on the east side of SE 27<sup>th</sup> St. at SE 18th Ave.**

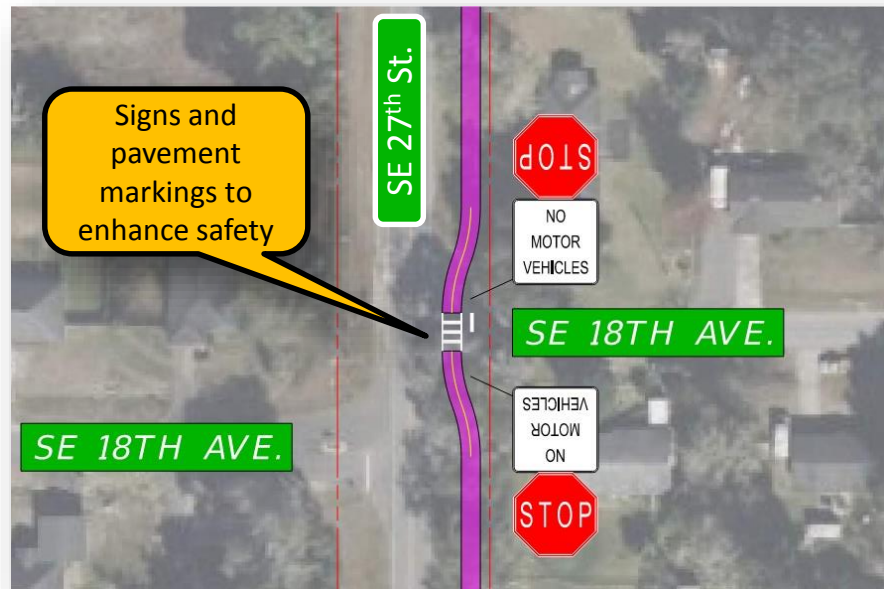
## Alternative 1

- 13 unsignalized side street crossings
- 18 driveways crossings
- Provides direct SUP access from adjacent community
- Safer alternative
- **Less severe conflict points**

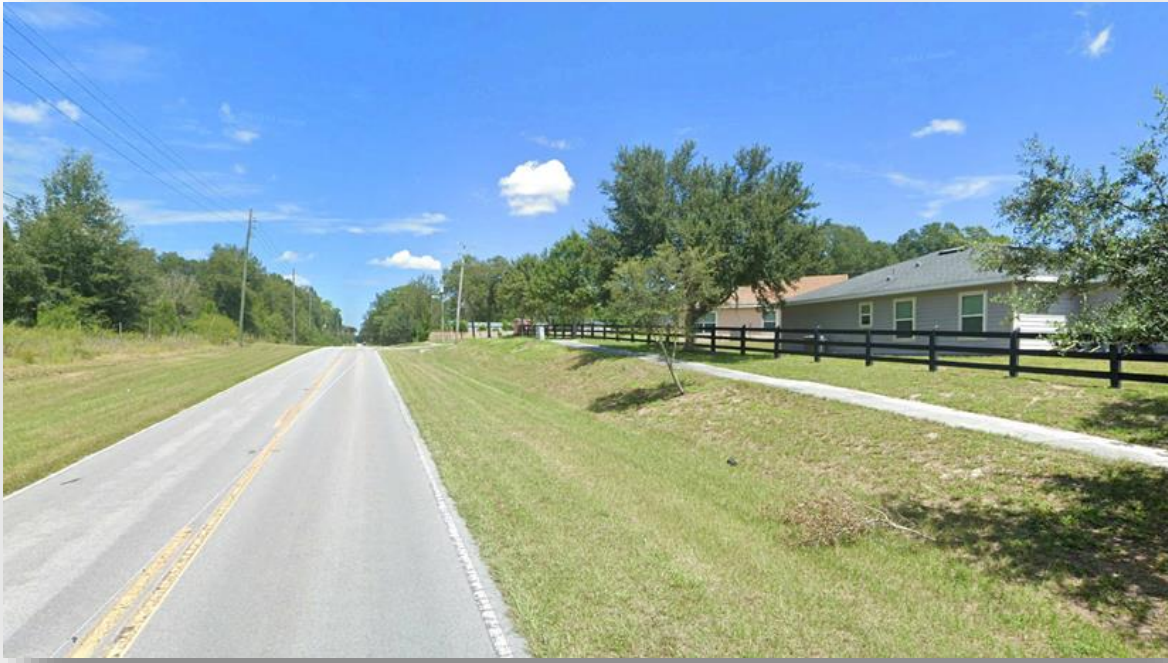
- Maintaining existing drainage patterns will be vital.
- Alternative 2 will have fewer impacts on existing drainage patterns.
- Alternative 1 will require a more comprehensive drainage design

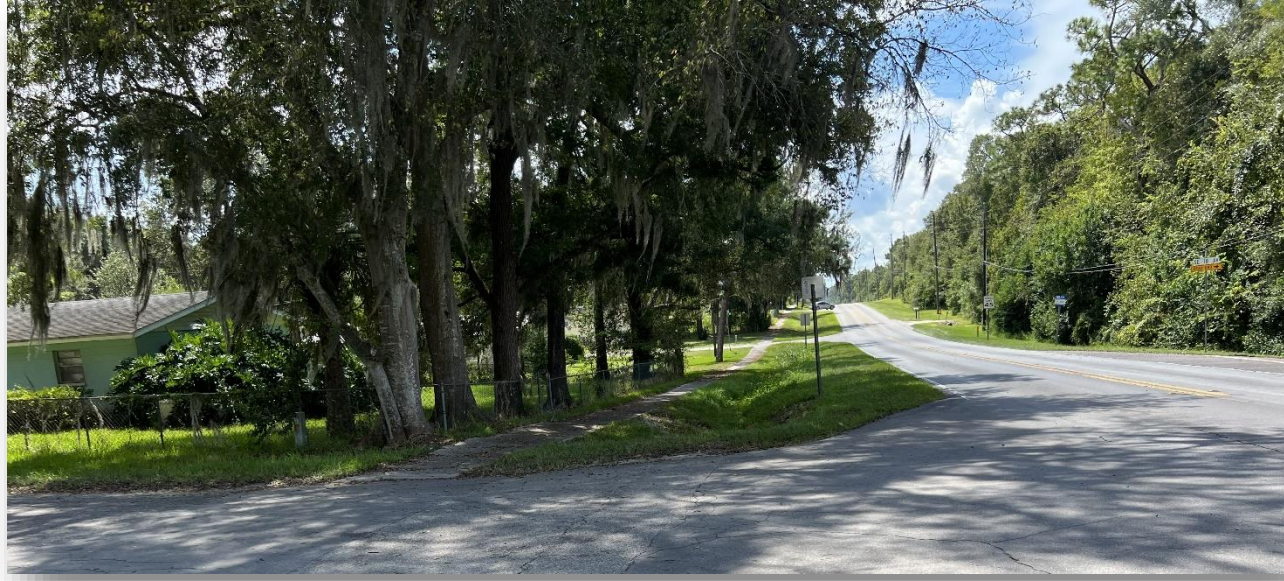
- Shade will help keep SUP users comfortable in the hot sun.
- Adequate shade will encourage users to the path.
- Alternative 1 provides better shade cover
