SUNRISE RESIDENCE INN

BUILDING CONDITION DUE DILIGENCE

July 3, 2024

Alachua County
Sunrise Residence Inn
Due Diligence Report
2105 & 2120 SW 14TH ST
Gainesville, FL 32608

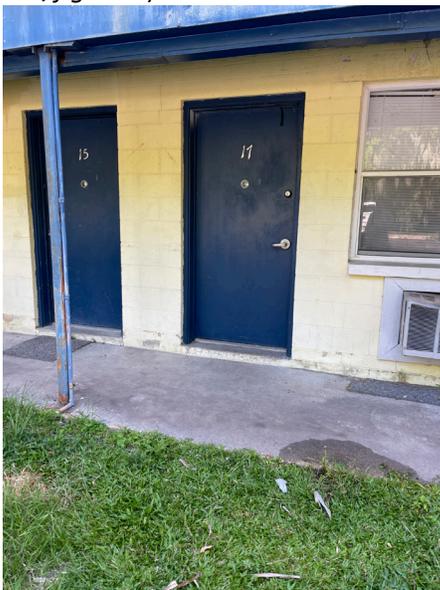
Figure 7 - Typical Door

- 1) Each unit has one single hung window and one exterior hollow metal door located on the same wall facing the exterior walkways. Both the windows and doors are generally in good condition. (See *photo/figures 7 & 8*)
- 2) Each unit is heated and cooled by a single wall mounted AC unit located below the windows. (See *photo/figure 9*)

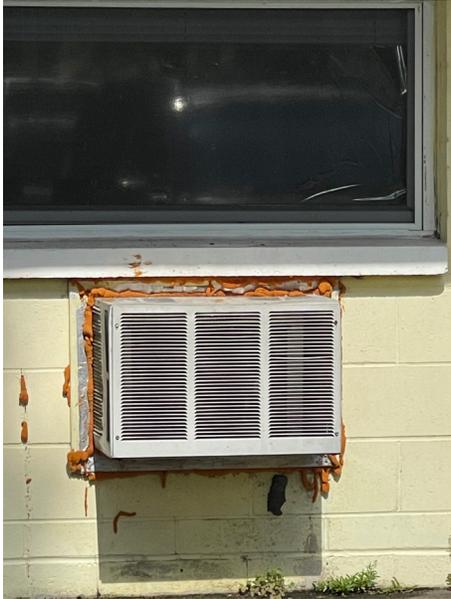
Figure 17 - Typical AC unit SW building

- 1) One of the guard rails on the North staircase is broken and loose. Our hypothesis is a combination of the steel structure rusting and possibly being hit by a vehicle from the parking lot. (See photo/figure 5)
- 2) The Southwest corner of the building possibly has an exposed part of the foundation. We believe erosion on this corner is from water falling from the roof. (See photo/figure 6) This should be corrected - see structural report for additional discussion of this item.
- 3) Each unit in this building has one single hung window and one exterior hollow metal door located on the same wall. Both the windows and doors are generally in good condition. (See photo/figure 16)
- 4) Apartments are heated and cooled by a single through-wall mounted AC unit located below the windows. (See photo/figure 17)

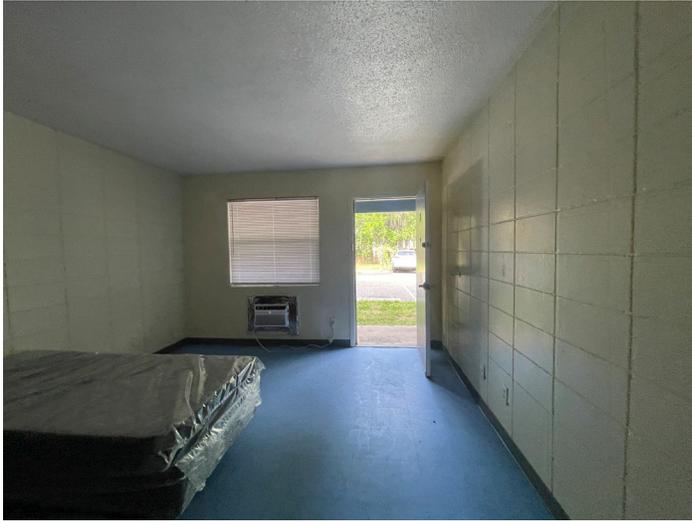
Figure 22 - Sleeping space typ. unit

- 1) Units are studio apartments, one room with a sleeping space, bathroom, kitchen nook, and closet. Each unit has one single hung window and exterior hollow metal door facing the walkway. Heating and cooling is via a single through-wall PTAC unit. There are 21 units in total. *(See photos/figures 22, 23, 24 & 25)*

- 11) The walls separating the units are CMU and the block surface is painted. The front and back walls of the units have GWB on the interior. Interior partitions are wood studs with GWB sheathing. *(See photo/figure 22)*

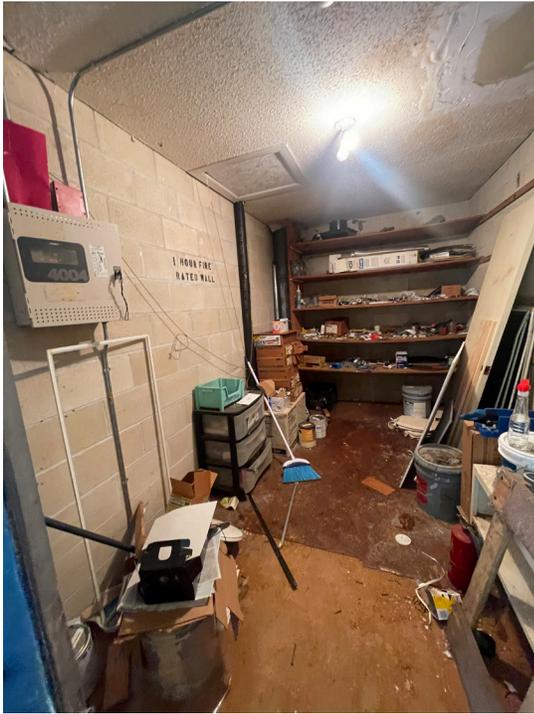
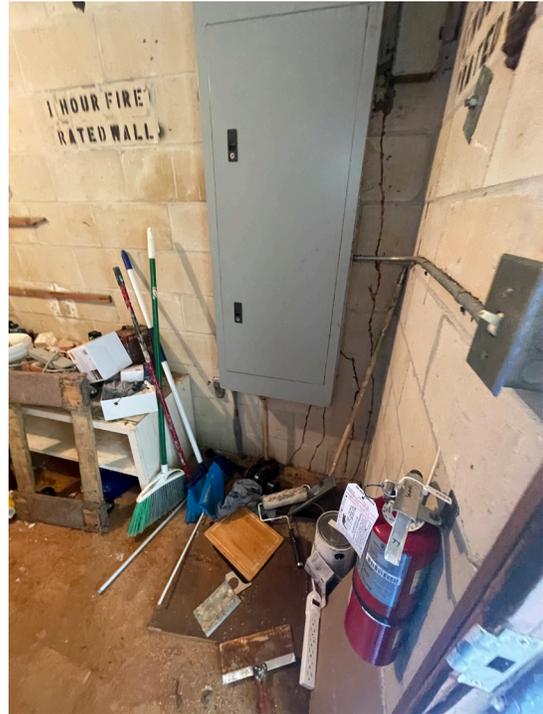
- 10) A laundry room is provided on the first floor and serves the entire building. There is a small utility room on both floors located at the South end of the building. The utility room has an electrical breaker panel located inside and attic access is from the second-floor utility room. *(See photos/figures 26, 27 & 28)*

Figure 26 - Utility room interior

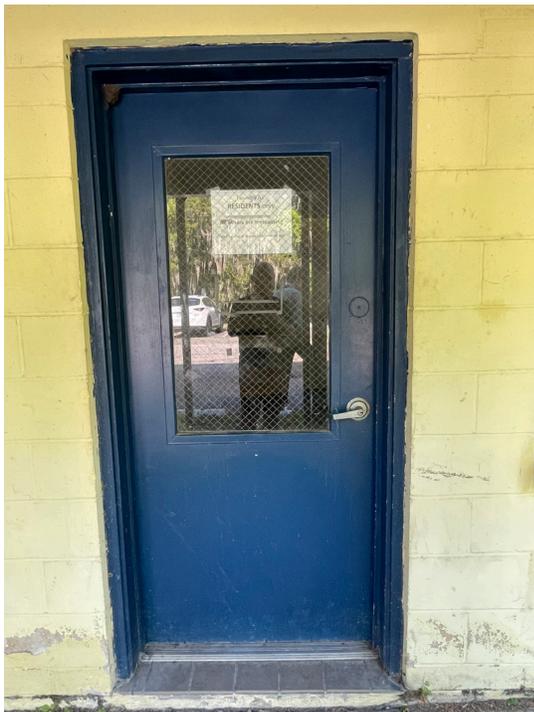
Figure 28 - Laundry room door

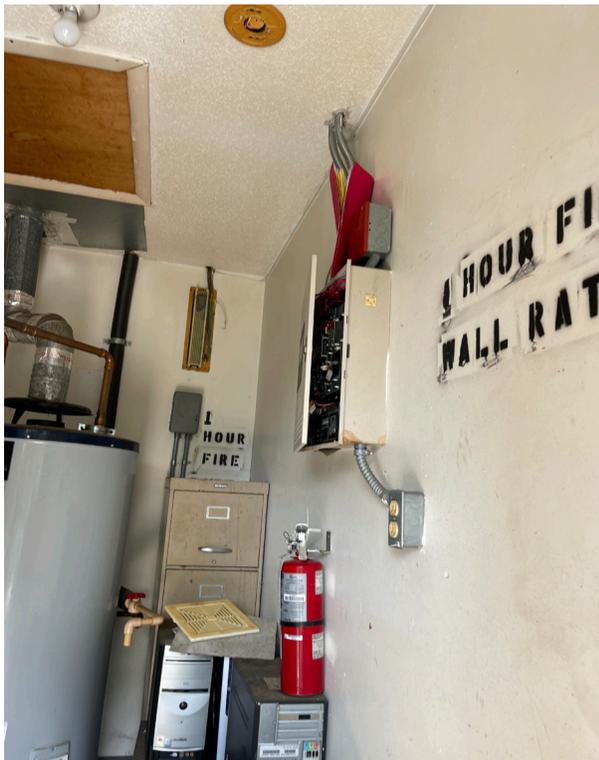
- 3) The boiler room/utility room is on the second floor and contains attic access and electrical breaker panel. (See photo/figure 34)
- 4) The walls separating units are painted CMU. The front and back walls of the units have GWB finish on the interior. Interior partitions are wood studs with GWB. (See photo/figure 35)

Figure 34 - Utility room SW building

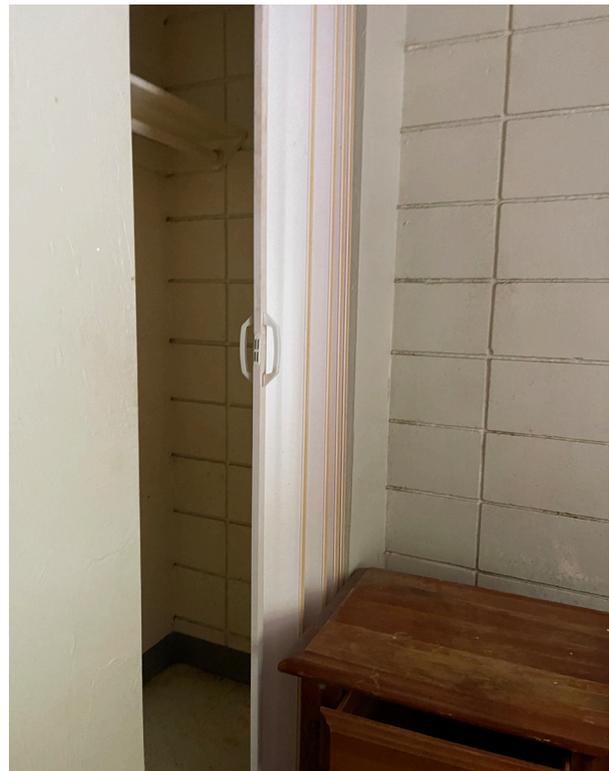
Figure 35 - CMU wall SW building

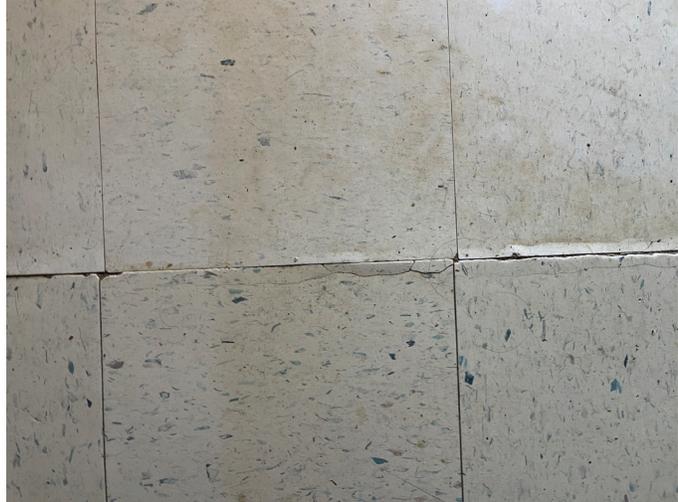
- 9) All units have vinyl tile flooring with vinyl wall bases. (See photo/figure 37)

Figure 37 - Vinyl tile flooring
