RE: Due Diligence Report – Burkhardt Sales & Service

As part of the County's due diligence efforts to evaluate the conditions of the existing commercial industrial warehouse building (Burkhardt Sales & Service) located at 6125 NW 18<sup>th</sup> Drive, Gainesville, FL 32653, Paul Stresing Associates (PSA) was tasked with conducting an inspection of the facility to evaluate its condition prior to entering into a full purchase agreement to its purchase. On May 30, 2024, I was accompanied by KPI Engineering (KPI) where we walked the roof and interior of the facility with Mr. Matt Fultz of the Alachua County Facilities Department and Mr. Daniel Burkhardt, representing the seller where we gained access to the site and buildings to begin our evaluation efforts.

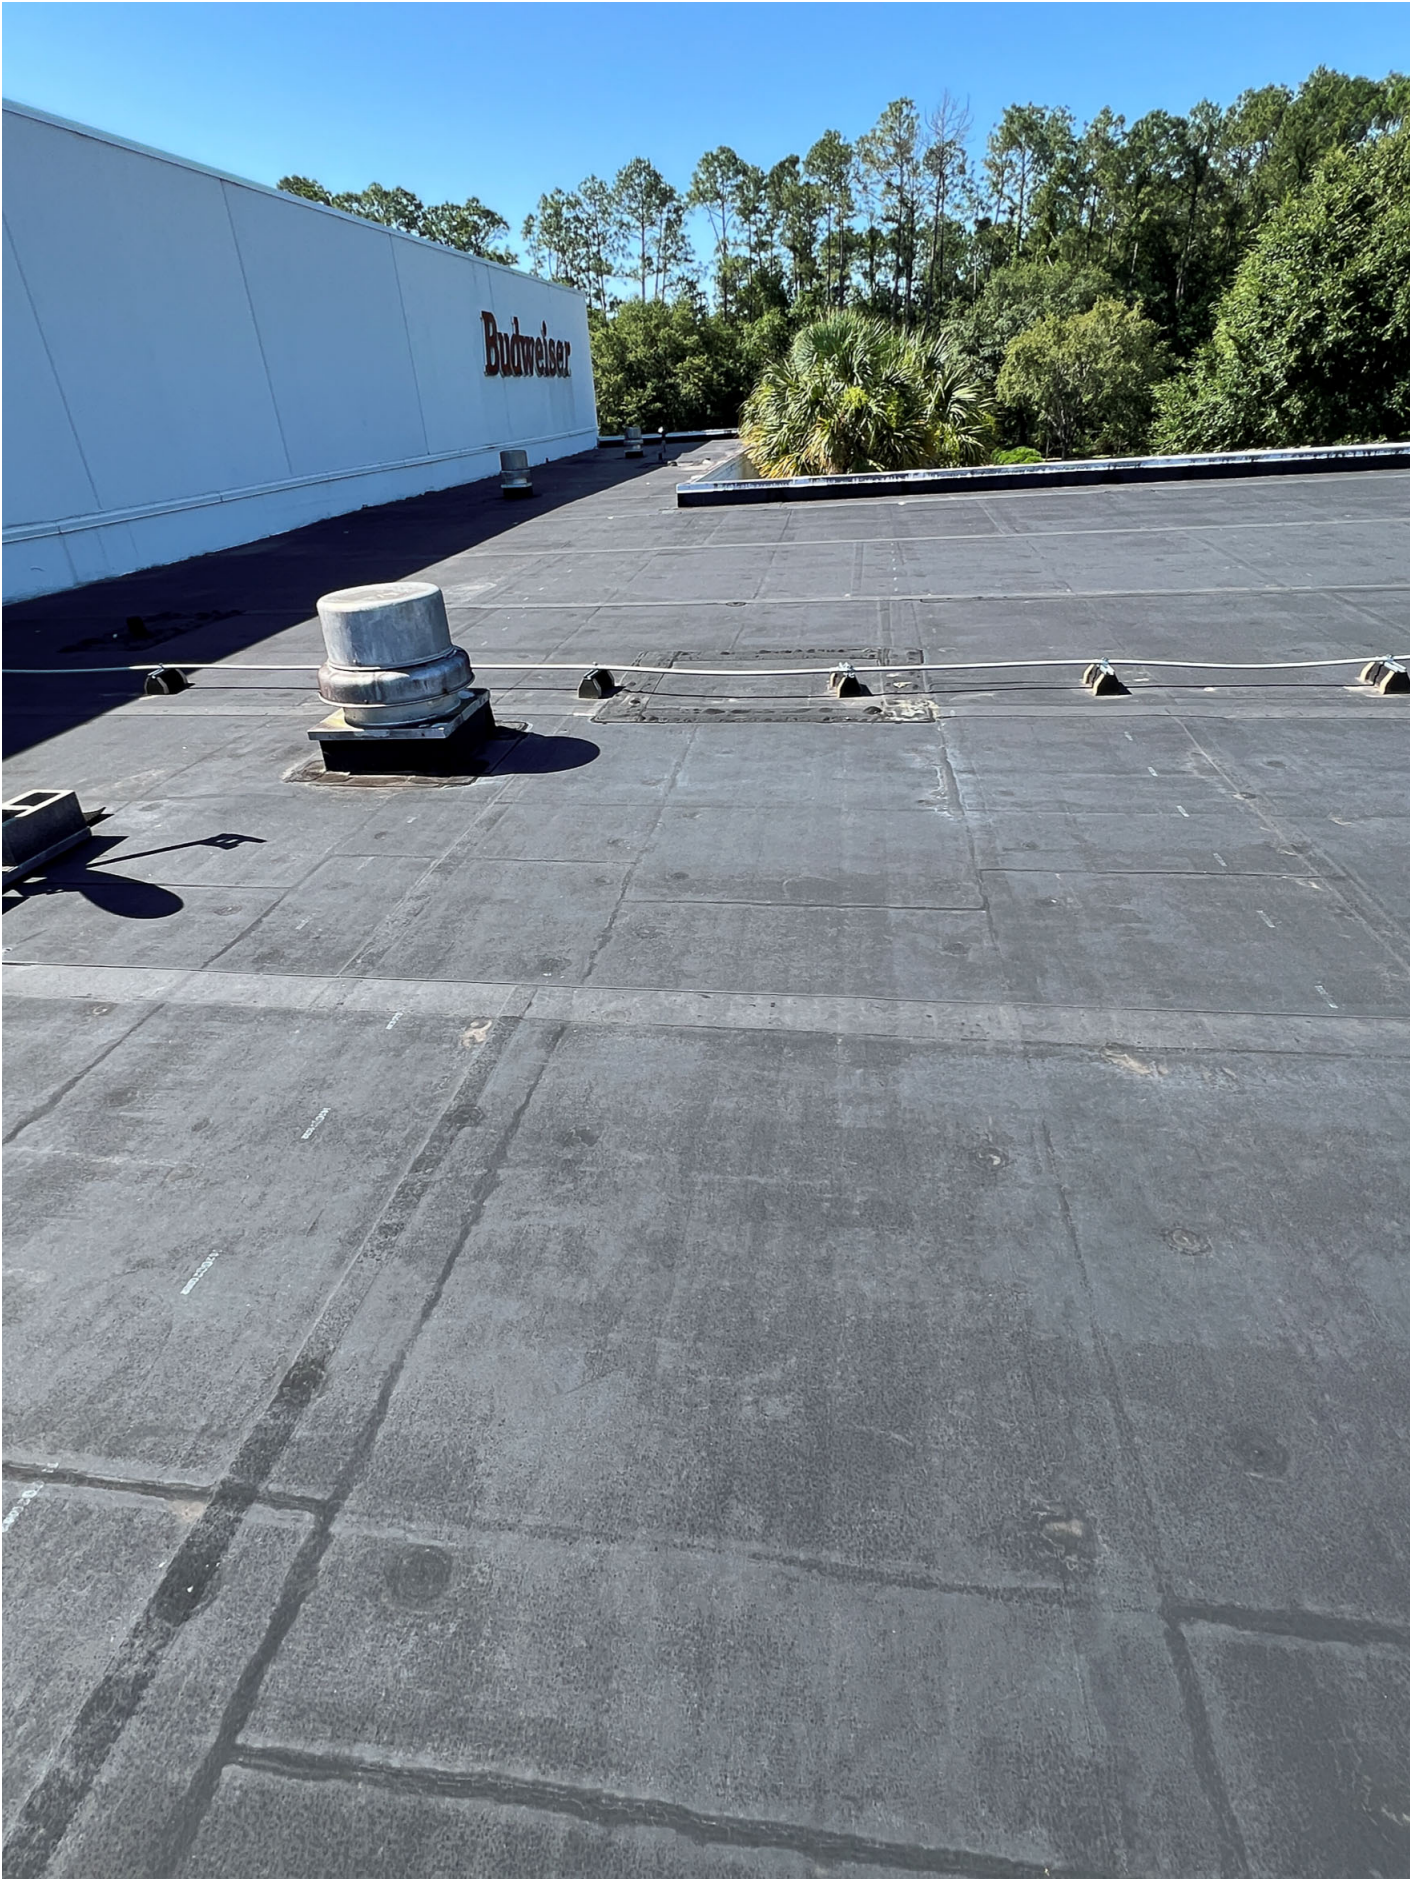
Admin area (lower) roof single-ply EPDM membrane w/ torched edges - exhaust fan on curb

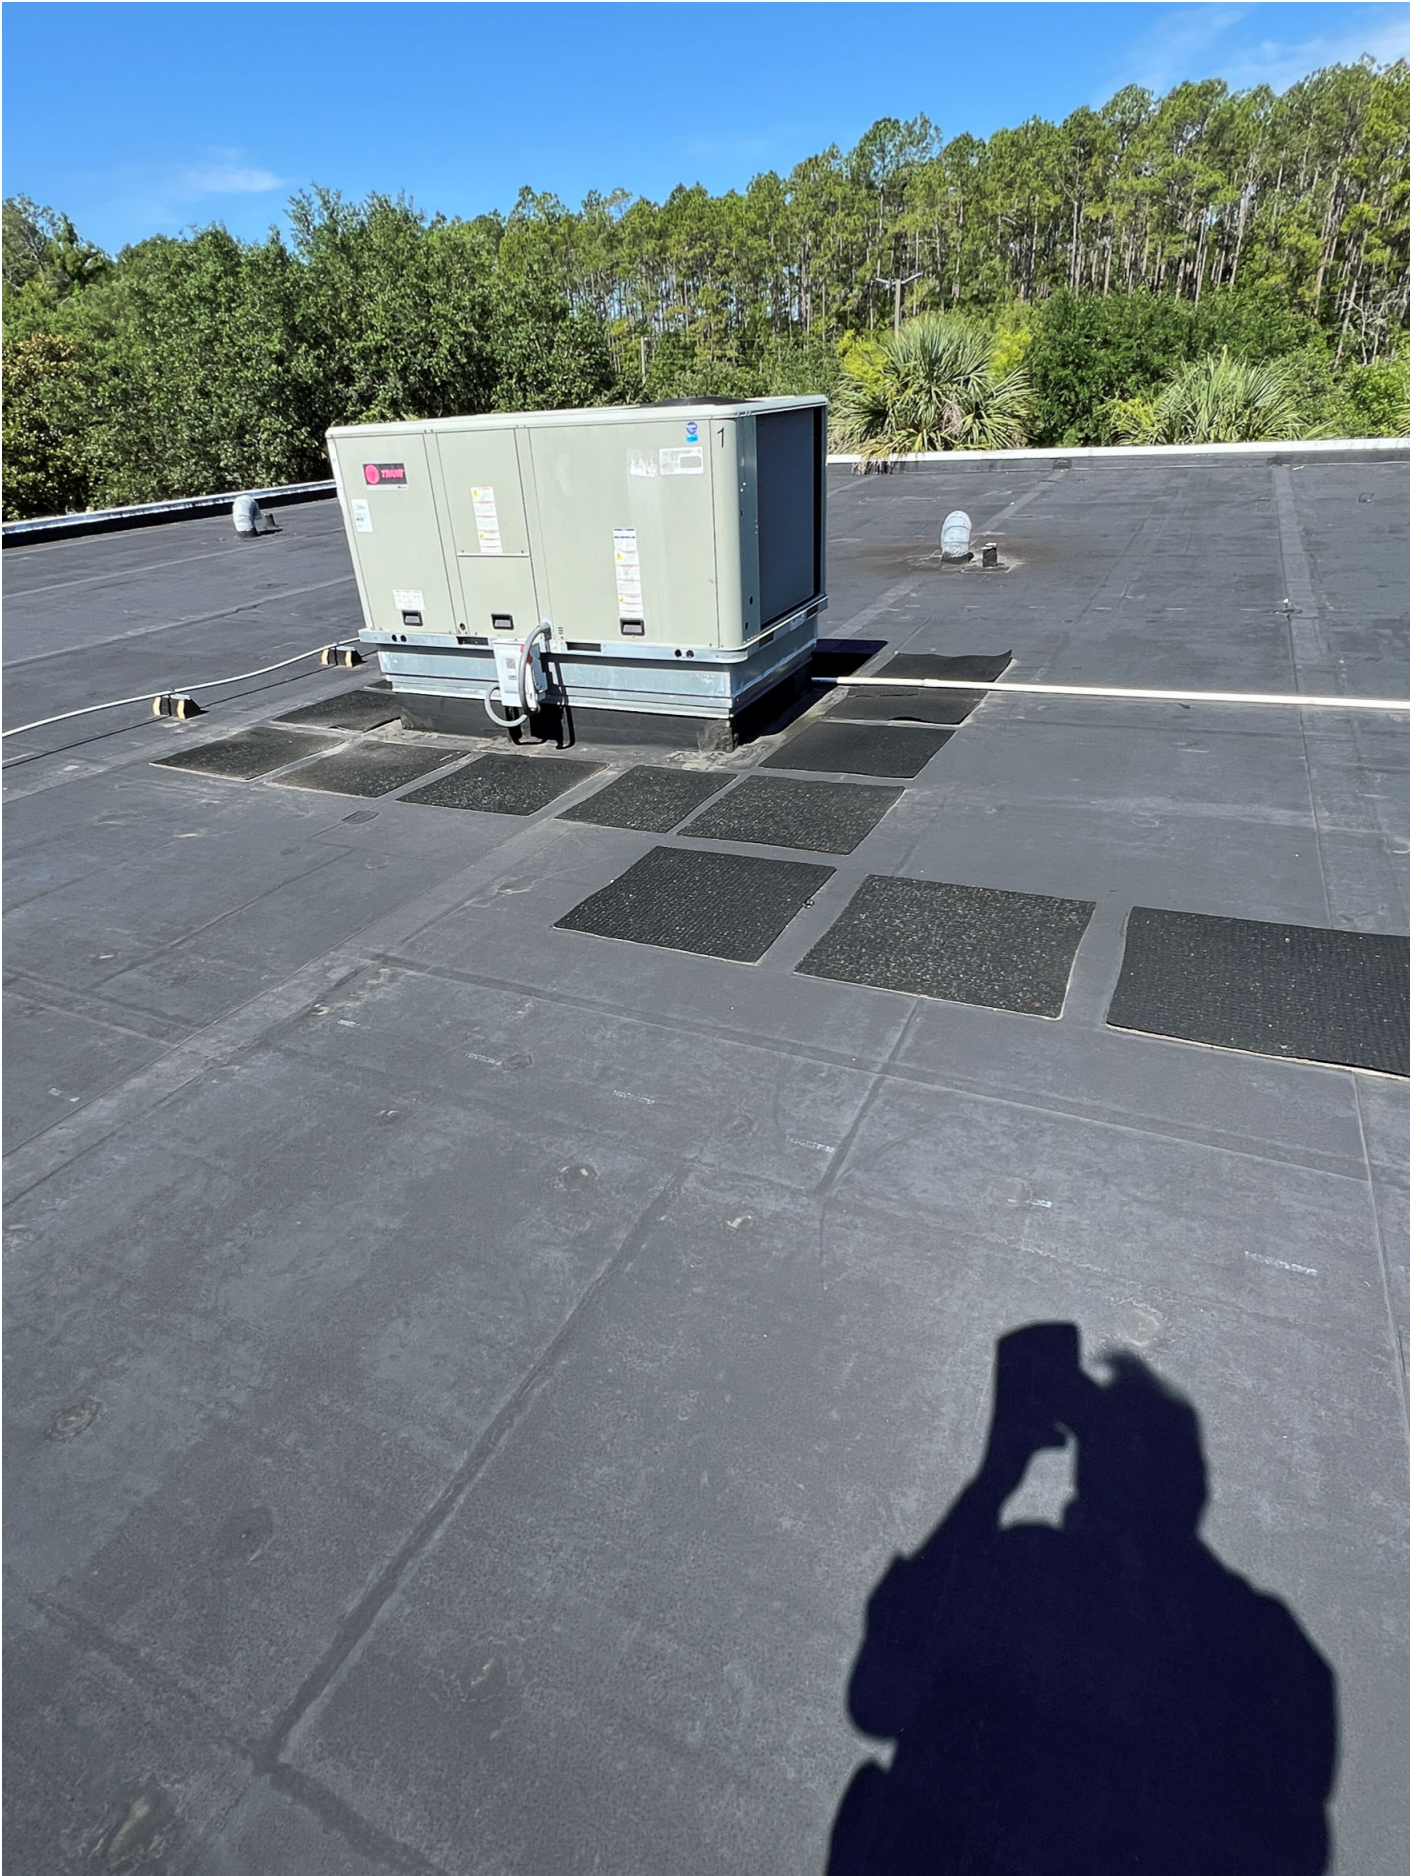
Admin area (lower) roof single-ply EPDM membrane w/ torched edges - one of four roof top

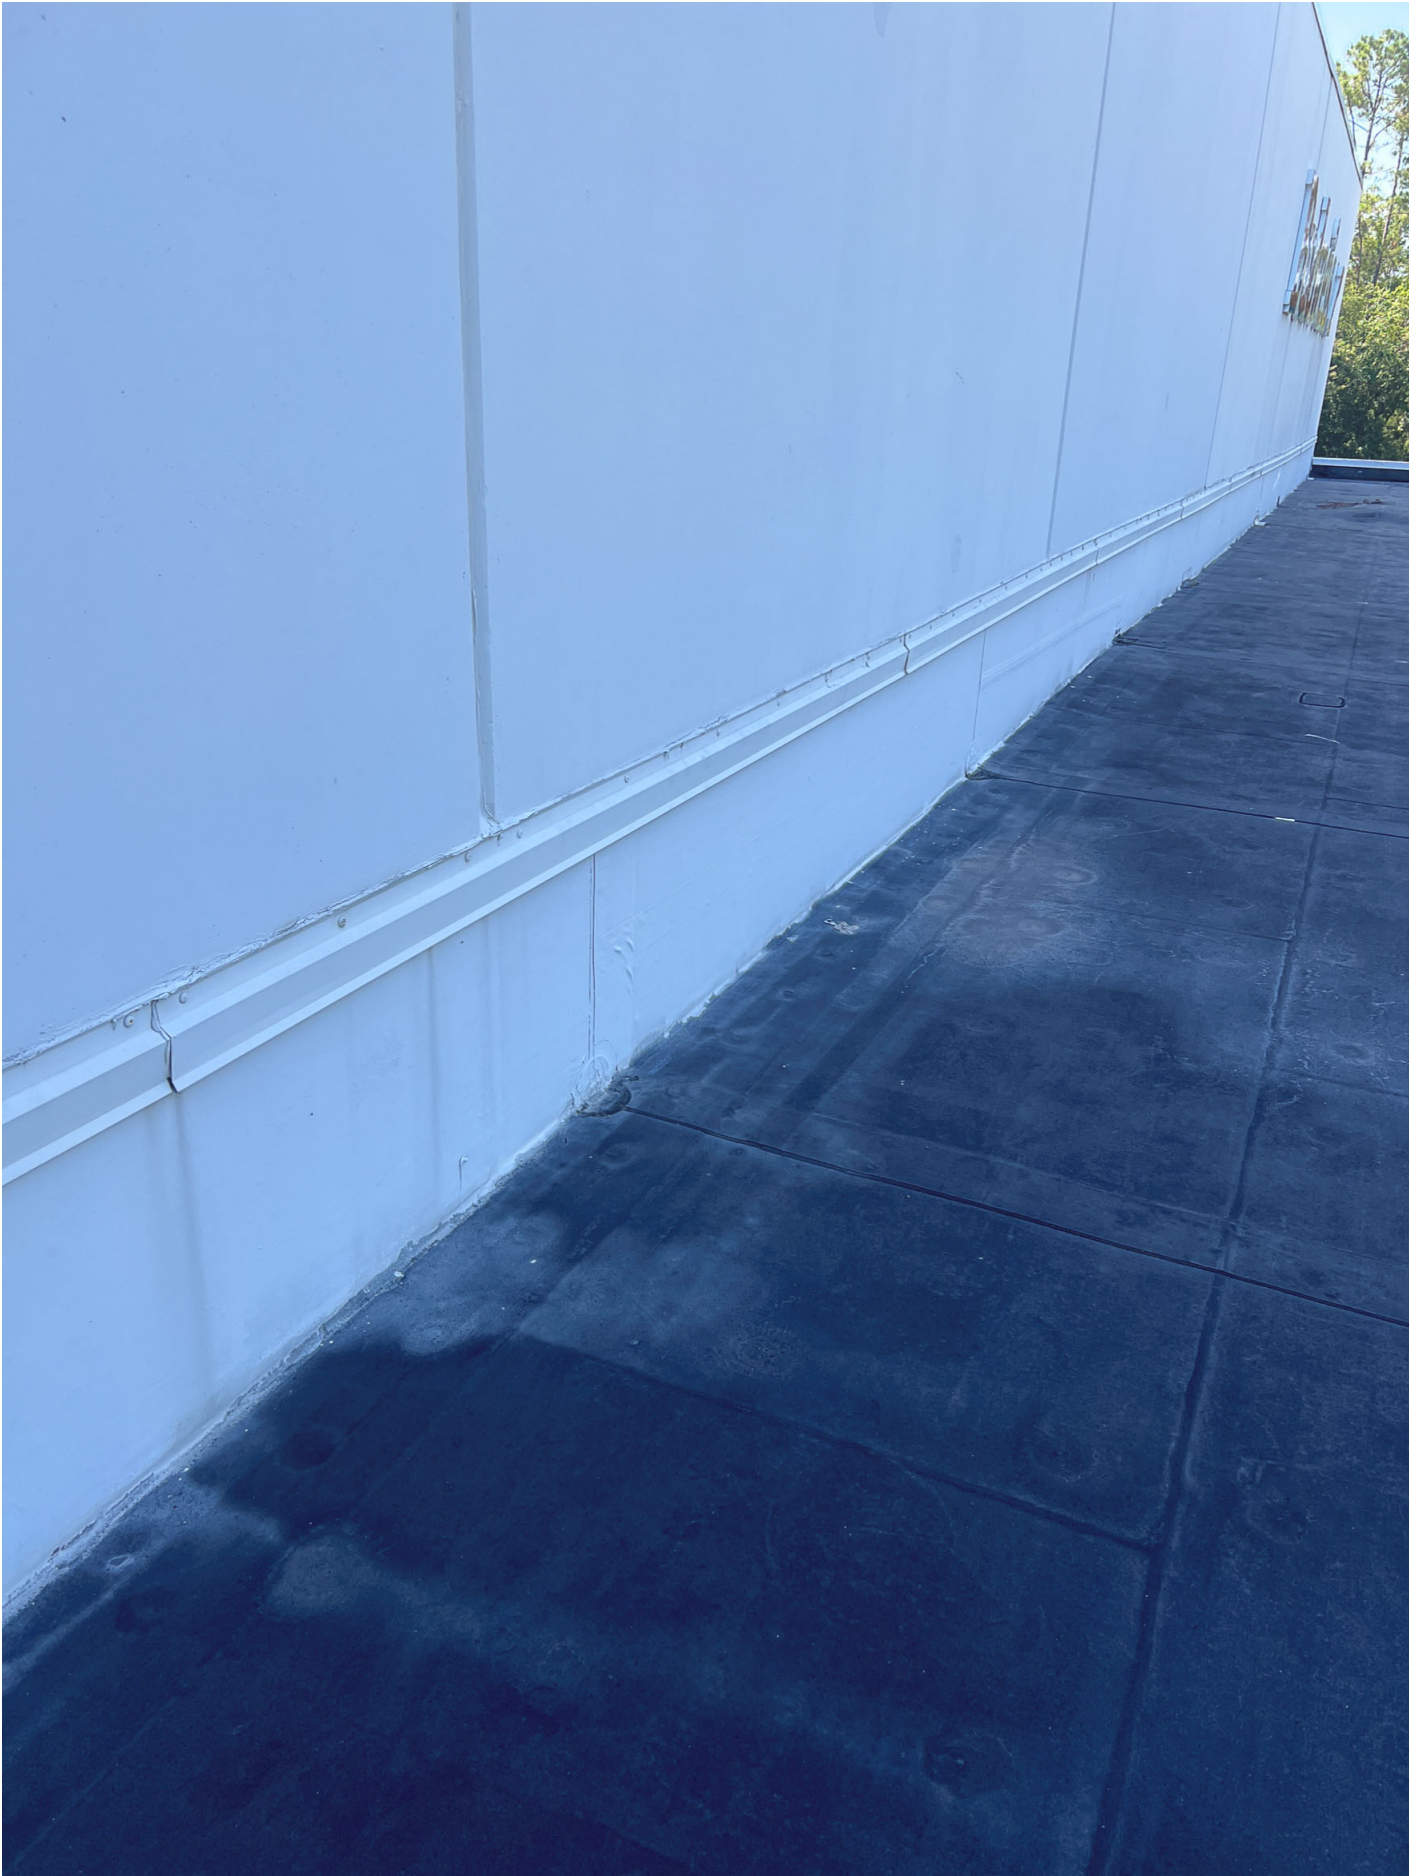
Lower admin roof area with (4) A/C units and a roof exhaust

In conclusion, the building is in very good general shape and there are no signs of structural concerns or compromises, three items do need to be addressed within the near future, the replacement of two of the A/C units on the lower administration roof will be required in the near future, the re-roofing of the original 2000 building should be considered to preserve the condition of the insulation and metal roof framing and interior finishes. Because of the amount of roof top equipment located on the lower roof area I would recommend a two-ply roof system to minimize exposure to tears and punctures. The upper roof of the warehouse does have exhaust fans which do not really require the maintenance that A/C equipment does so the exposure to damage is lessened, and you could go back with a white fleece back PTO product. The 2011 warehouse addition is capped with a single-ply TPO type membrane and was found to be in reasonably good shape and has a number of additional years of performance in it so this area could wait a few years before being re-roofed or you could decide to simply use this time to re-roof the entire building and get a single building roof warranty. The asphalt heavy duty truck paving requires maintenance that I would do immediately to ensure the subgrade and paving base do not become compromised.

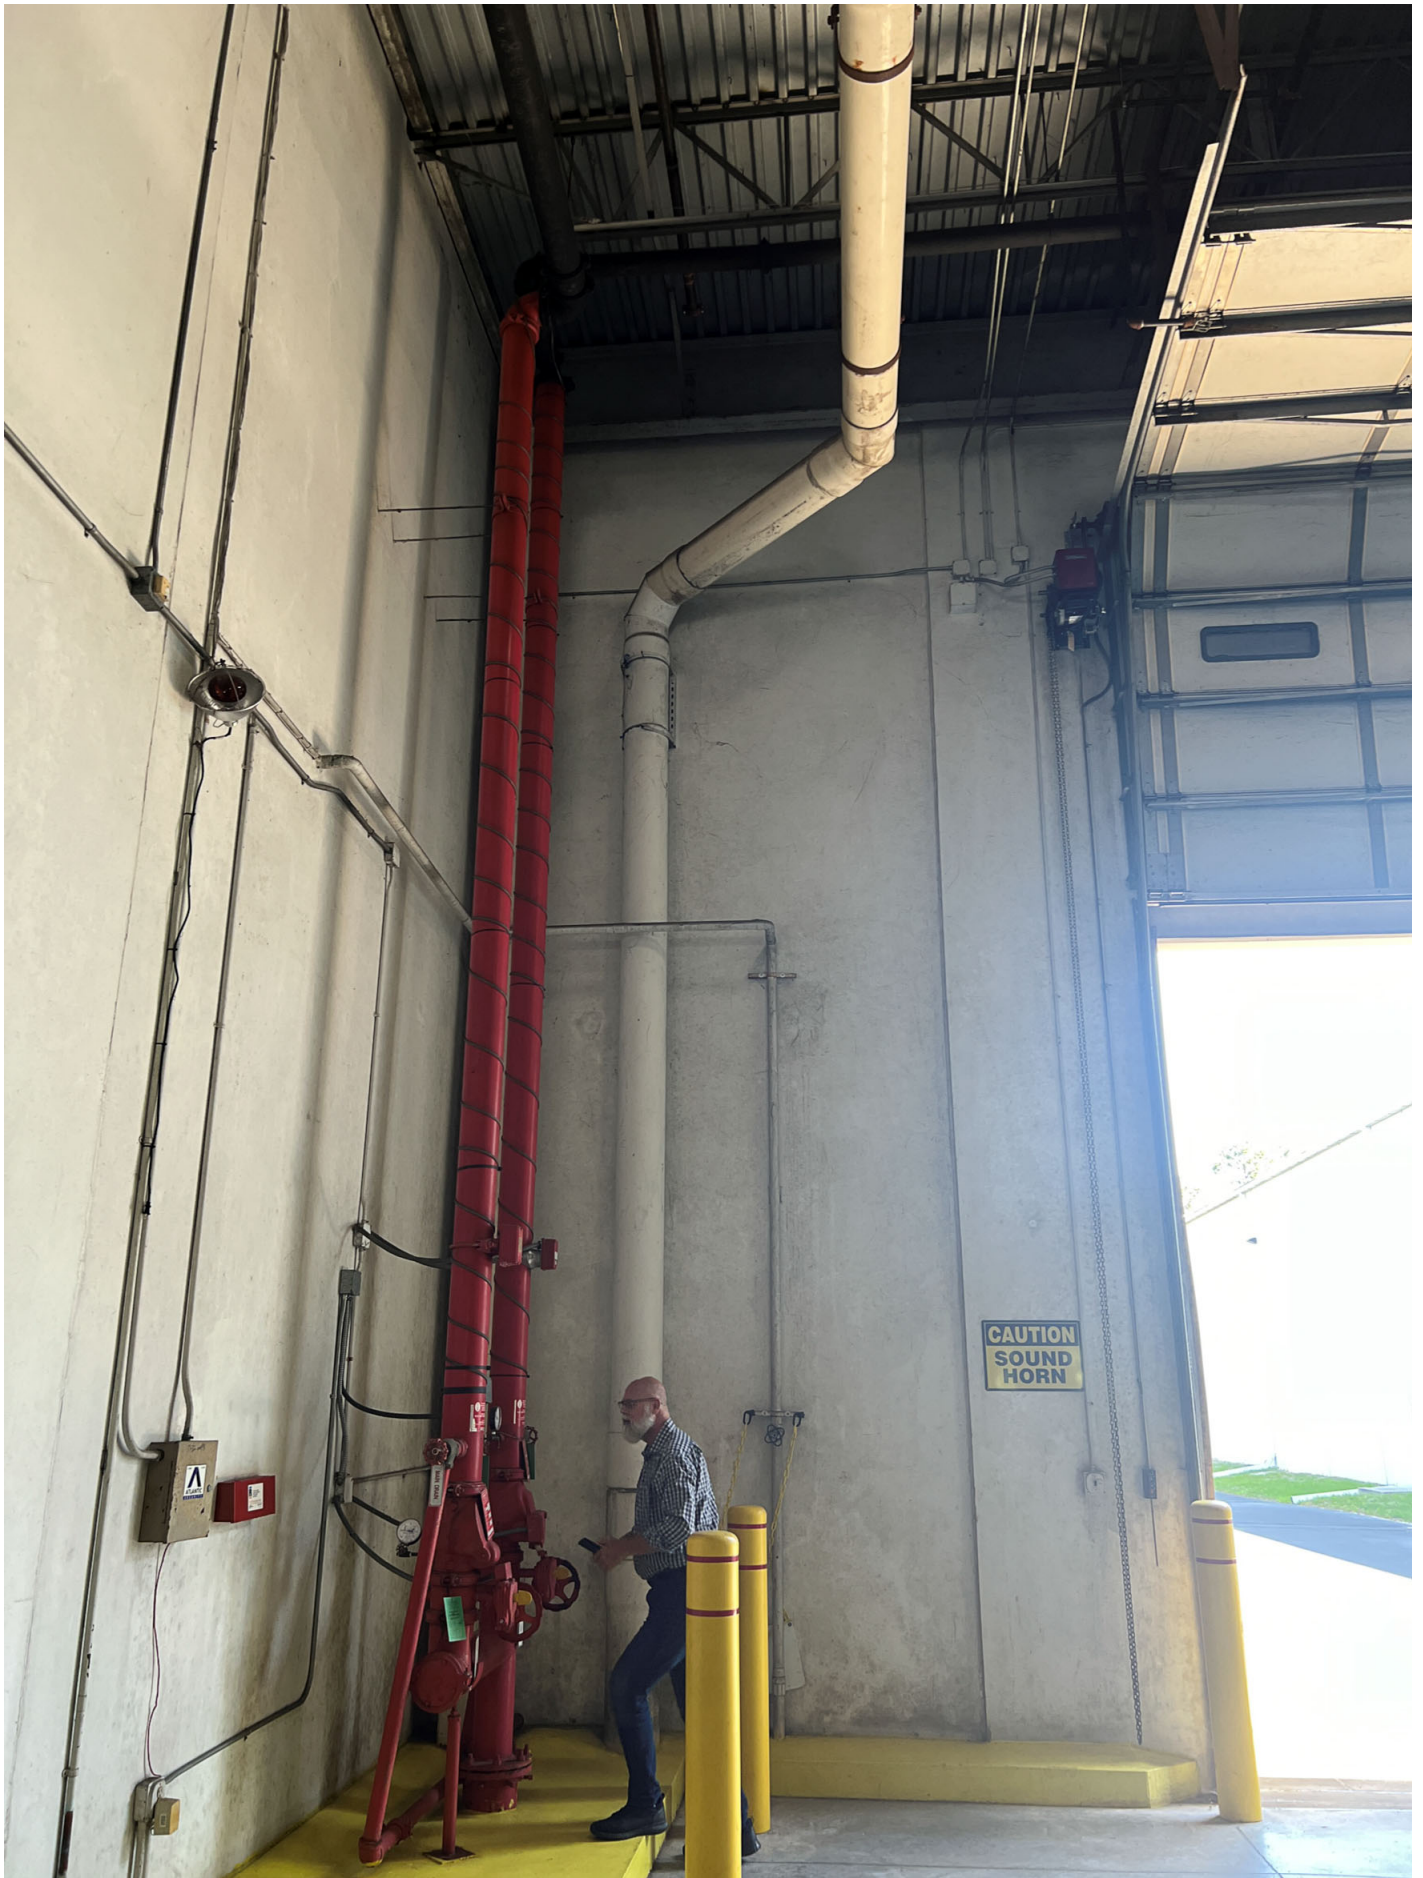
The existing main electrical Service – 480V/277V, 3Φ 1200A service located in Utility Room 150 with panels throughout the building. The electrical infrastructure is observed to be in good working order with no noticeable issues.

Electrical room

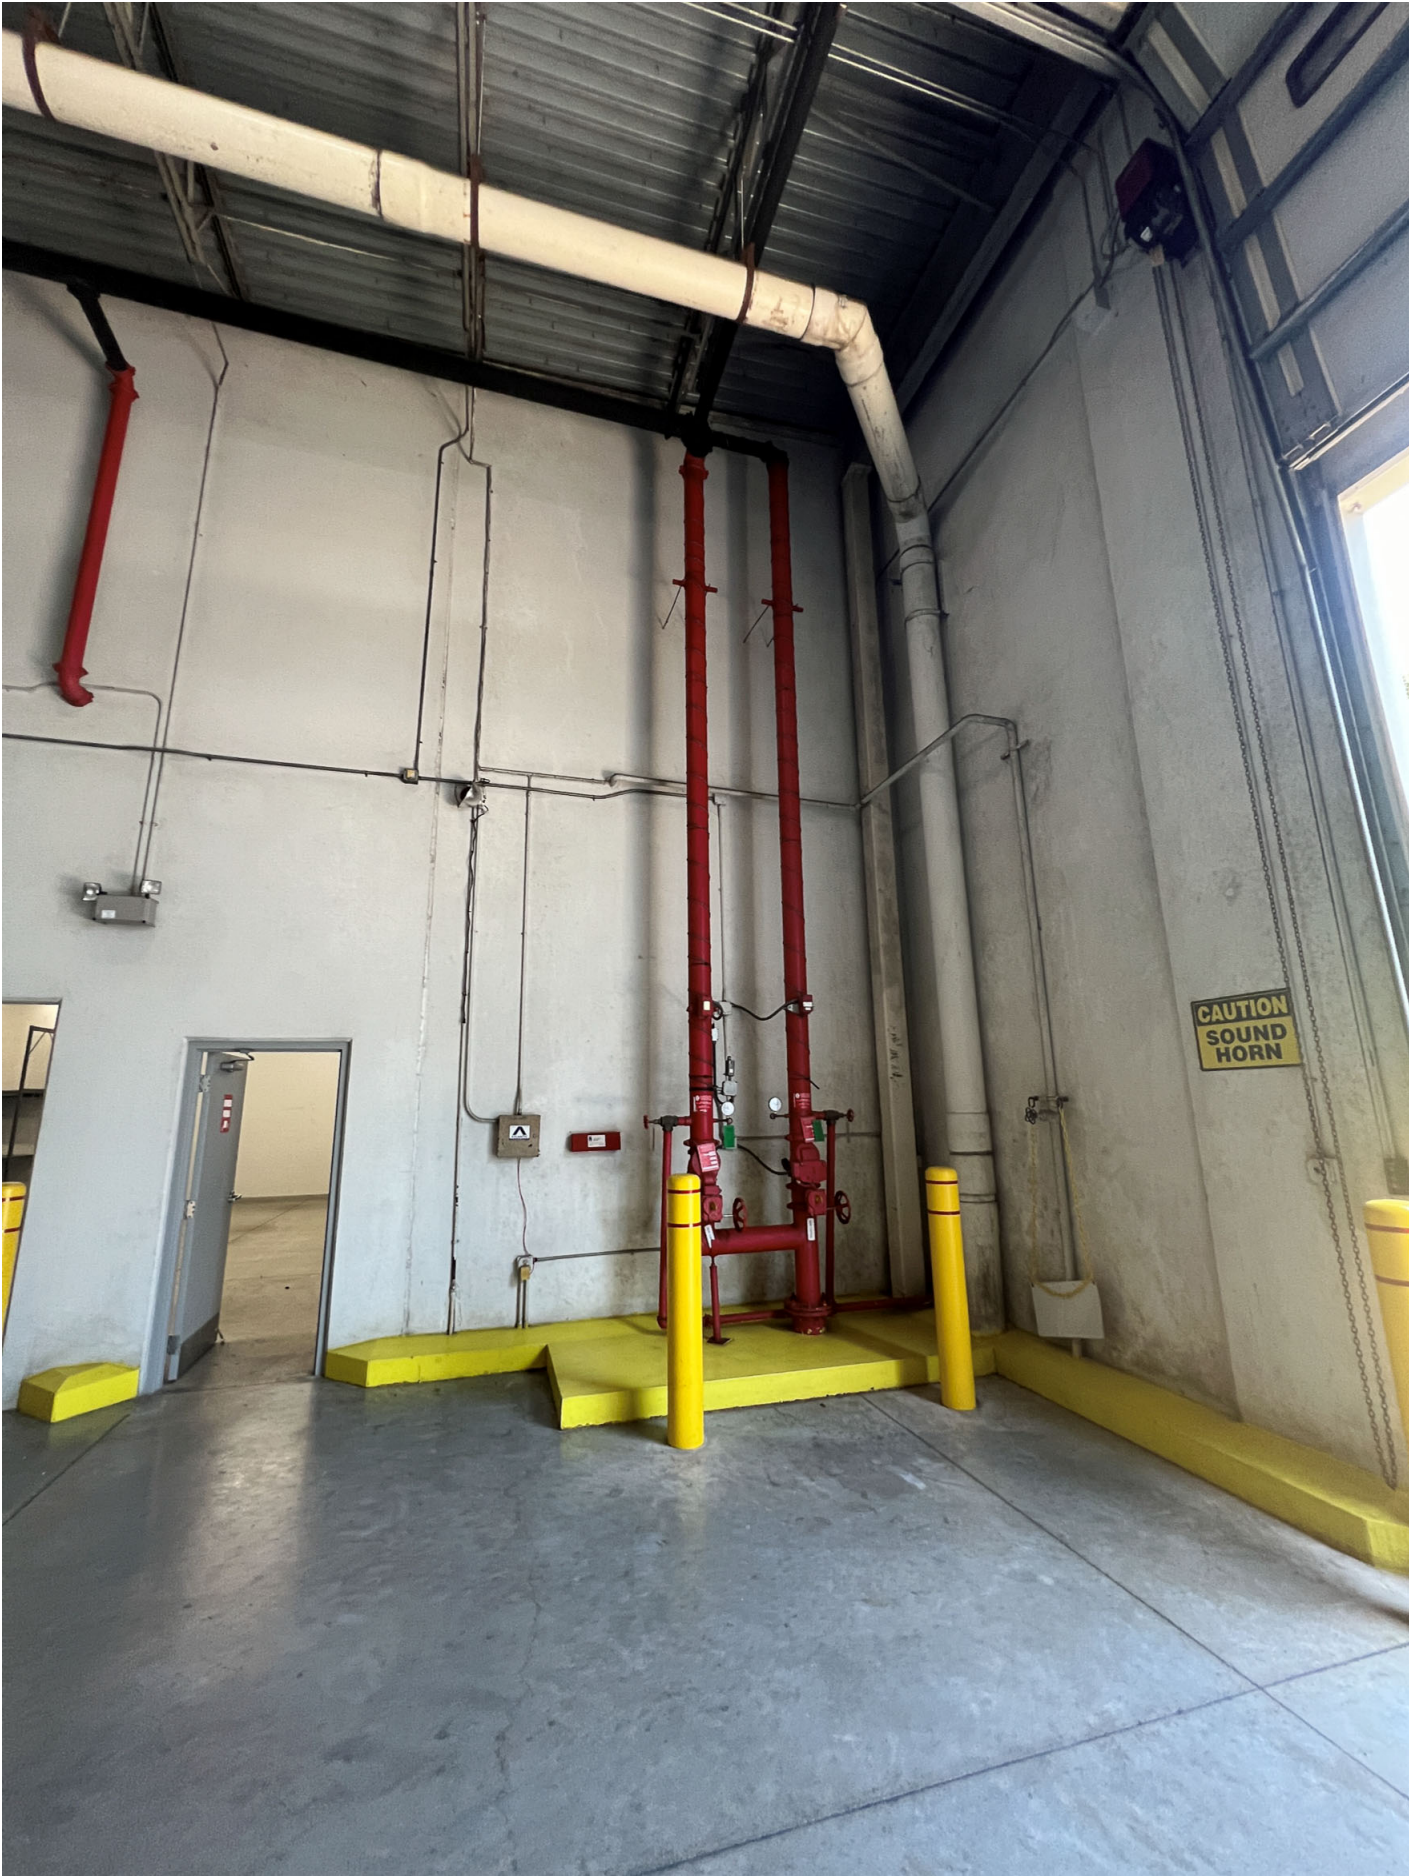
The existing fire sprinkler system is currently served from the front of the building with an insulated 8" backflow preventor above grade. All observed piping, valves and sprinkler heads looked to be in good working condition with no noticeable issues. It was observed that the yearly system inspections have been completed as of February 2024.

Warehouse fire sprinkler main

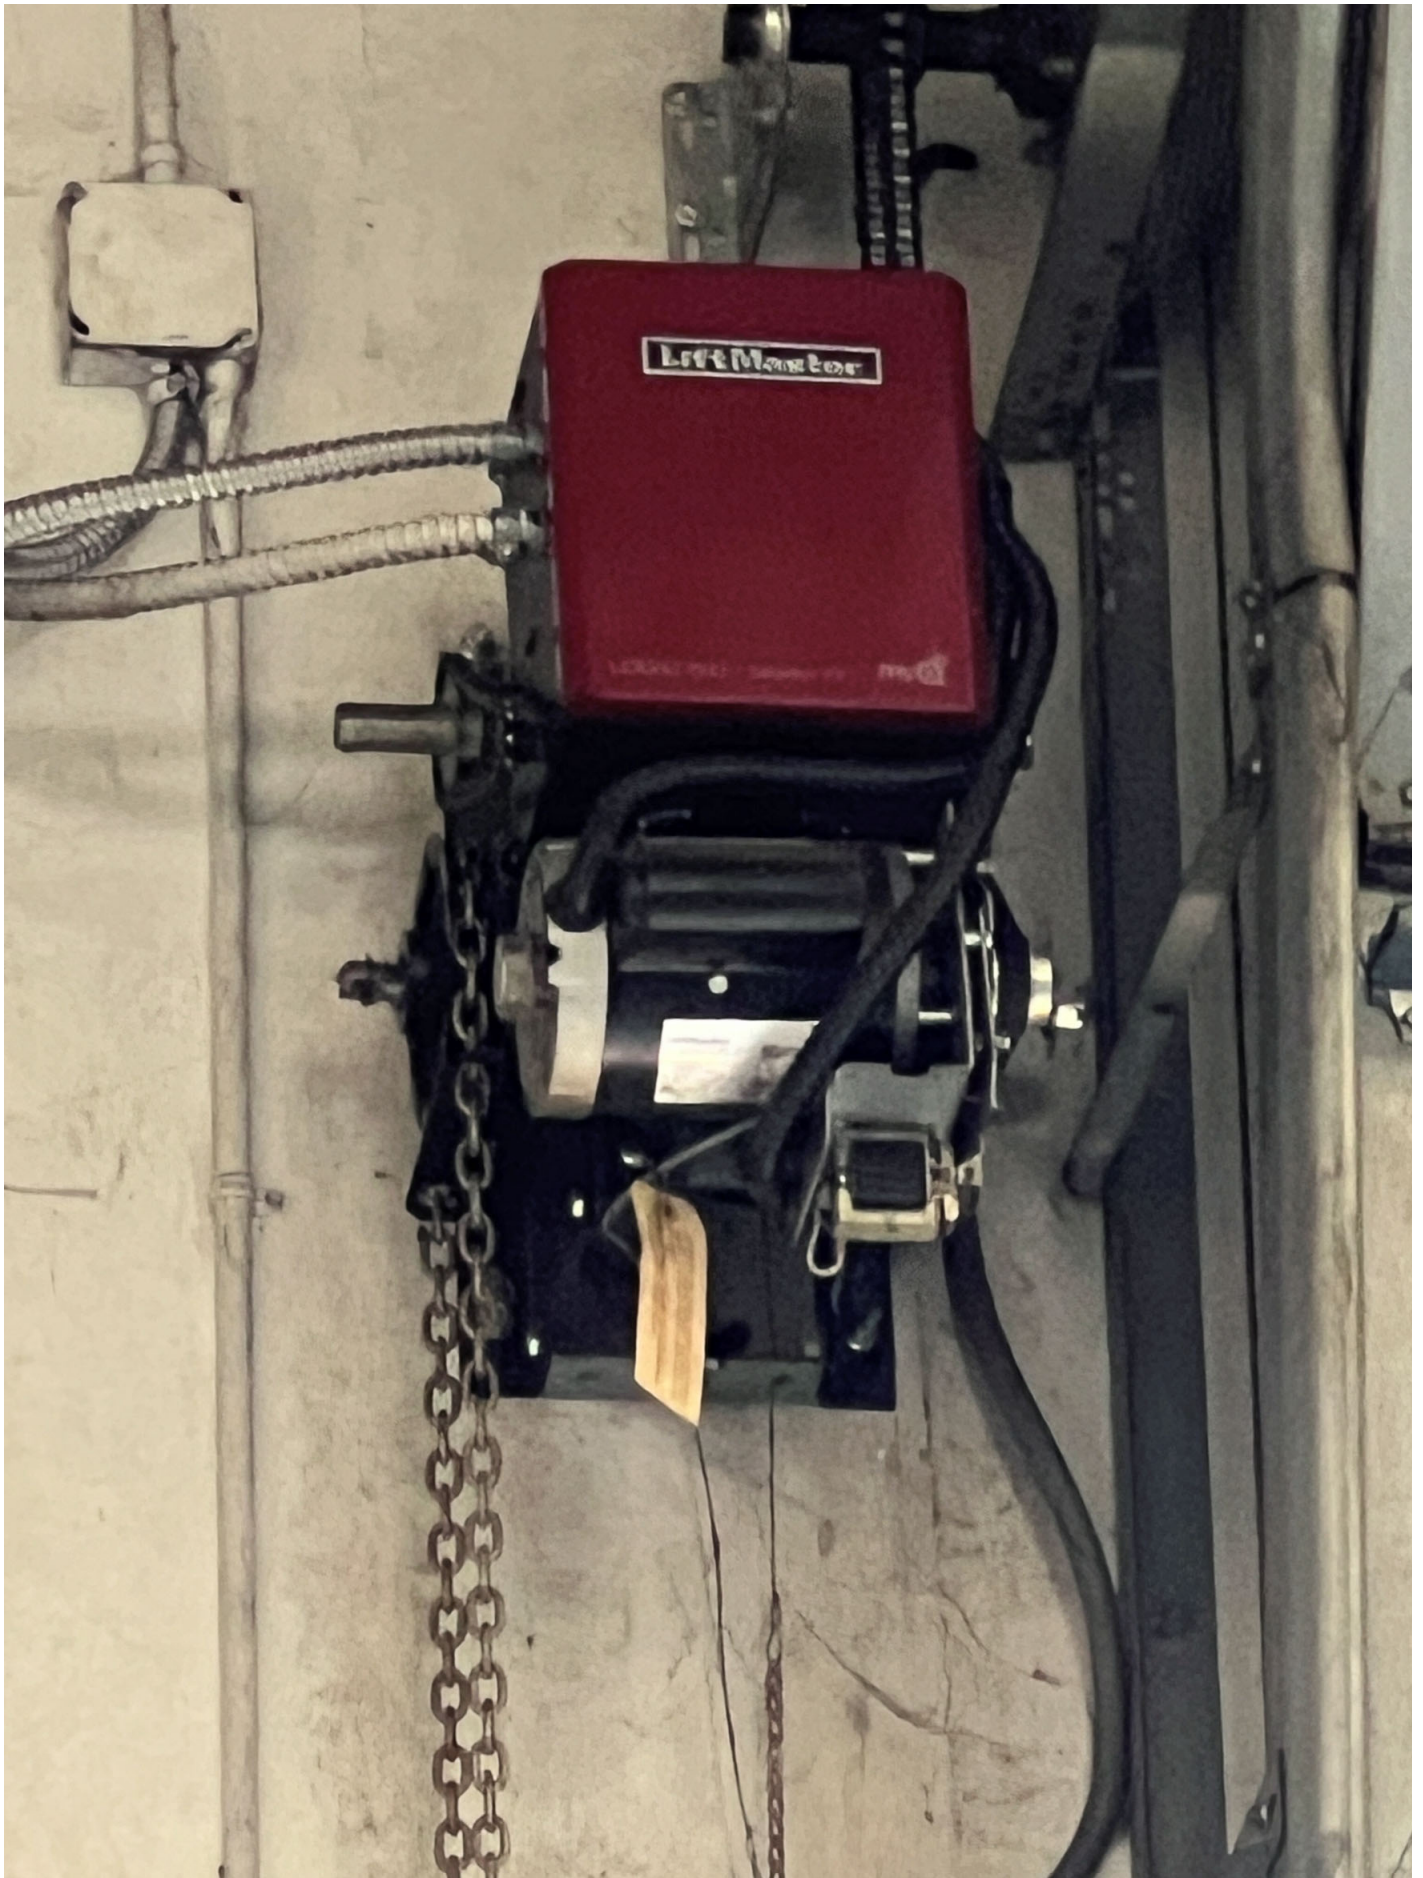
Warehouse fire sprinkler main

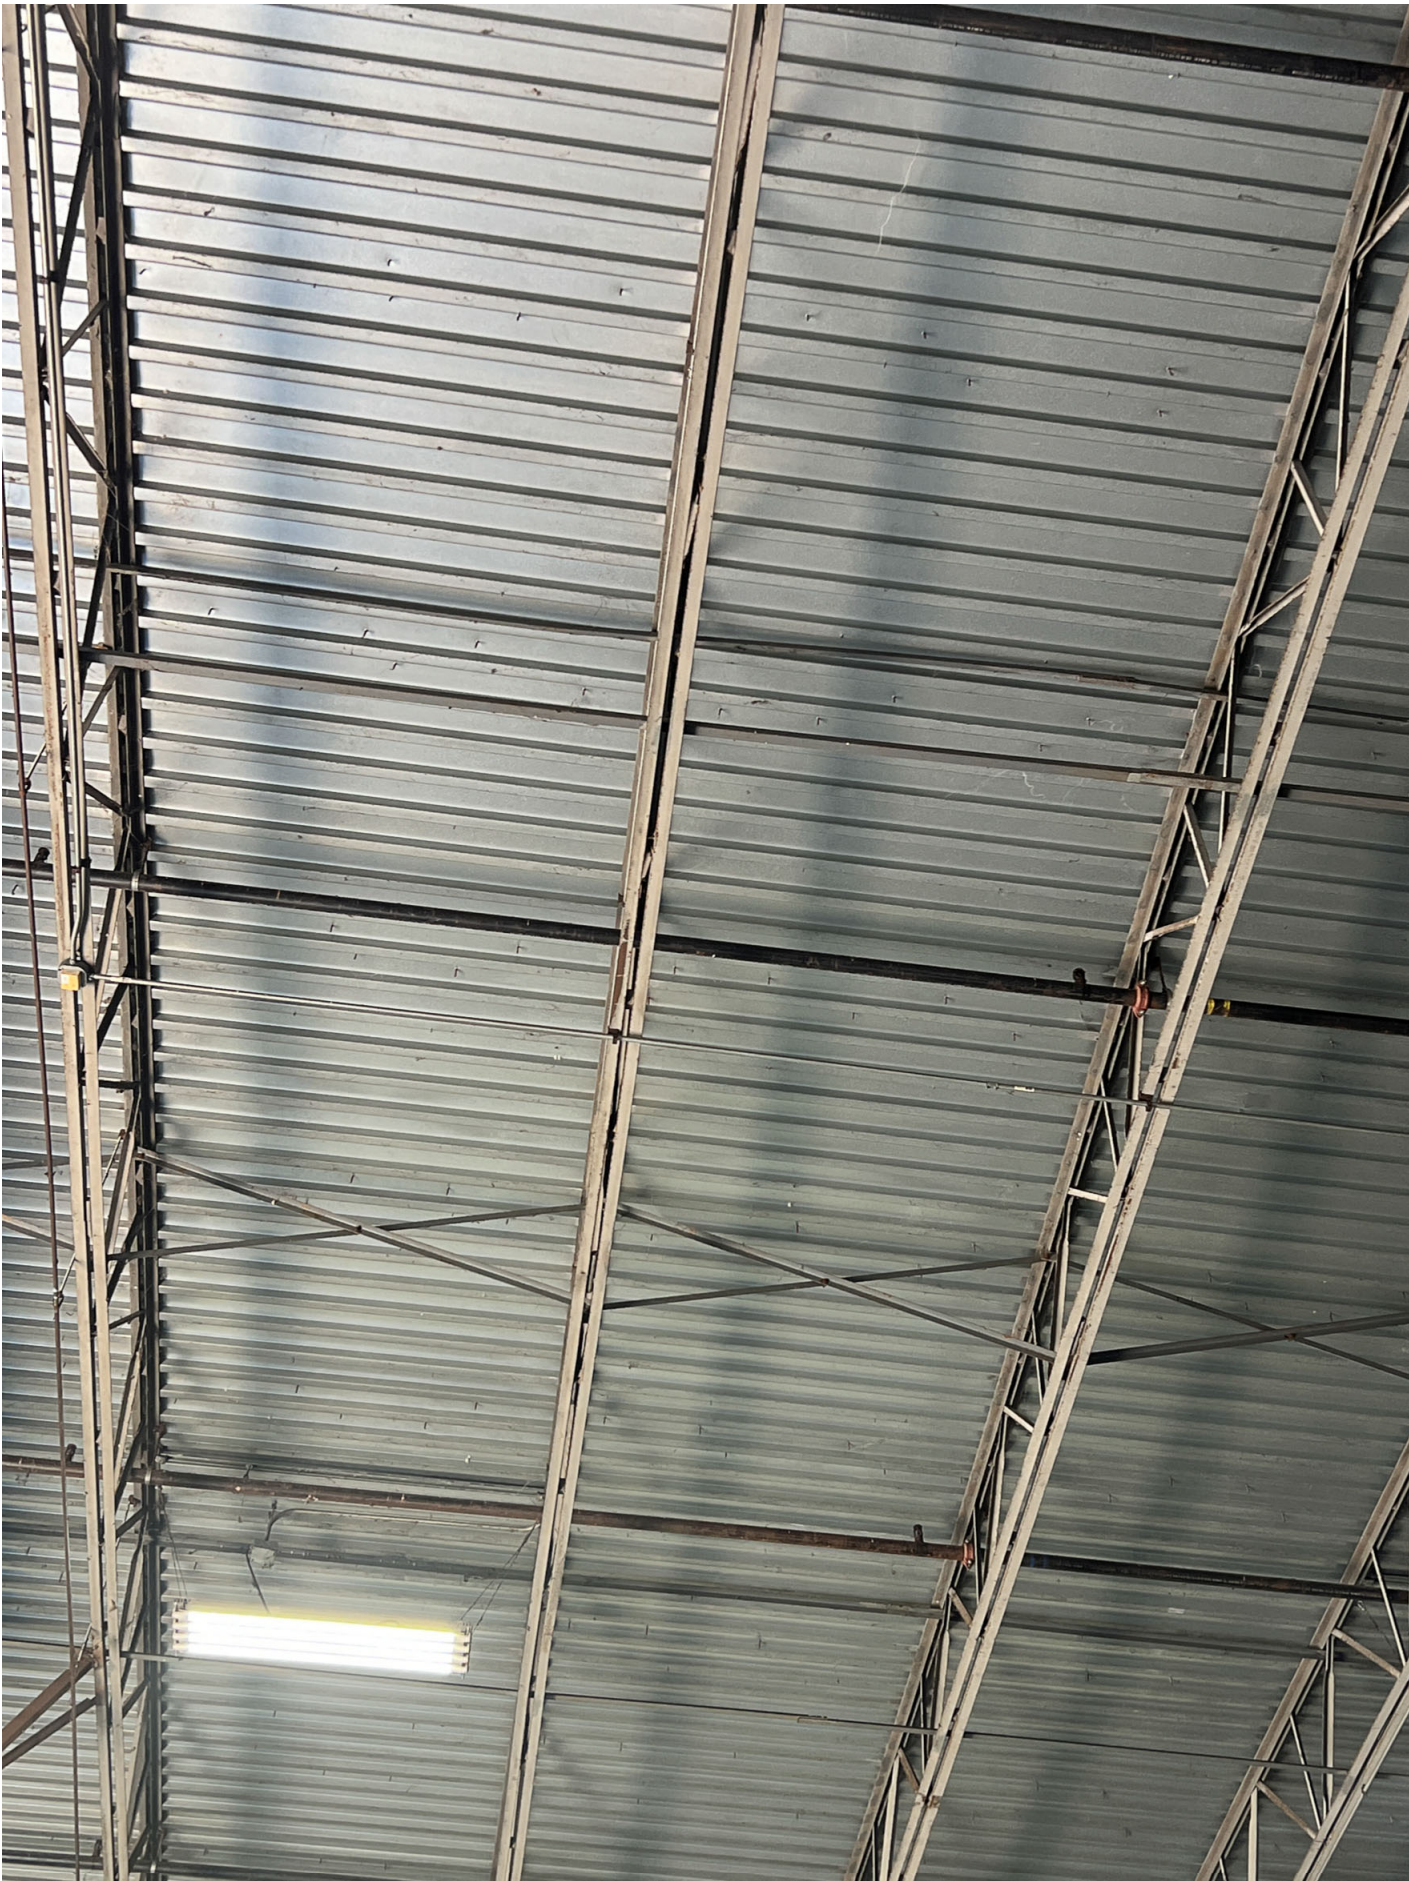
West drive-thru warehouse bay

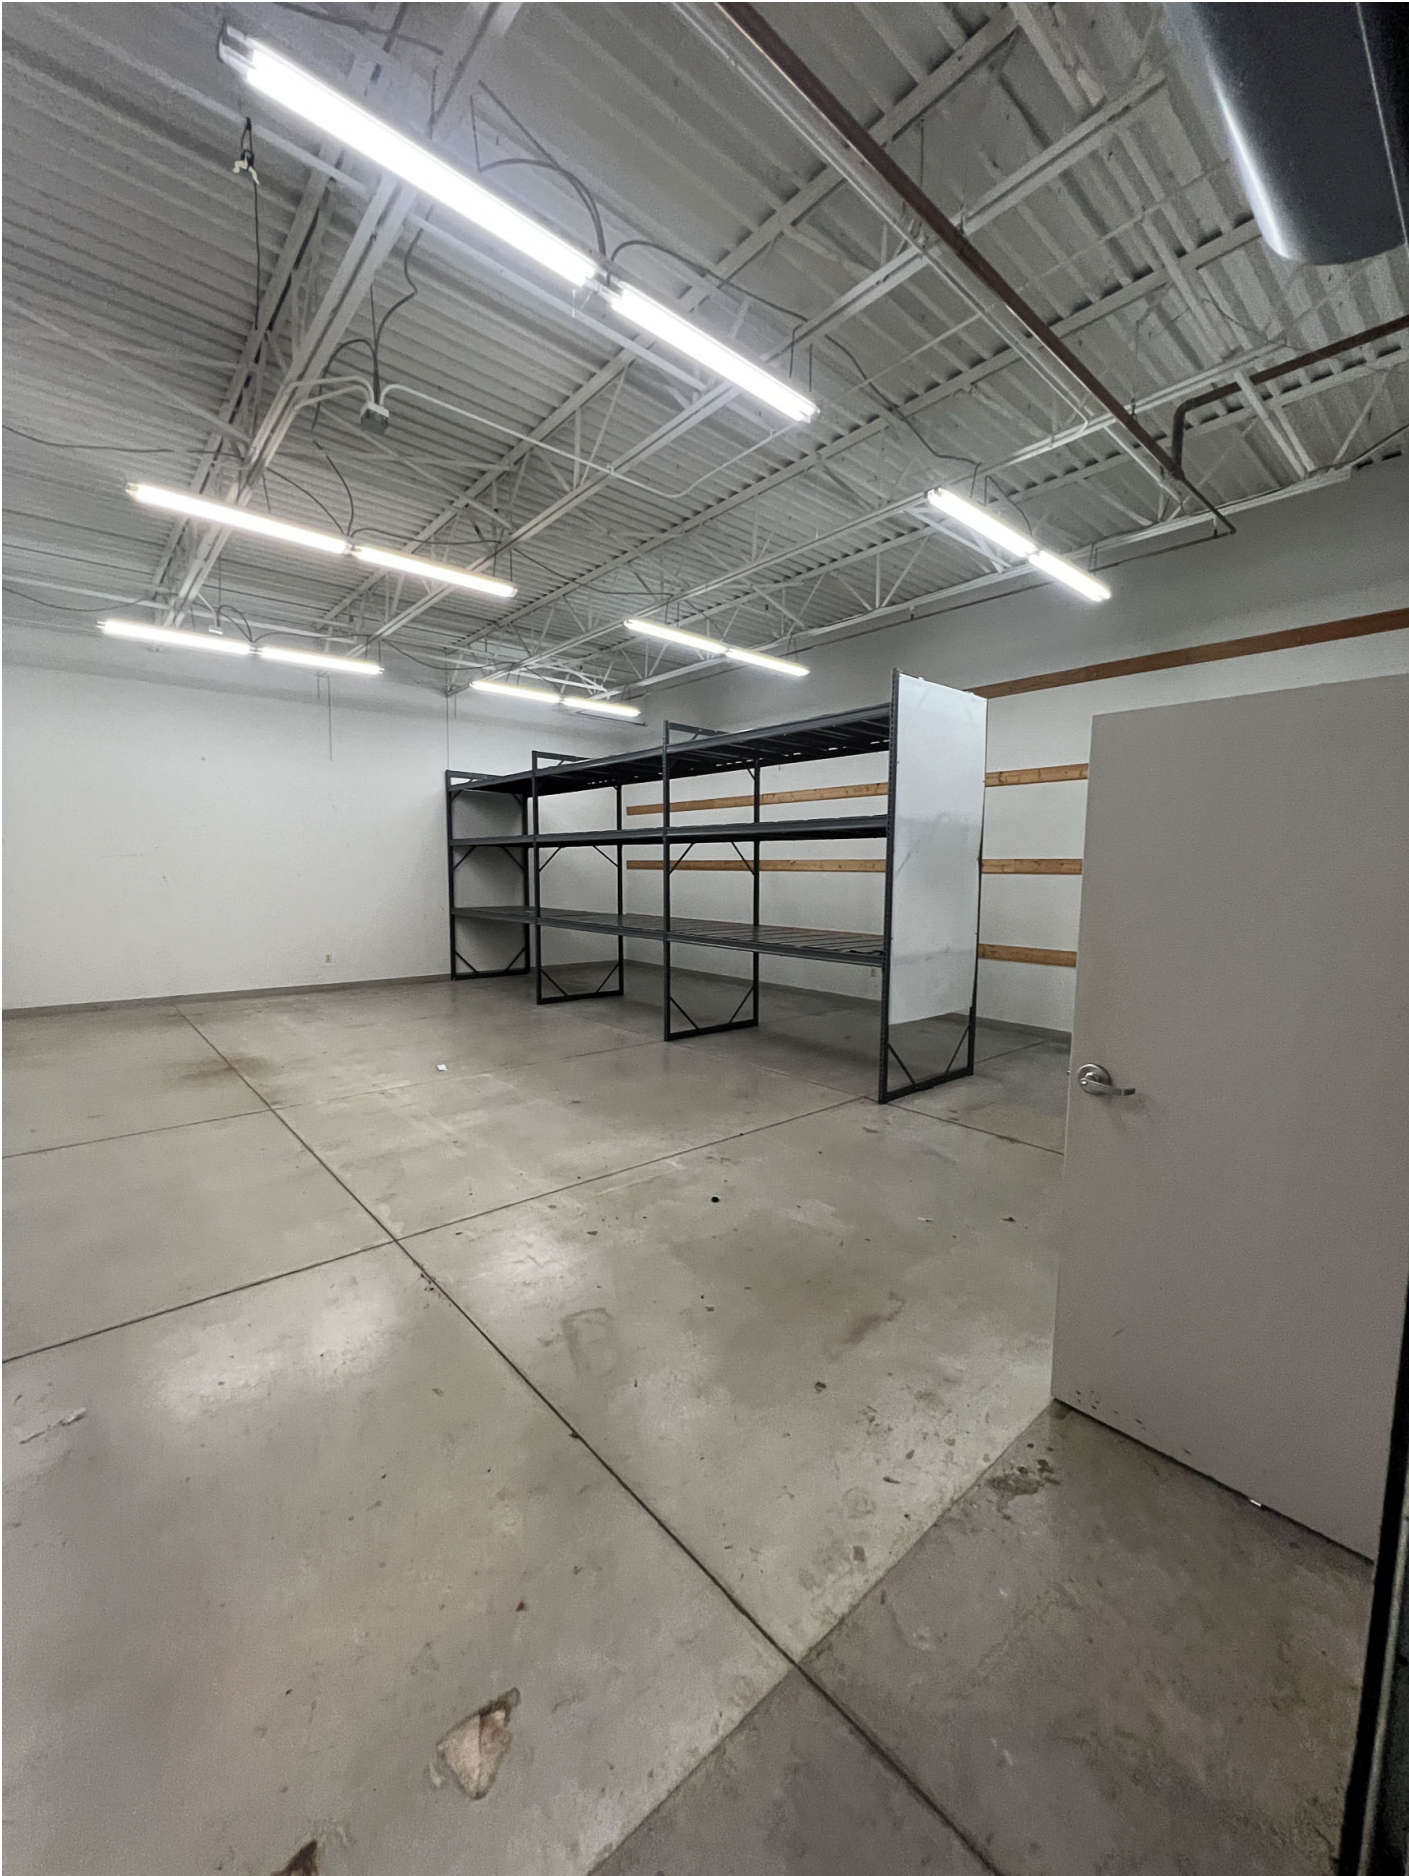
West side of the 2011 warehouse expansion
