RE: Due Diligence Report – Burkhardt Sales & Service

As part of the County's due diligence efforts to evaluate the conditions of the existing commercial industrial warehouse building (Burkhardt Sales & Service) located at 6125 NW 18<sup>th</sup> Drive, Gainesville, FL 32653, Paul Stresing Associates (PSA) was tasked with conducting an inspection of the facility to evaluate its condition prior to entering into a full purchase agreement to its purchase. On May 30, 2024, I was accompanied by KPI Engineering (KPI) where we walked the roof and interior of the facility with Mr. Matt Fultz of the Alachua County Facilities Department and Mr. Daniel Burkhardt, representing the seller where we gained access to the site and buildings to begin our evaluation efforts.

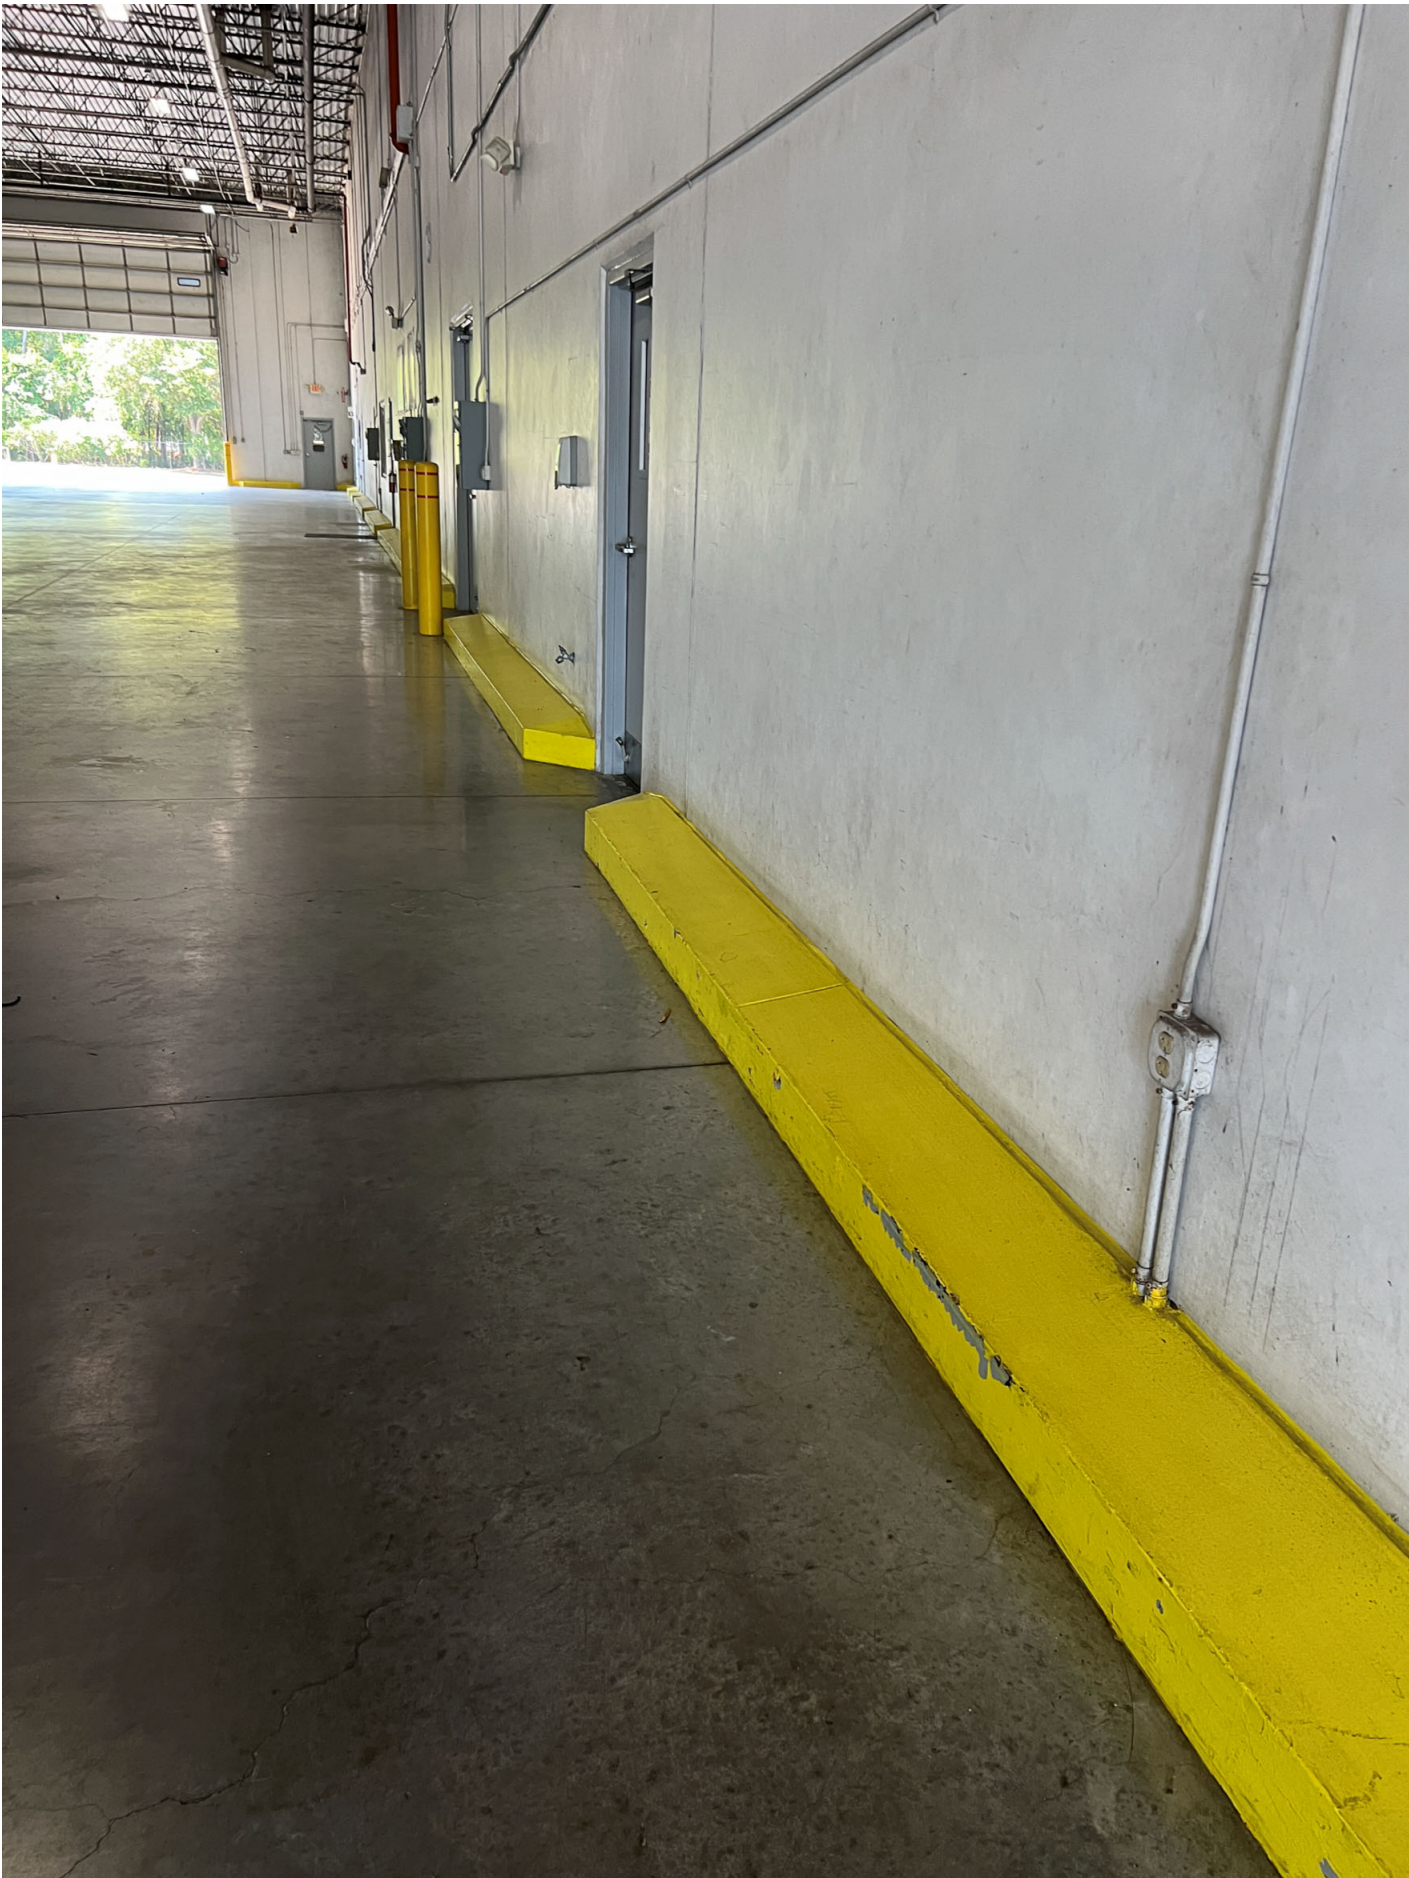
Storage room off west drive-thru warehouse bay

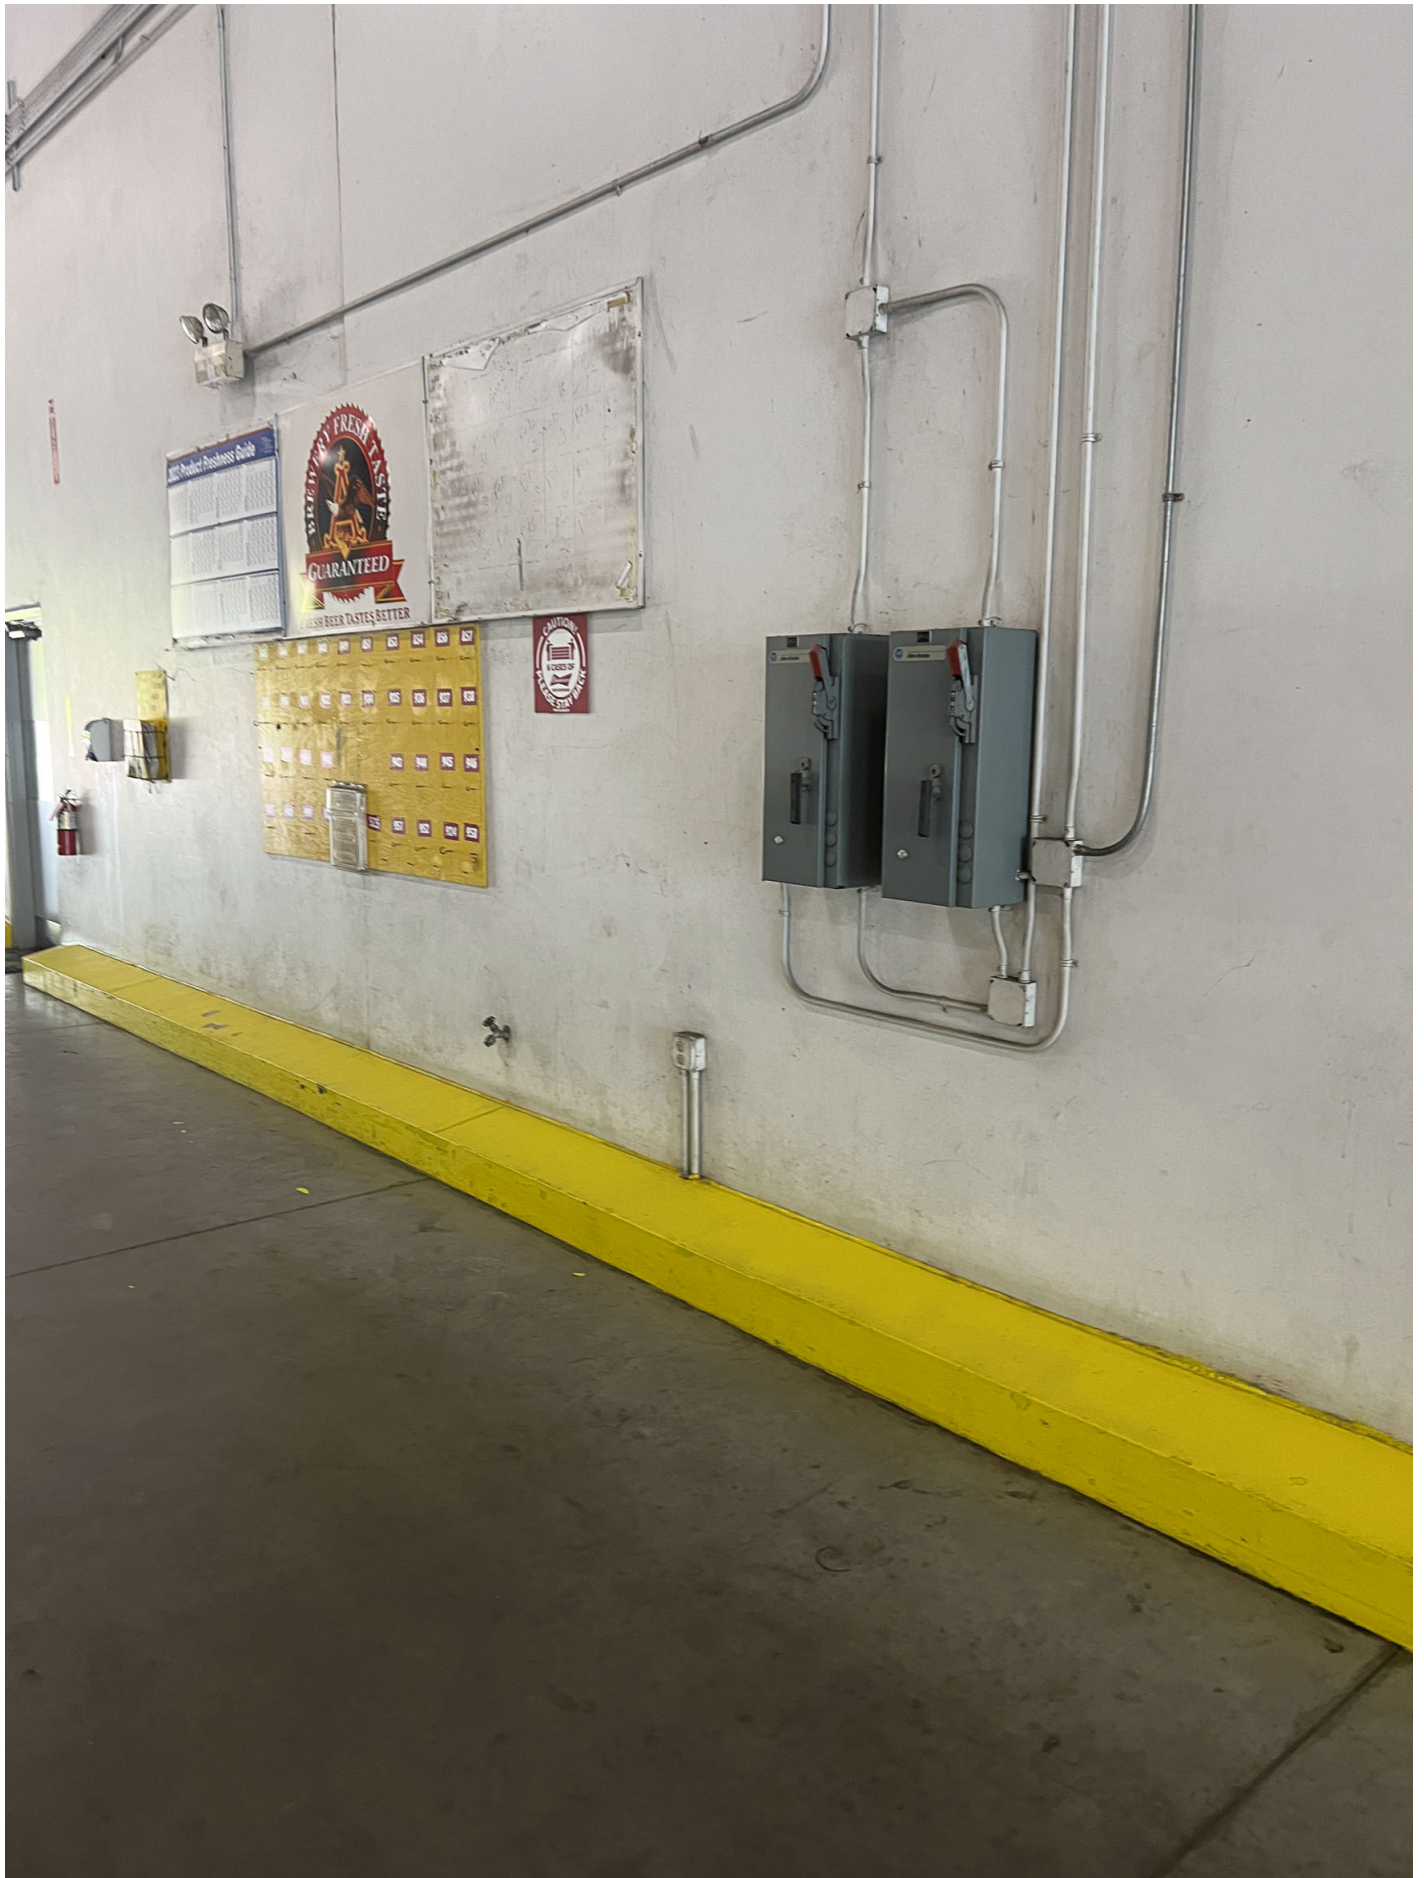
East wall of the west drive-thru bay - Emergency & general disconnects

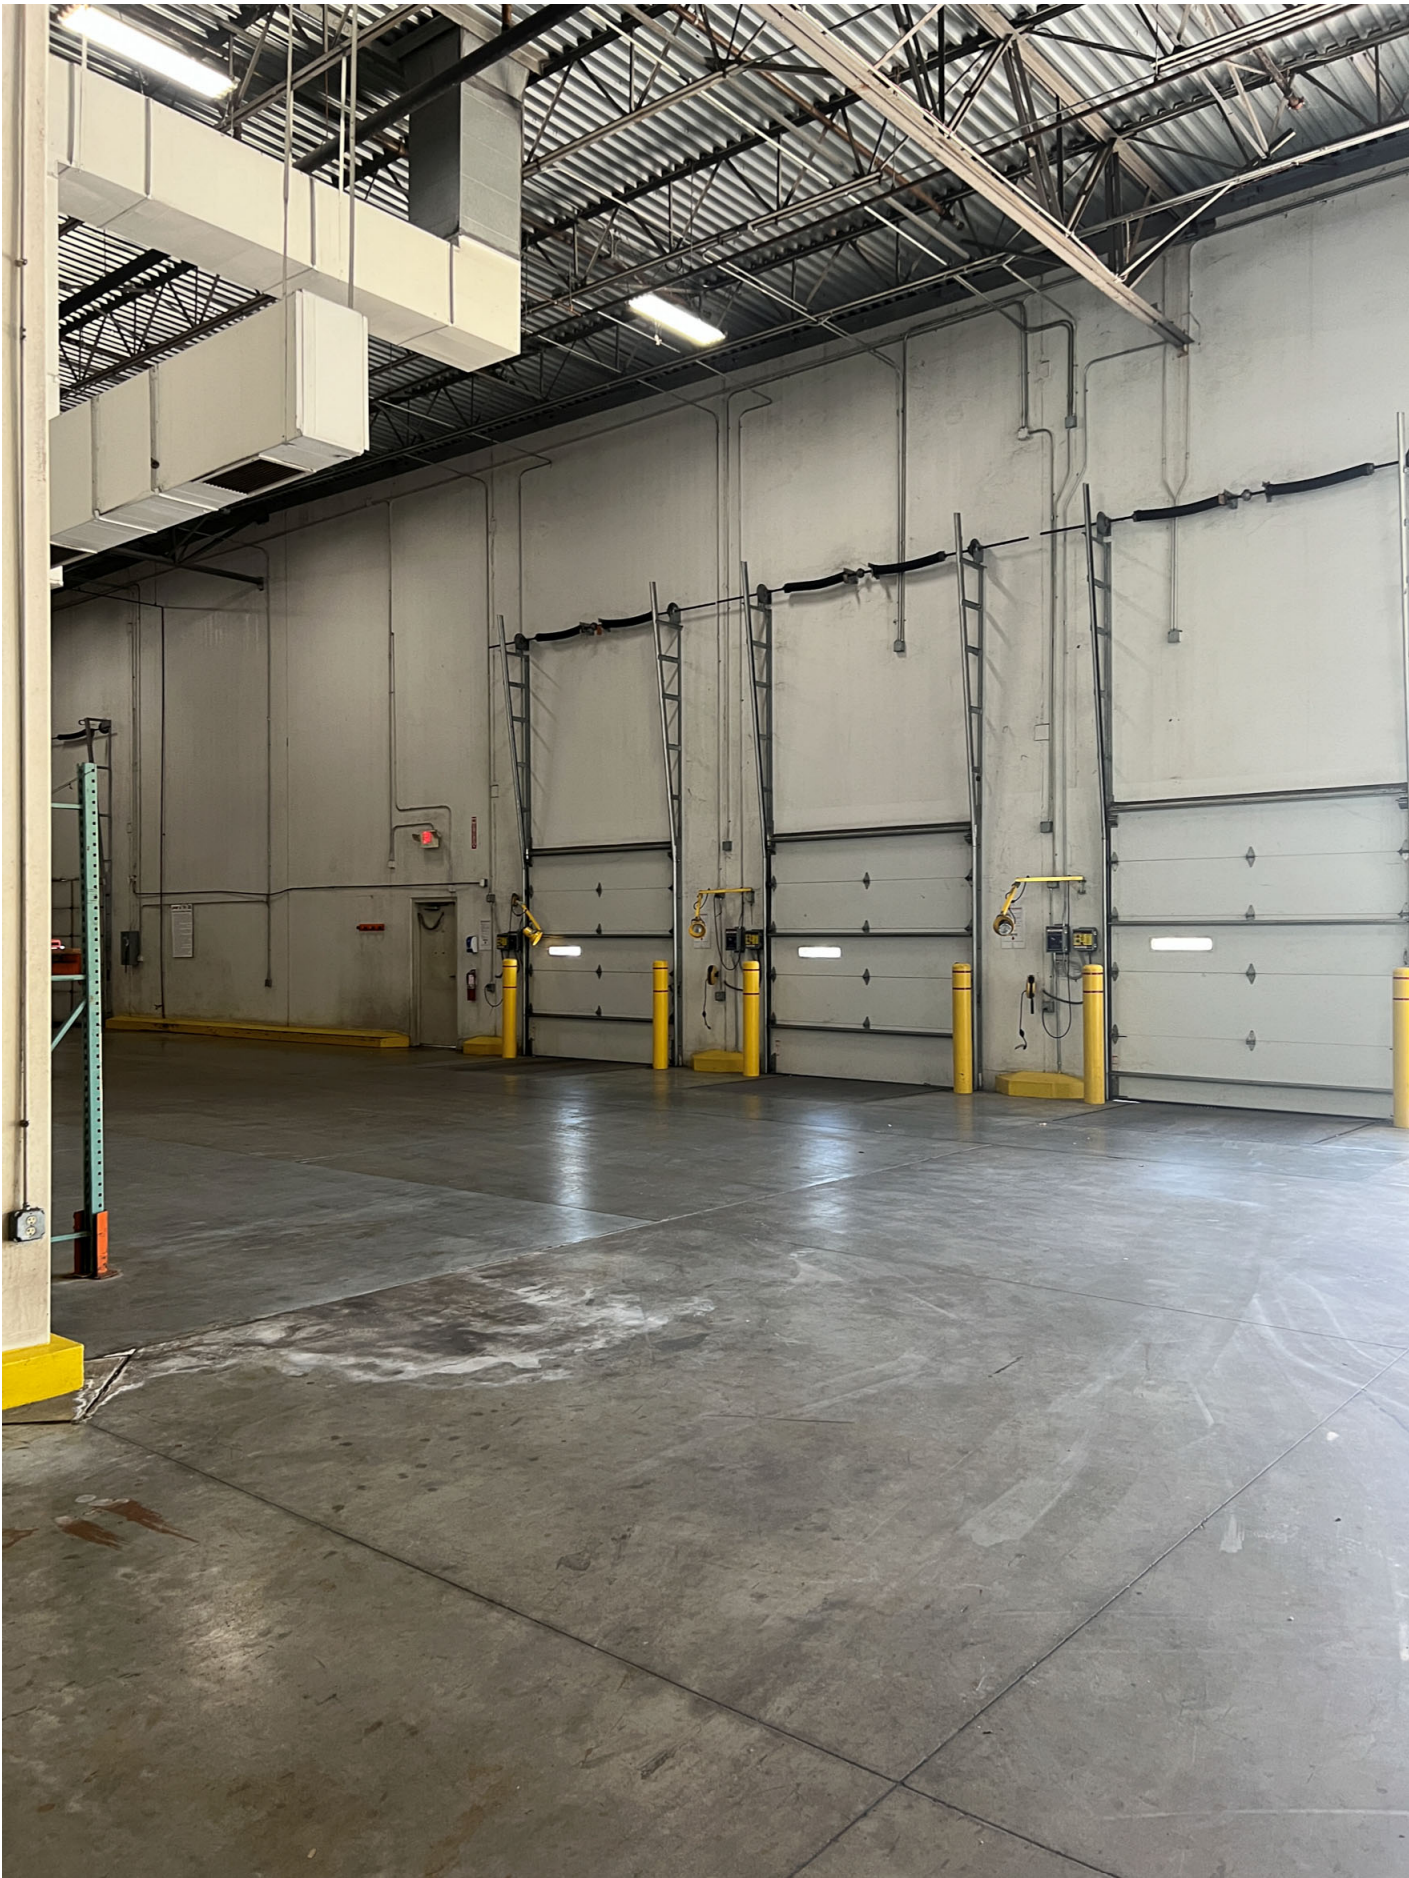
West drive-thru bay with exposed utilities for easy access

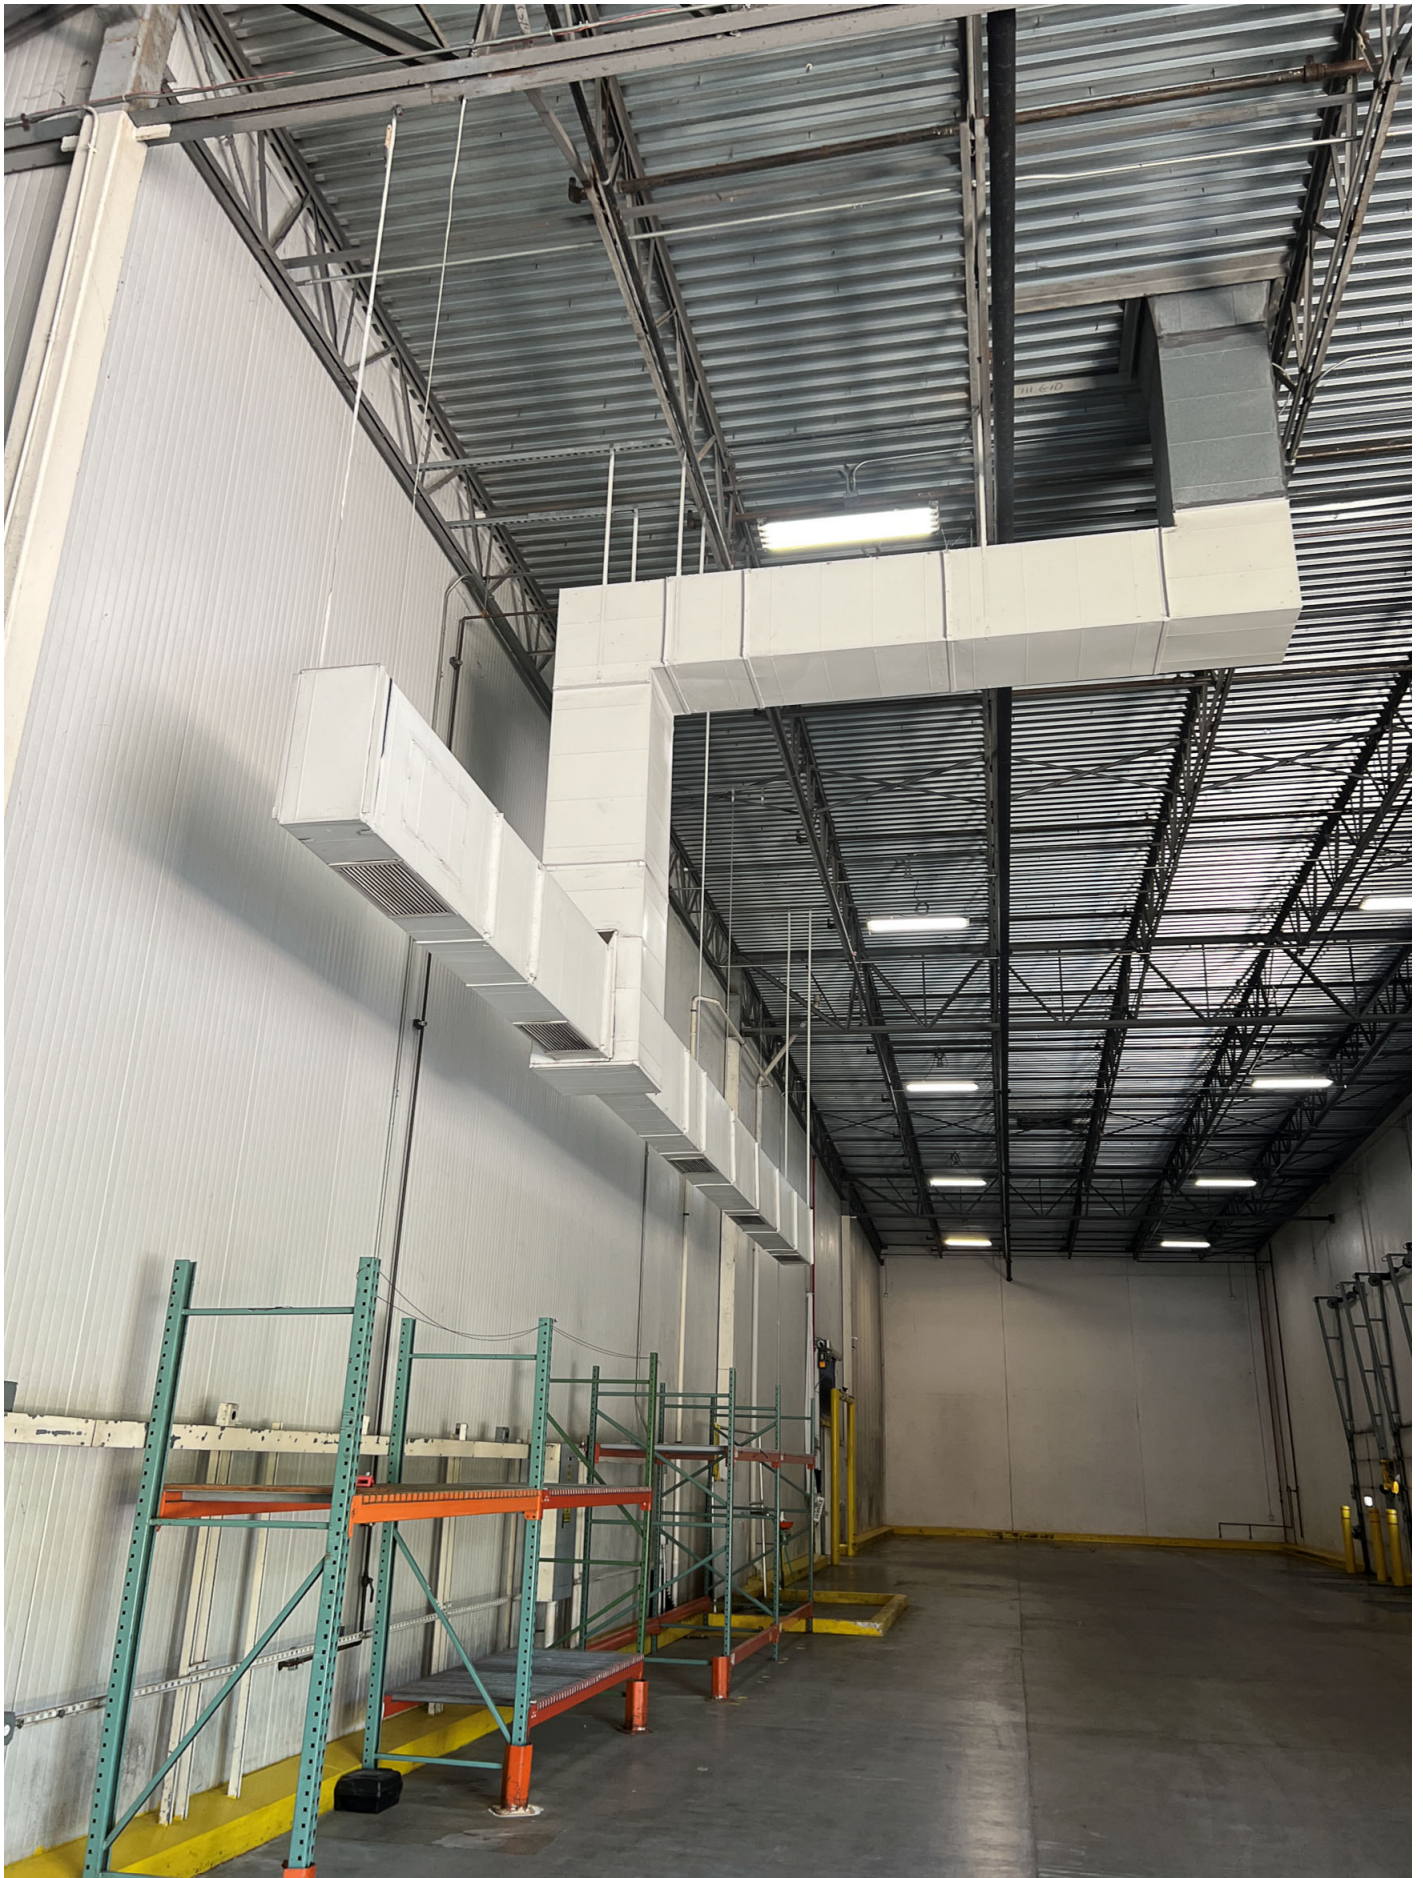
South recessed loading dock service doors

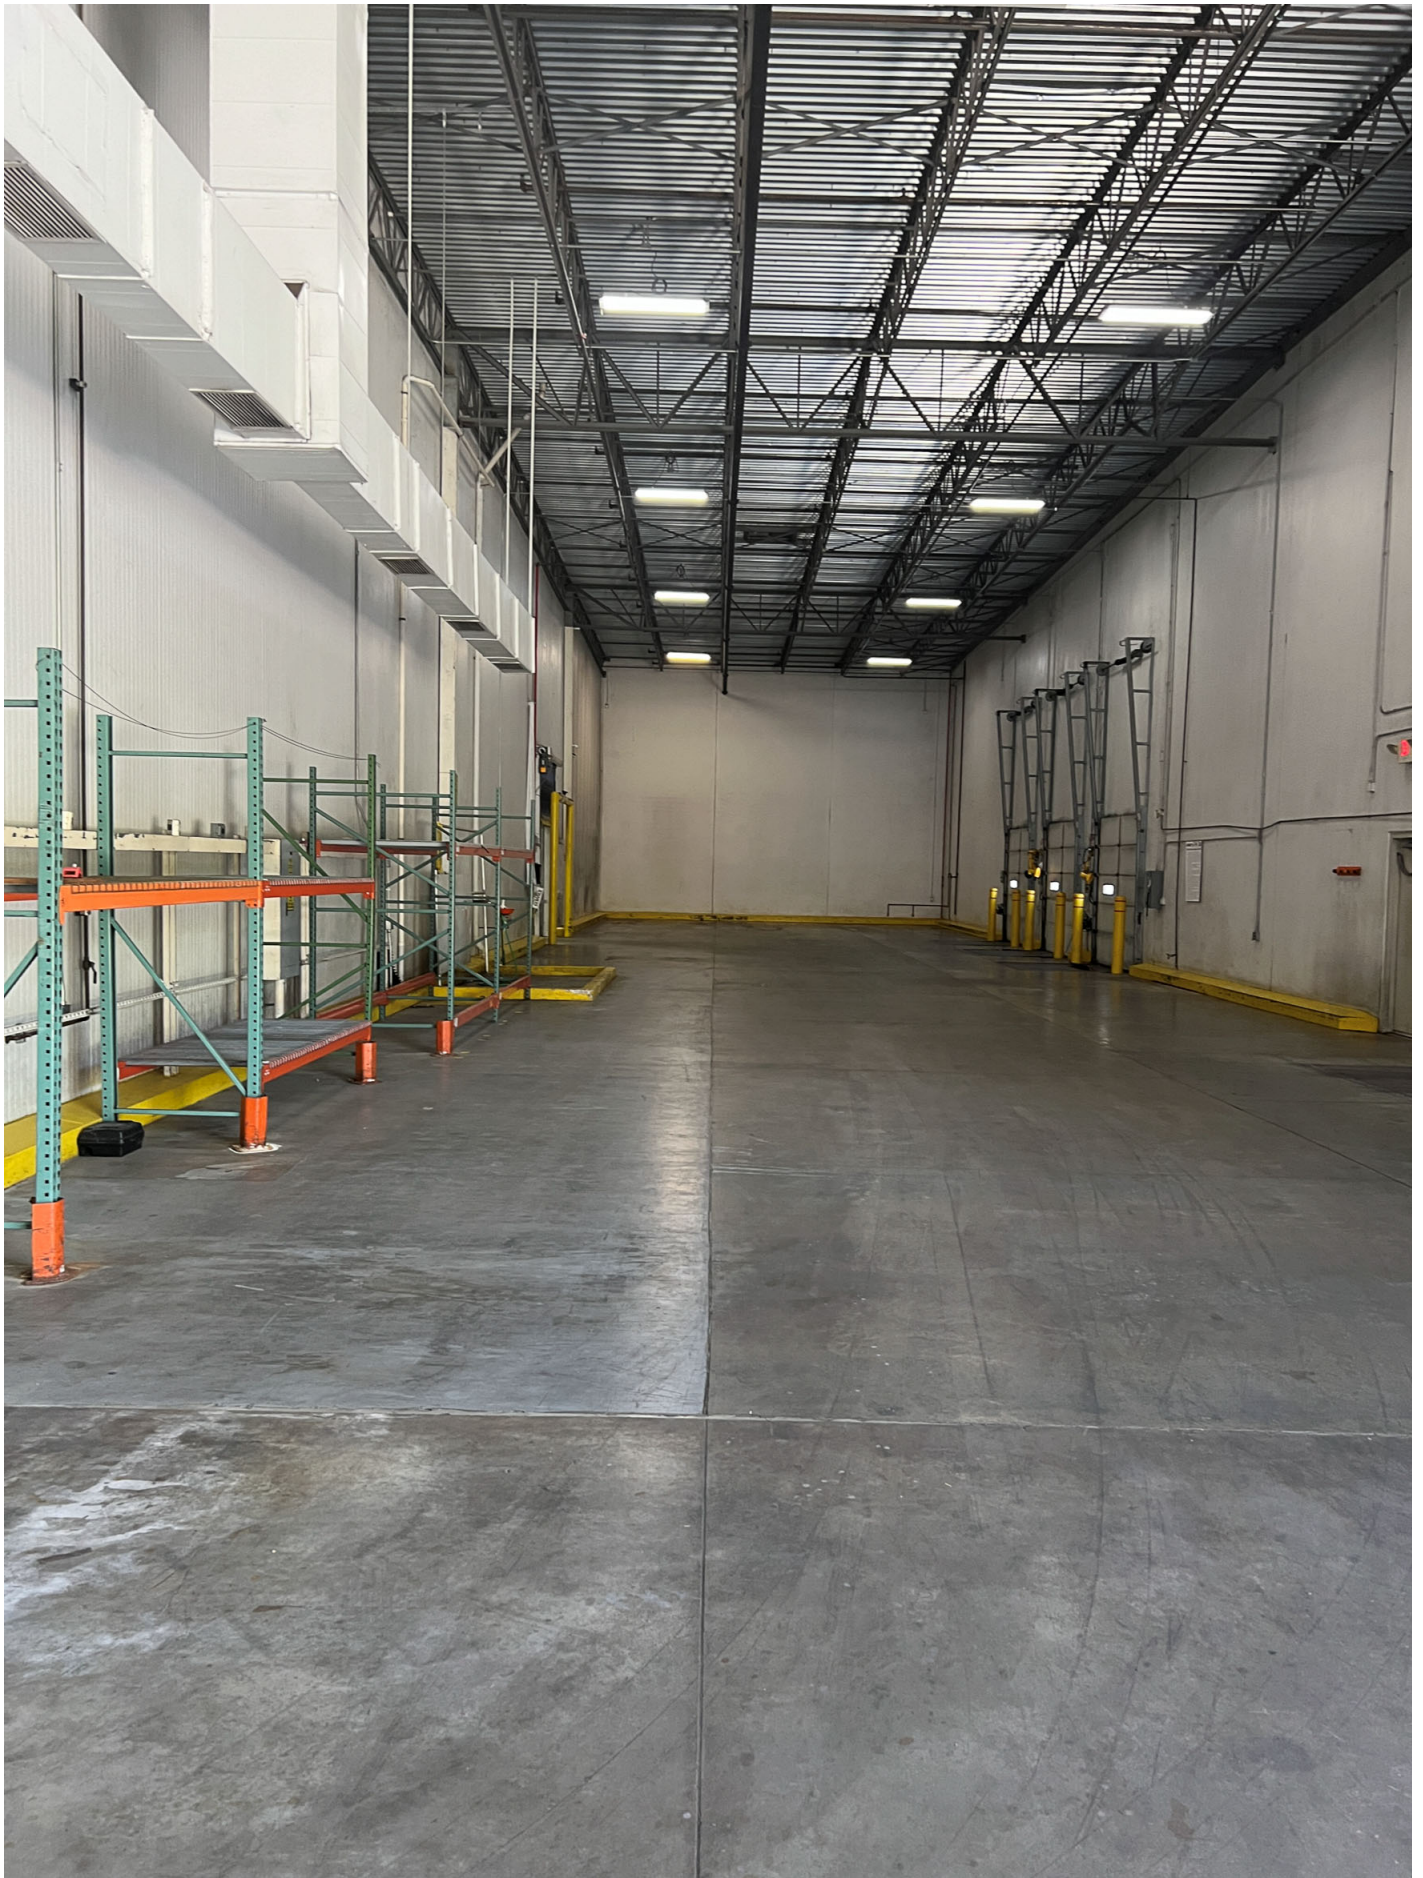
South storage / staging area for service truck loading at recessed loading dock

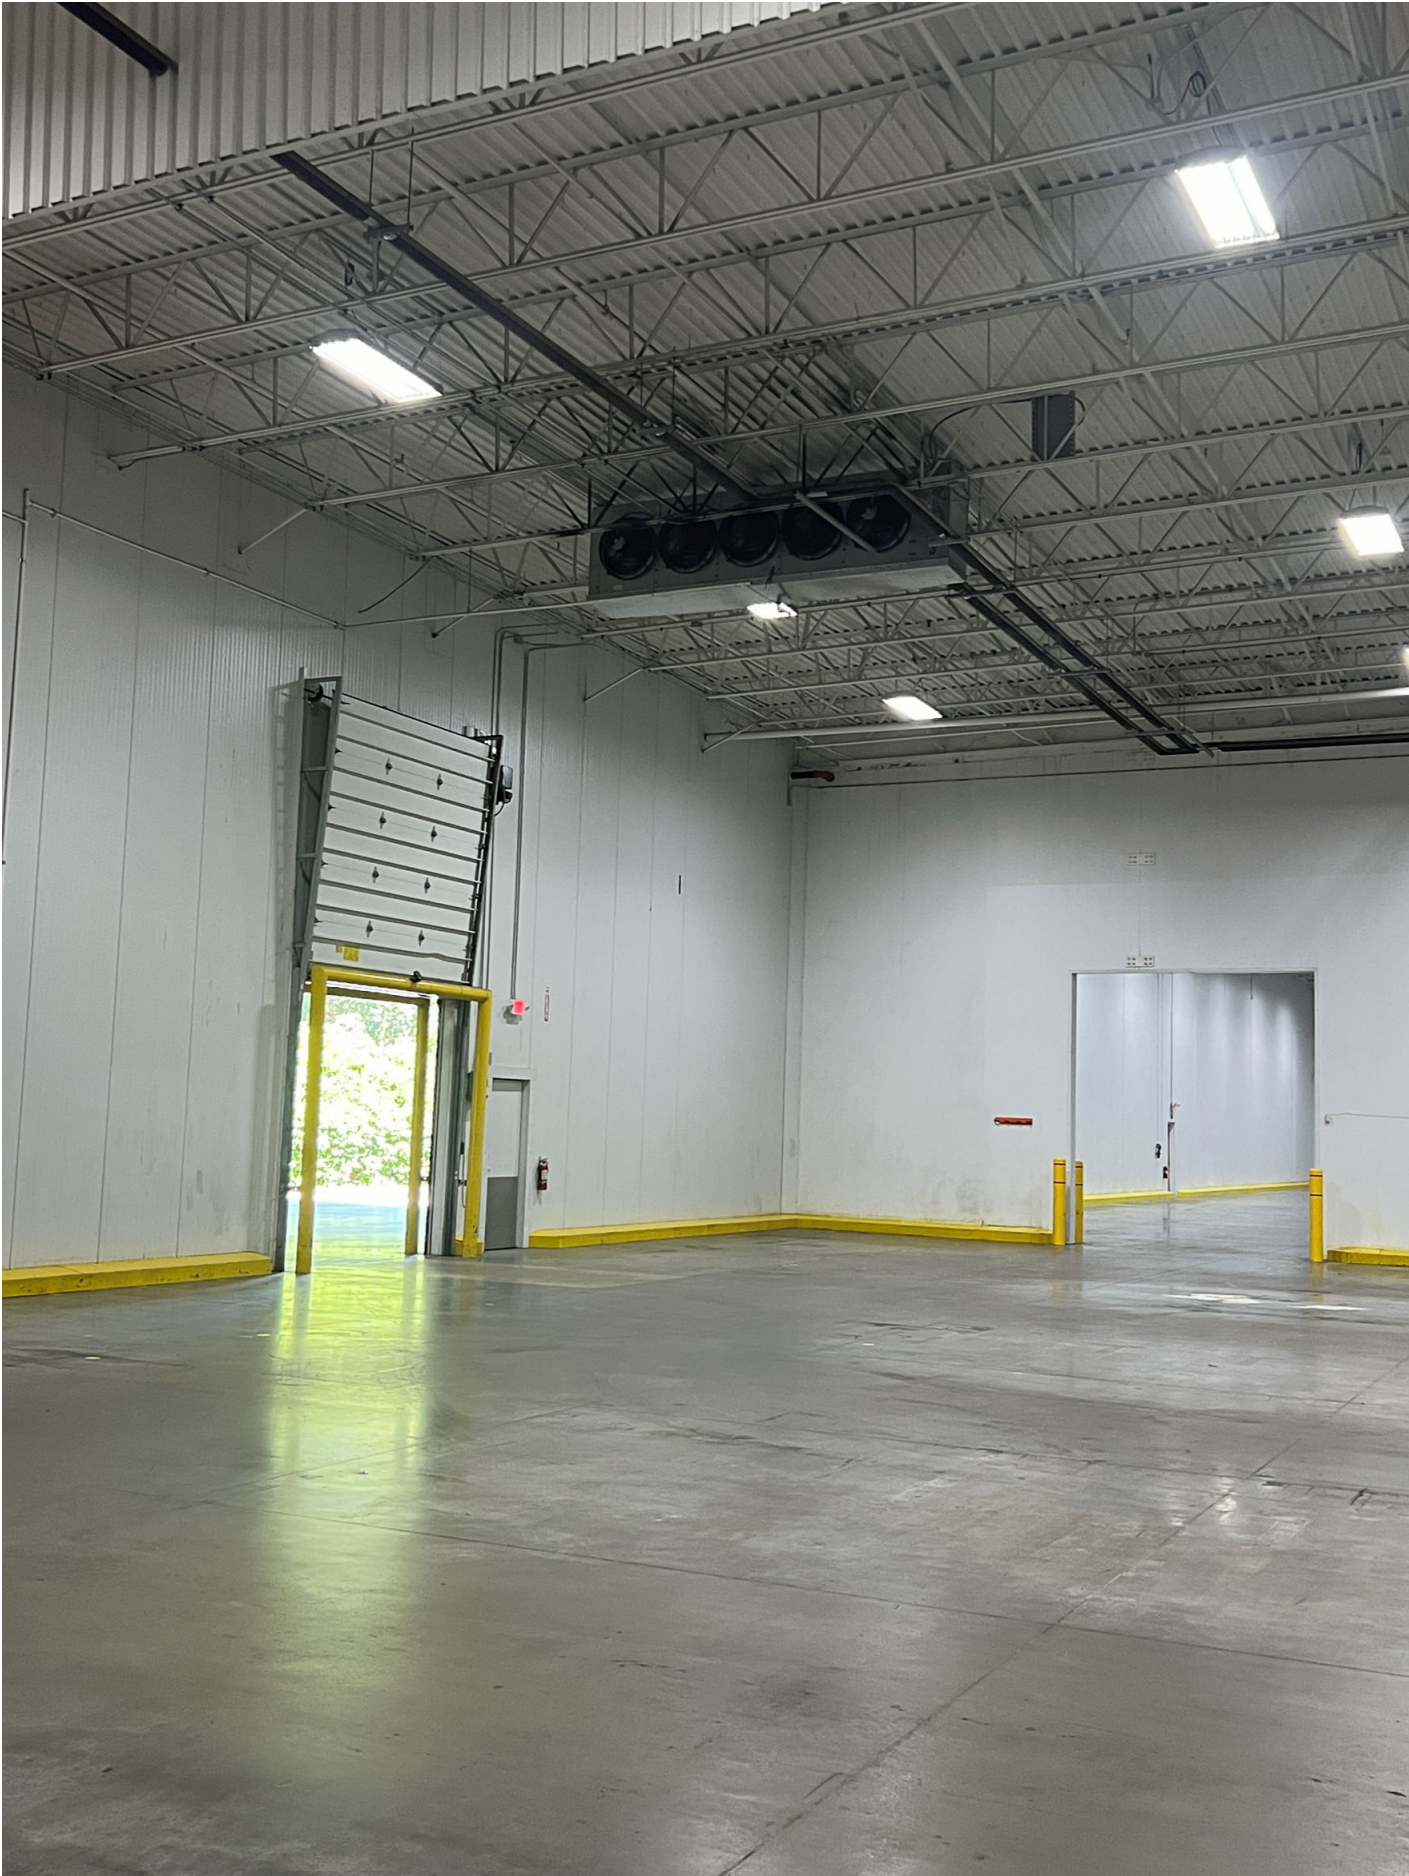
South storage / staging area for service truck loading at recessed loading dock

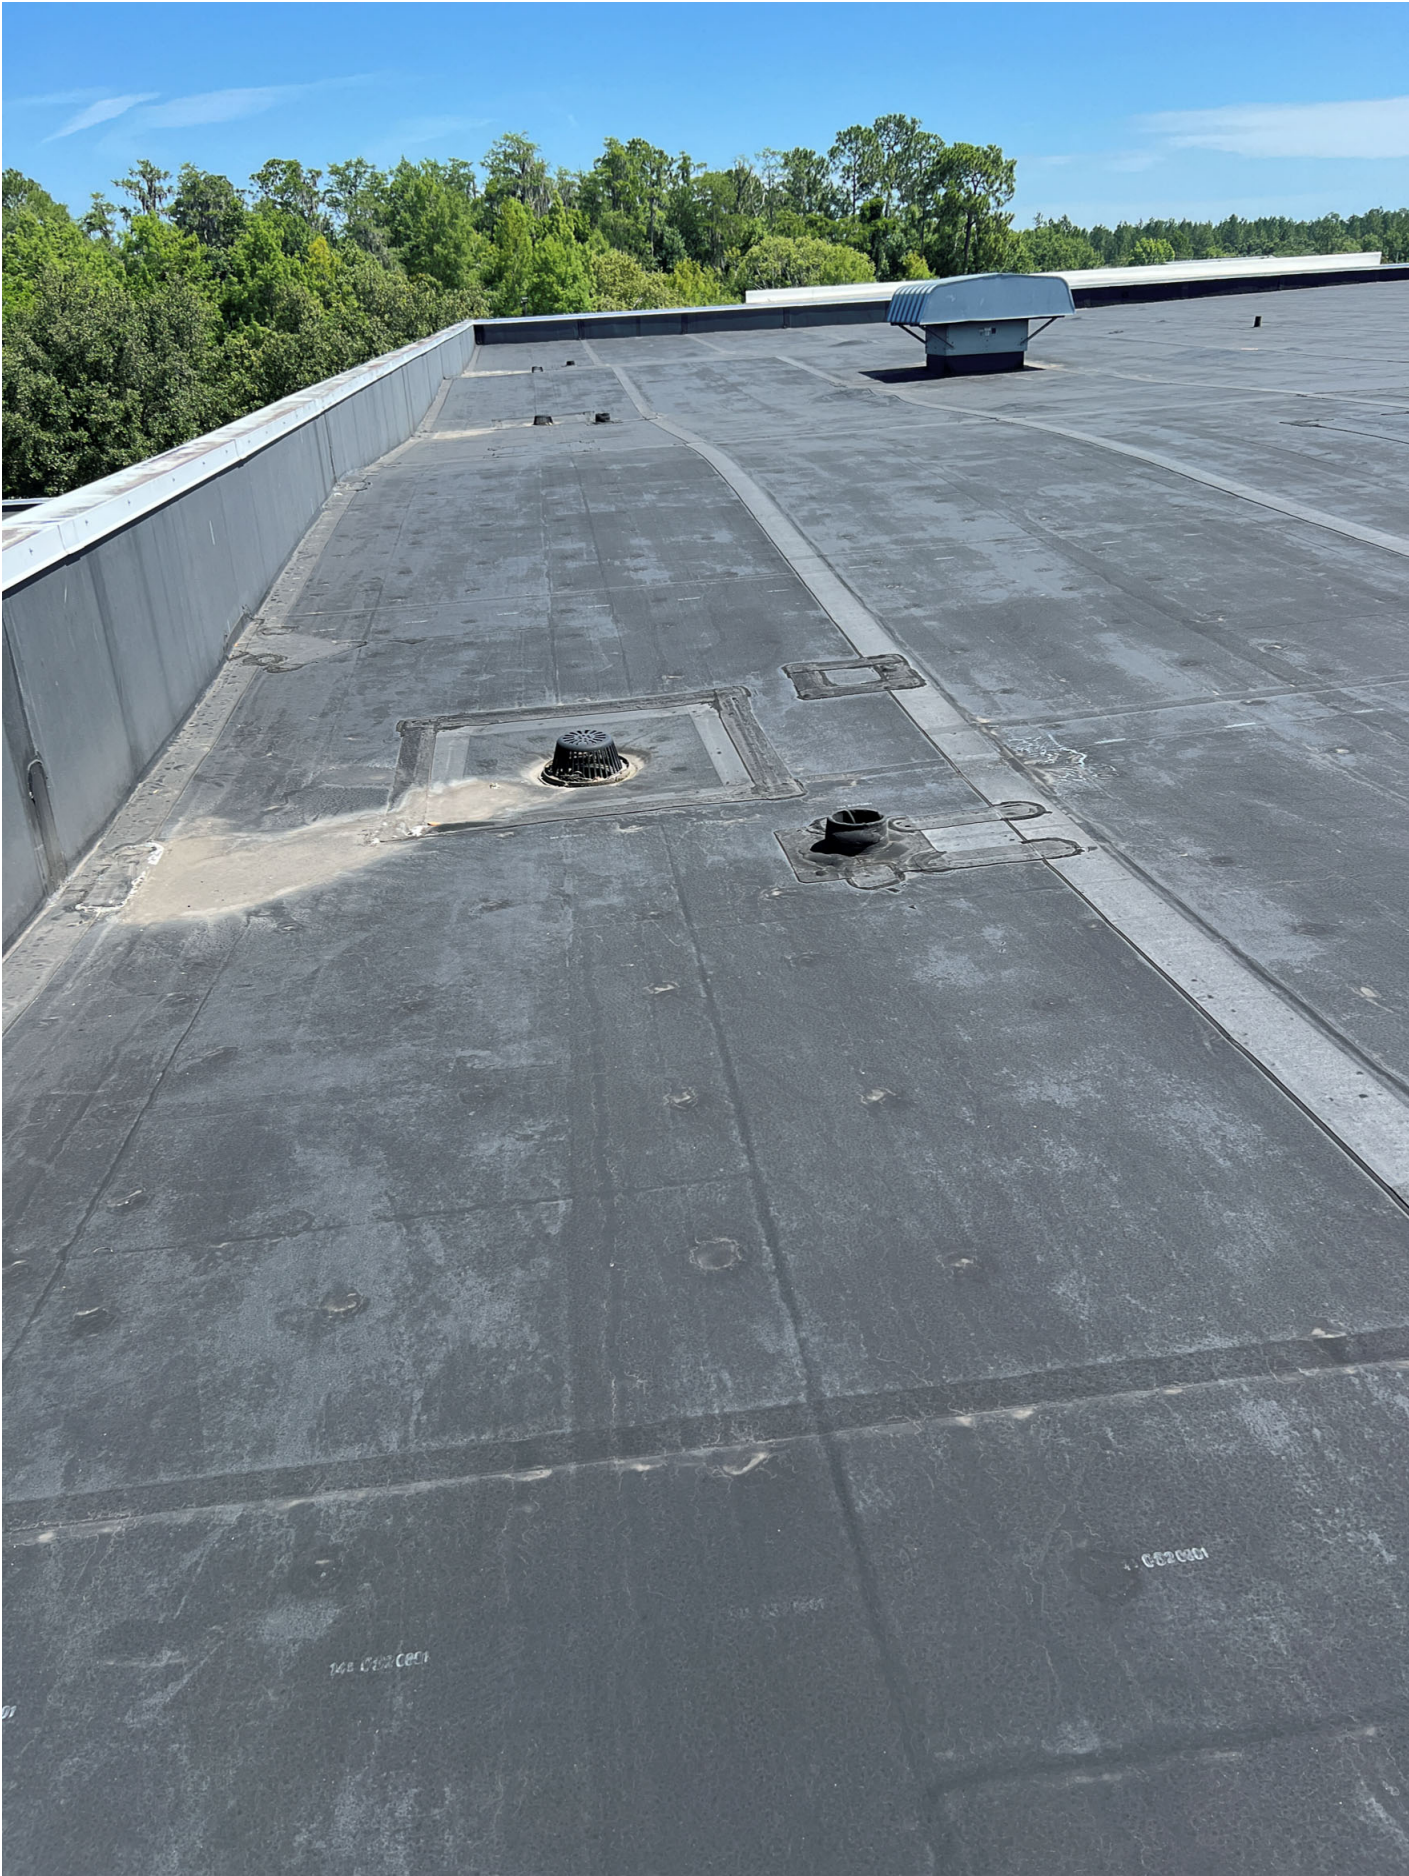
Lower admin roof viewing south large vapor bladders & patching

asphalt paved areas and replacement of the two-roof top A/C units this could be done to minimize daily operation inconvenience once the facility is fully operational. The re-roofing efforts can occur at this time or with substantial patching and repairs the building can gain a little more time out of the 24-year-old roof, but it needs to be pointed out the roof has exceeded any roof warranty issued at the time its installation.

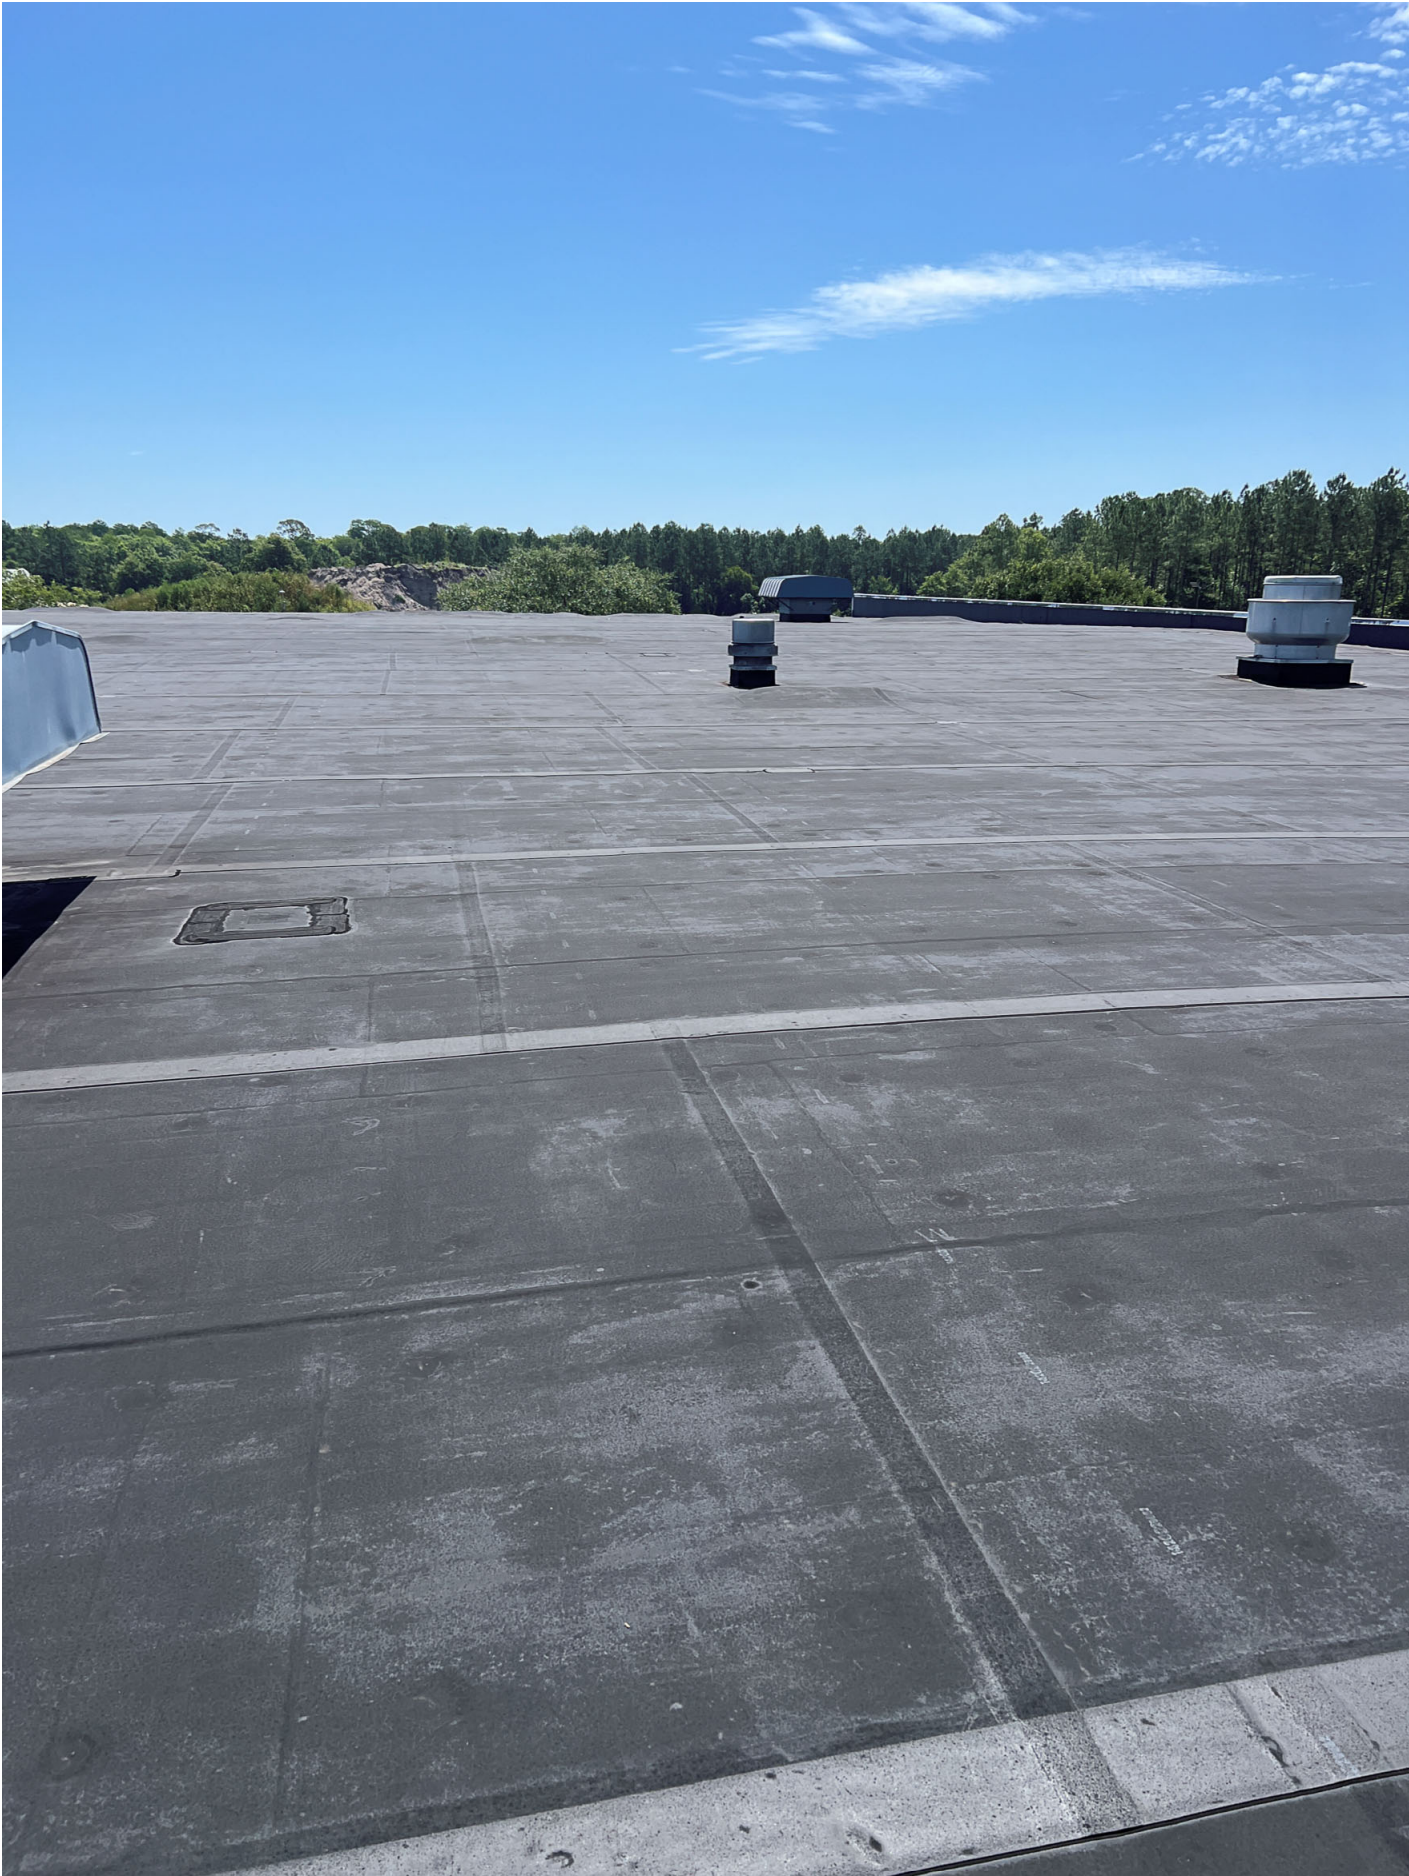
2000 warehouse roof viewing east/ roof exhaust fans / misc. paching / vapor bladders
