RE: Due Diligence Report – Burkhardt Sales & Service

As part of the County's due diligence efforts to evaluate the conditions of the existing commercial industrial warehouse building (Burkhardt Sales & Service) located at 6125 NW 18<sup>th</sup> Drive, Gainesville, FL 32653, Paul Stresing Associates (PSA) was tasked with conducting an inspection of the facility to evaluate its condition prior to entering into a full purchase agreement to its purchase. On May 30, 2024, I was accompanied by KPI Engineering (KPI) where we walked the roof and interior of the facility with Mr. Matt Fultz of the Alachua County Facilities Department and Mr. Daniel Burkhardt, representing the seller where we gained access to the site and buildings to begin our evaluation efforts.

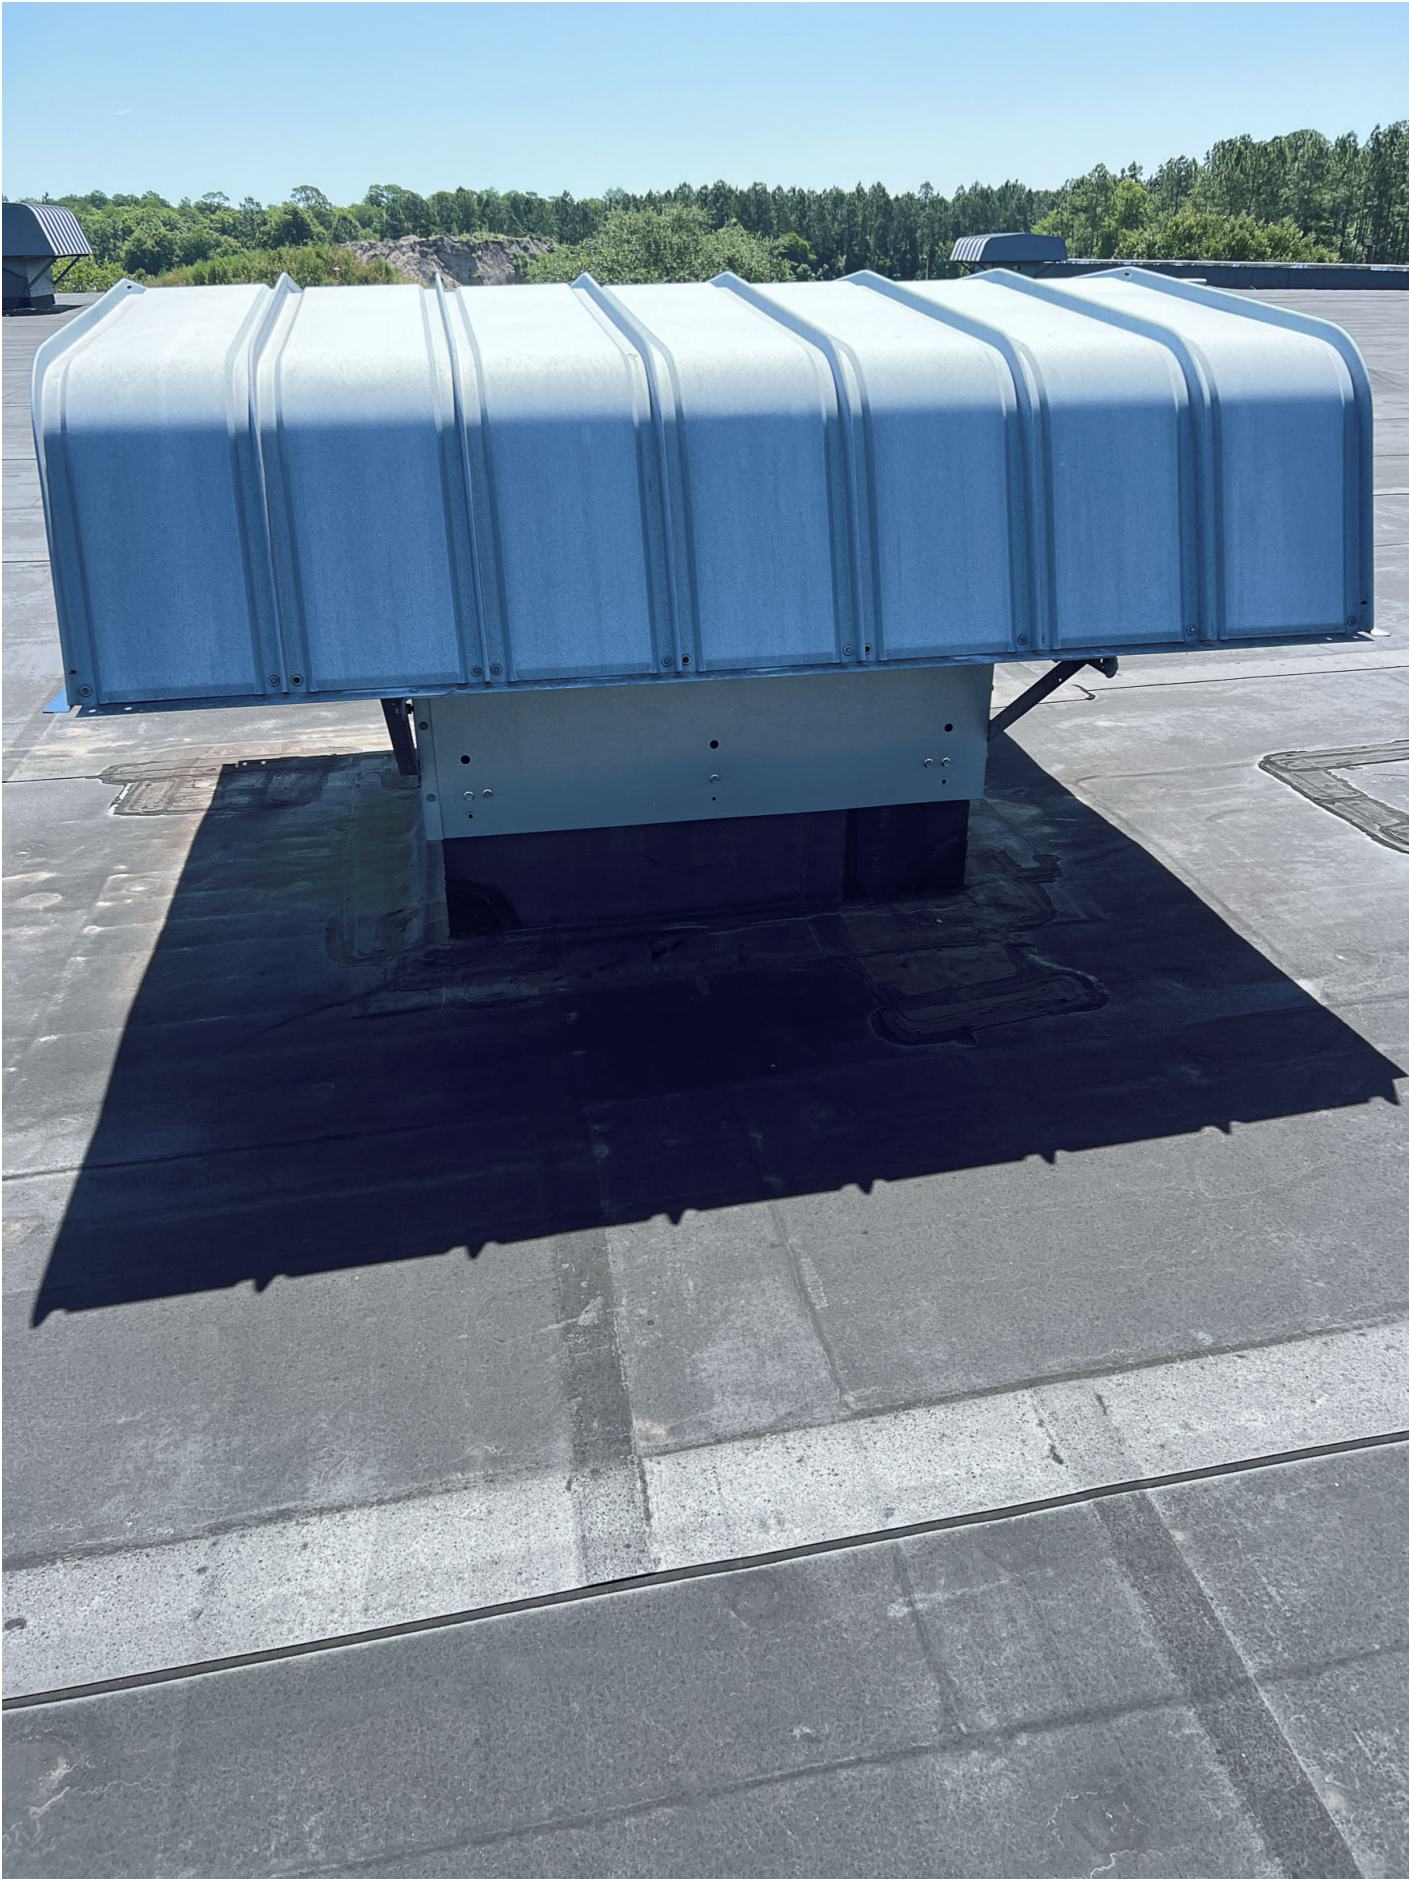
2000 warehouse roof with exhaust fan hoods

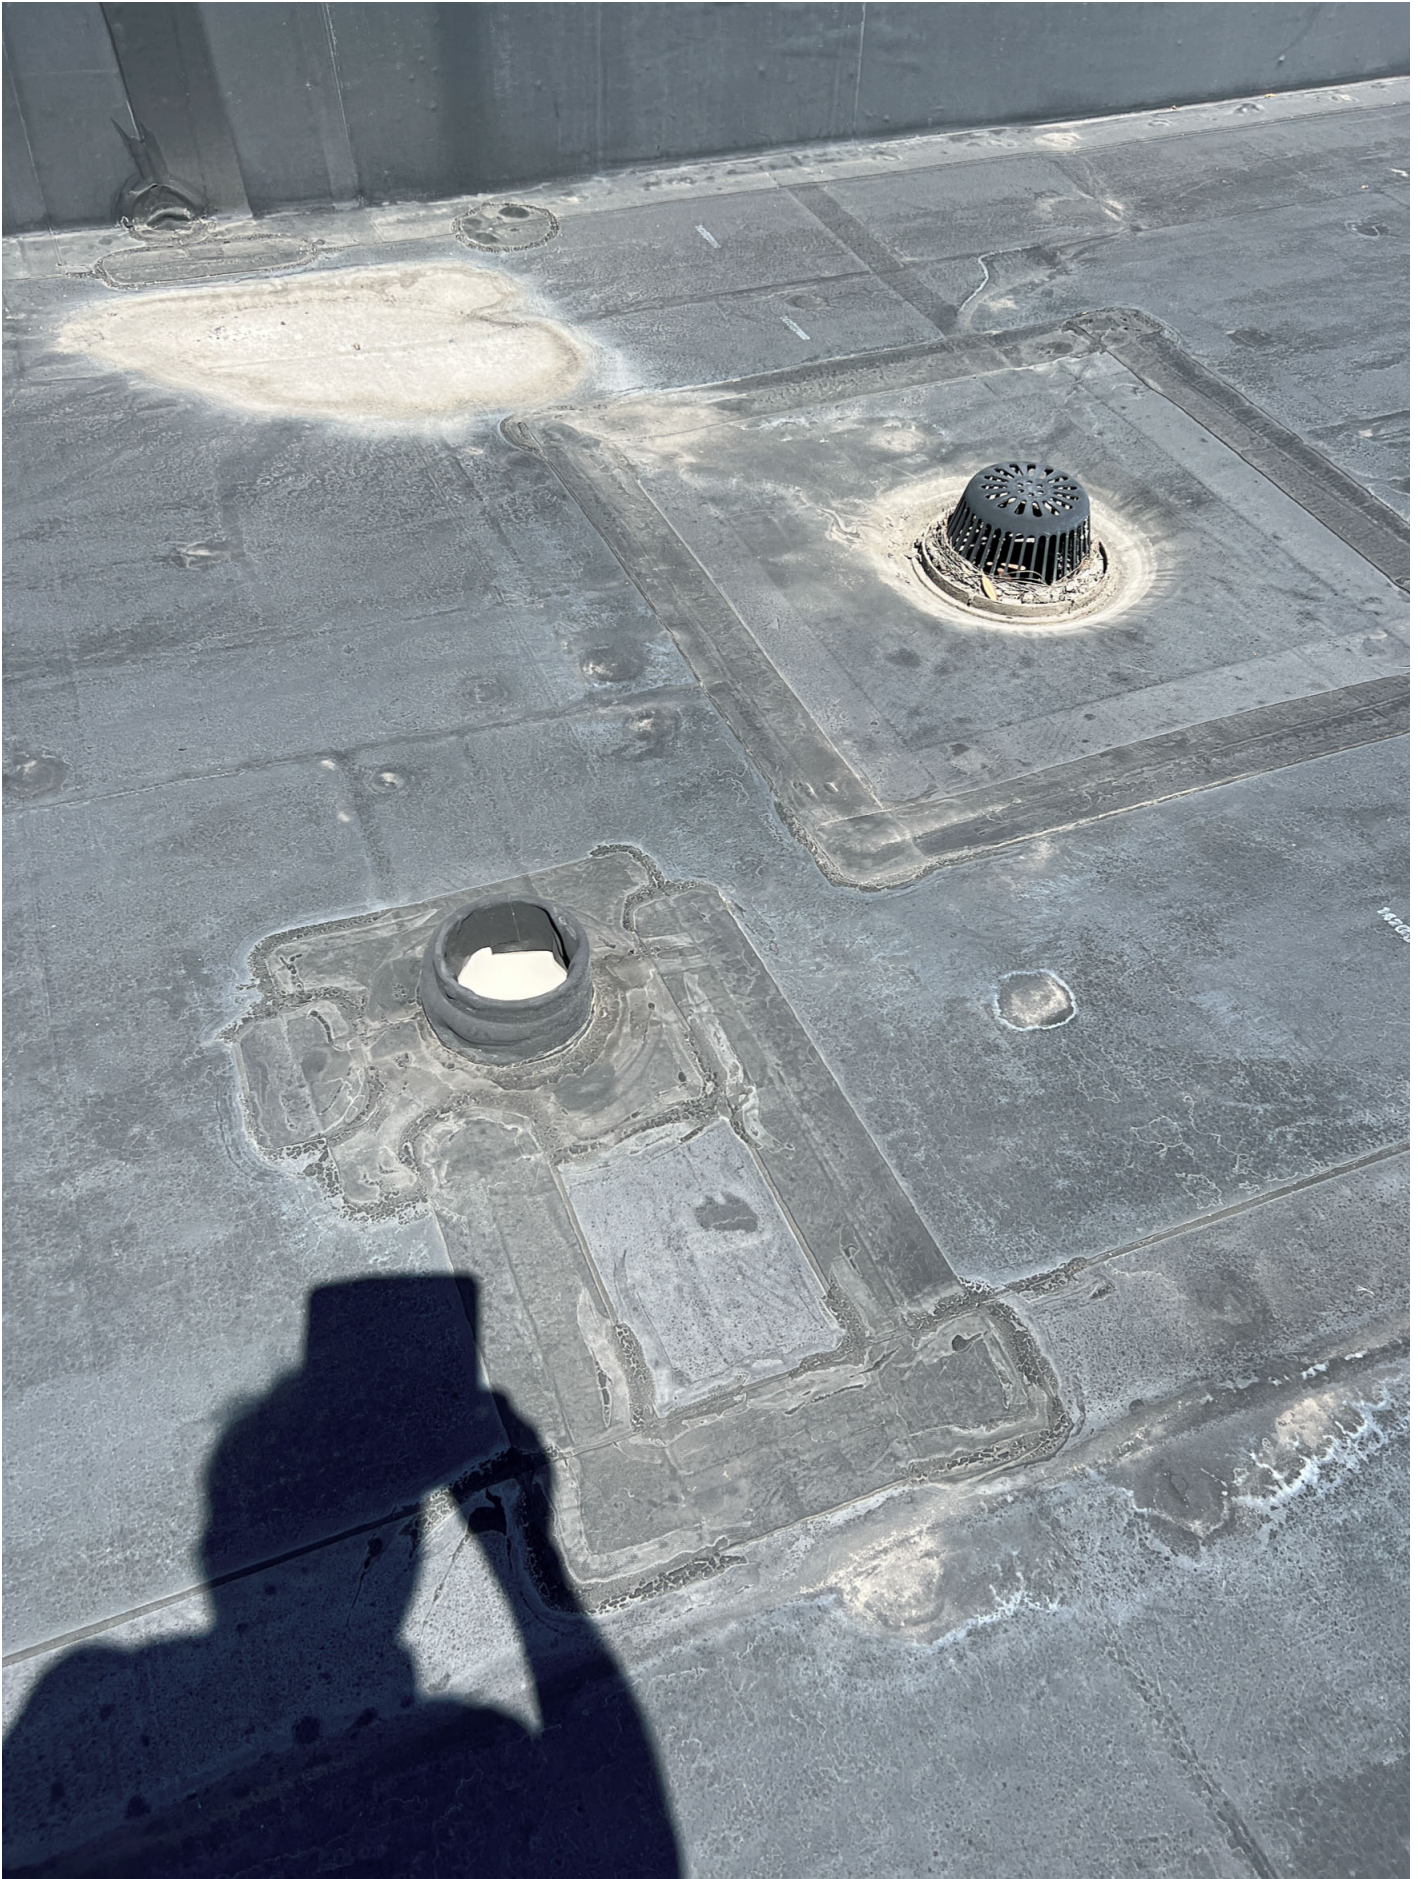
2000 warehouse roof west roof area adjacent to lower admin roof / roof drain & emergency o

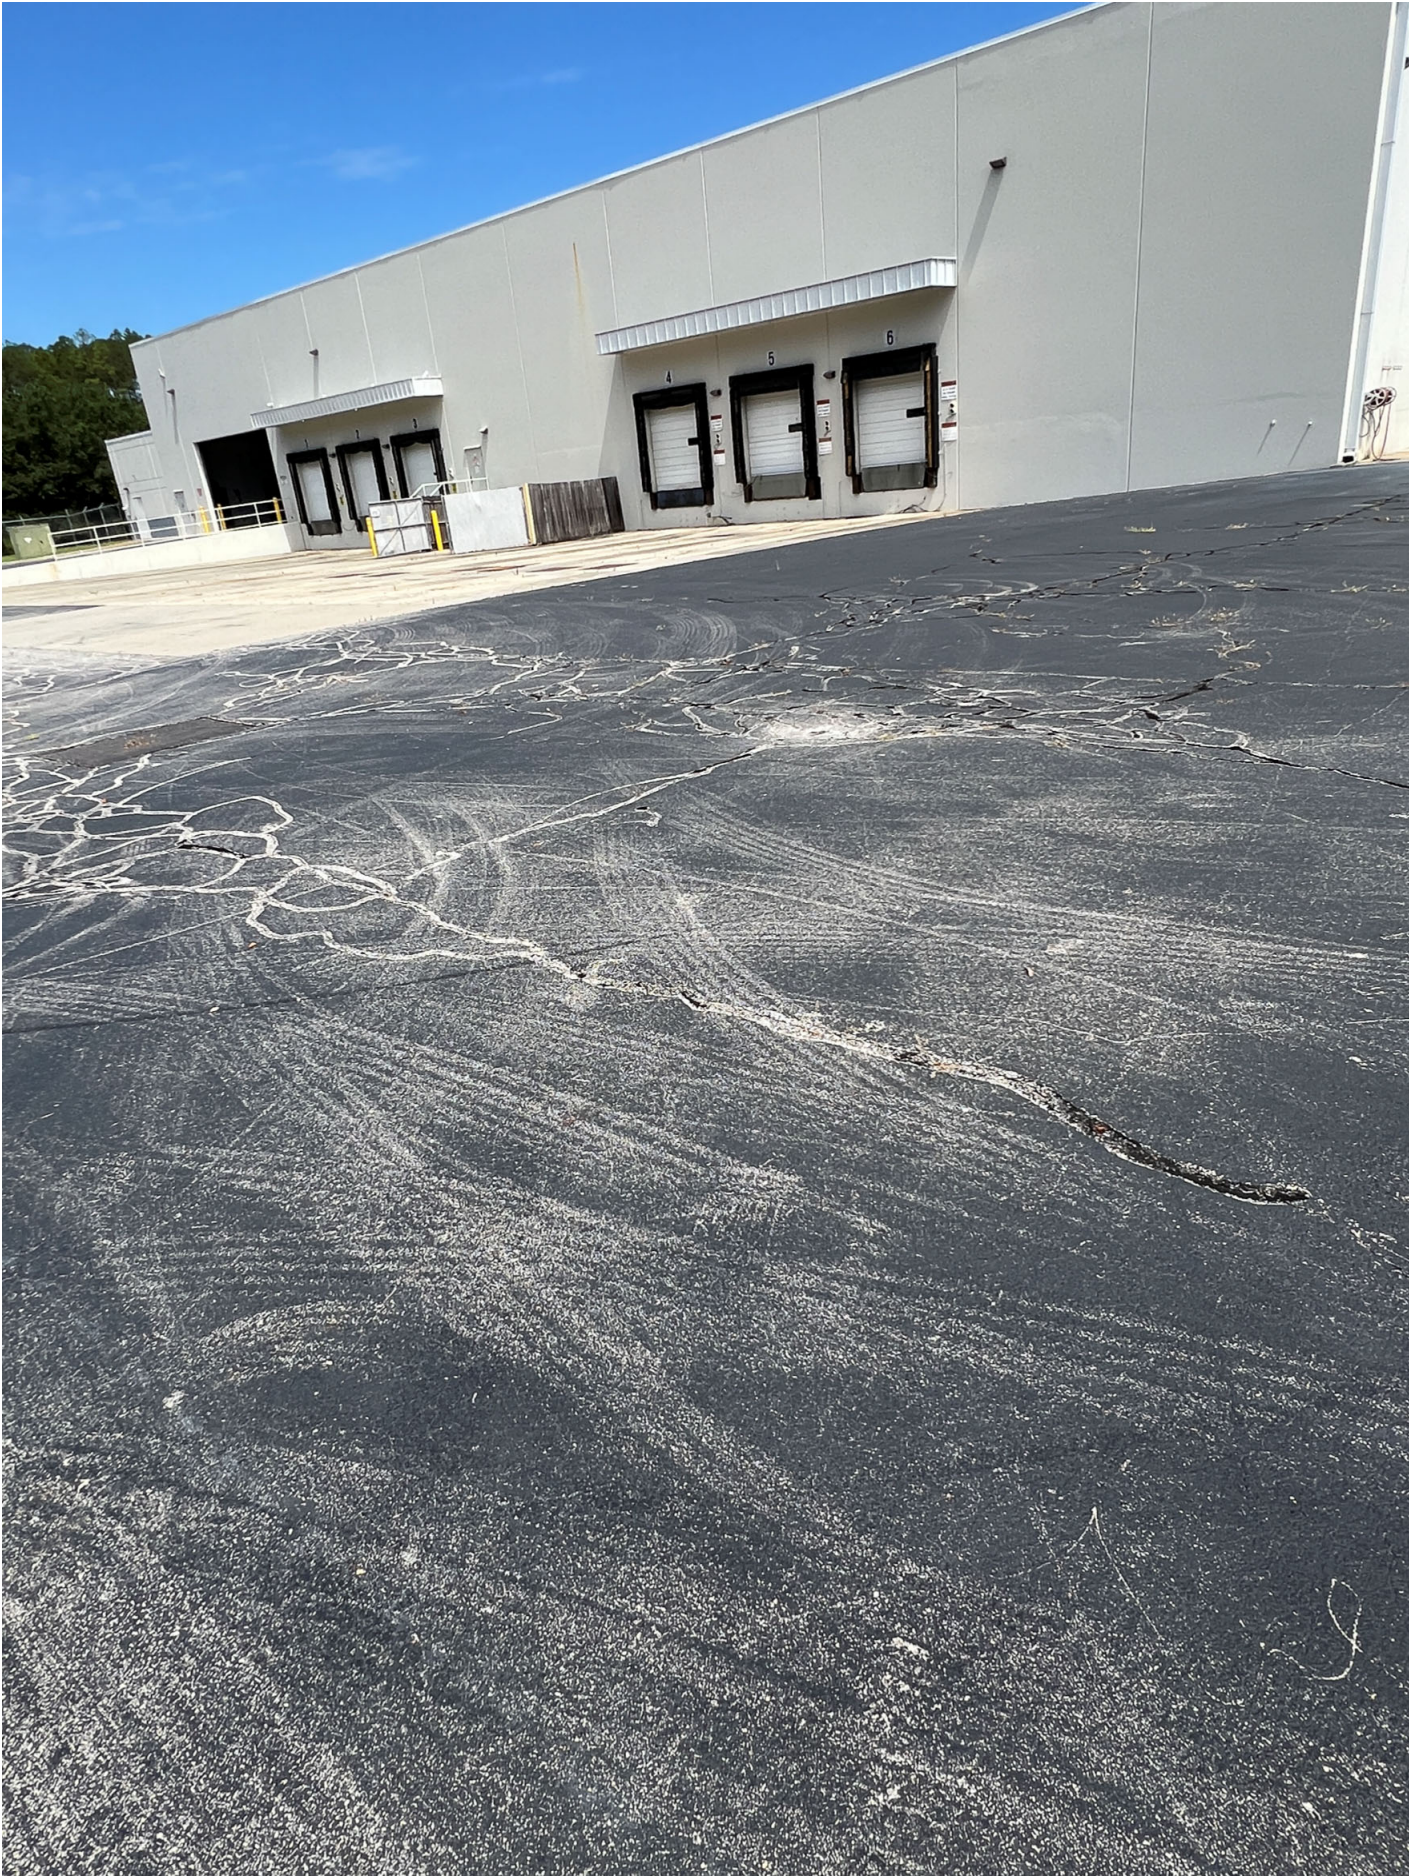
Southeast asphalt paved area requiring maintenance

In conclusion, the building is in very good general shape and there are no signs of structural concerns or compromises, three items do need to be addressed within the near future, the replacement of two of the A/C units on the lower administration roof will be required in the near future, the re-roofing of the original 2000 building should be considered to preserve the condition of the insulation and metal roof framing and interior finishes. Because of the amount of roof top equipment located on the lower roof area I would recommend a two-ply roof system to minimize exposure to tears and punctures. The upper roof of the warehouse does have exhaust fans which do not really require the maintenance that A/C equipment does so the exposure to damage is lessened, and you could go back with a white fleece back PTO product. The 2011 warehouse addition is capped with a single-ply TPO type membrane and was found to be in reasonably good shape and has a number of additional years of performance in it so this area could wait a few years before being re-roofed or you could decide to simply use this time to re-roof the entire building and get a single building roof warranty. The asphalt heavy duty truck paving requires maintenance that I would do immediately to ensure the subgrade and paving base do not become compromised.
