June 26, 2024

Subject: Summary Report of a Limited Structural Assessment  
**Sunrise Residence Inn**  
Gainesville, Alachua County, Florida  
GSE Project No. 16612

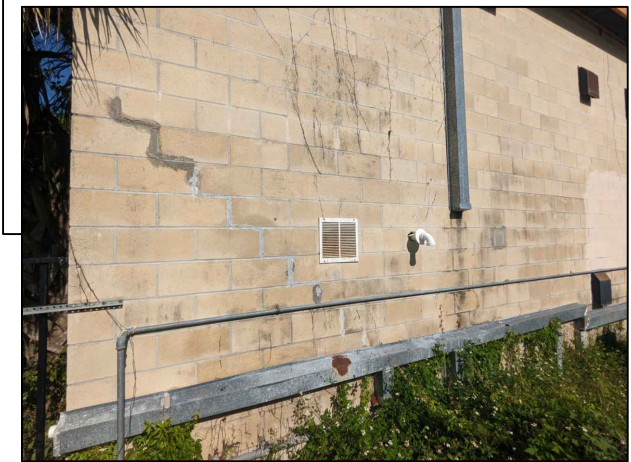
FIGURE  
 2A

It is GSE's opinion that the CMU walls overall are in good condition. Cracking damage observed in the exterior CMU walls of both structures is not a structural concern. Most of the cracks in the exterior CMU walls are attributed to differential movement resulting from long-term post-construction settlement of the soils supporting the foundation. The differential settlement is consistent with foundation settlement that is within an expected range for the type and age of construction. Various factors influence actual post-construction differential settlement including lack of adequate compaction, disturbance of the foundation supporting soils during construction, surface water diversion, foundation embedment, and erosion. GSE recommends patching/filling all cracks larger than 1/16 inch and repainting the exterior CMU walls with an elastomeric paint system.

The oxidation, rusting, and cracking damage observed within the walkways is a structural concern. At the time of the assessment, much of the support framing for the walkways and the underside of the concrete slabs were covered and could not be properly inspected. It is GSE's professional opinion that all framing and the underside of walkway slabs be uncovered, all oxidation/rust removed, and members cleaned to determine the extent of damage to the walkway support framing and concrete slab. This should be done immediately, or shoring added mid-way between columns prior to a full inspection.
