RE: Due Diligence Report – Burkhardt Sales & Service

As part of the County's due diligence efforts to evaluate the conditions of the existing commercial industrial warehouse building (Burkhardt Sales & Service) located at 6125 NW 18<sup>th</sup> Drive, Gainesville, FL 32653, Paul Stresing Associates (PSA) was tasked with conducting an inspection of the facility to evaluate its condition prior to entering into a full purchase agreement to its purchase. On May 30, 2024, I was accompanied by KPI Engineering (KPI) where we walked the roof and interior of the facility with Mr. Matt Fultz of the Alachua County Facilities Department and Mr. Daniel Burkhardt, representing the seller where we gained access to the site and buildings to begin our evaluation efforts.

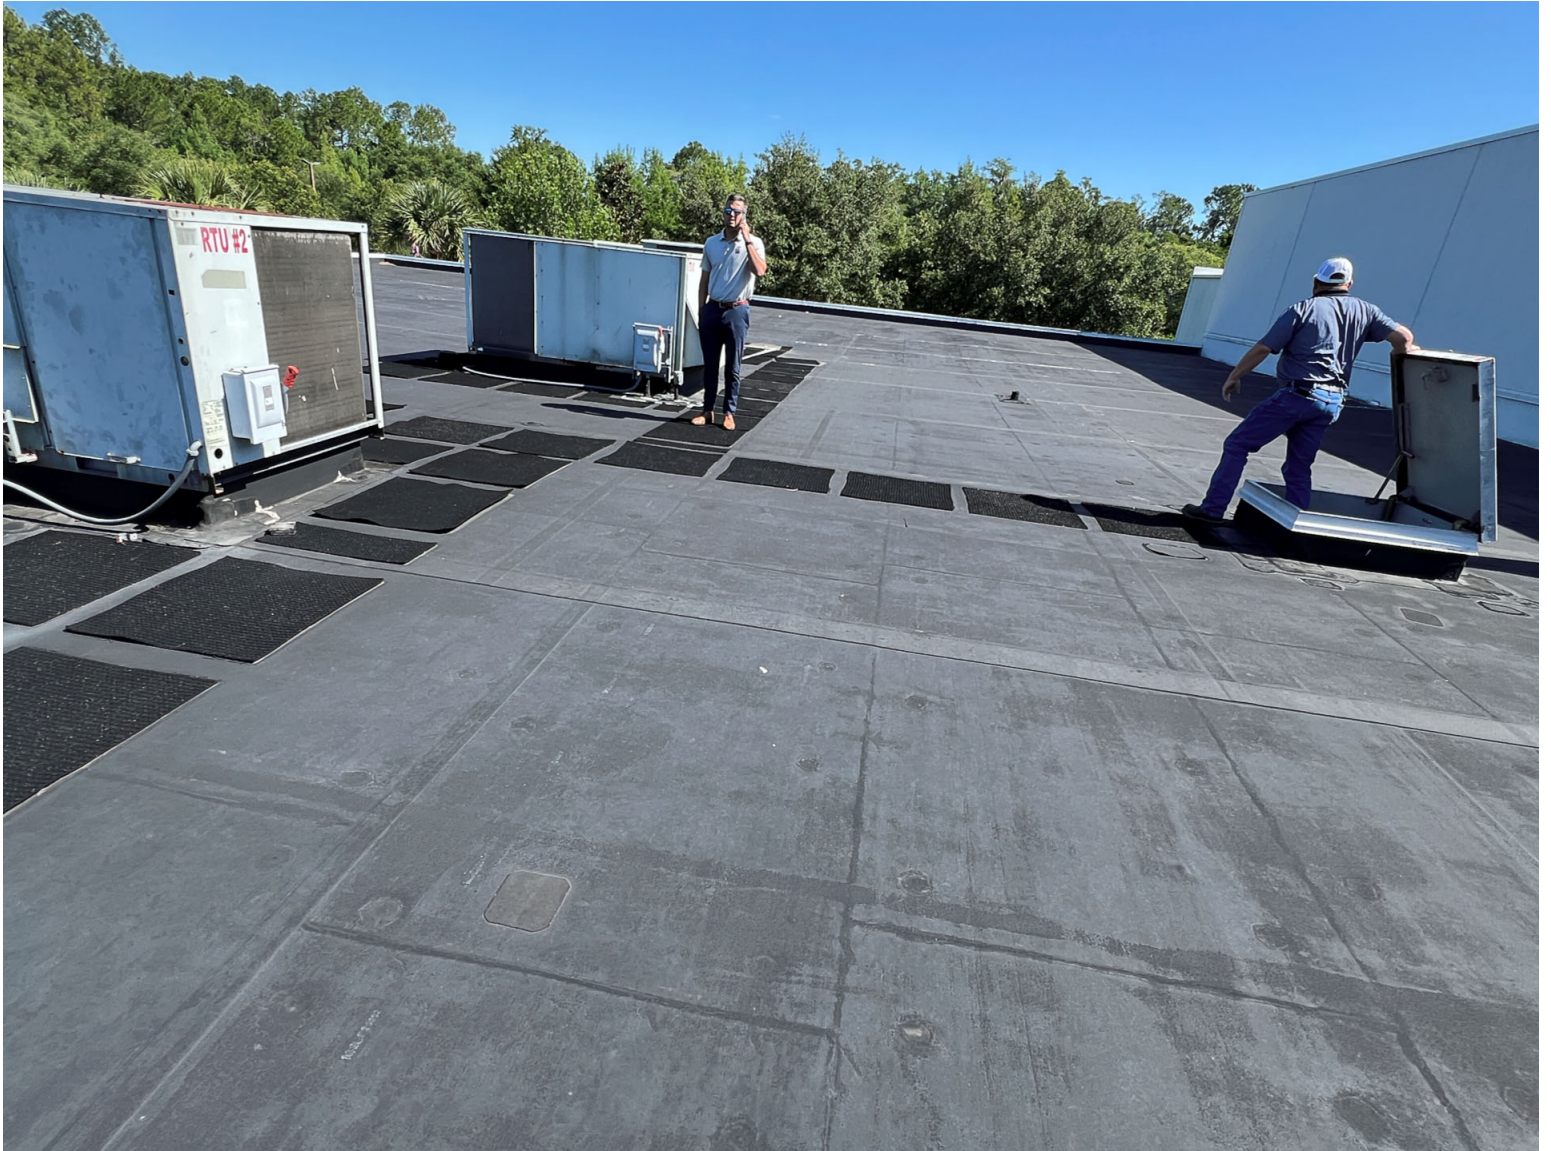
Admin area (lower) roof single-ply EPDM membrane - Roof access hatch & A/C configuration

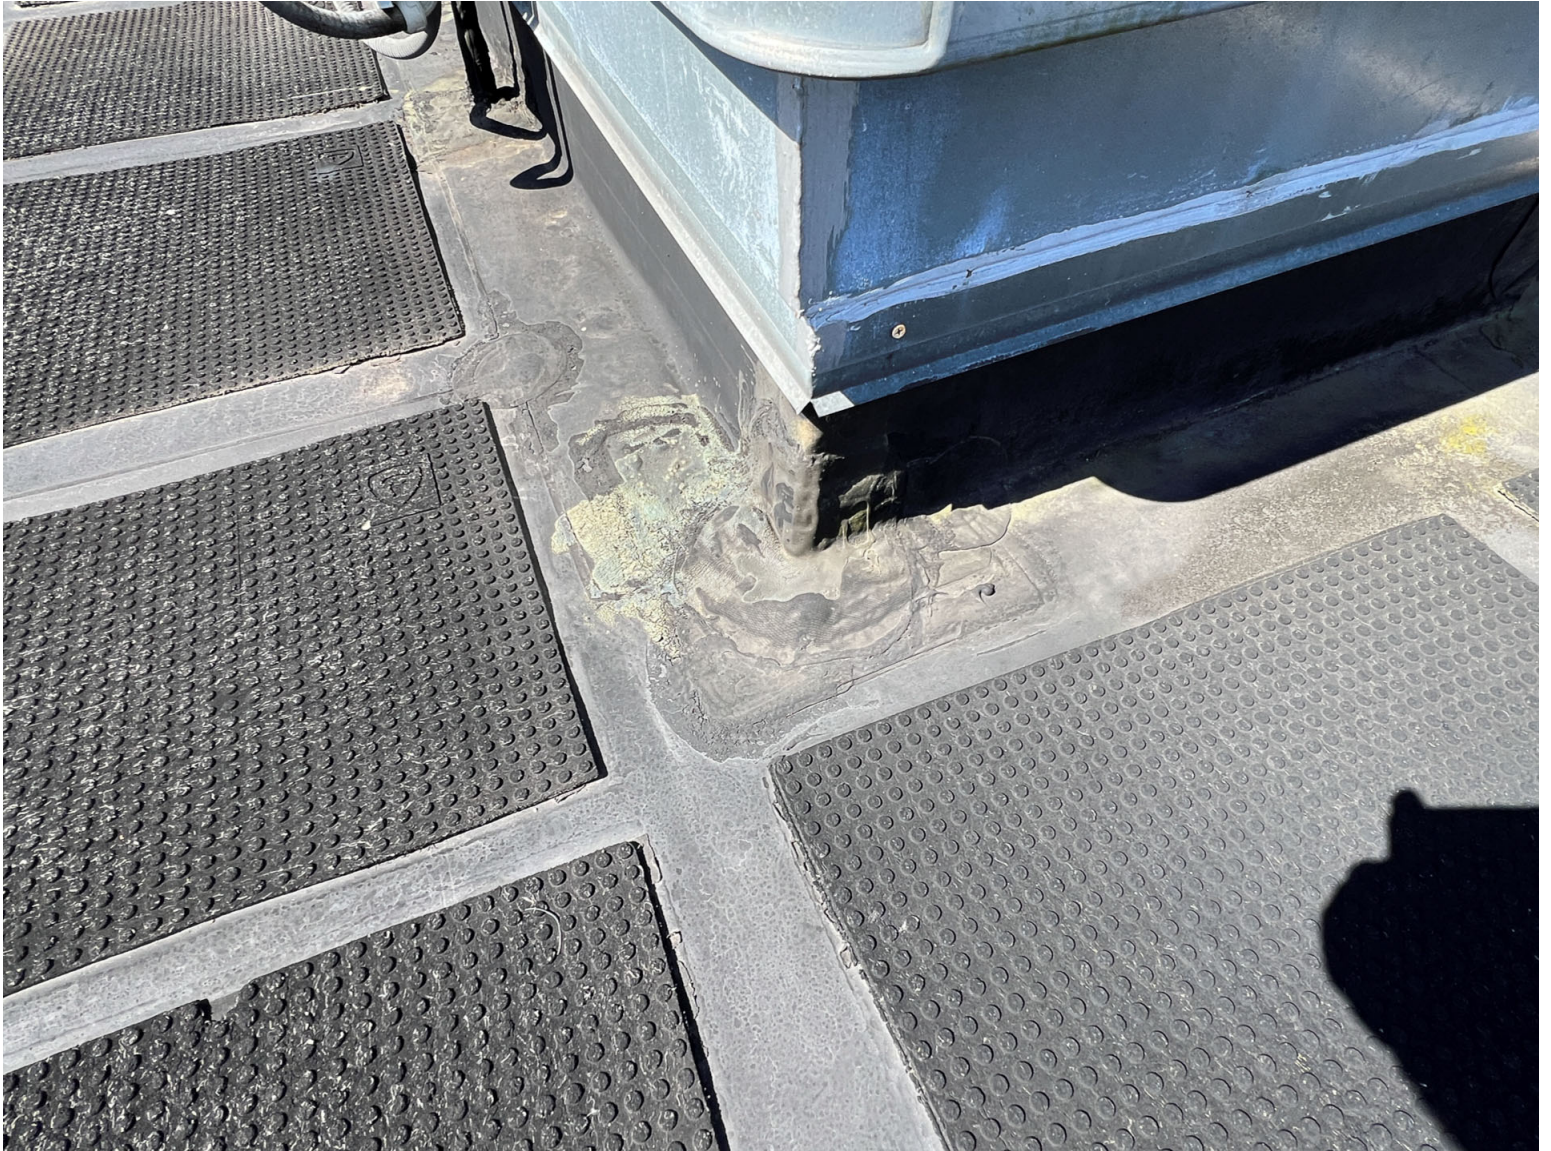
Admin roof area mechanical equipment roof curb flashing corners beginning to break down fr

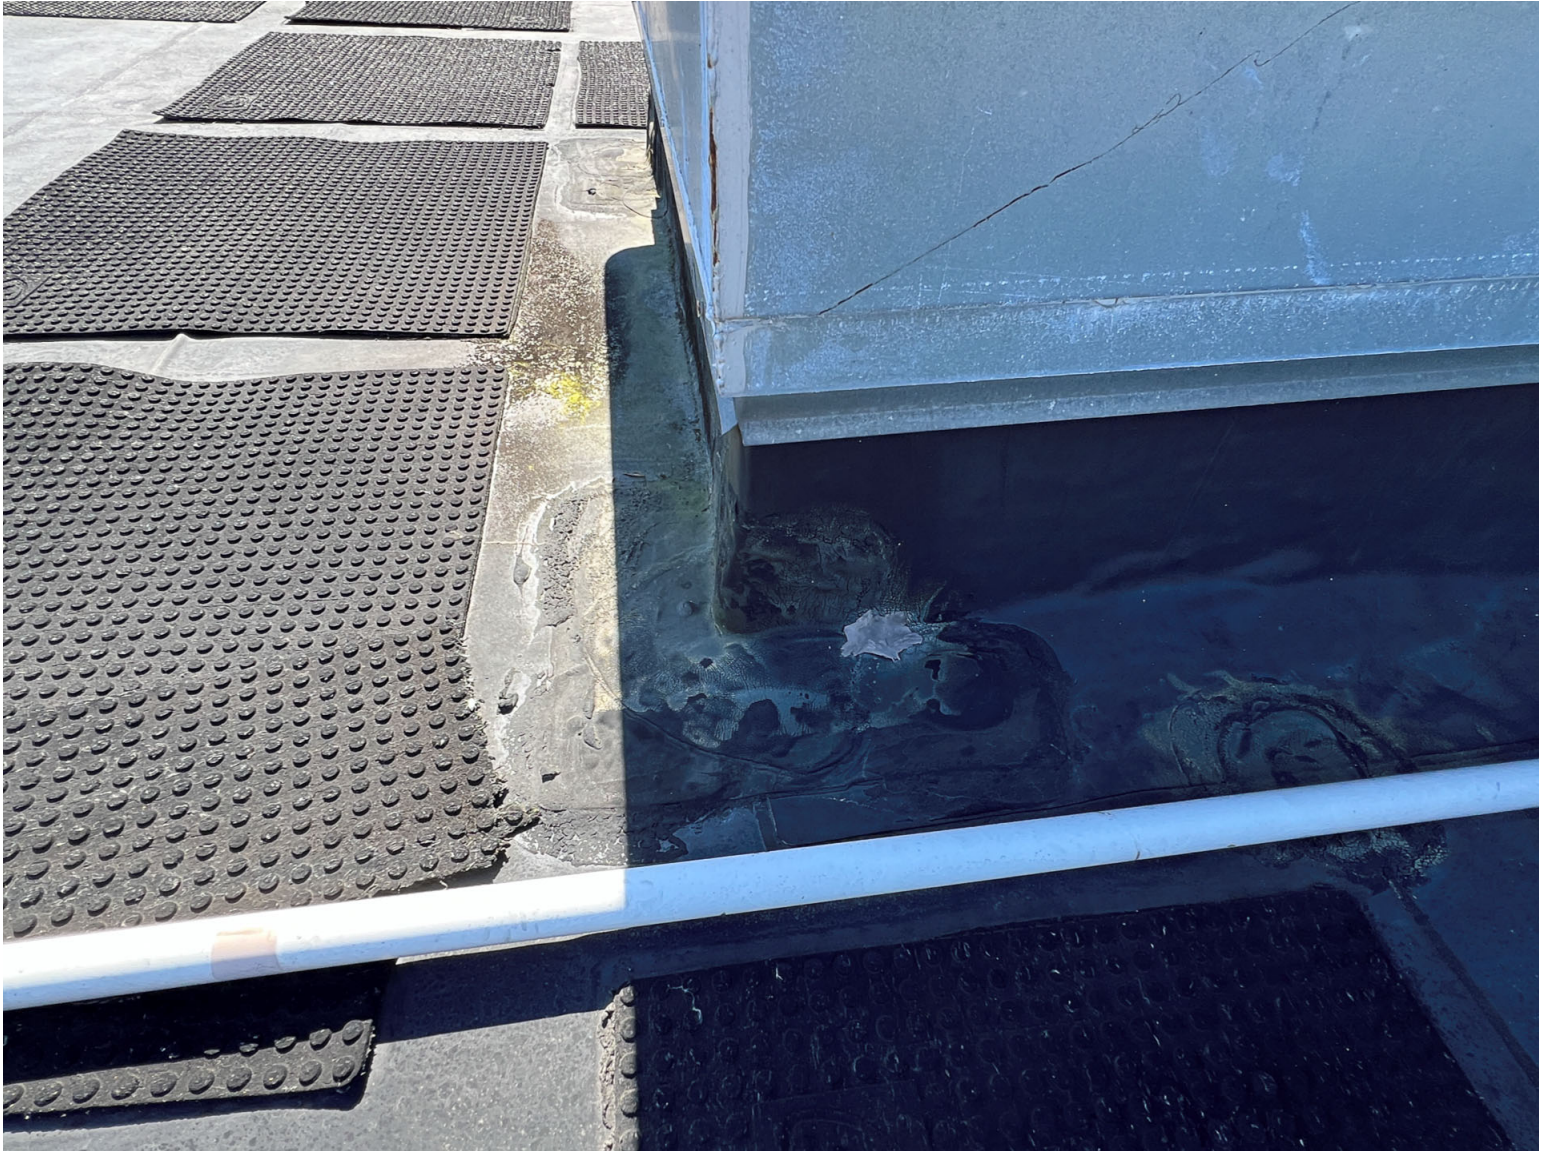
Admin roof area mechanical equipment roof curb flashing corners beginning to break down fr

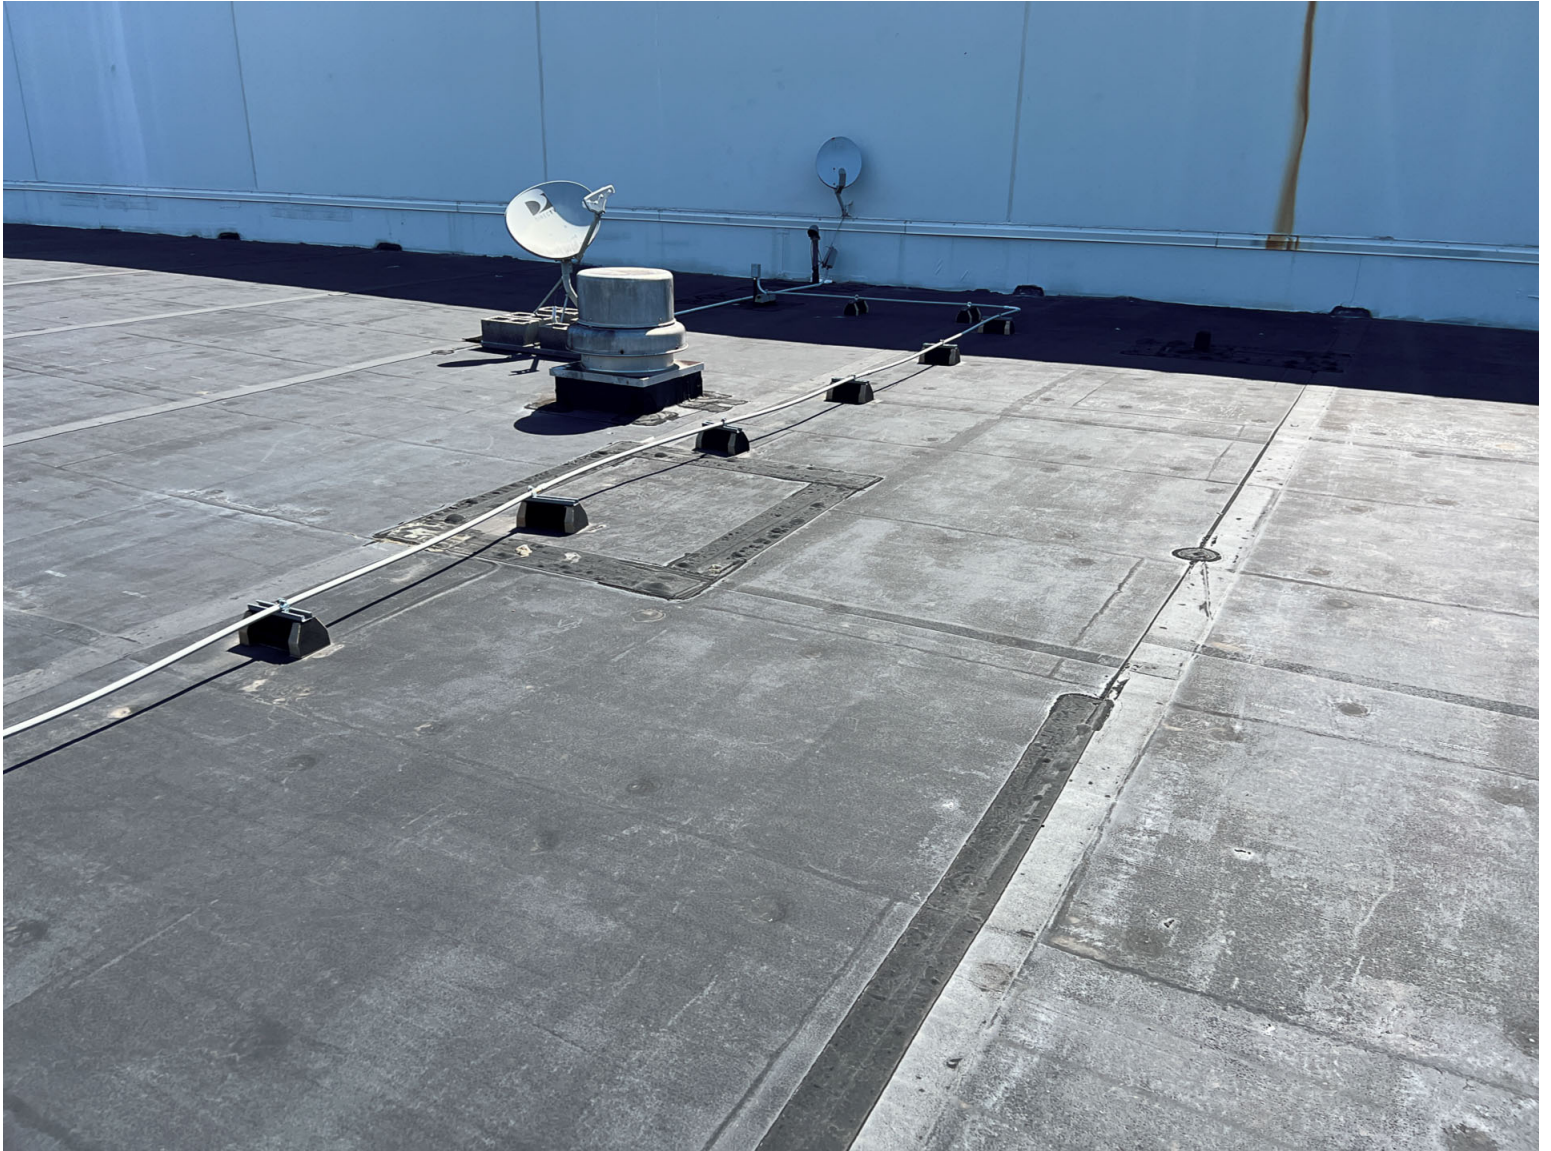
Lower admin roof area - Roof top A/C units

In conclusion, the building is in very good general shape and there are no signs of structural concerns or compromises, three items do need to be addressed within the near future, the replacement of two of the A/C units on the lower administration roof will be required in the near future, the re-roofing of the original 2000 building should be considered to preserve the condition of the insulation and metal roof framing and interior finishes. Because of the amount of roof top equipment located on the lower roof area I would recommend a two-ply roof system to minimize exposure to tears and punctures. The upper roof of the warehouse does have exhaust fans which do not really require the maintenance that A/C equipment does so the exposure to damage is lessened, and you could go back with a white fleece back PTO product. The 2011 warehouse addition is capped with a single-ply TPO type membrane and was found to be in reasonably good shape and has a number of additional years of performance in it so this area could wait a few years before being re-roofed or you could decide to simply use this time to re-roof the entire building and get a single building roof warranty. The asphalt heavy duty truck paving requires maintenance that I would do immediately to ensure the subgrade and paving base do not become compromised.

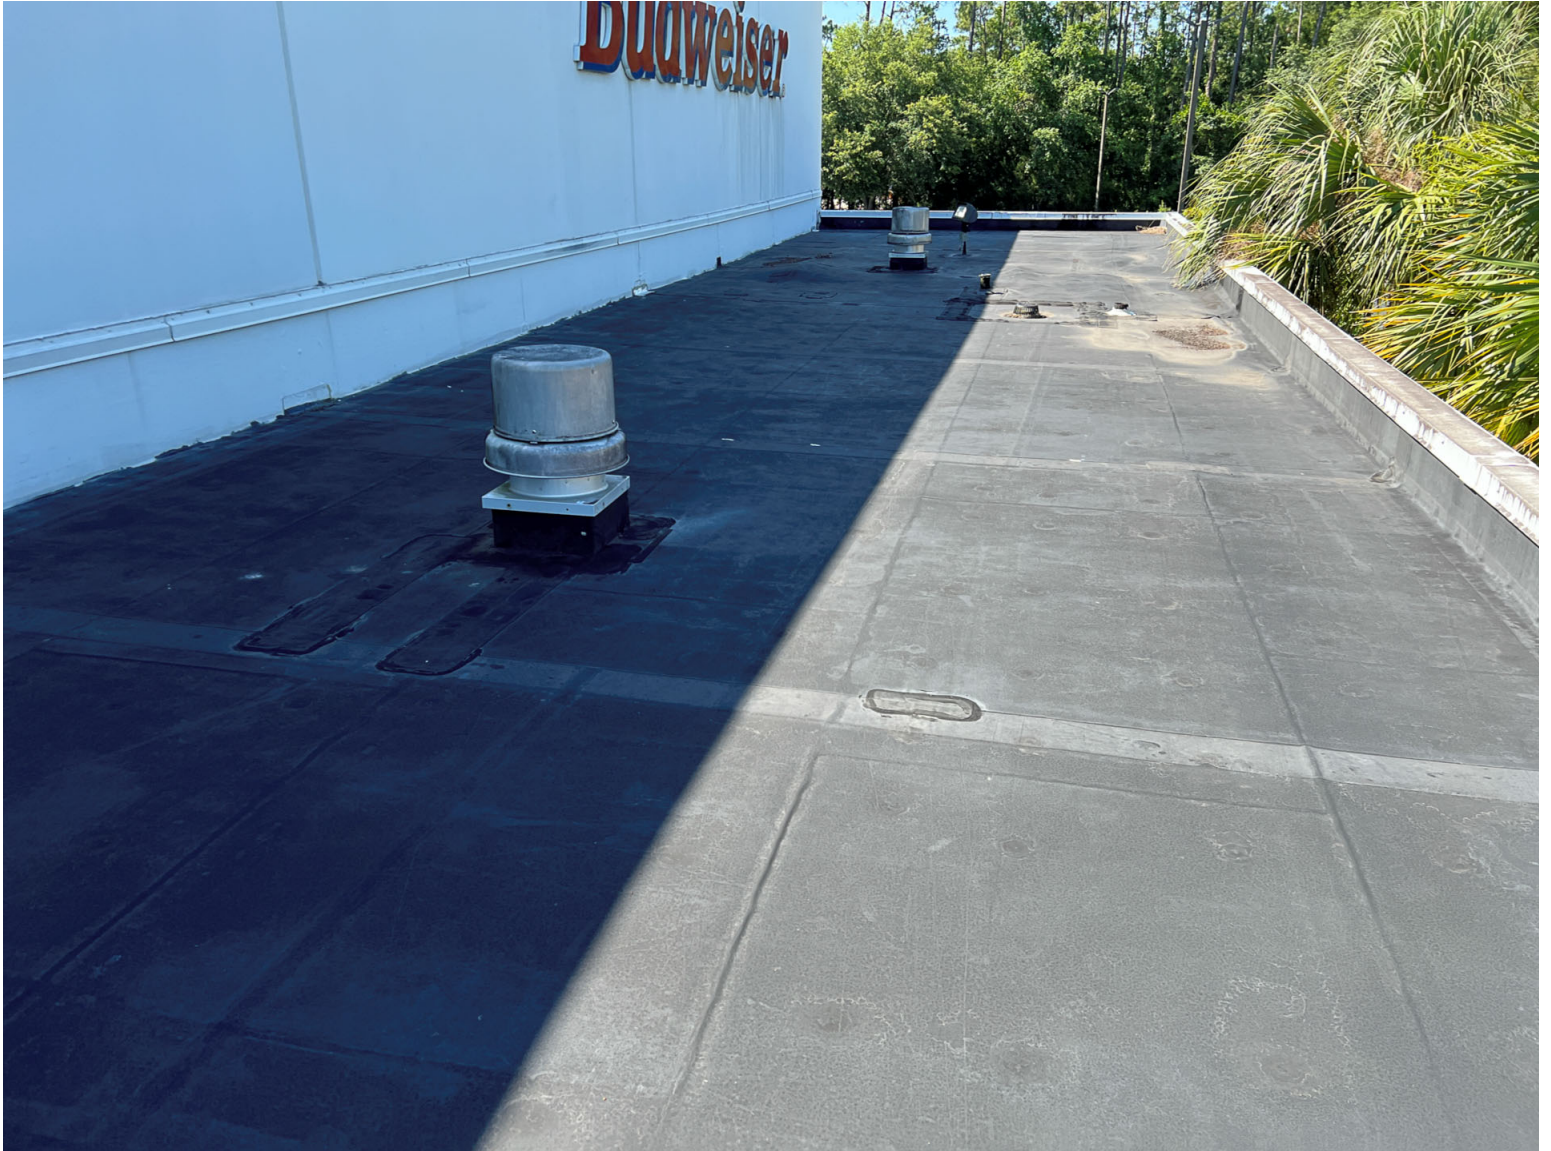
Lower Admin roof area with previous patching

asphalt paved areas and replacement of the two-roof top A/C units this could be done to minimize daily operation inconvenience once the facility is fully operational. The re-roofing efforts can occur at this time or with substantial patching and repairs the building can gain a little more time out of the 24-year-old roof, but it needs to be pointed out the roof has exceeded any roof warranty issued at the time its installation.

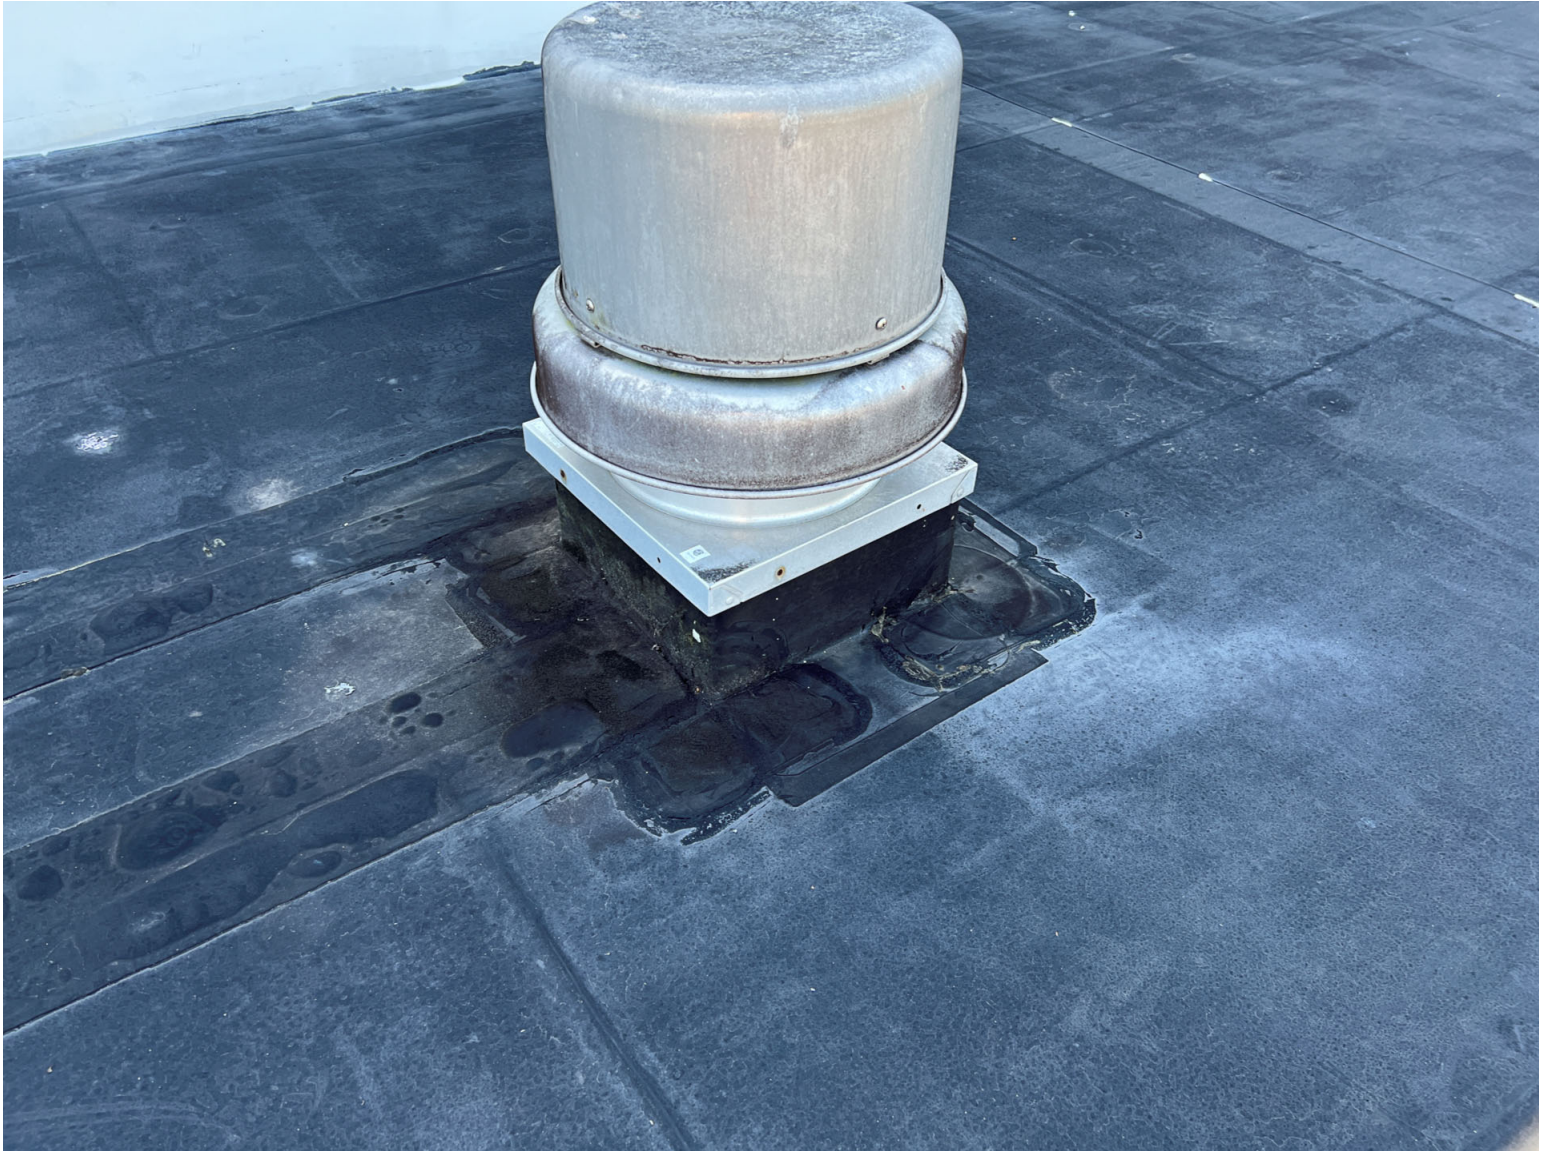
Lower Admin roof area with previous patching

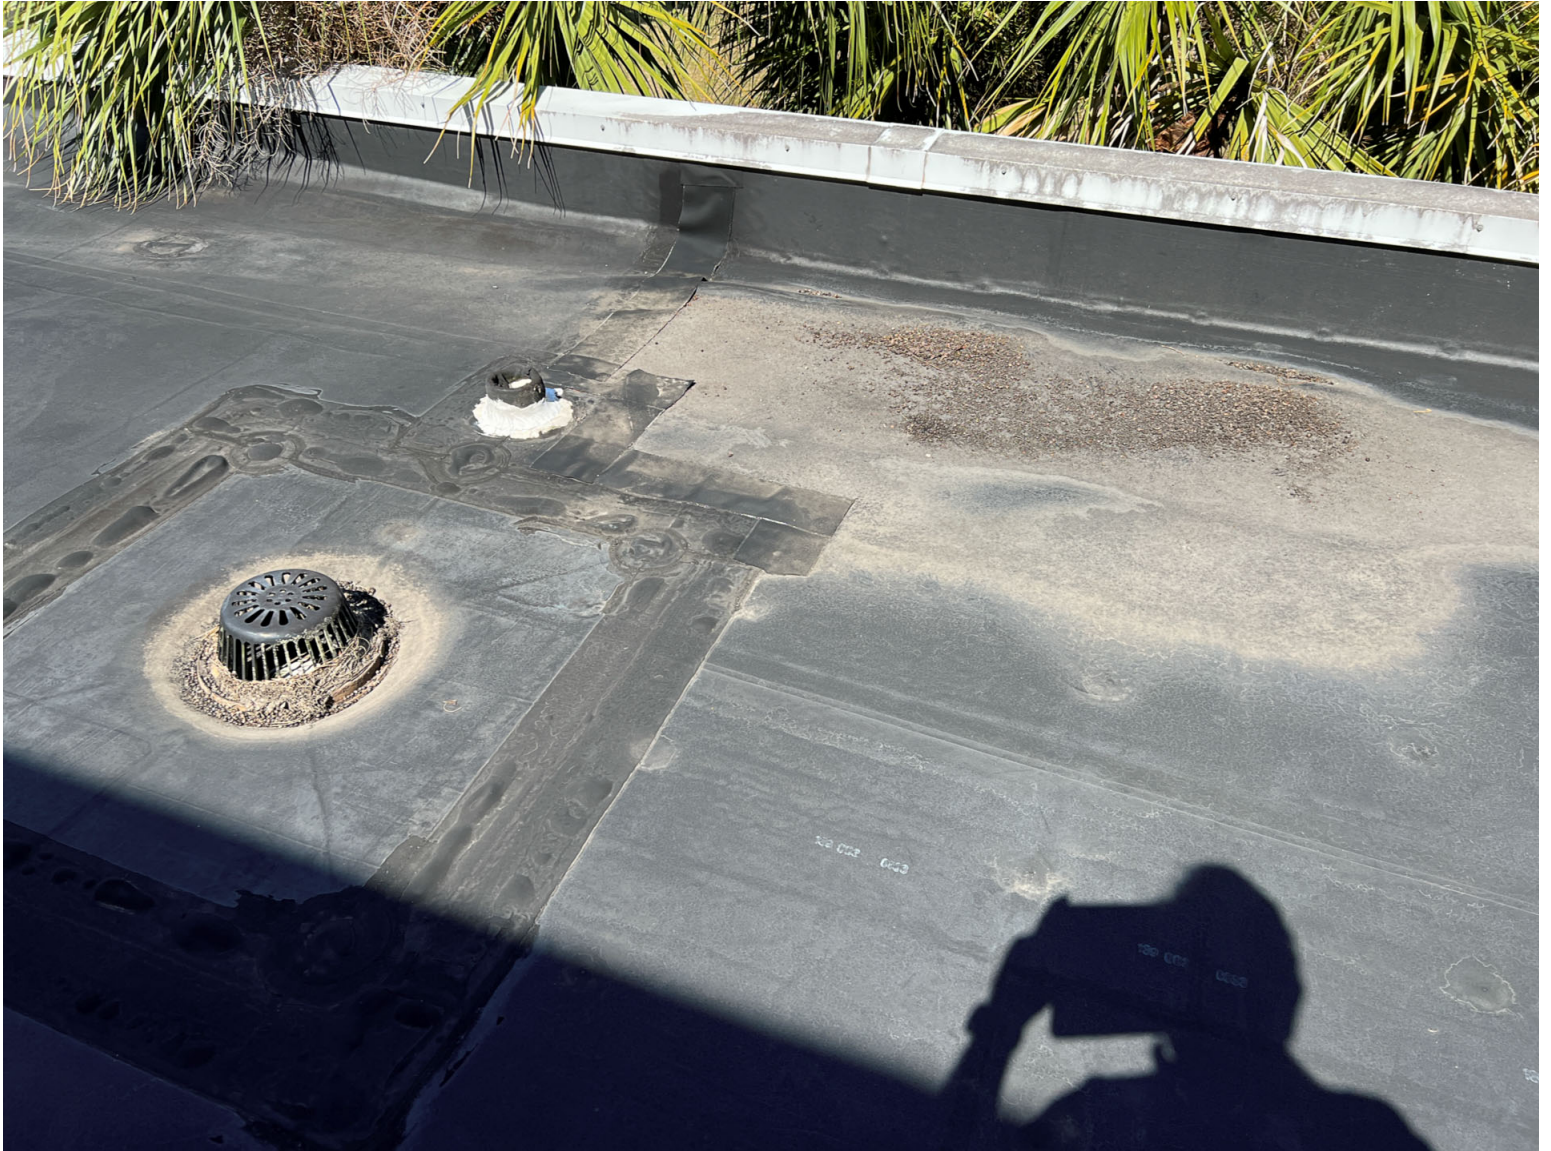
Lower Admin roof area with previous patching

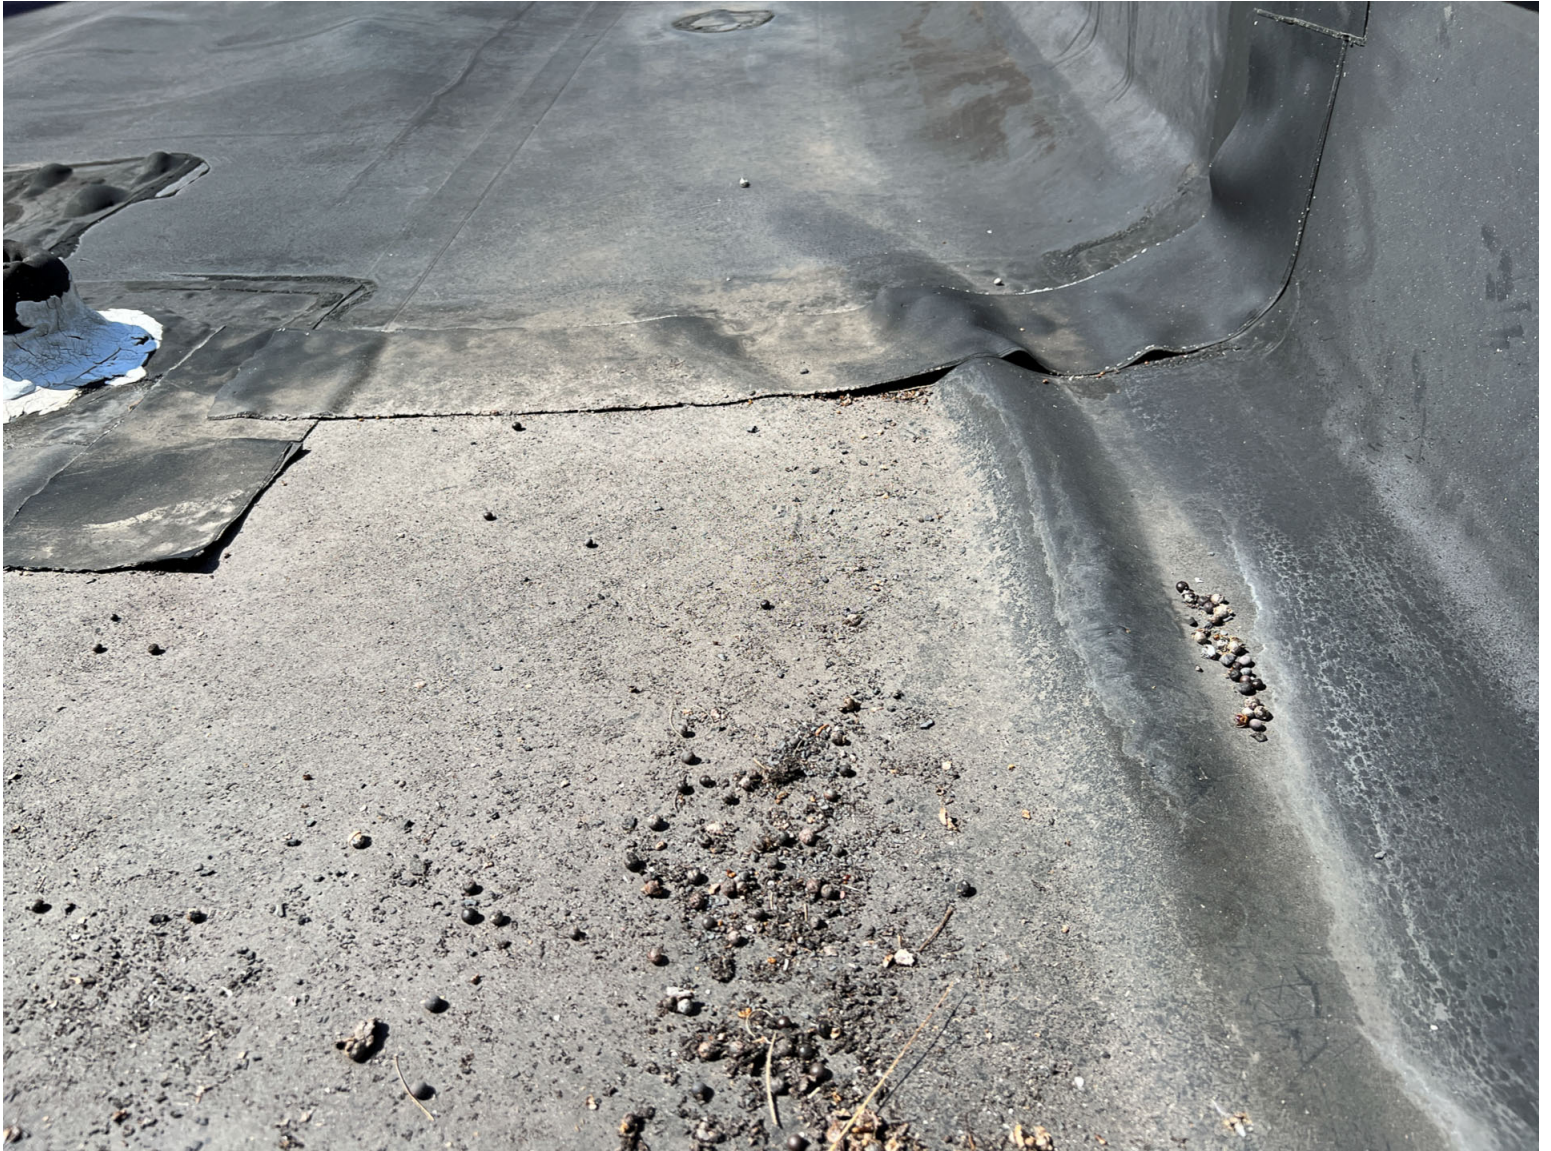
Lower admin roof south end roof drain & emergency overflow & roof membrane vapor bladd

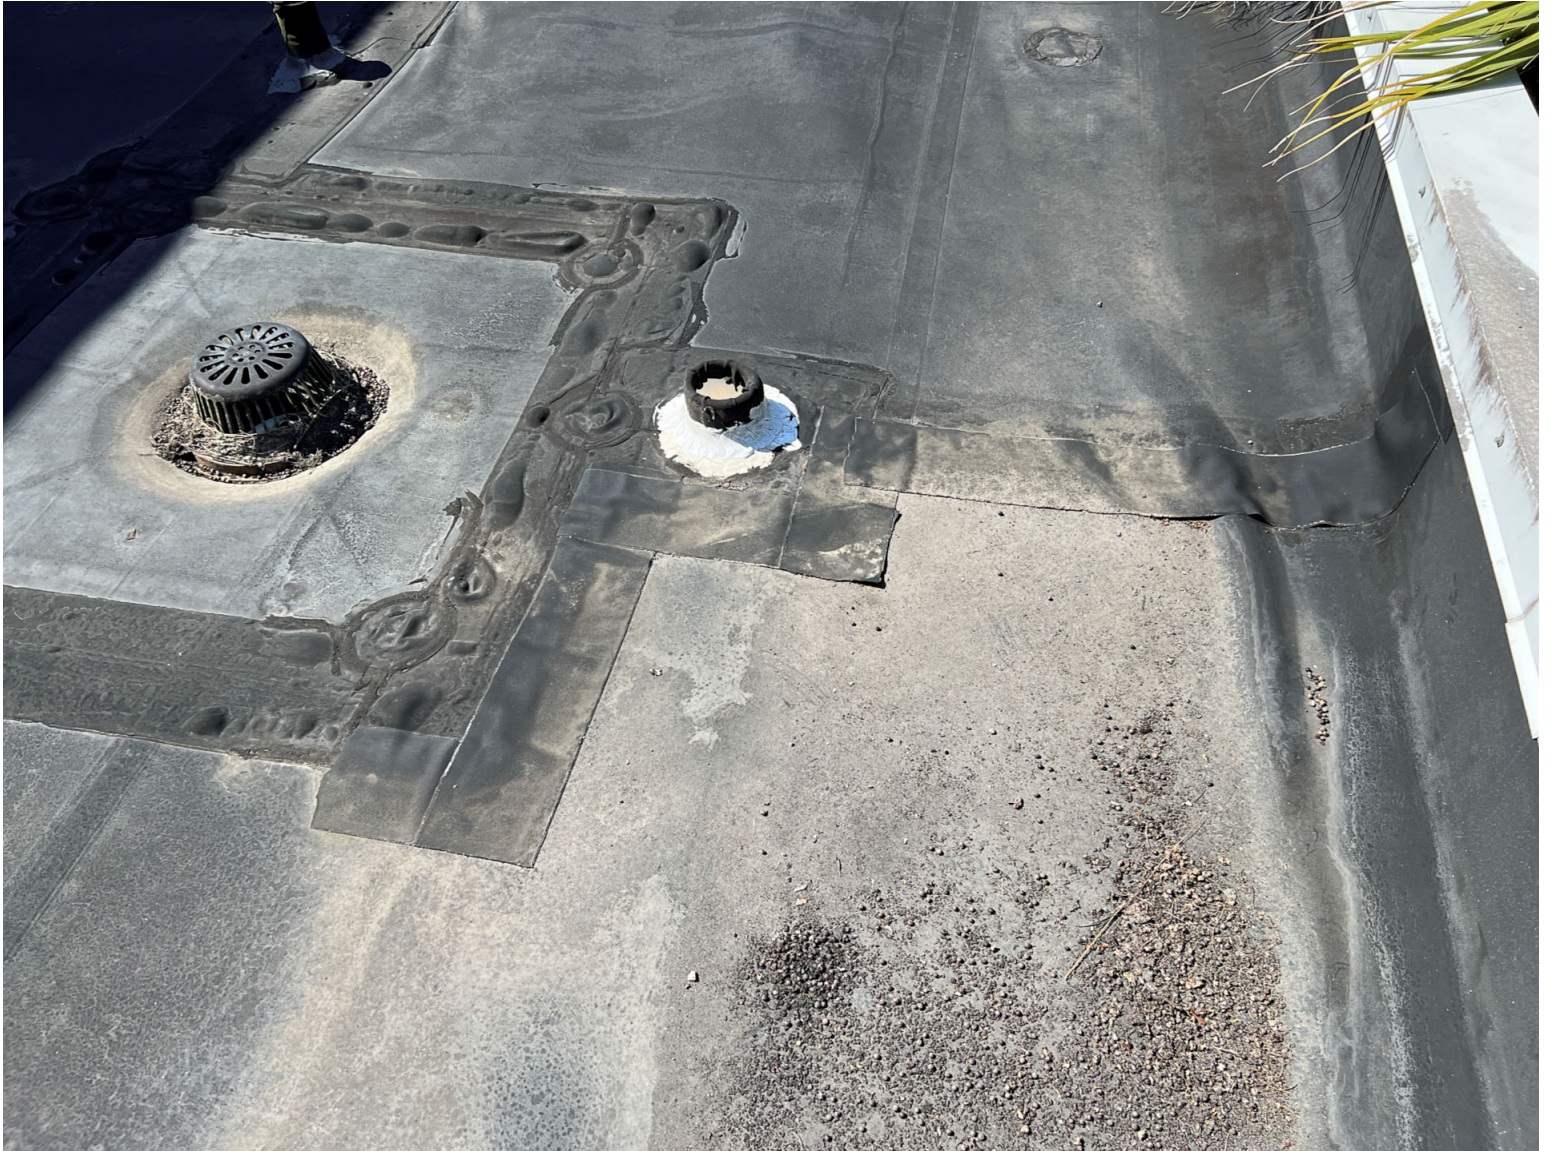
Lower admin roof south end roof drain & emergency overflow & roof membrane vapor bladd

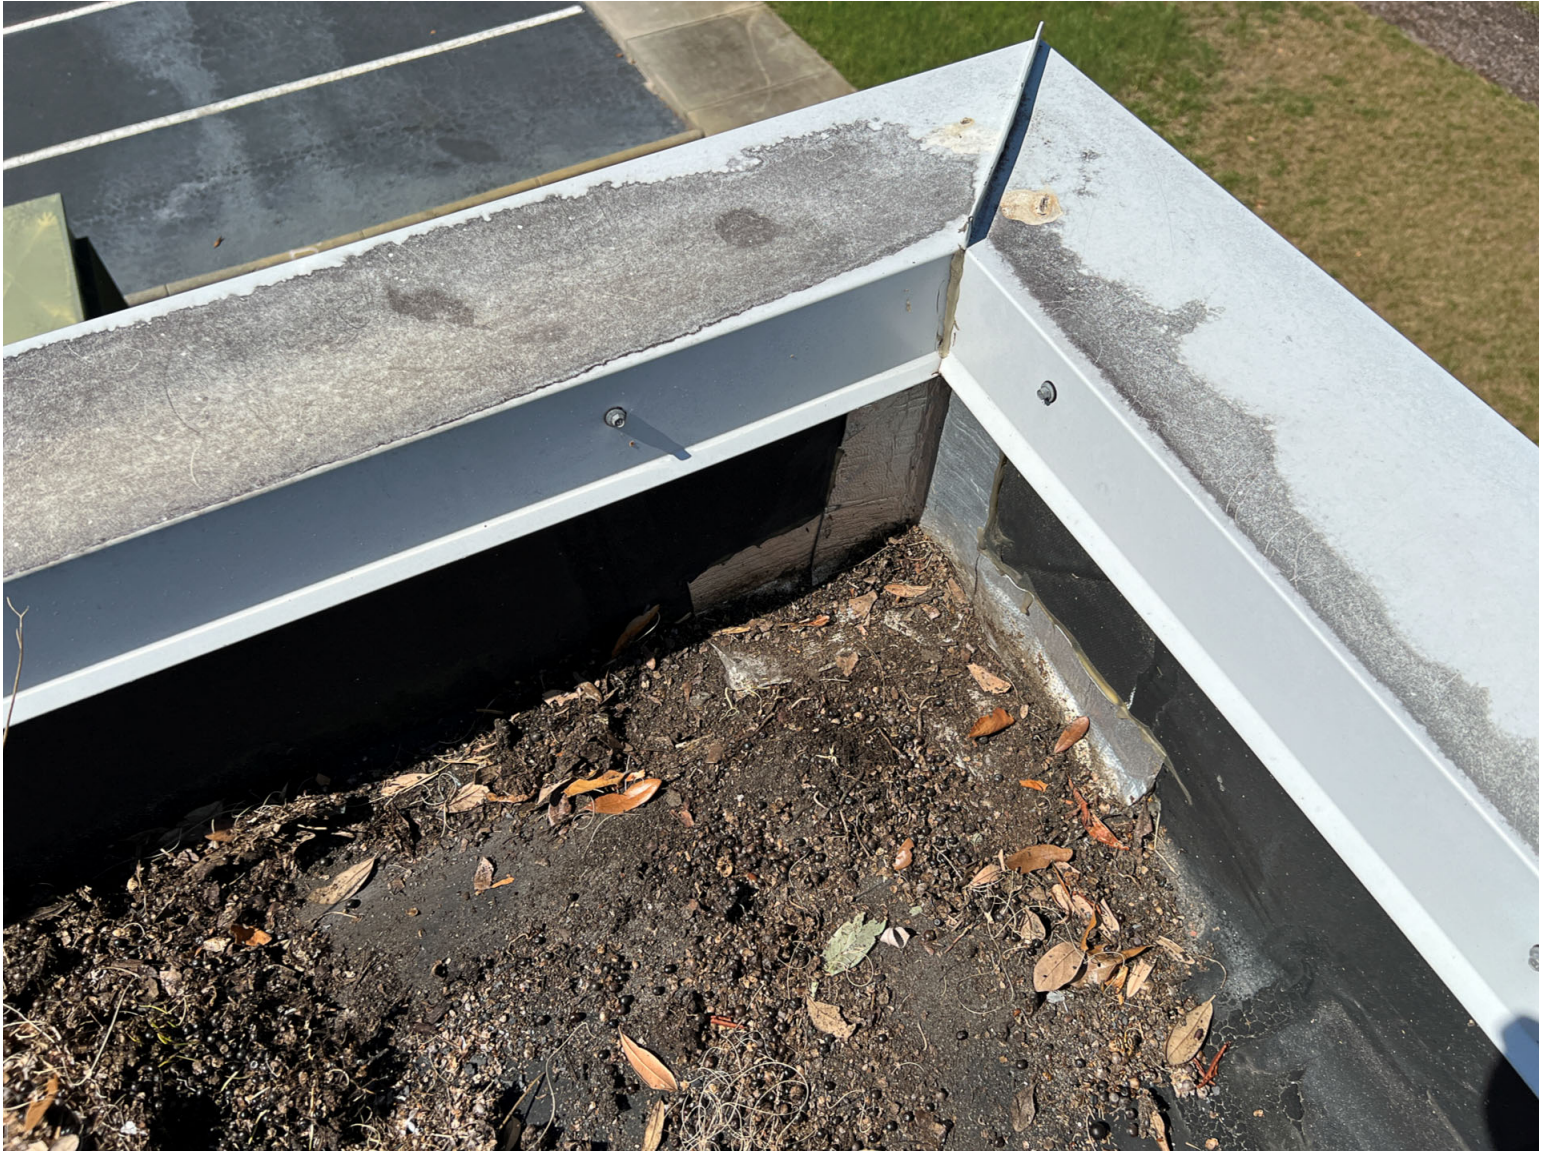
Lower admin roof south end roof drain & emergency overflow & roof membrane vapor bladd

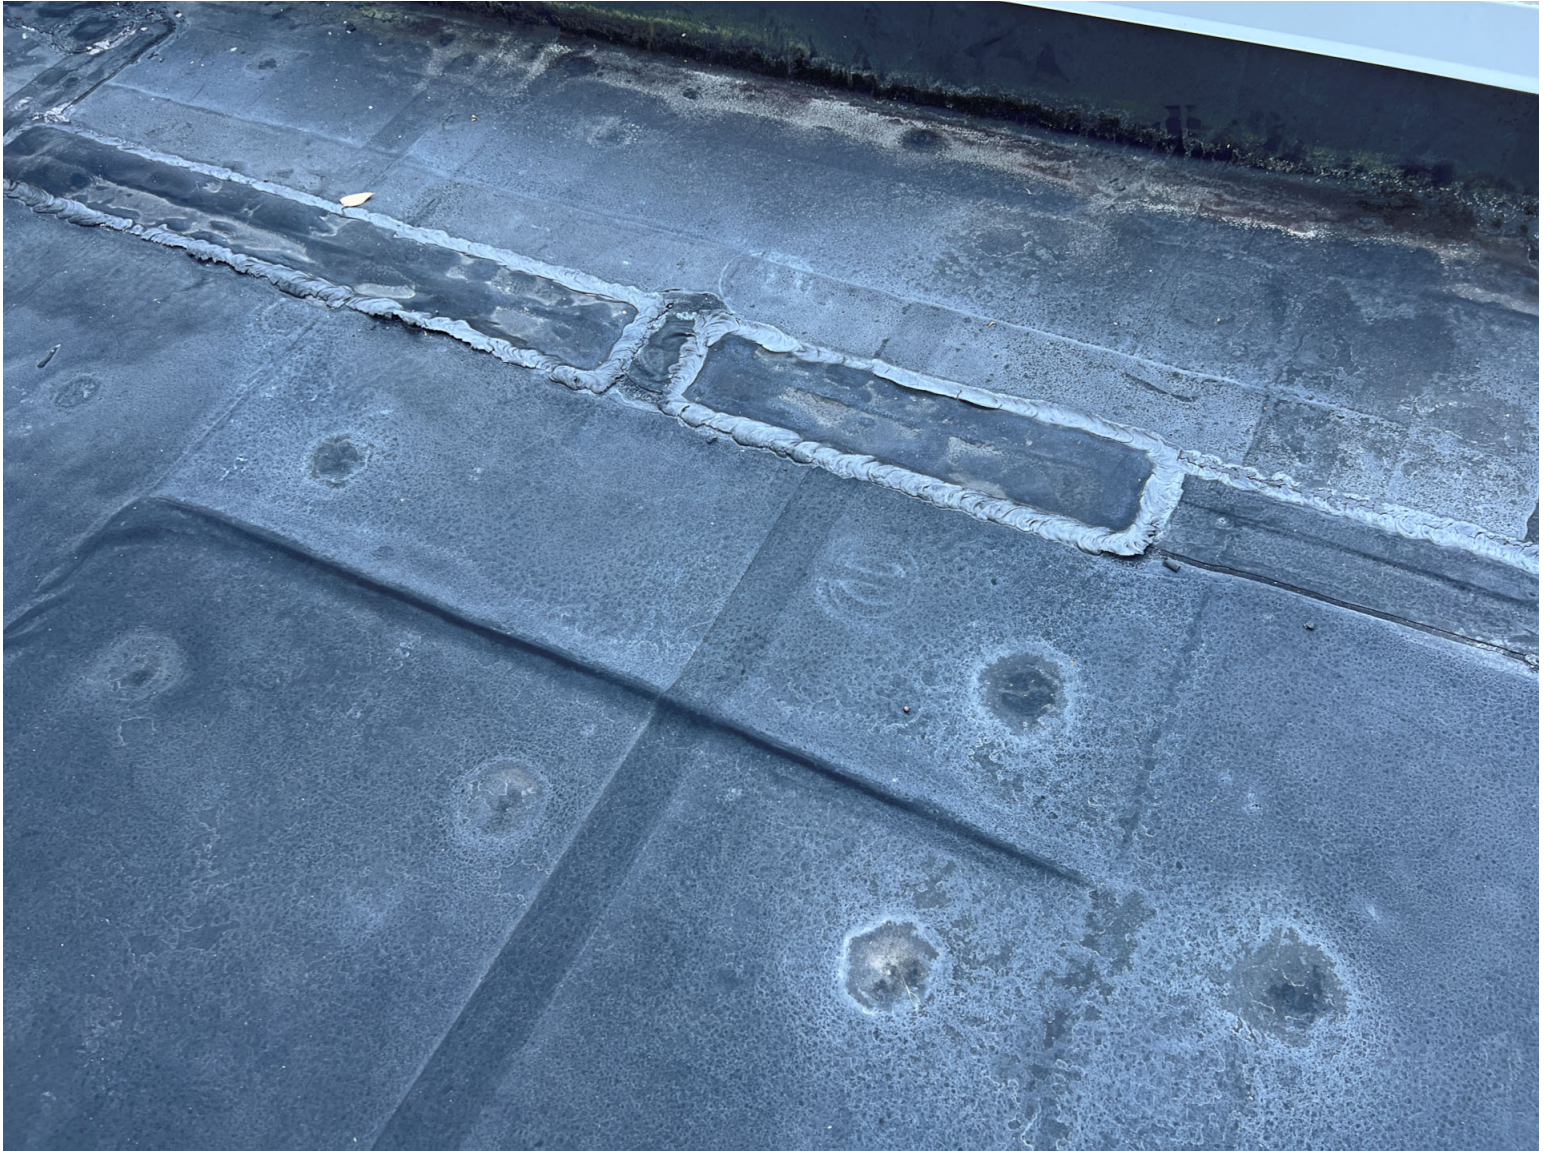
Roof to parapet patching

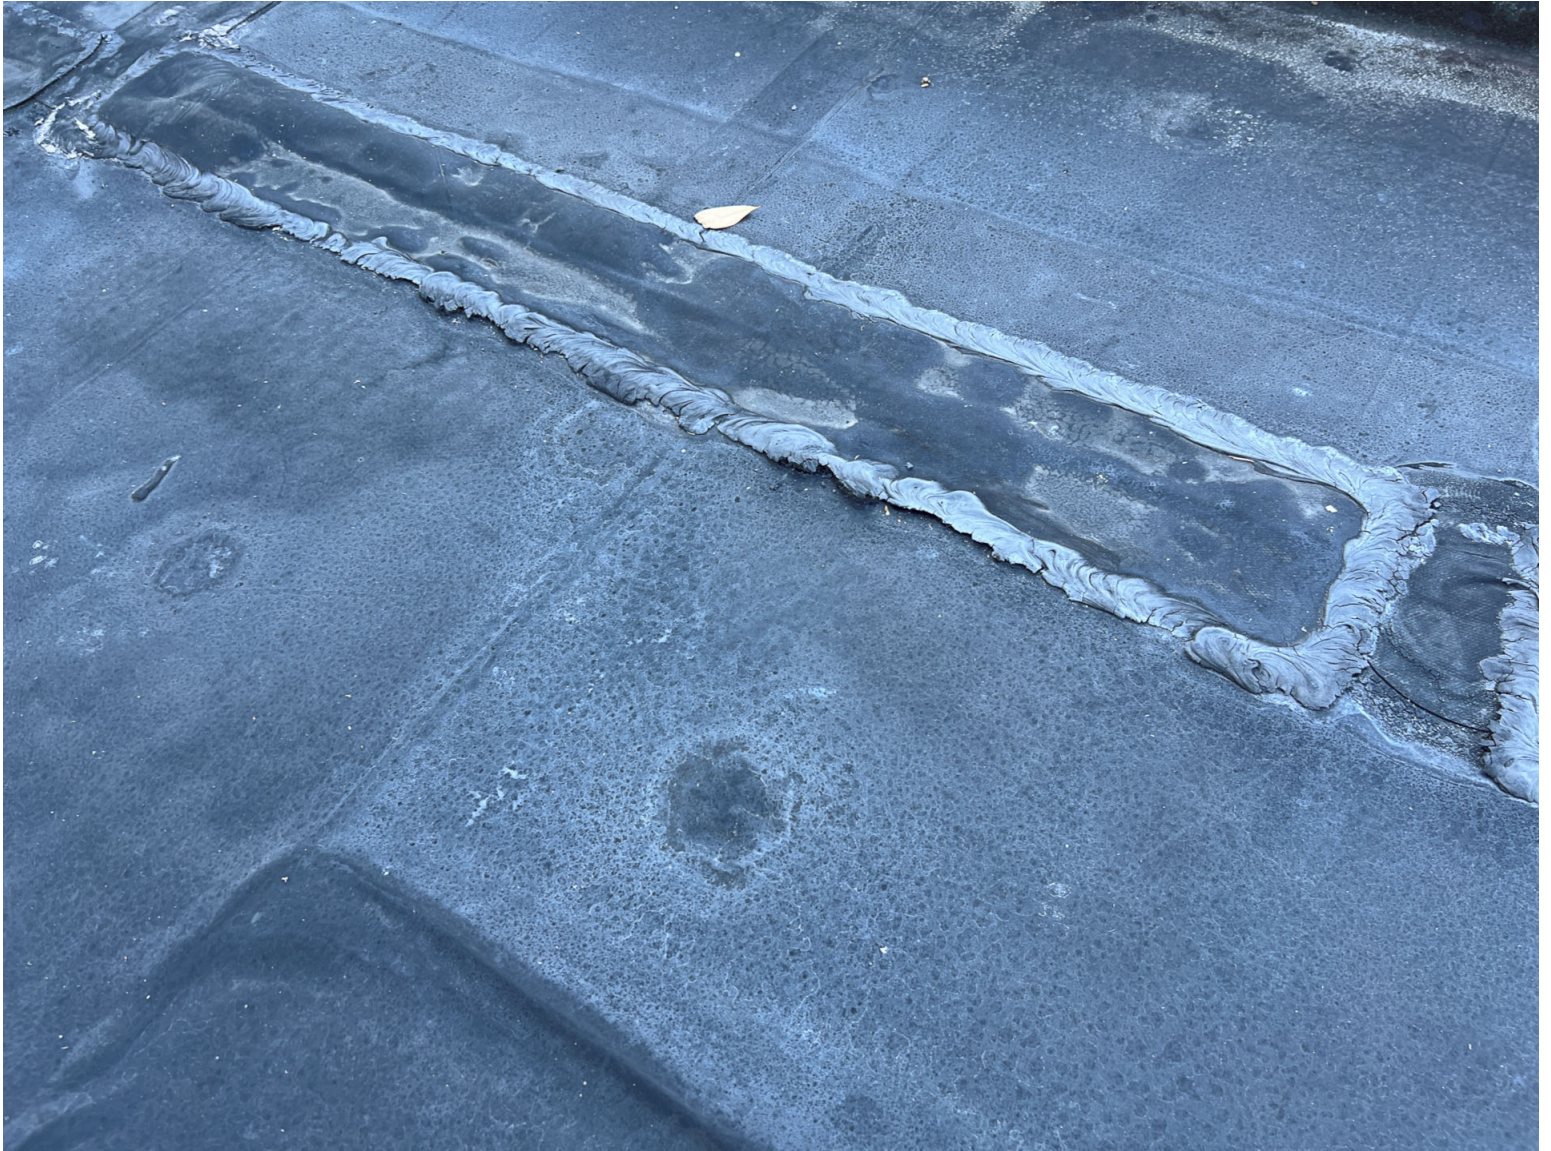
Lower admin roof area seam & membrane patching
