RE: Due Diligence Report – Burkhardt Sales & Service

As part of the County's due diligence efforts to evaluate the conditions of the existing commercial industrial warehouse building (Burkhardt Sales & Service) located at 6125 NW 18<sup>th</sup> Drive, Gainesville, FL 32653, Paul Stresing Associates (PSA) was tasked with conducting an inspection of the facility to evaluate its condition prior to entering into a full purchase agreement to its purchase. On May 30, 2024, I was accompanied by KPI Engineering (KPI) where we walked the roof and interior of the facility with Mr. Matt Fultz of the Alachua County Facilities Department and Mr. Daniel Burkhardt, representing the seller where we gained access to the site and buildings to begin our evaluation efforts.

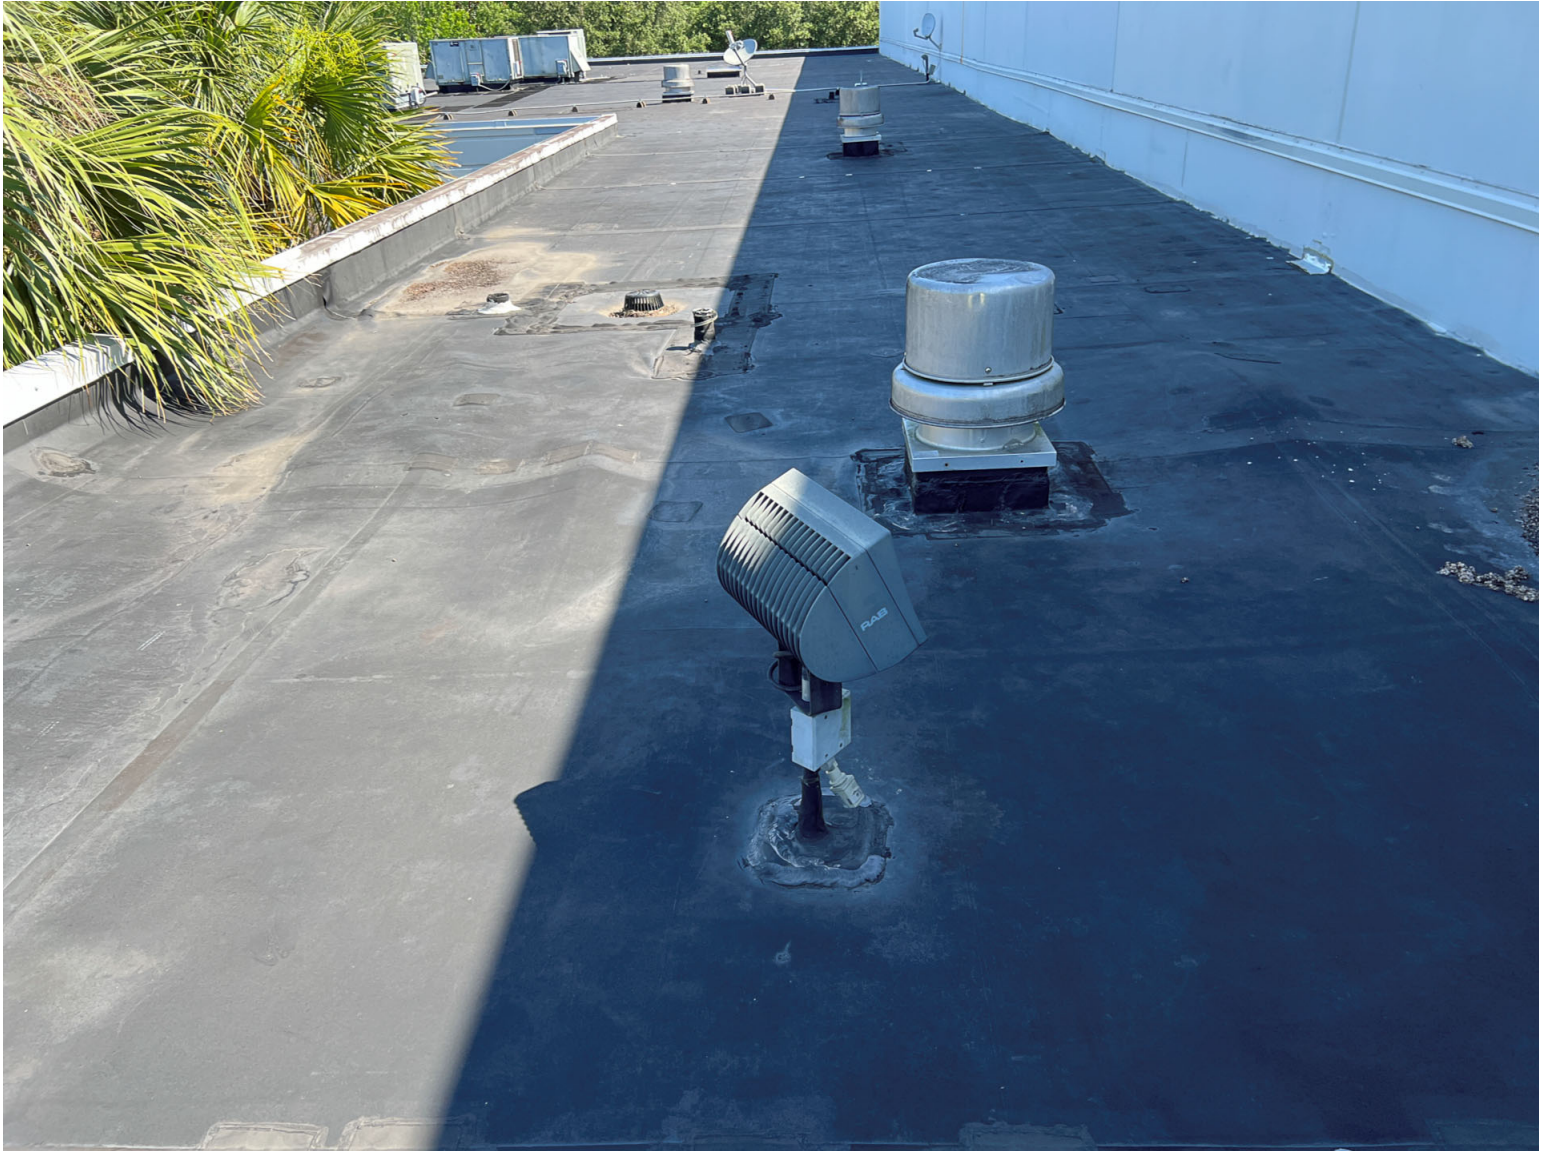
Lower admin roof area seam & membrane patching

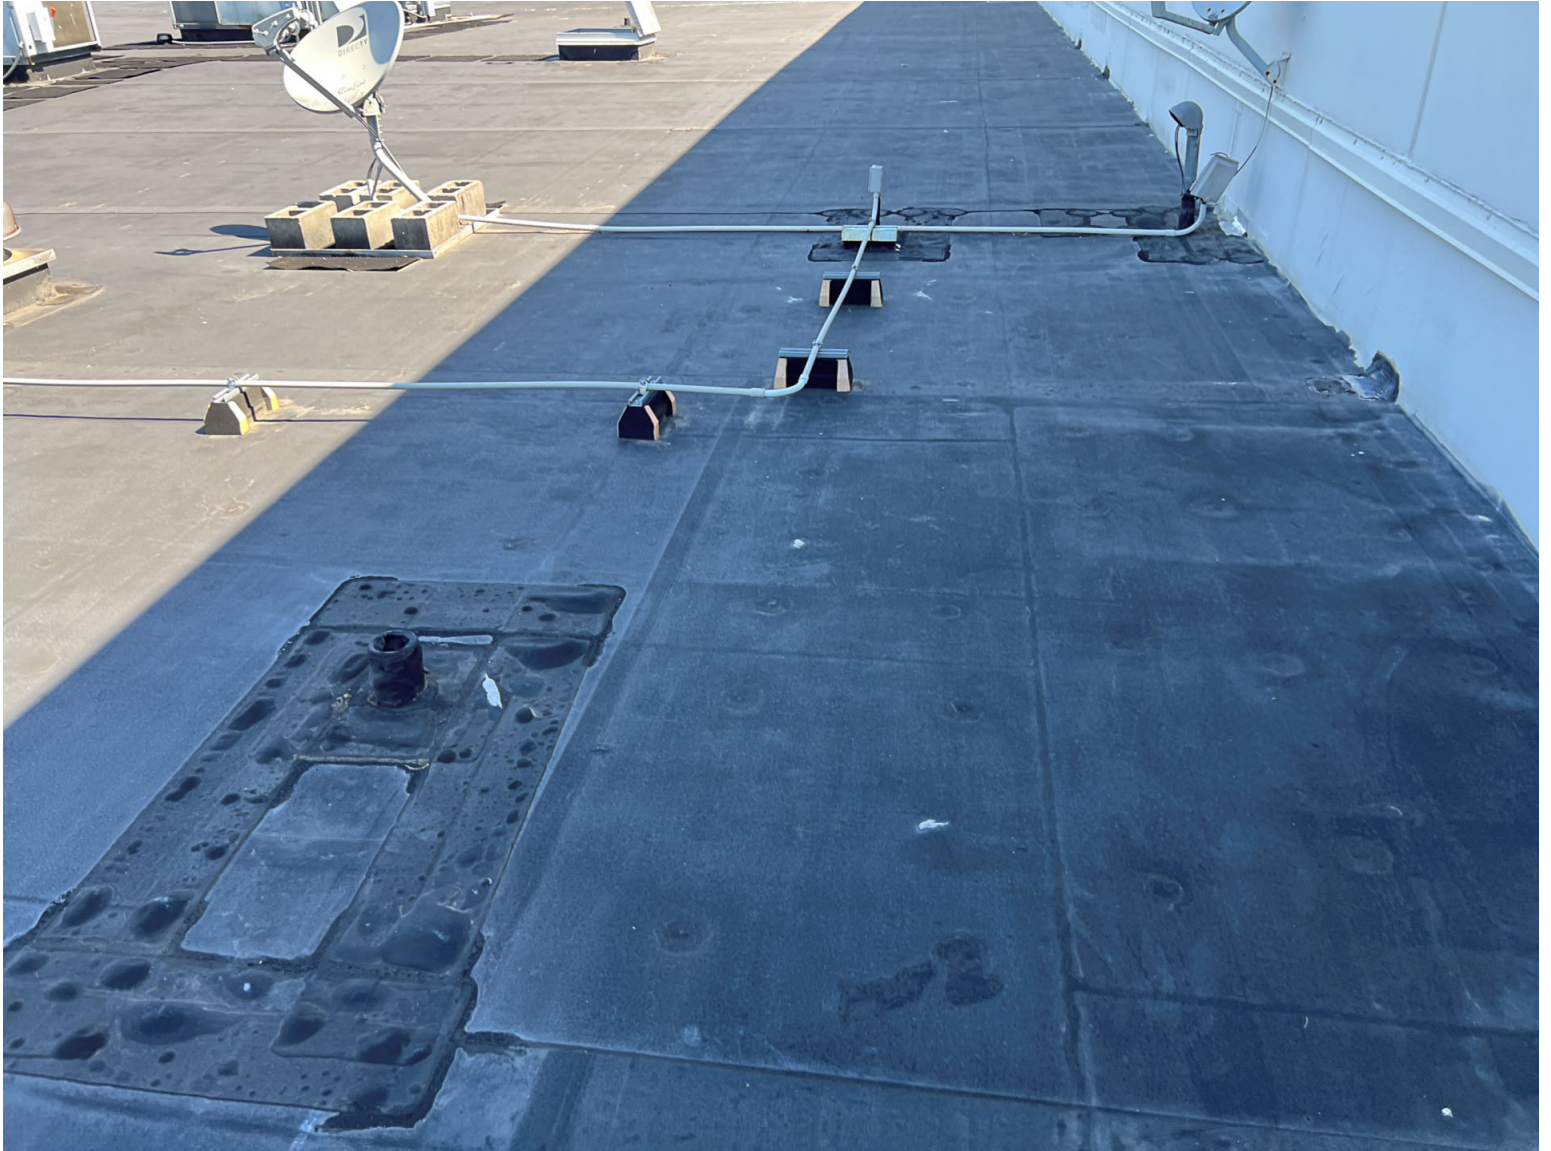
Lower admin roof area seam & membrane patching

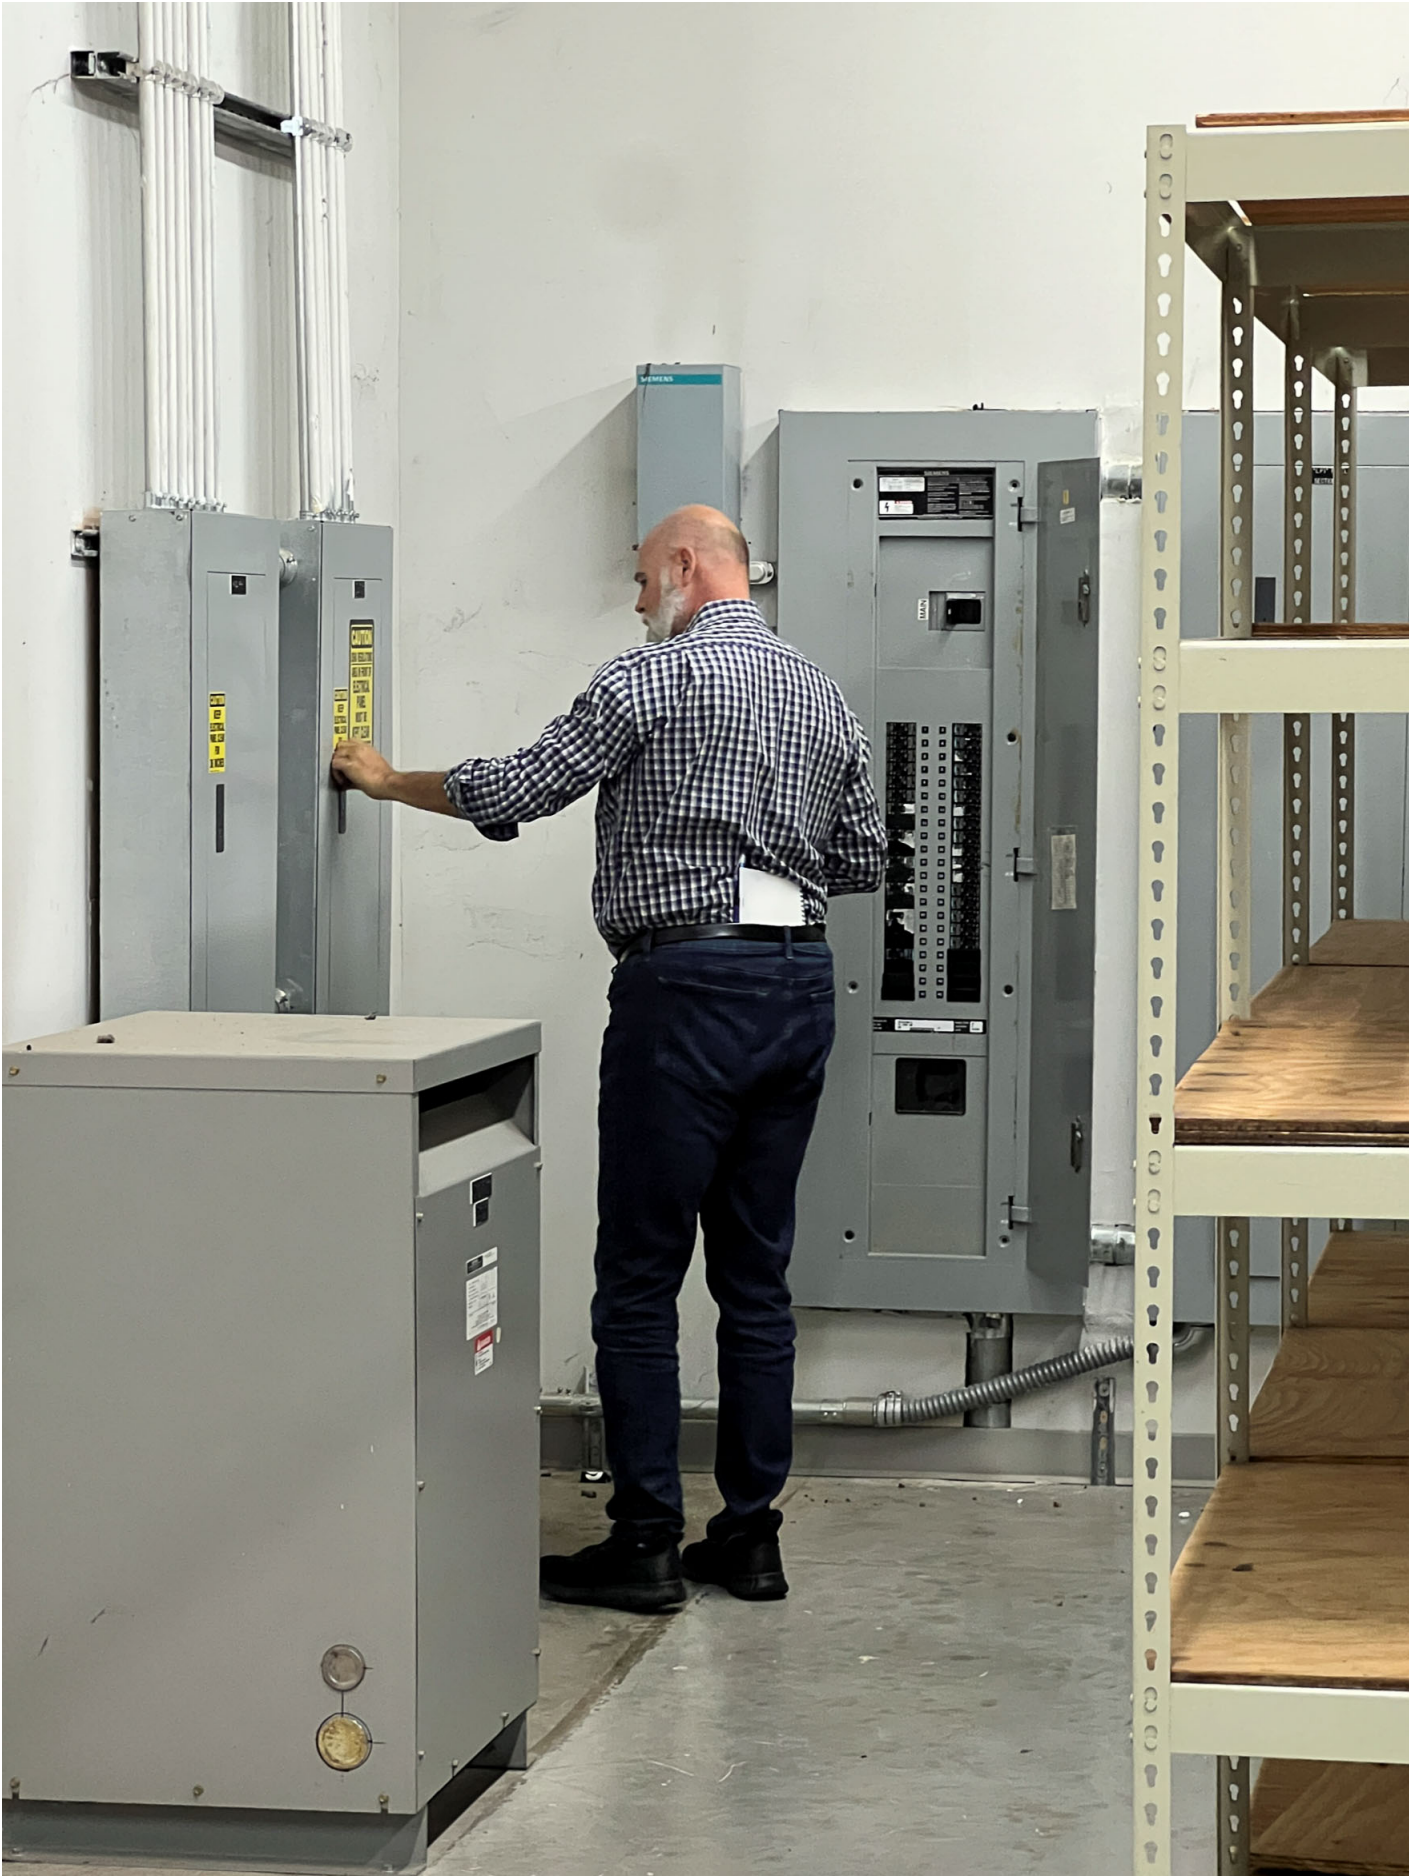
Access to the lower admin roof area

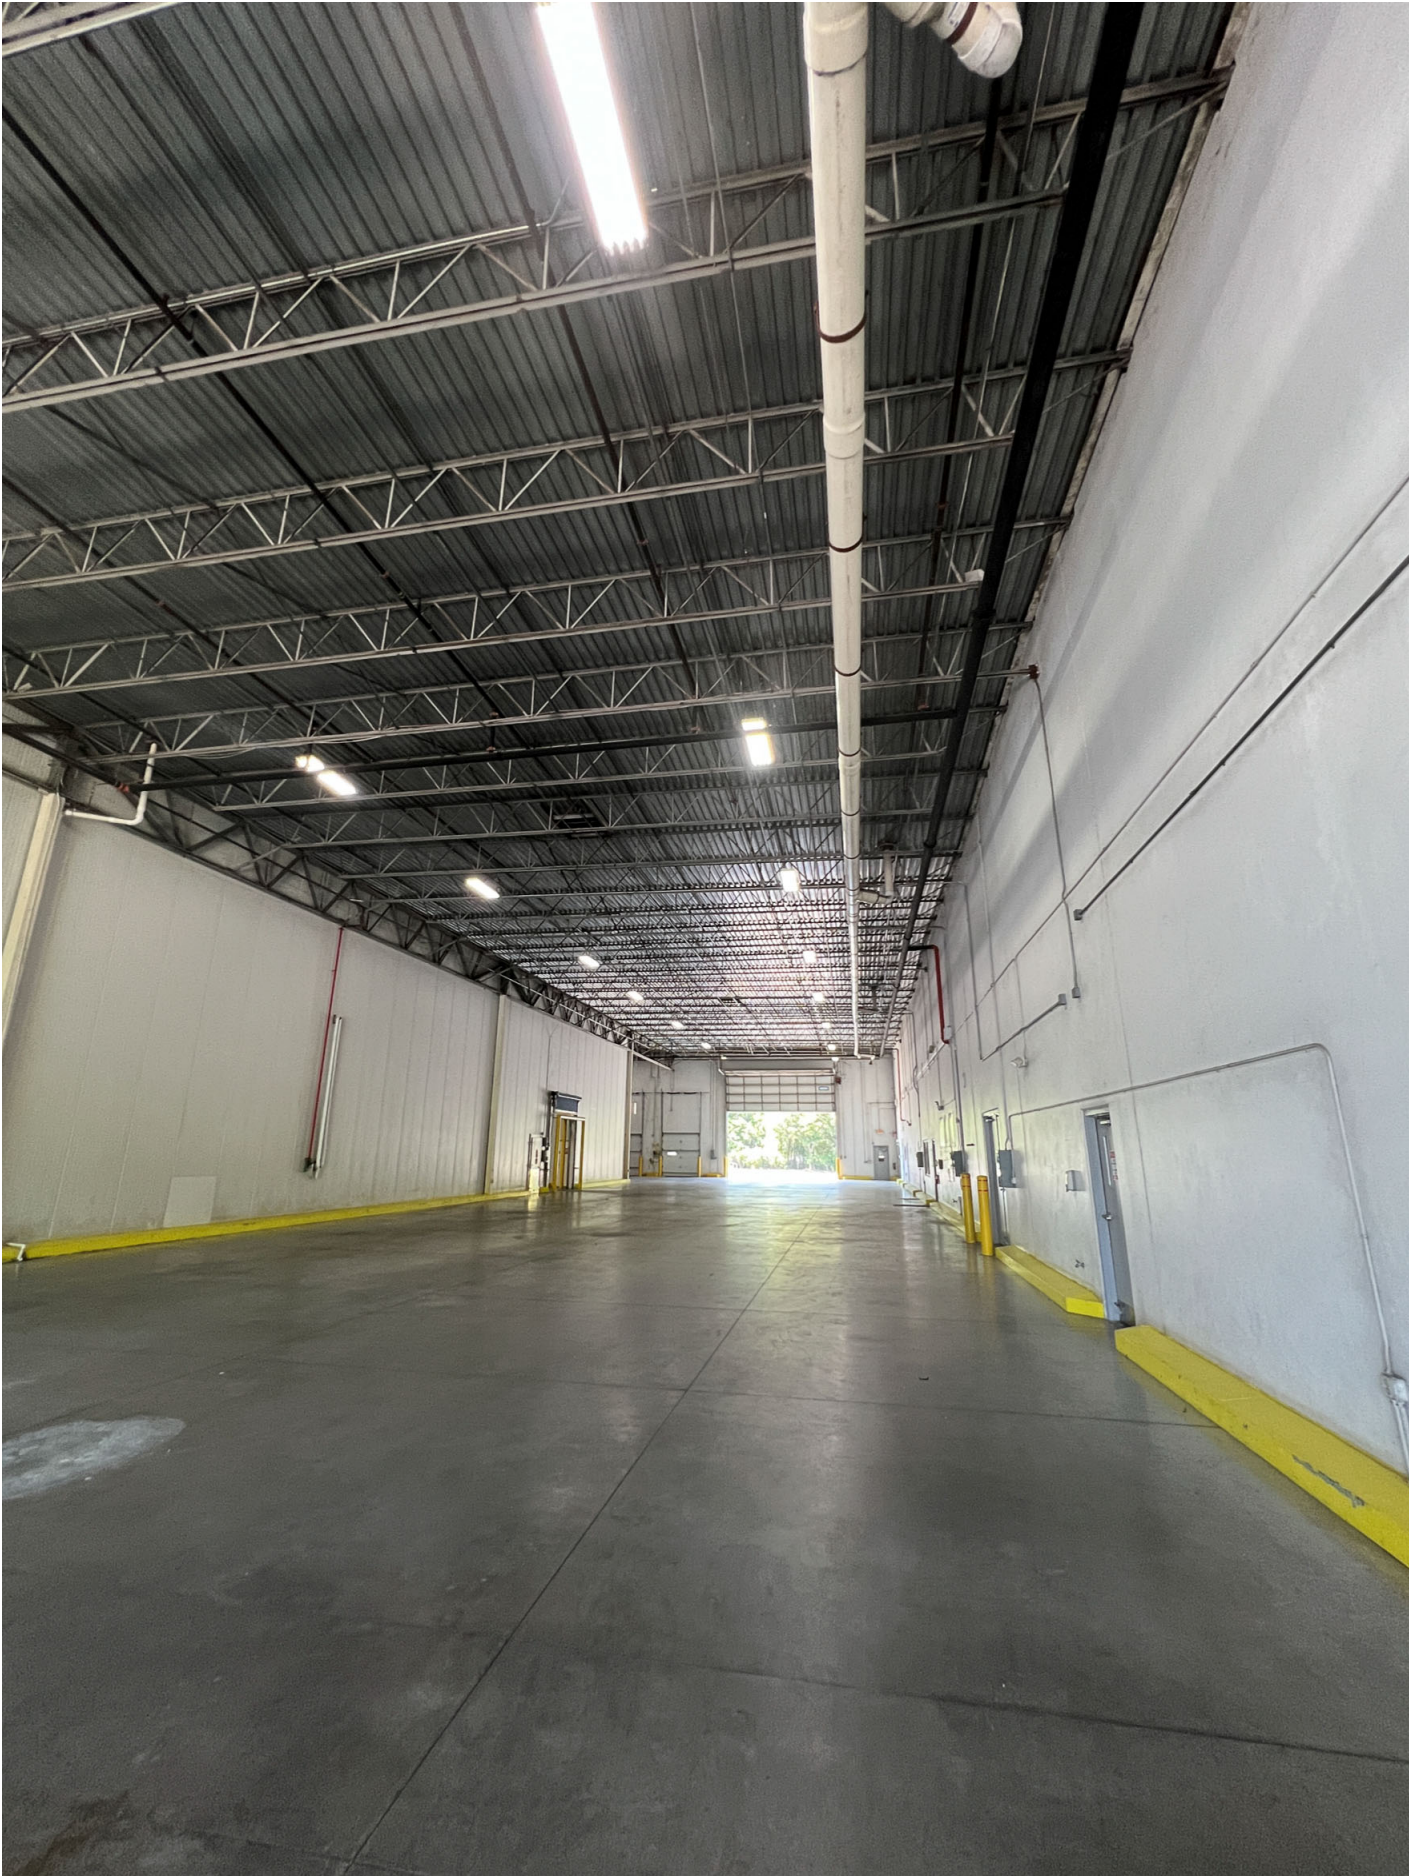
Motorized roll-up door operator - typical each door

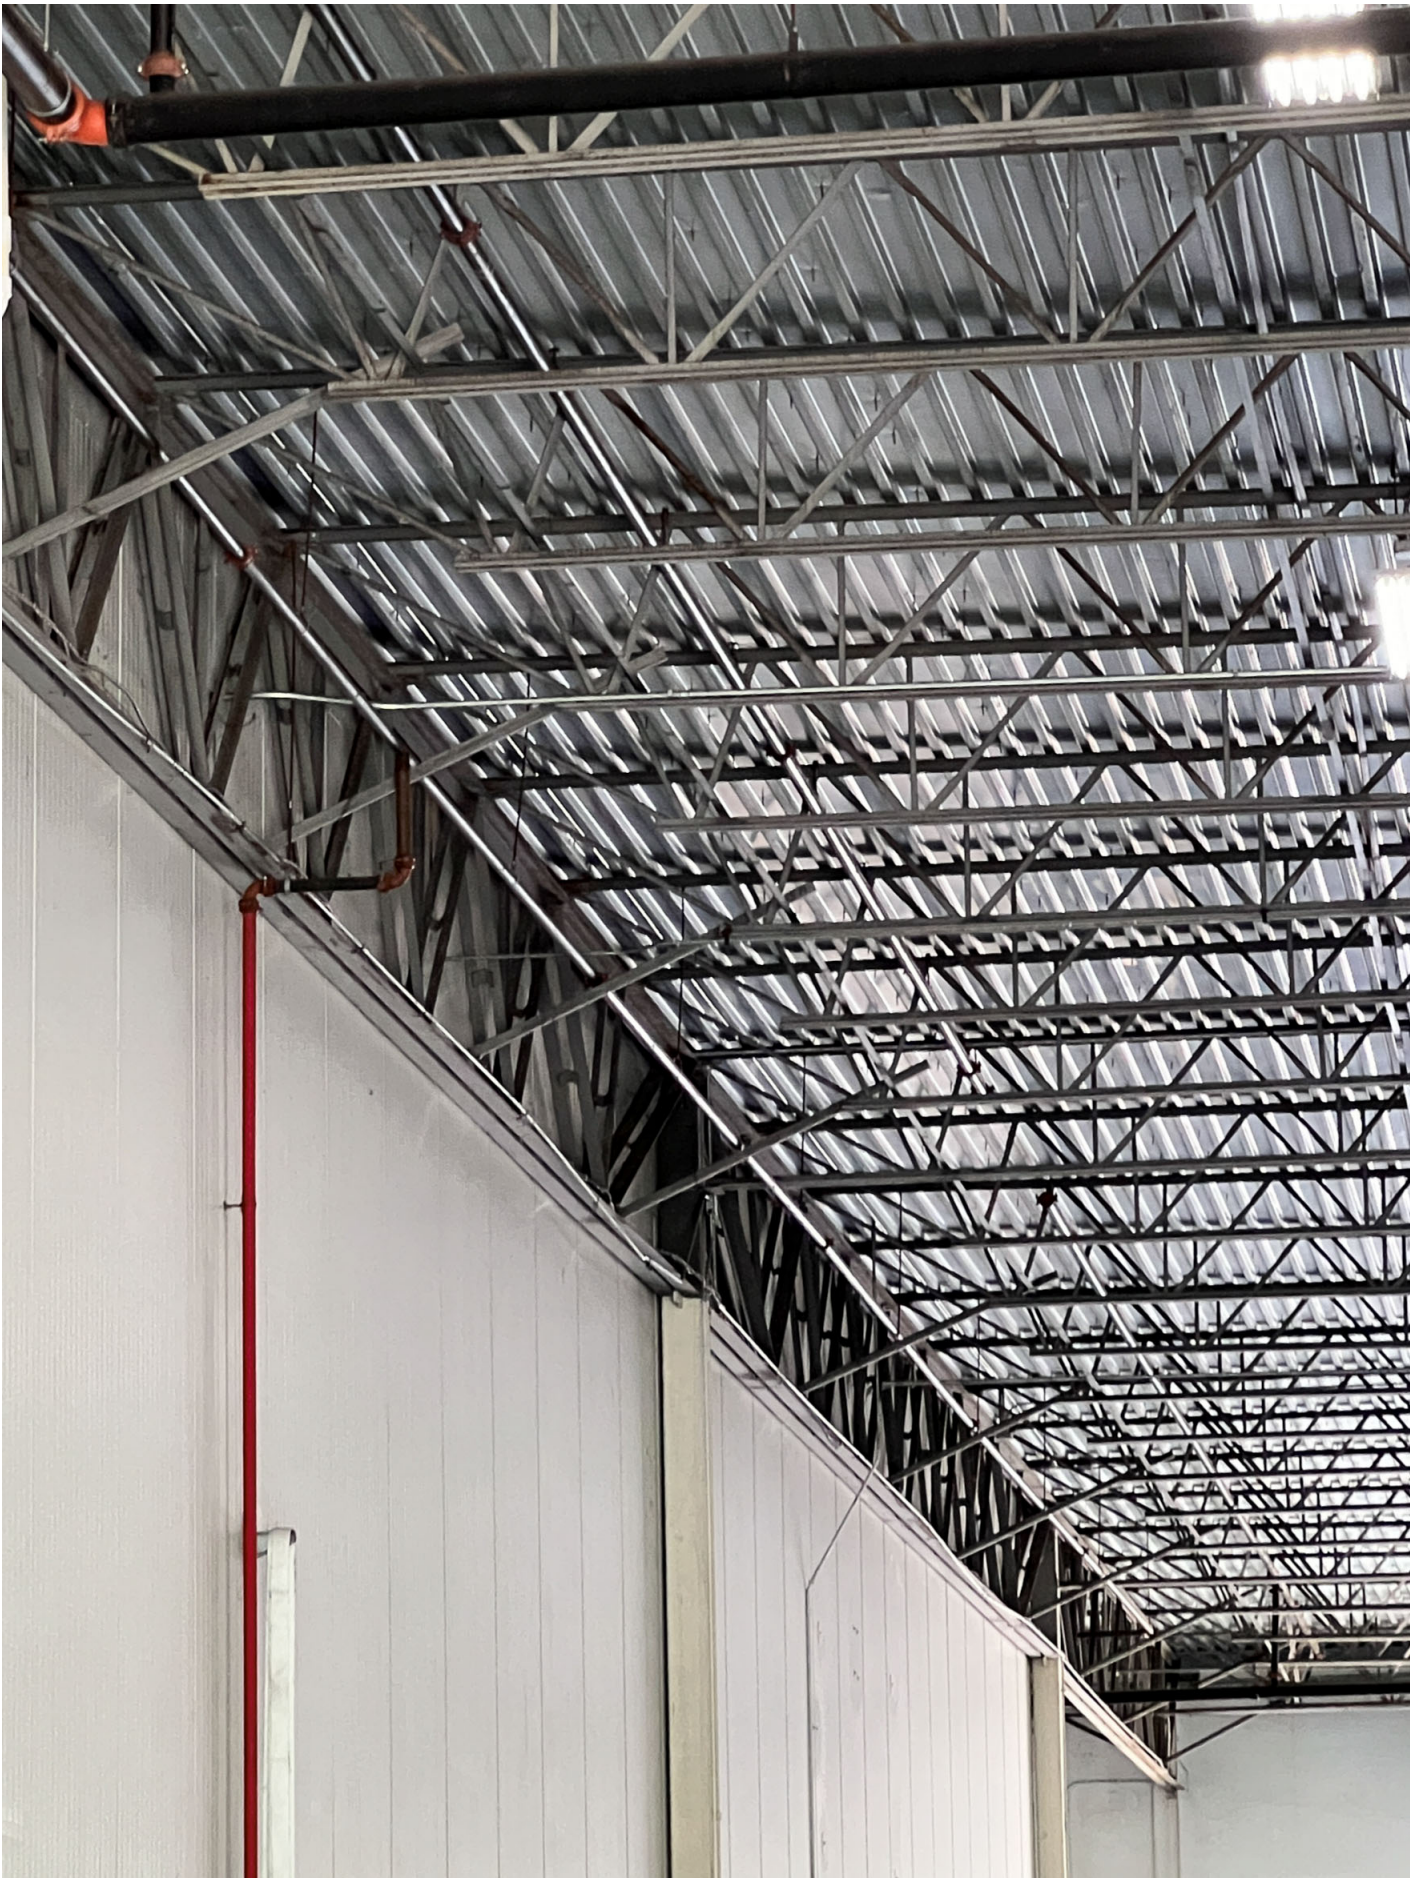
Utility penetration

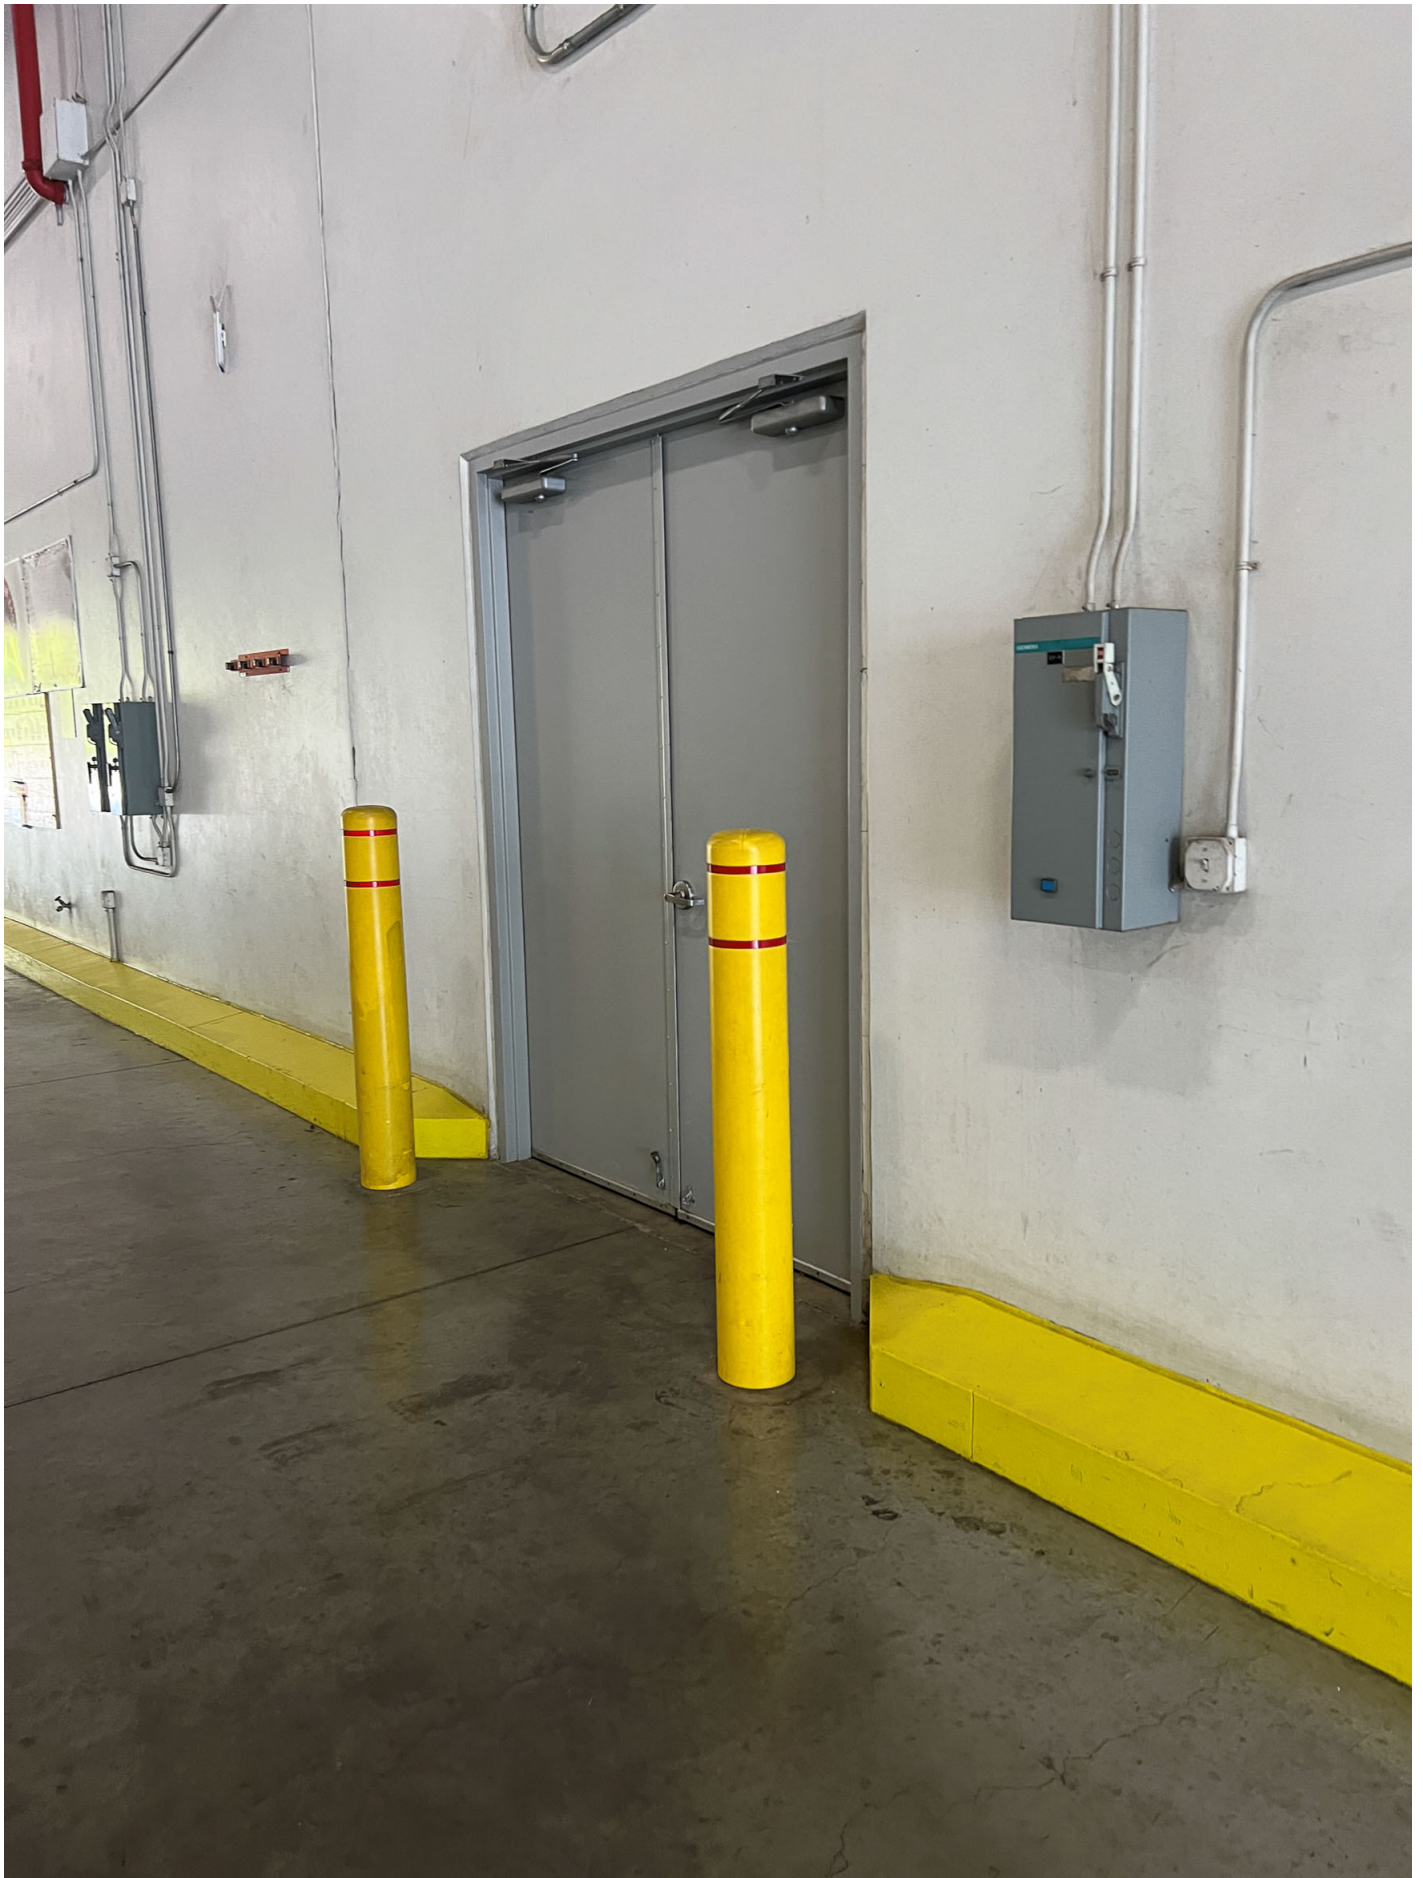
East wall of west drive-thru warehouse

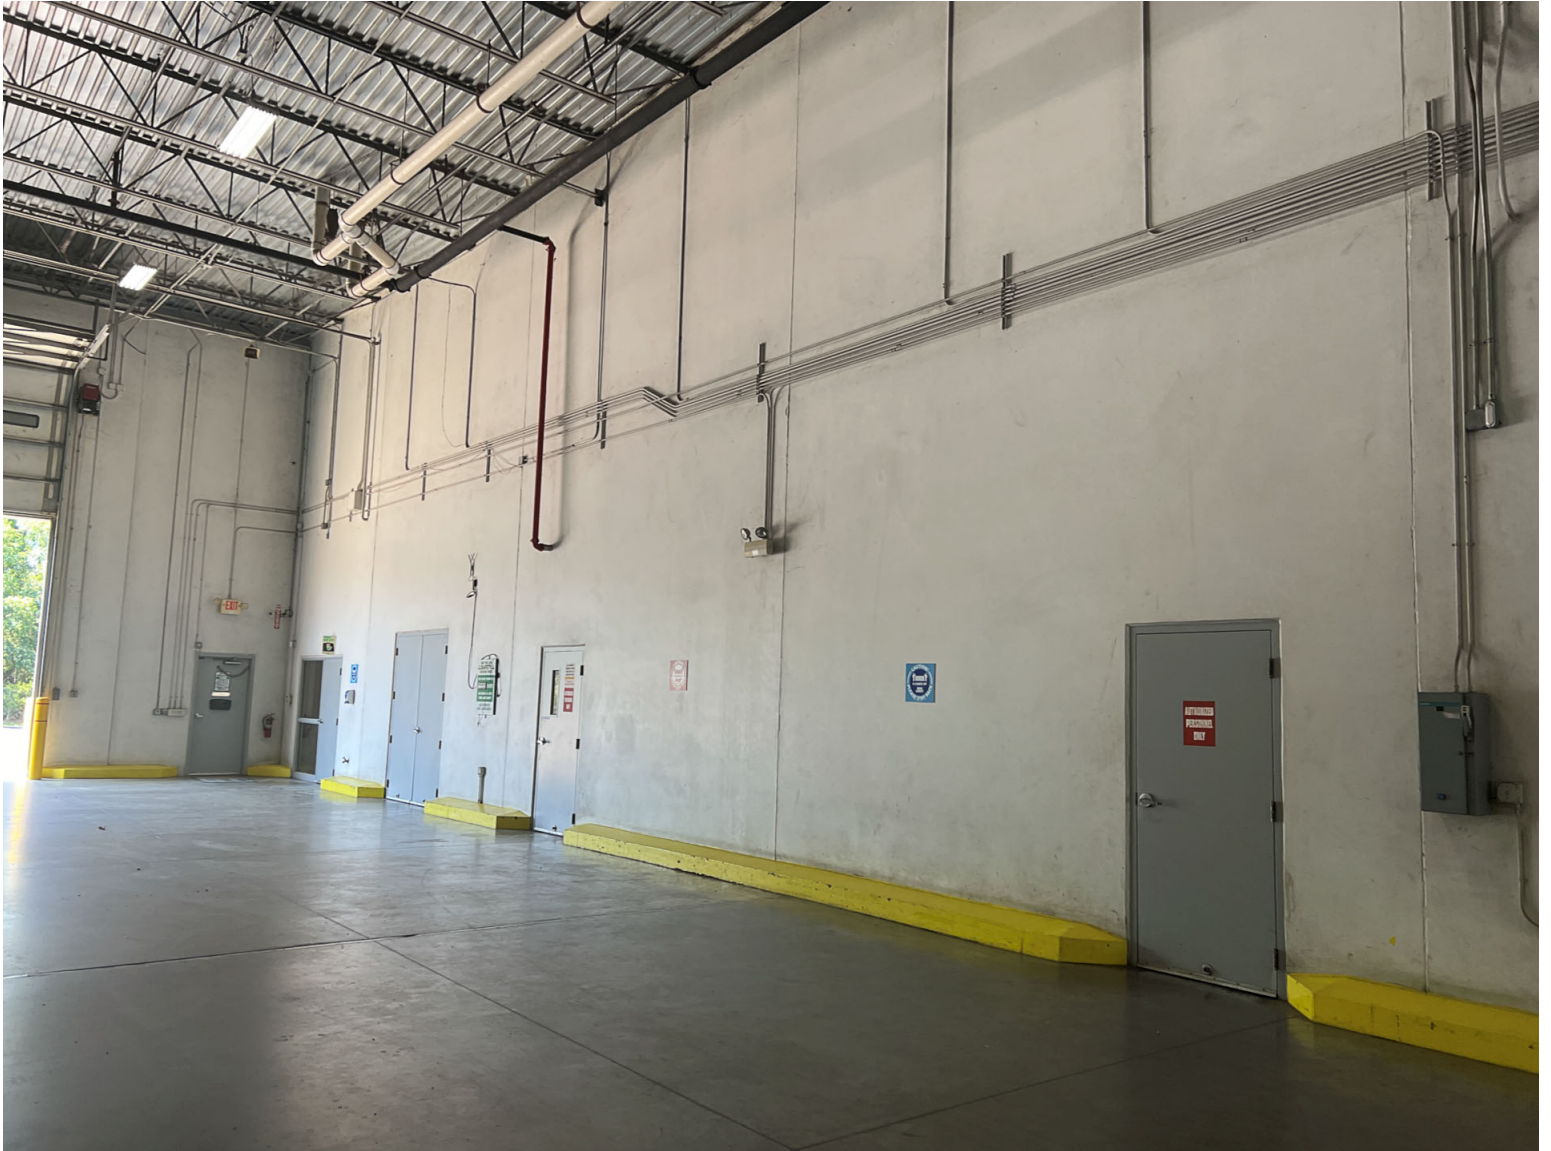
East wall of the west drive-thru bay - Emergency & general disconnects

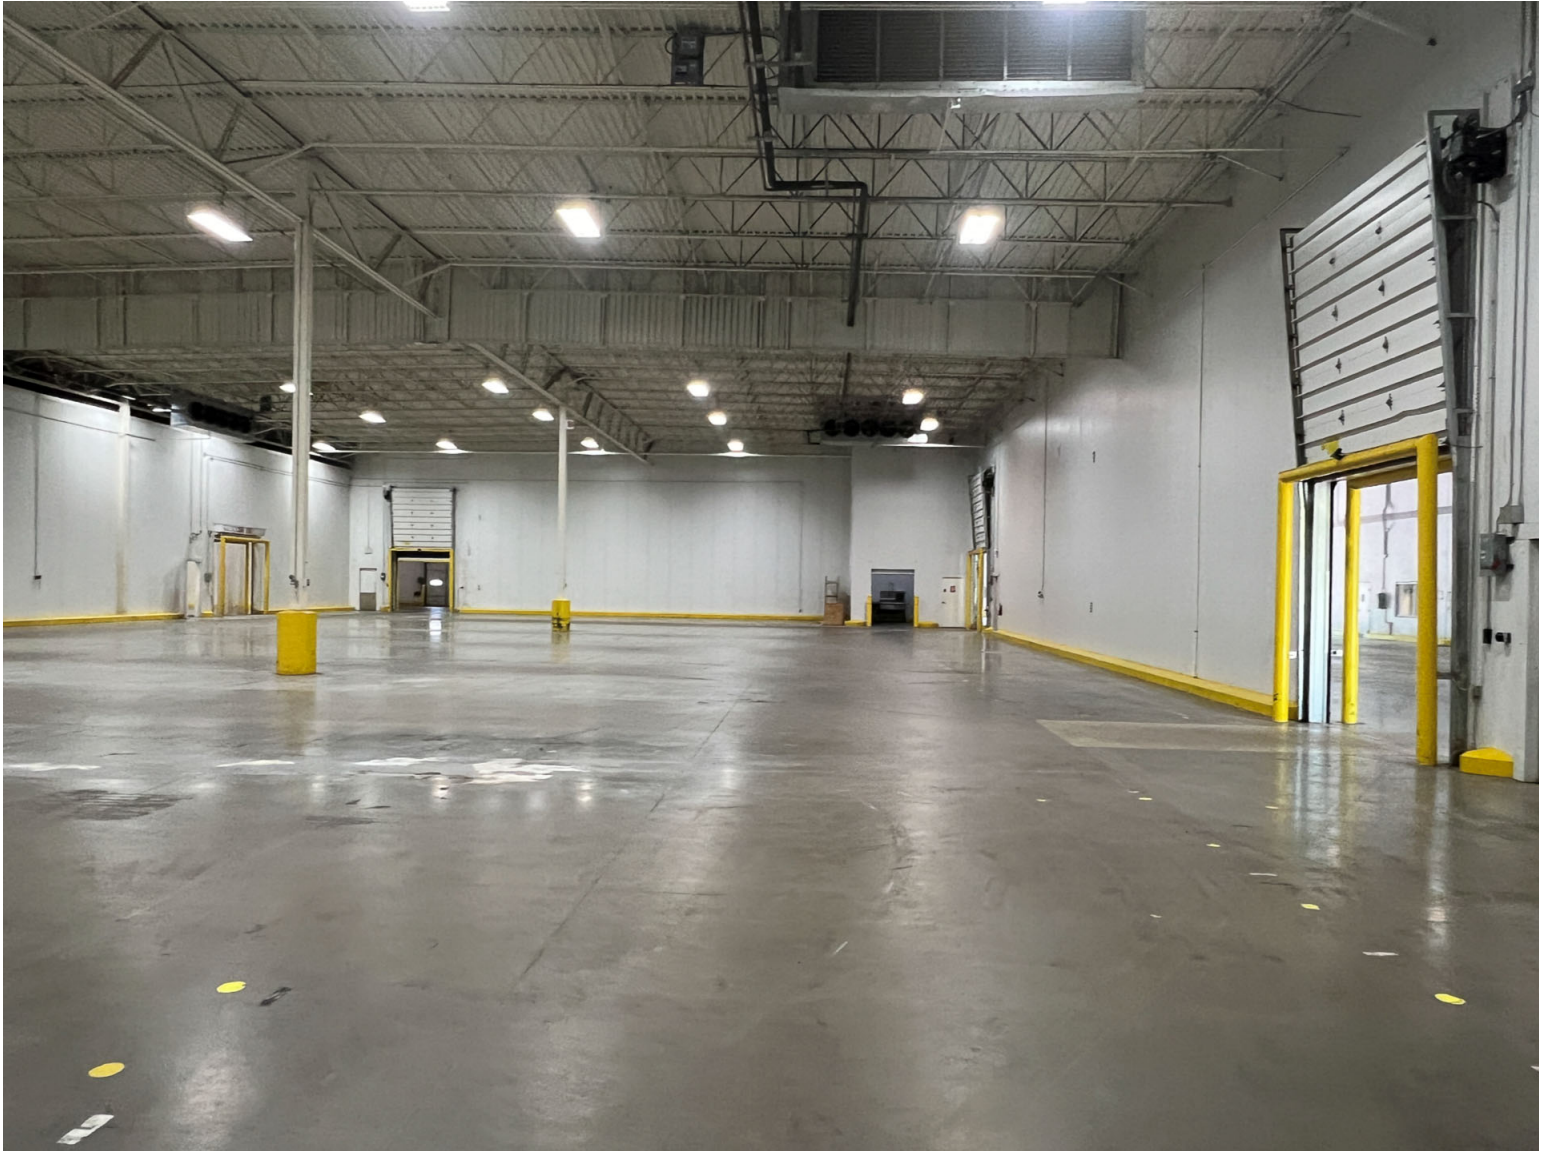
The existing fire sprinkler system is currently served from the front of the building with an insulated 8" backflow preventor above grade. All observed piping, valves and sprinkler heads looked to be in good working condition with no noticeable issues. It was observed that the yearly system inspections have been completed as of February 2024.

Fire sprinkler system

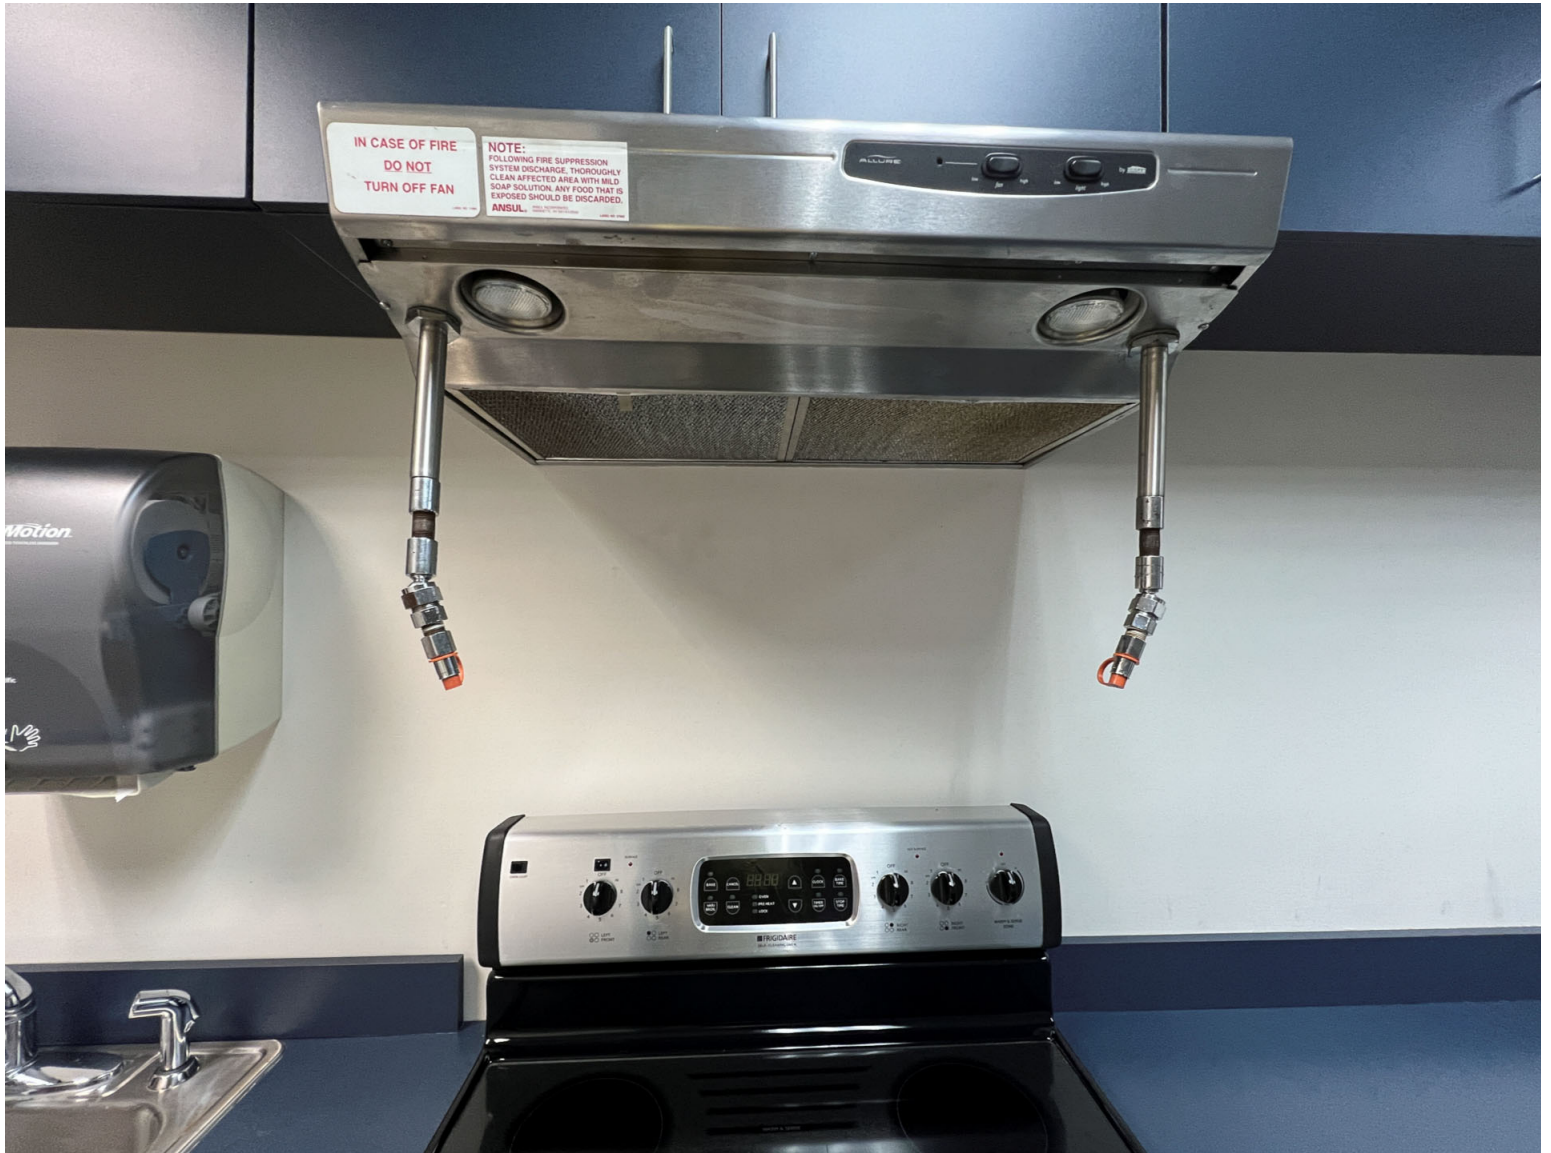
Stove / Oven with exhaust hood & Ansul system

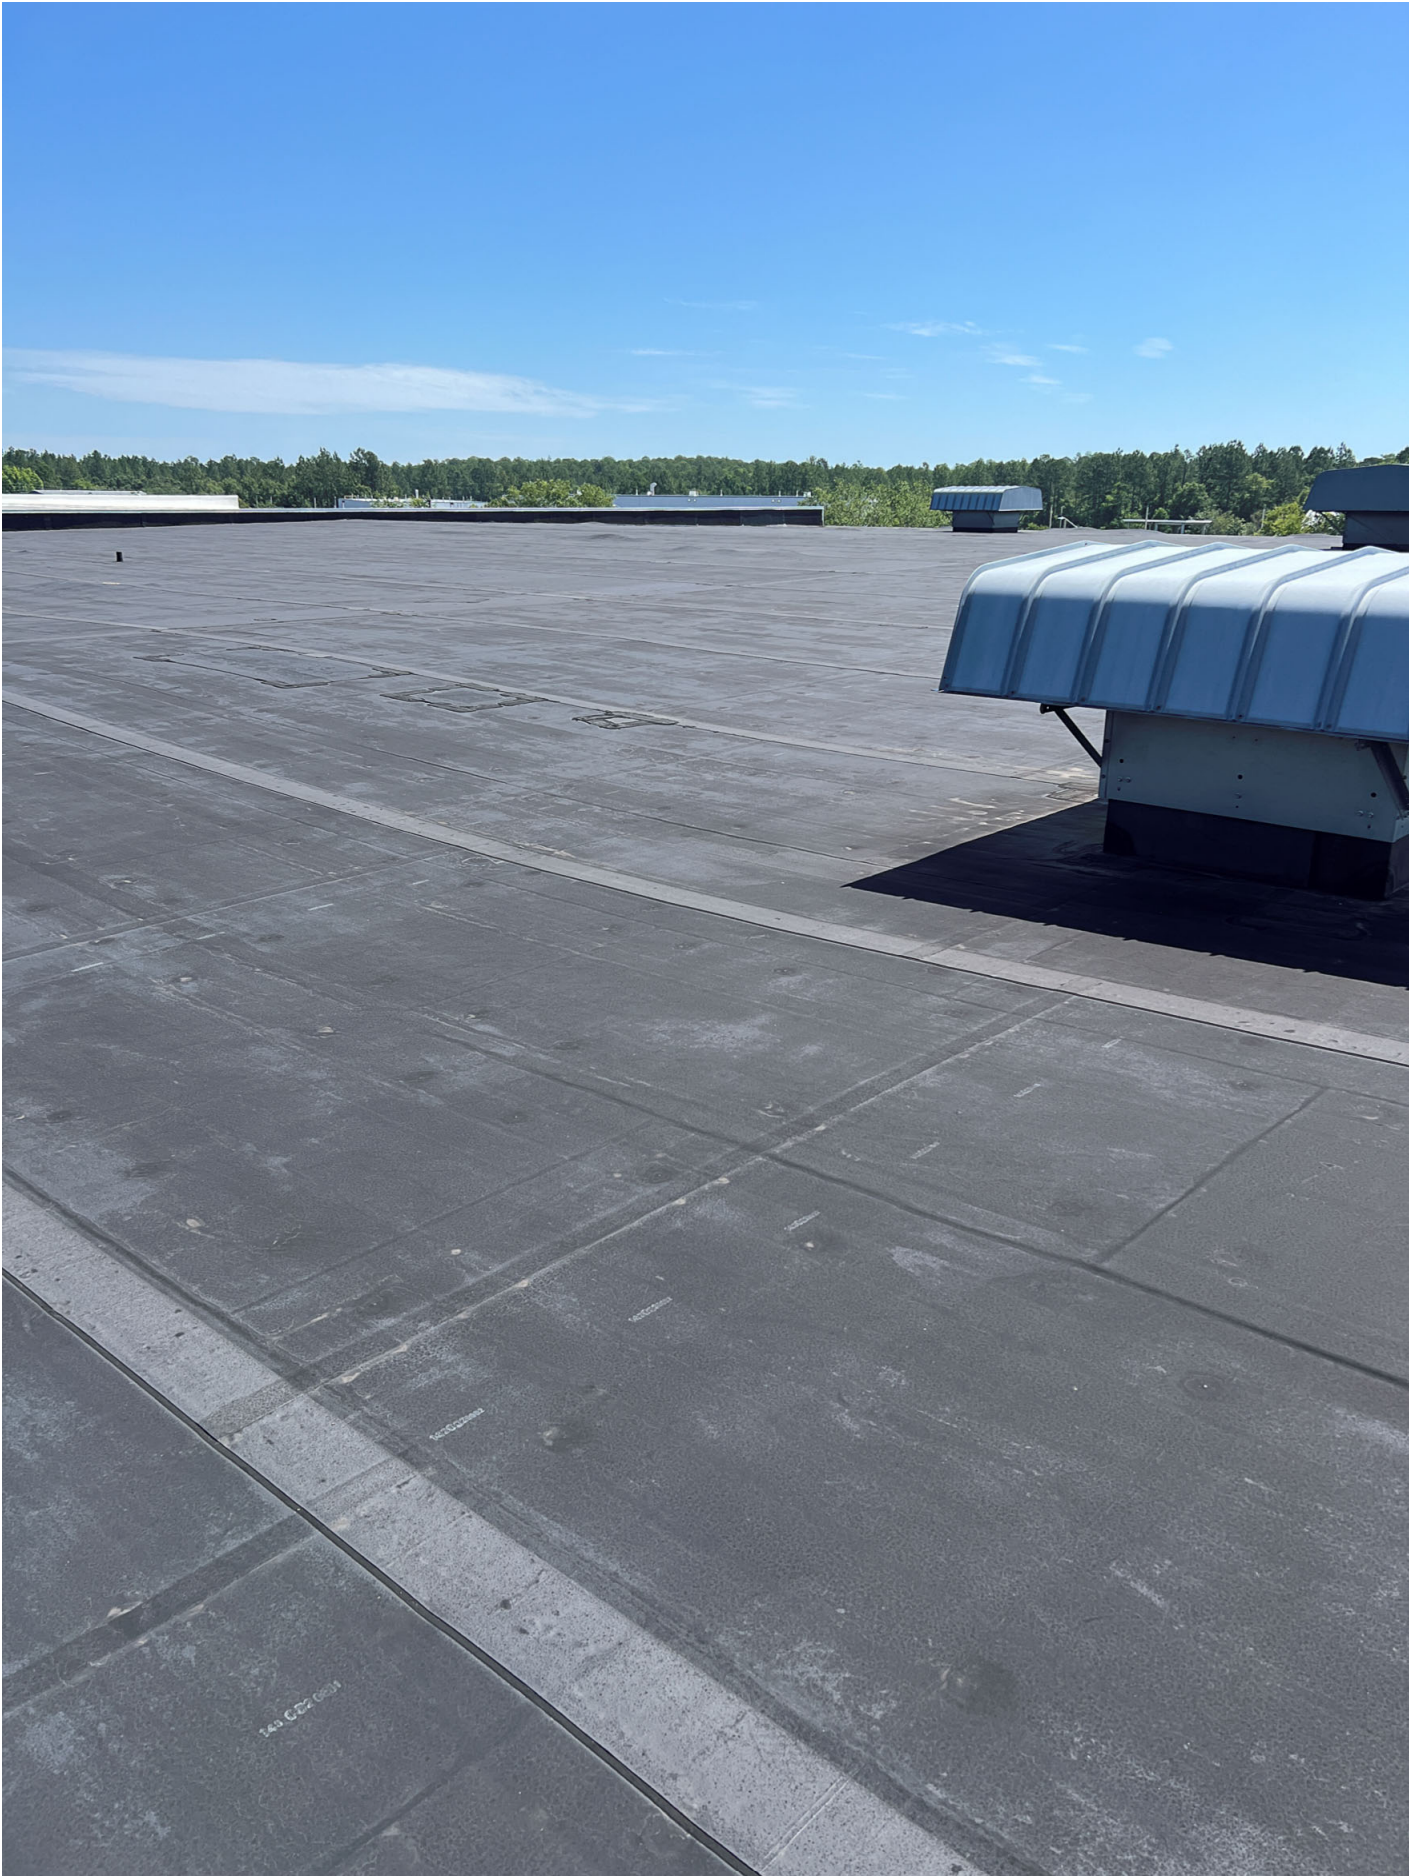
Upper 2000 warehouse roof east portion
