RE: Due Diligence Report – Burkhardt Sales & Service

As part of the County's due diligence efforts to evaluate the conditions of the existing commercial industrial warehouse building (Burkhardt Sales & Service) located at 6125 NW 18<sup>th</sup> Drive, Gainesville, FL 32653, Paul Stresing Associates (PSA) was tasked with conducting an inspection of the facility to evaluate its condition prior to entering into a full purchase agreement to its purchase. On May 30, 2024, I was accompanied by KPI Engineering (KPI) where we walked the roof and interior of the facility with Mr. Matt Fultz of the Alachua County Facilities Department and Mr. Daniel Burkhardt, representing the seller where we gained access to the site and buildings to begin our evaluation efforts.

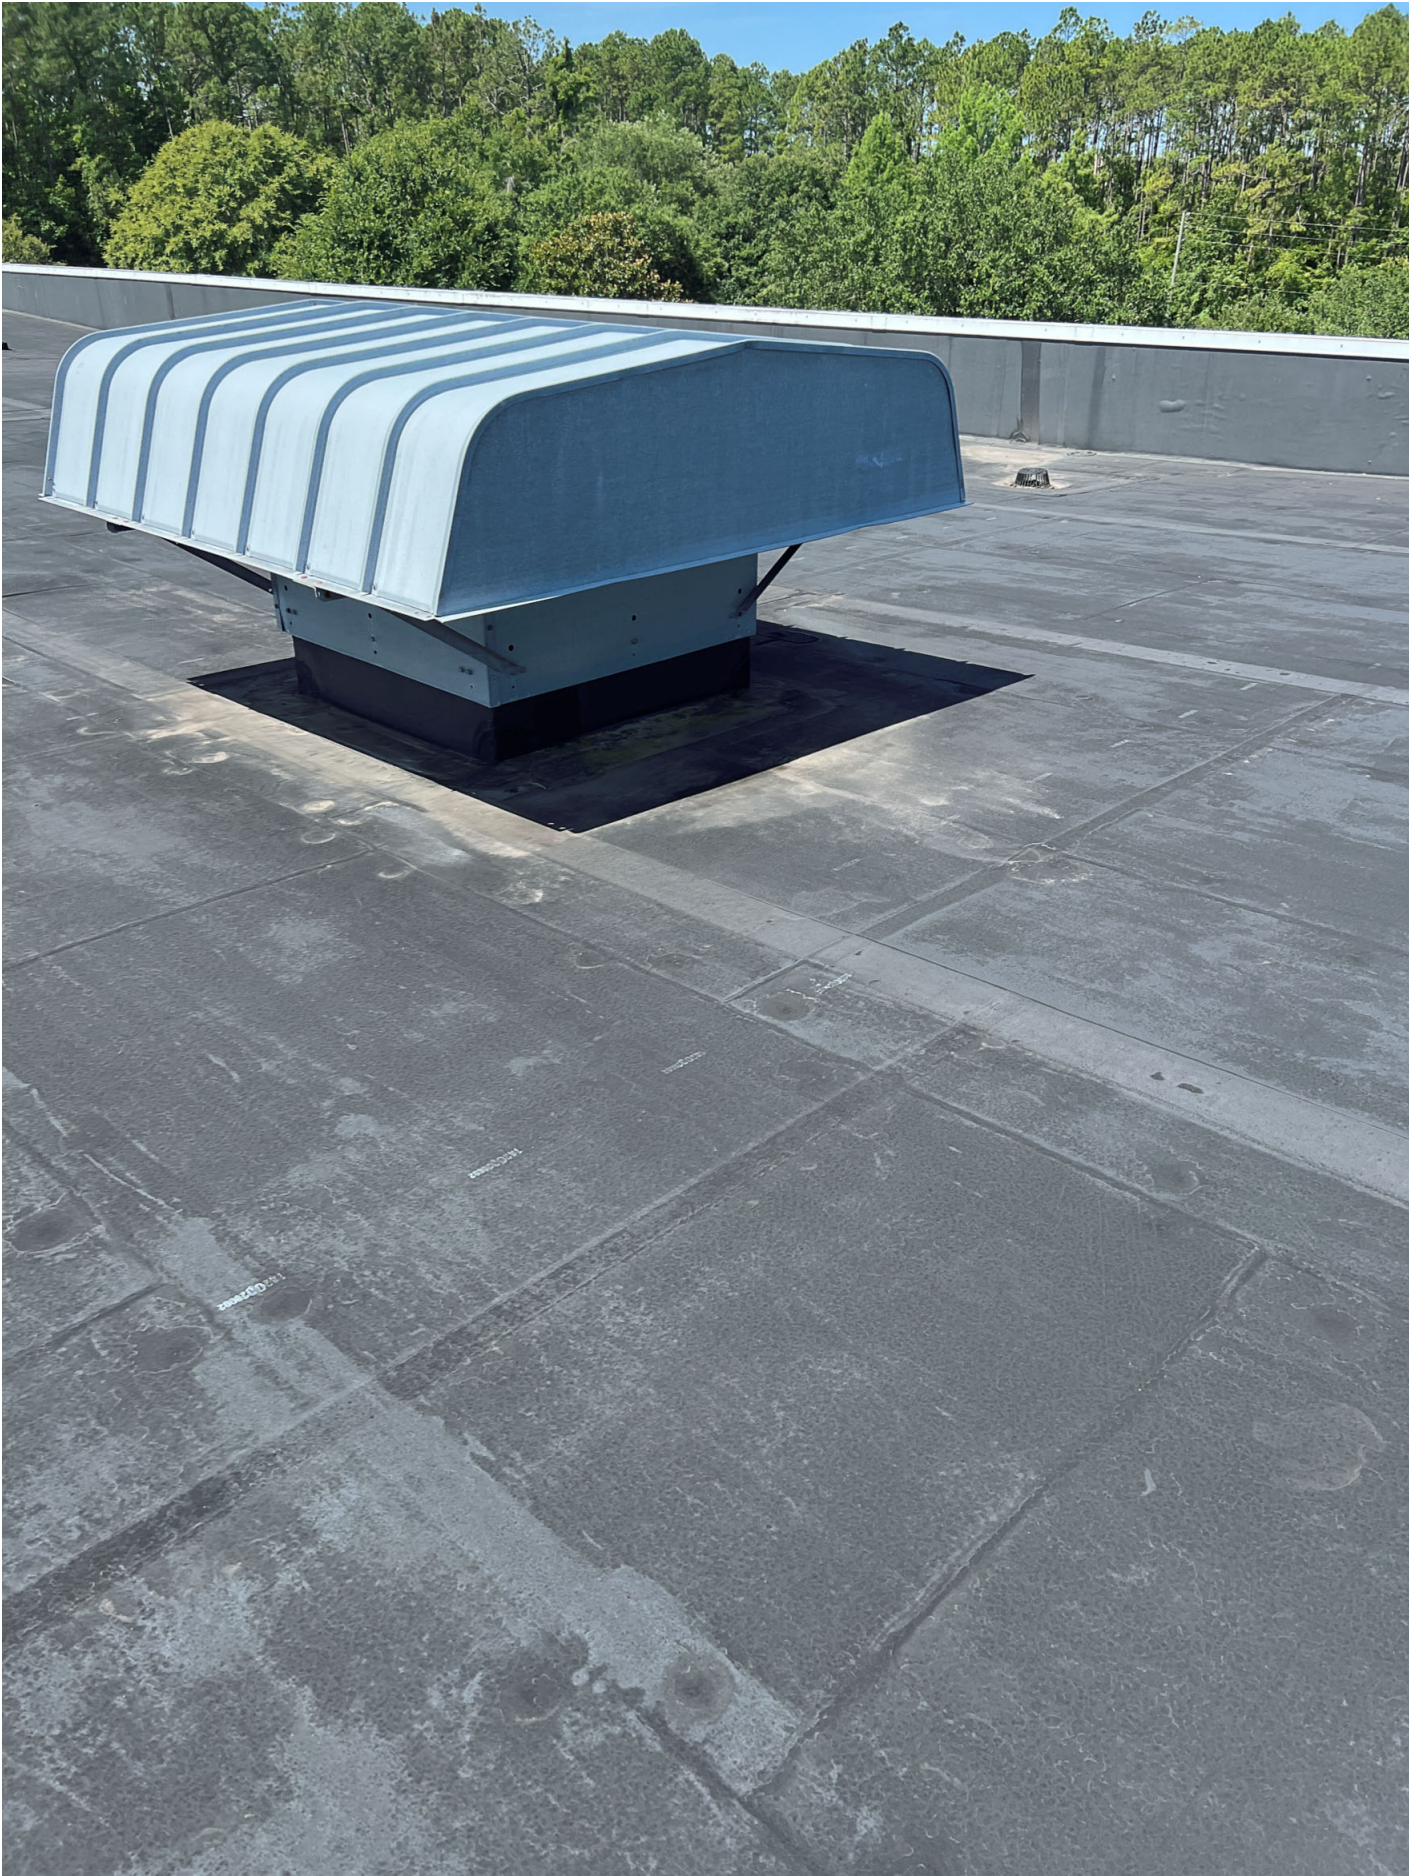
Large vapor bladders under the EPDM single-ply roof membrane

asphalt paved areas and replacement of the two-roof top A/C units this could be done to minimize daily operation inconvenience once the facility is fully operational. The re-roofing efforts can occur at this time or with substantial patching and repairs the building can gain a little more time out of the 24-year-old roof, but it needs to be pointed out the roof has exceeded any roof warranty issued at the time its installation.

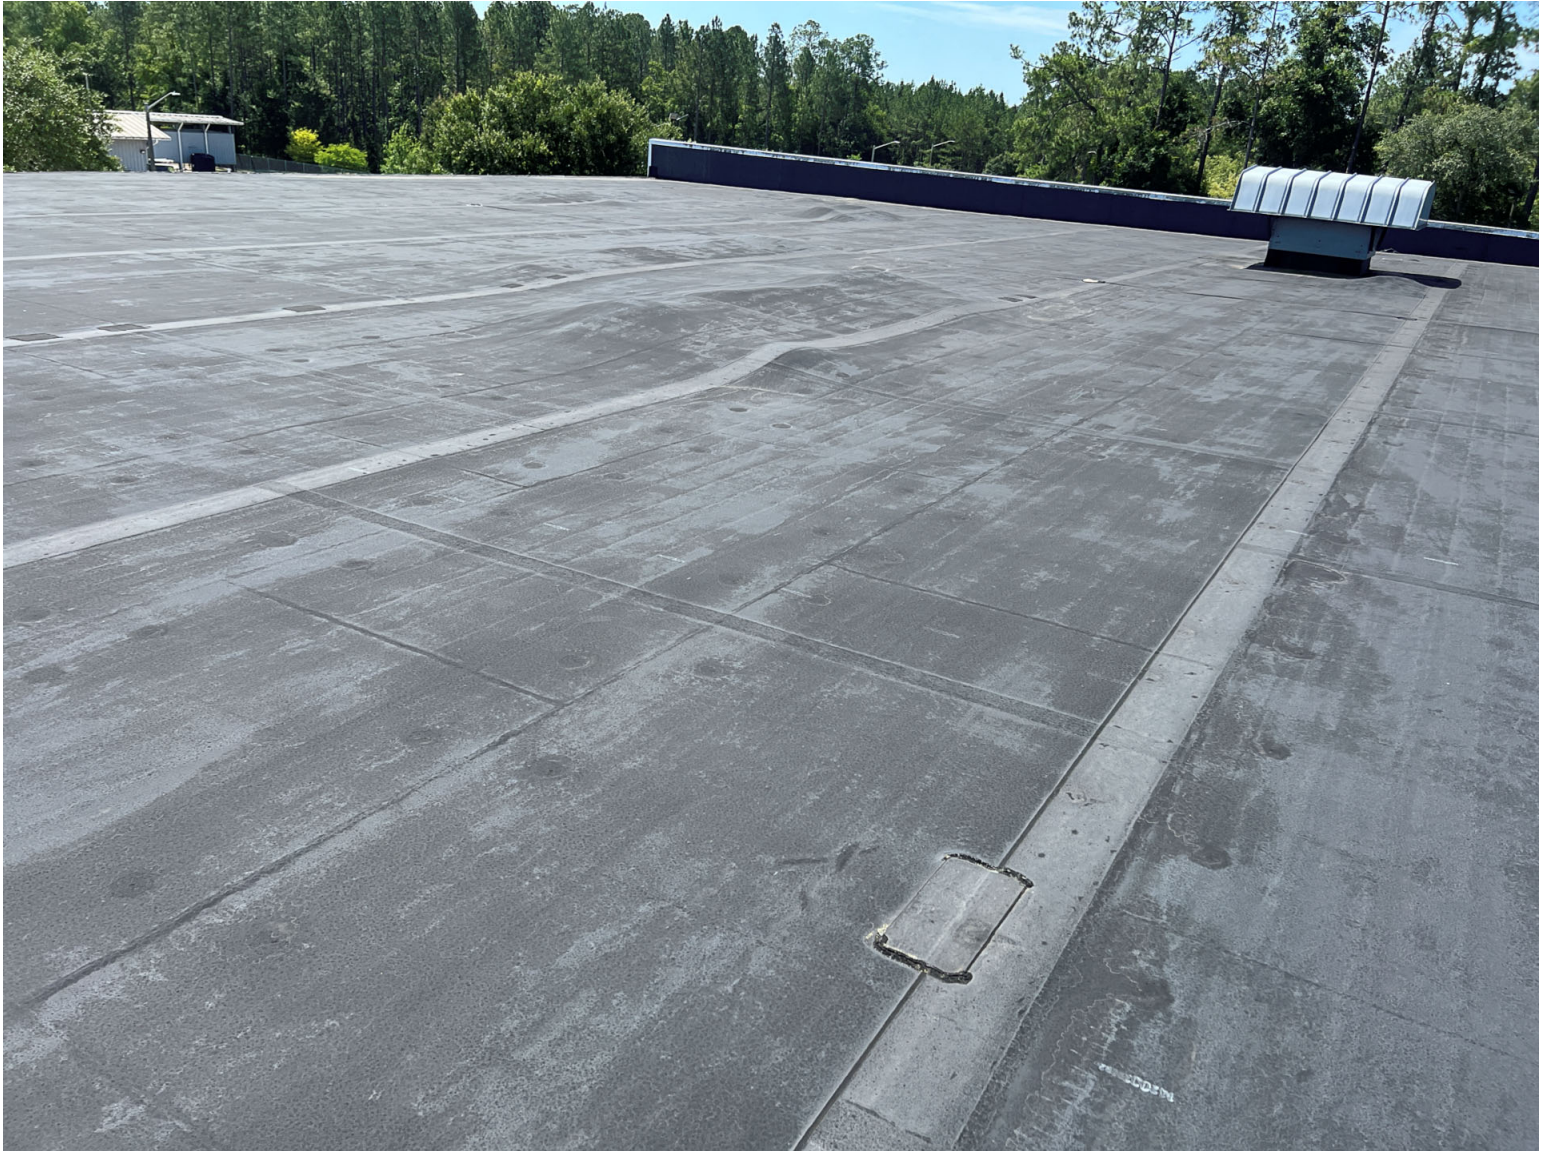
2000 warehouse roof open roof area with large vapor bladders plaguing the roof area

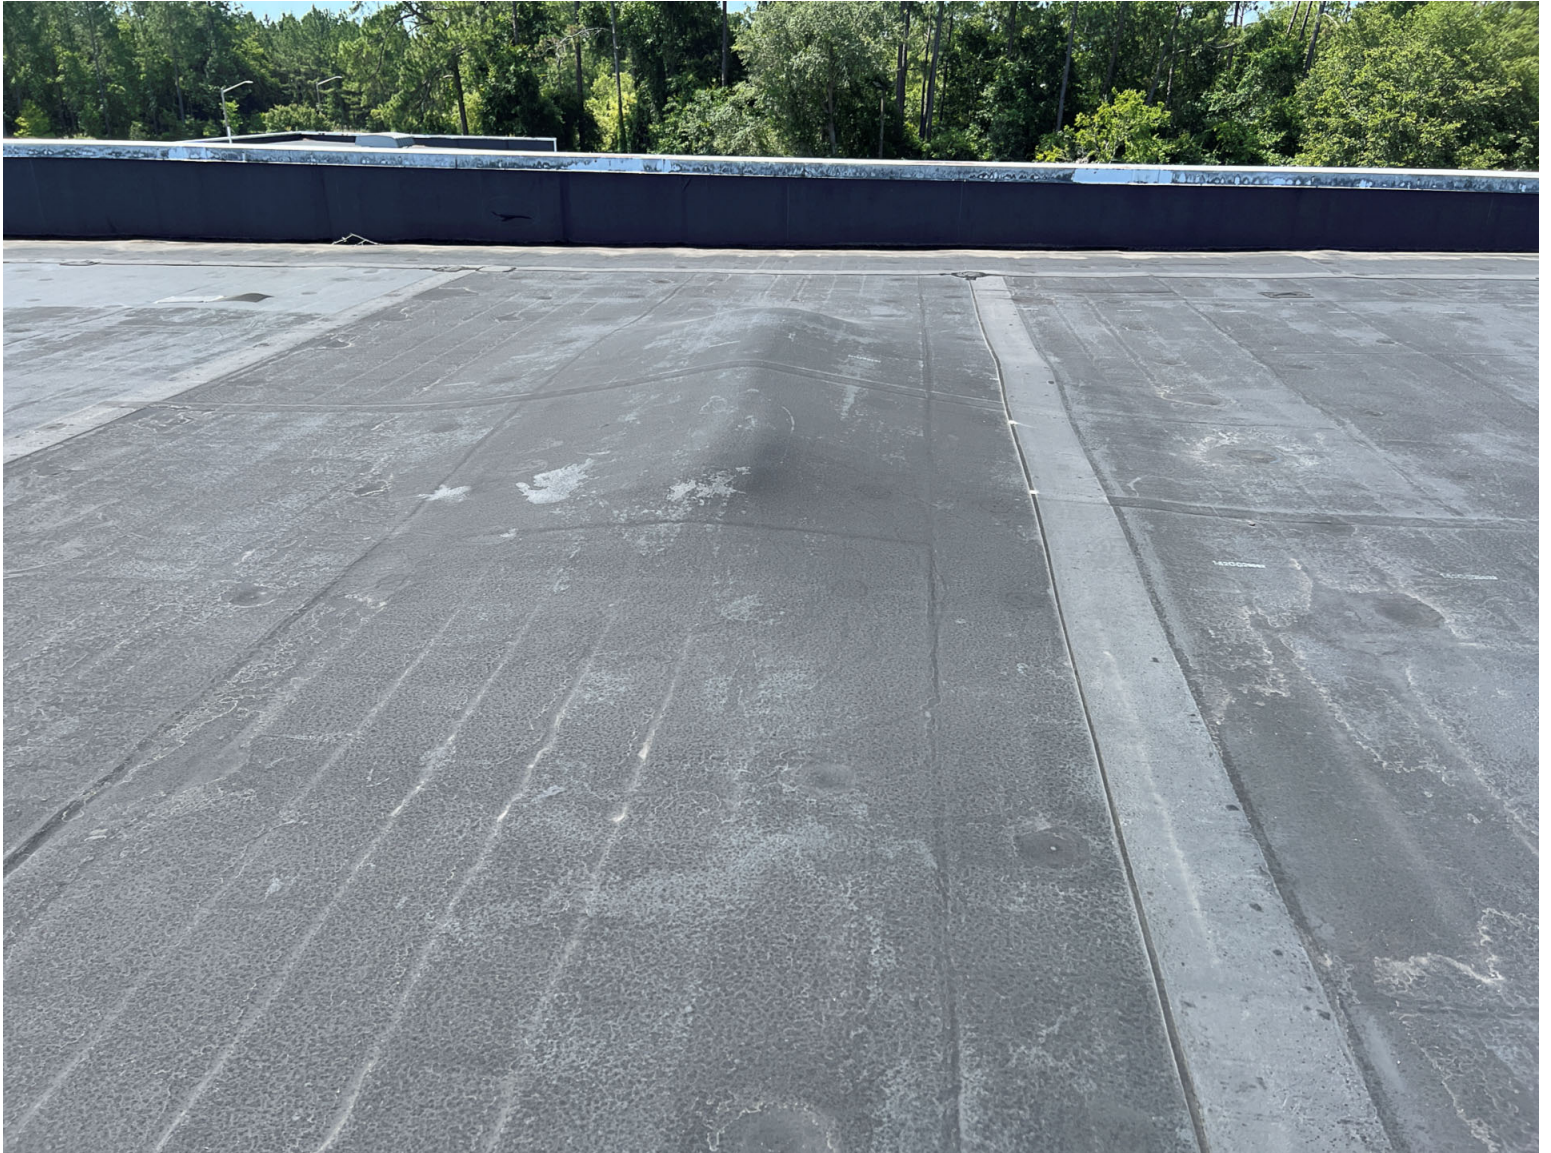
2000 warehouse roof open roof area with large vapor bladders plaguing the roof area

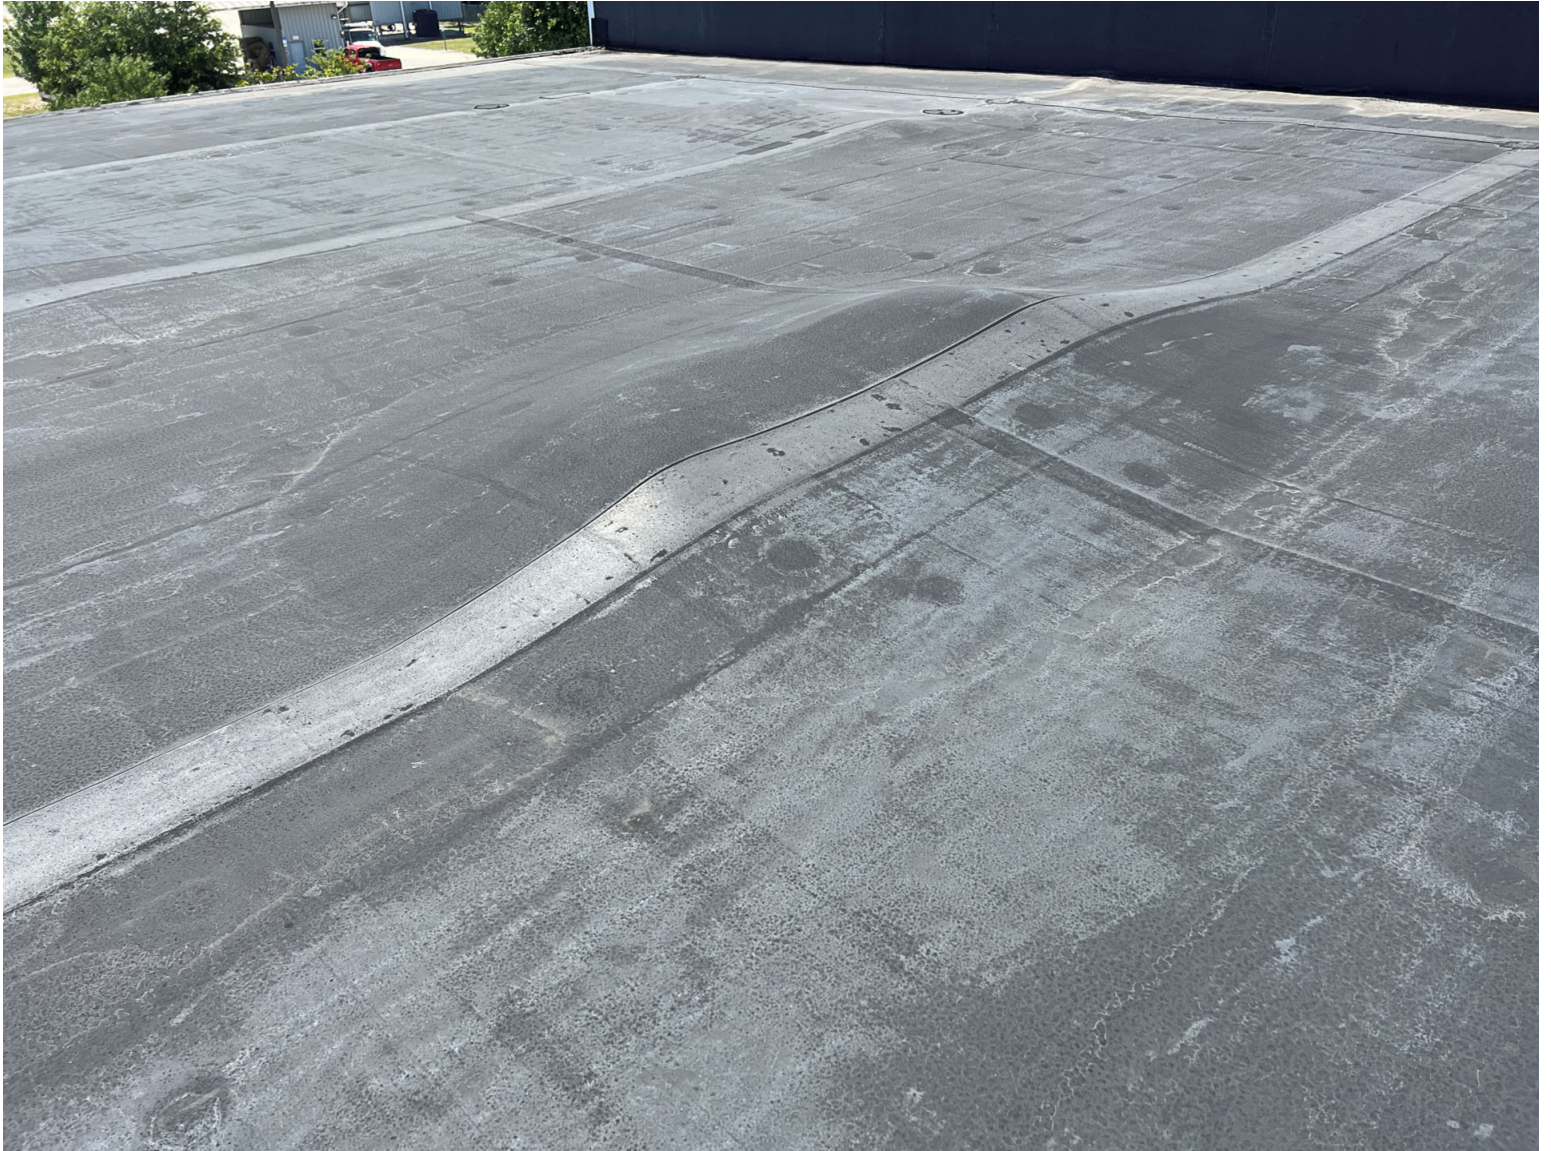
2000 warehouse roof open roof area with large vapor bladders plaguing the roof area

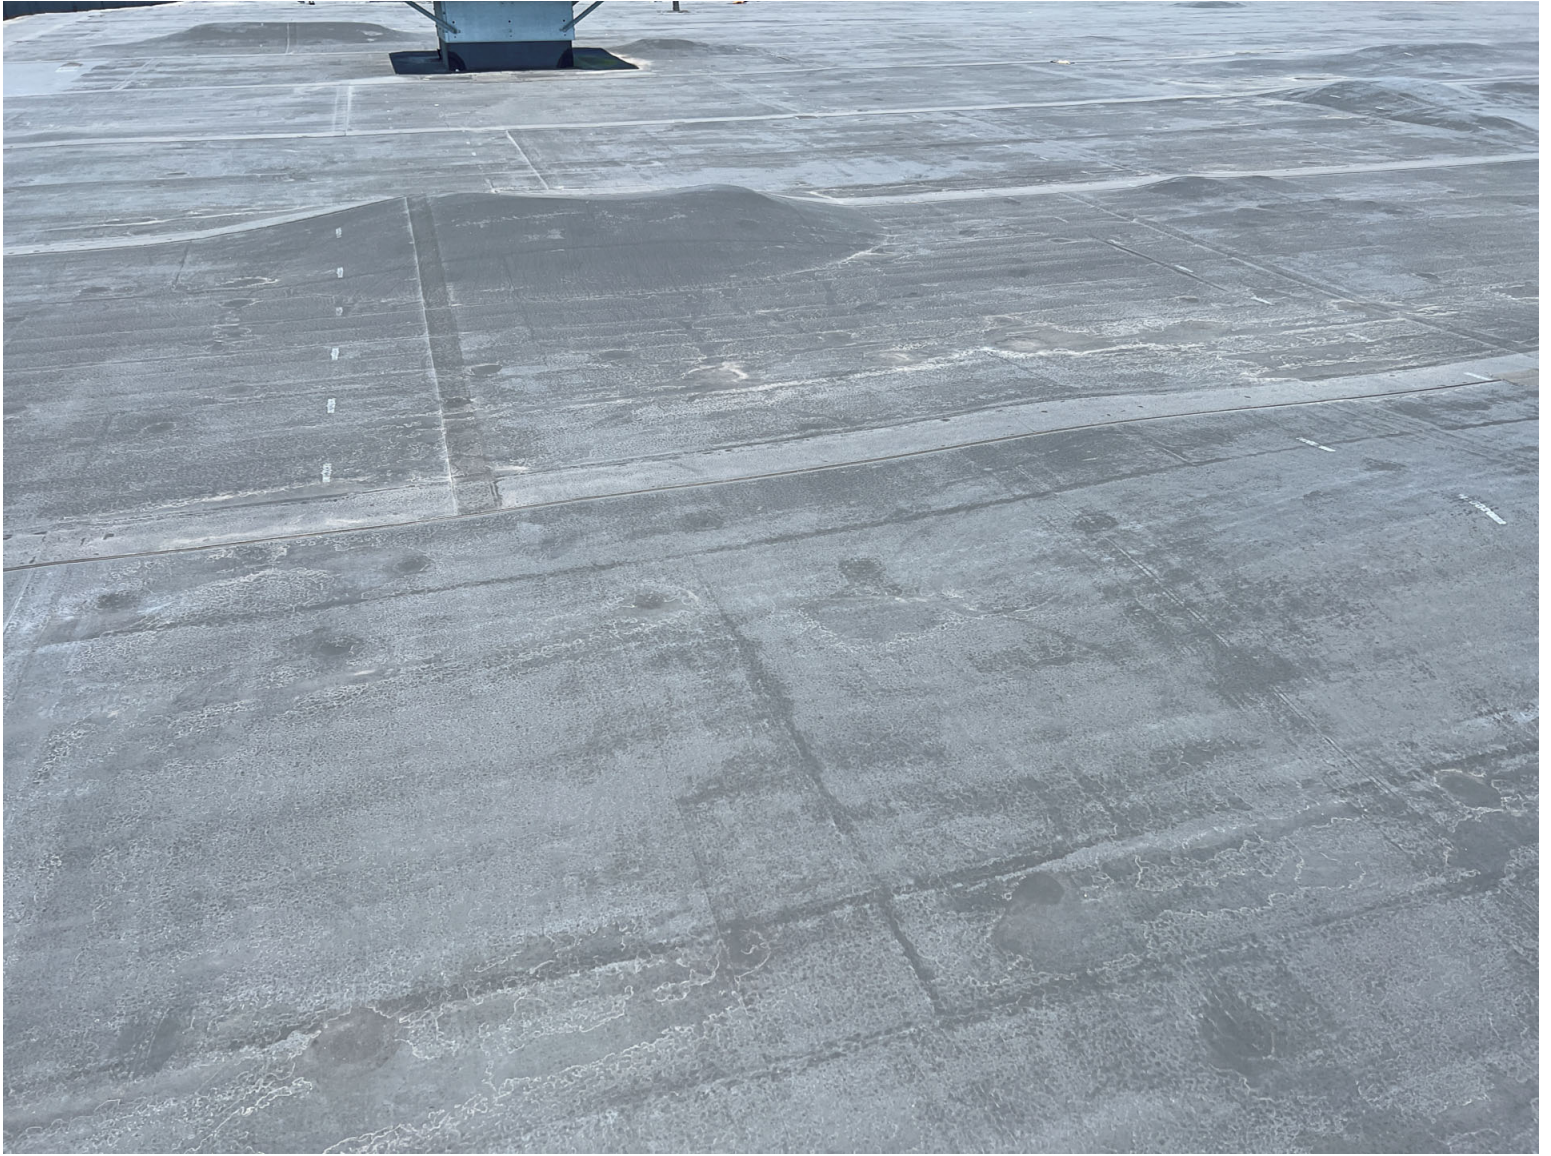
2000 warehouse roof open roof area with large vapor bladders plaguing the roof area

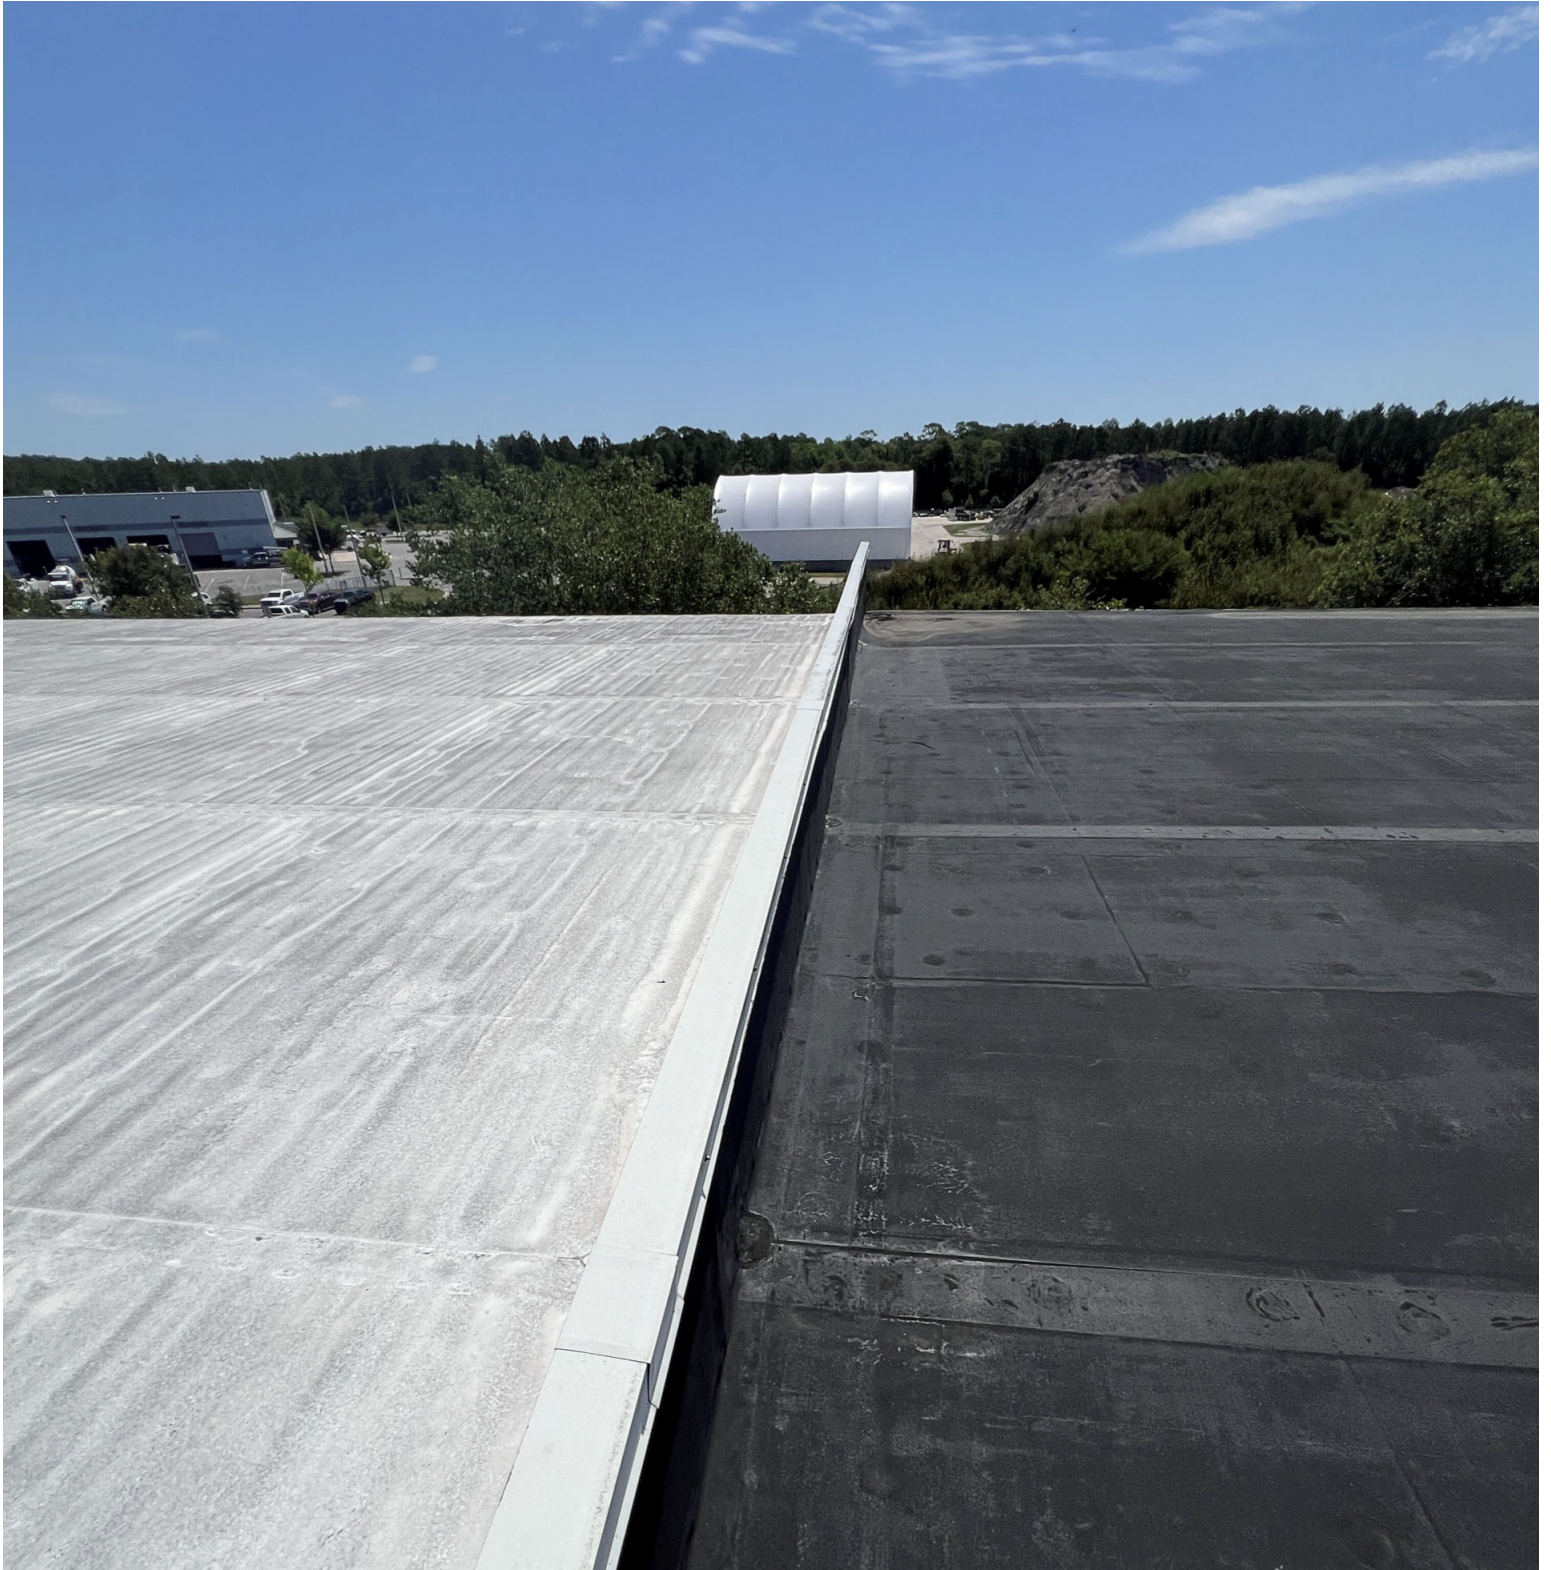
2011 warehouse addition single-ply PTO roof membrane, a few small vapor bladders

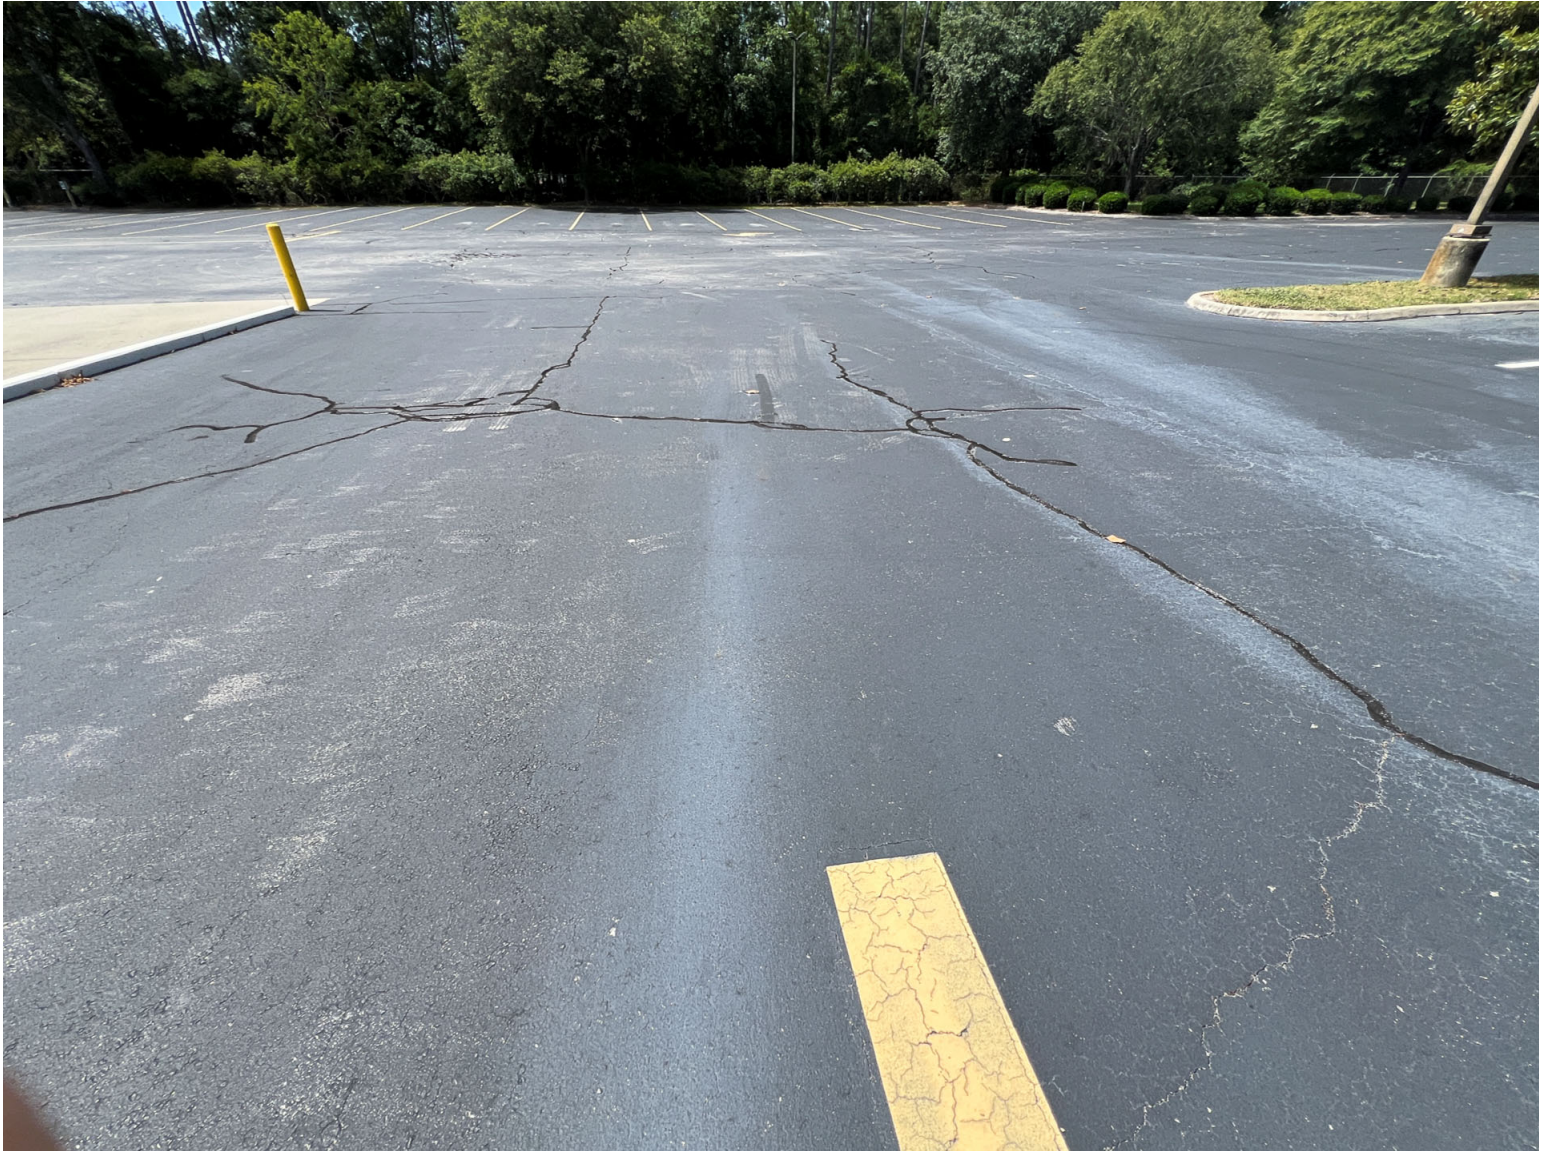
Heavy duty truck paving & parking area asphalt paving requiring maintenance

In conclusion, the building is in very good general shape and there are no signs of structural concerns or compromises, three items do need to be addressed within the near future, the replacement of two of the A/C units on the lower administration roof will be required in the near future, the re-roofing of the original 2000 building should be considered to preserve the condition of the insulation and metal roof framing and interior finishes. Because of the amount of roof top equipment located on the lower roof area I would recommend a two-ply roof system to minimize exposure to tears and punctures. The upper roof of the warehouse does have exhaust fans which do not really require the maintenance that A/C equipment does so the exposure to damage is lessened, and you could go back with a white fleece back PTO product. The 2011 warehouse addition is capped with a single-ply TPO type membrane and was found to be in reasonably good shape and has a number of additional years of performance in it so this area could wait a few years before being re-roofed or you could decide to simply use this time to re-roof the entire building and get a single building roof warranty. The asphalt heavy duty truck paving requires maintenance that I would do immediately to ensure the subgrade and paving base do not become compromised.

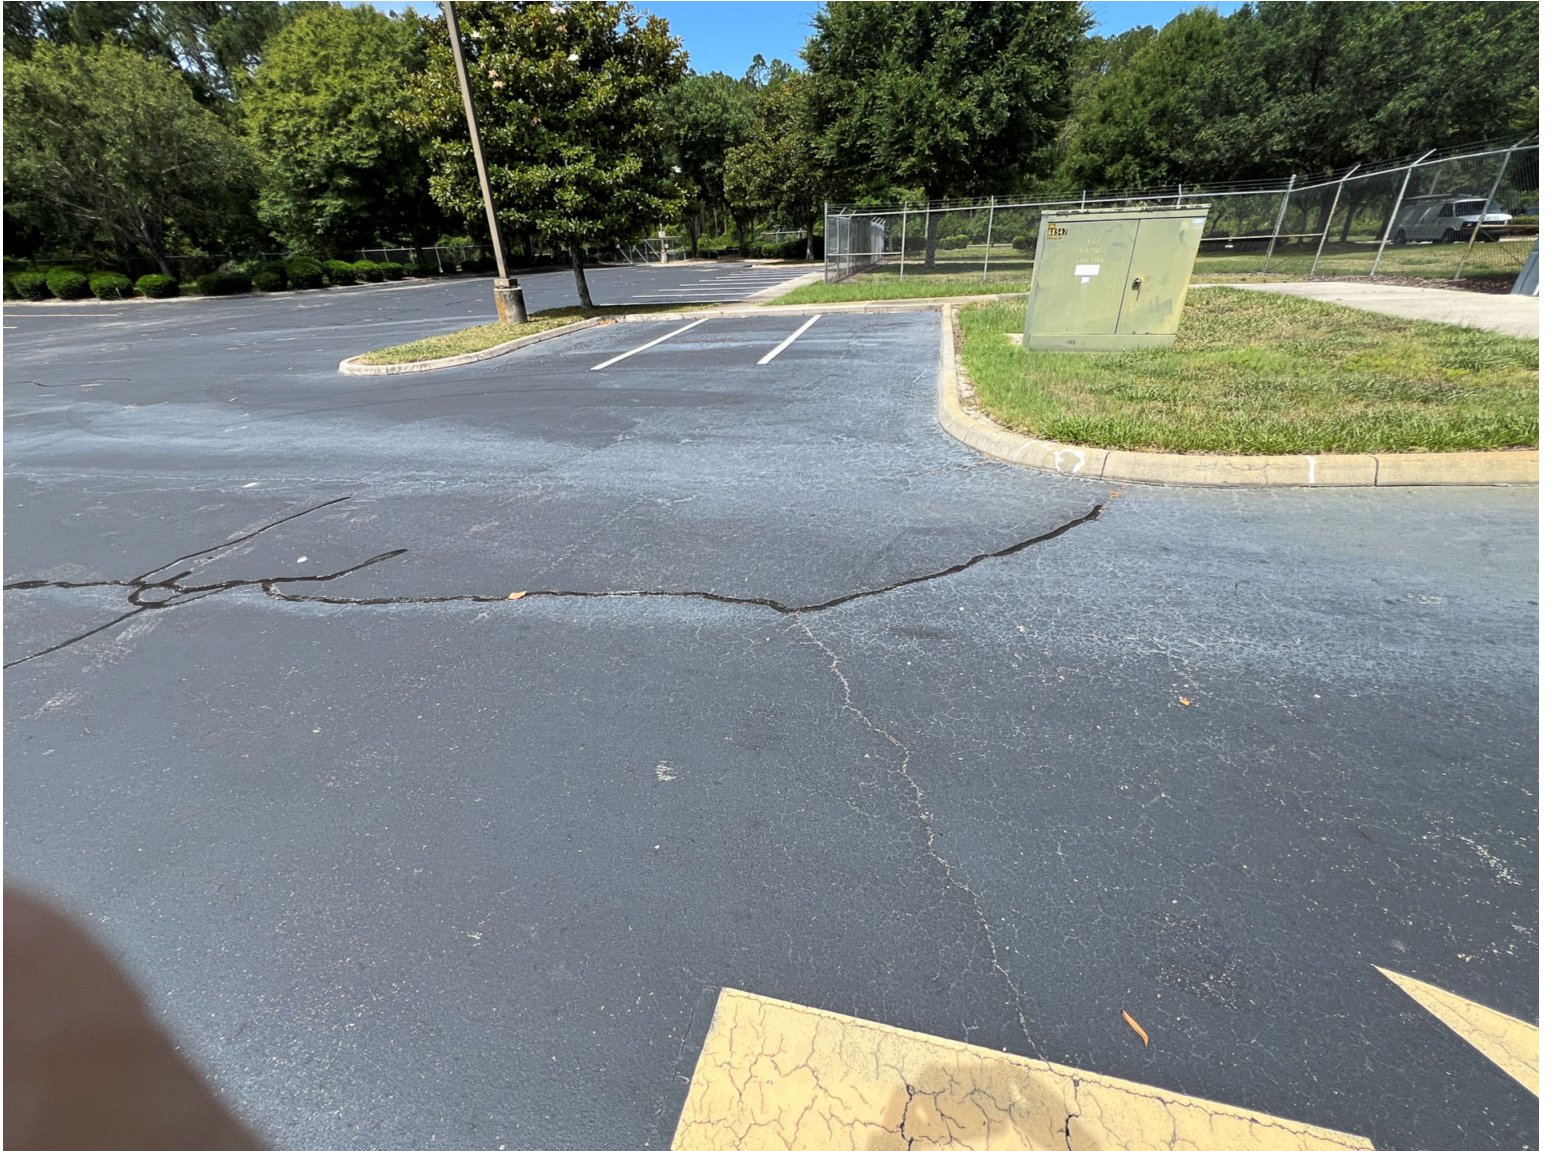
Heavy duty truck paving & parking area asphalt paving requiring maintenance

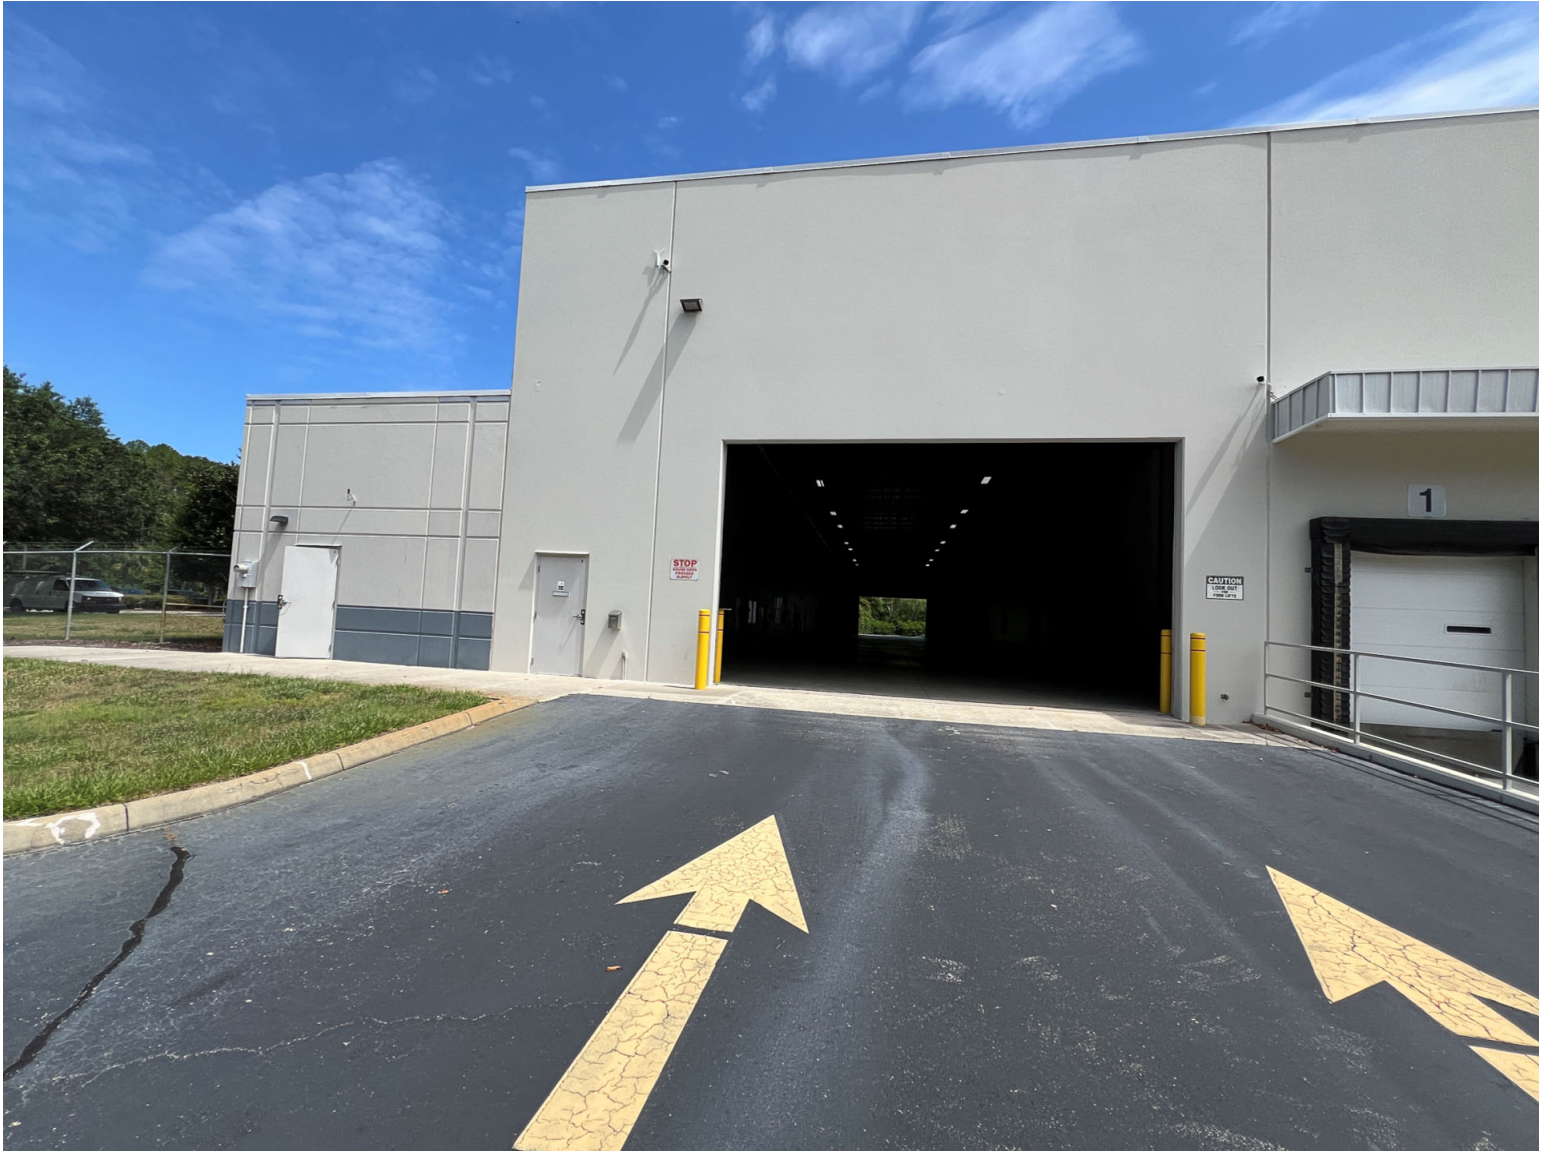
2000 warehouse drive-thru bay / asphalt paving requires attention

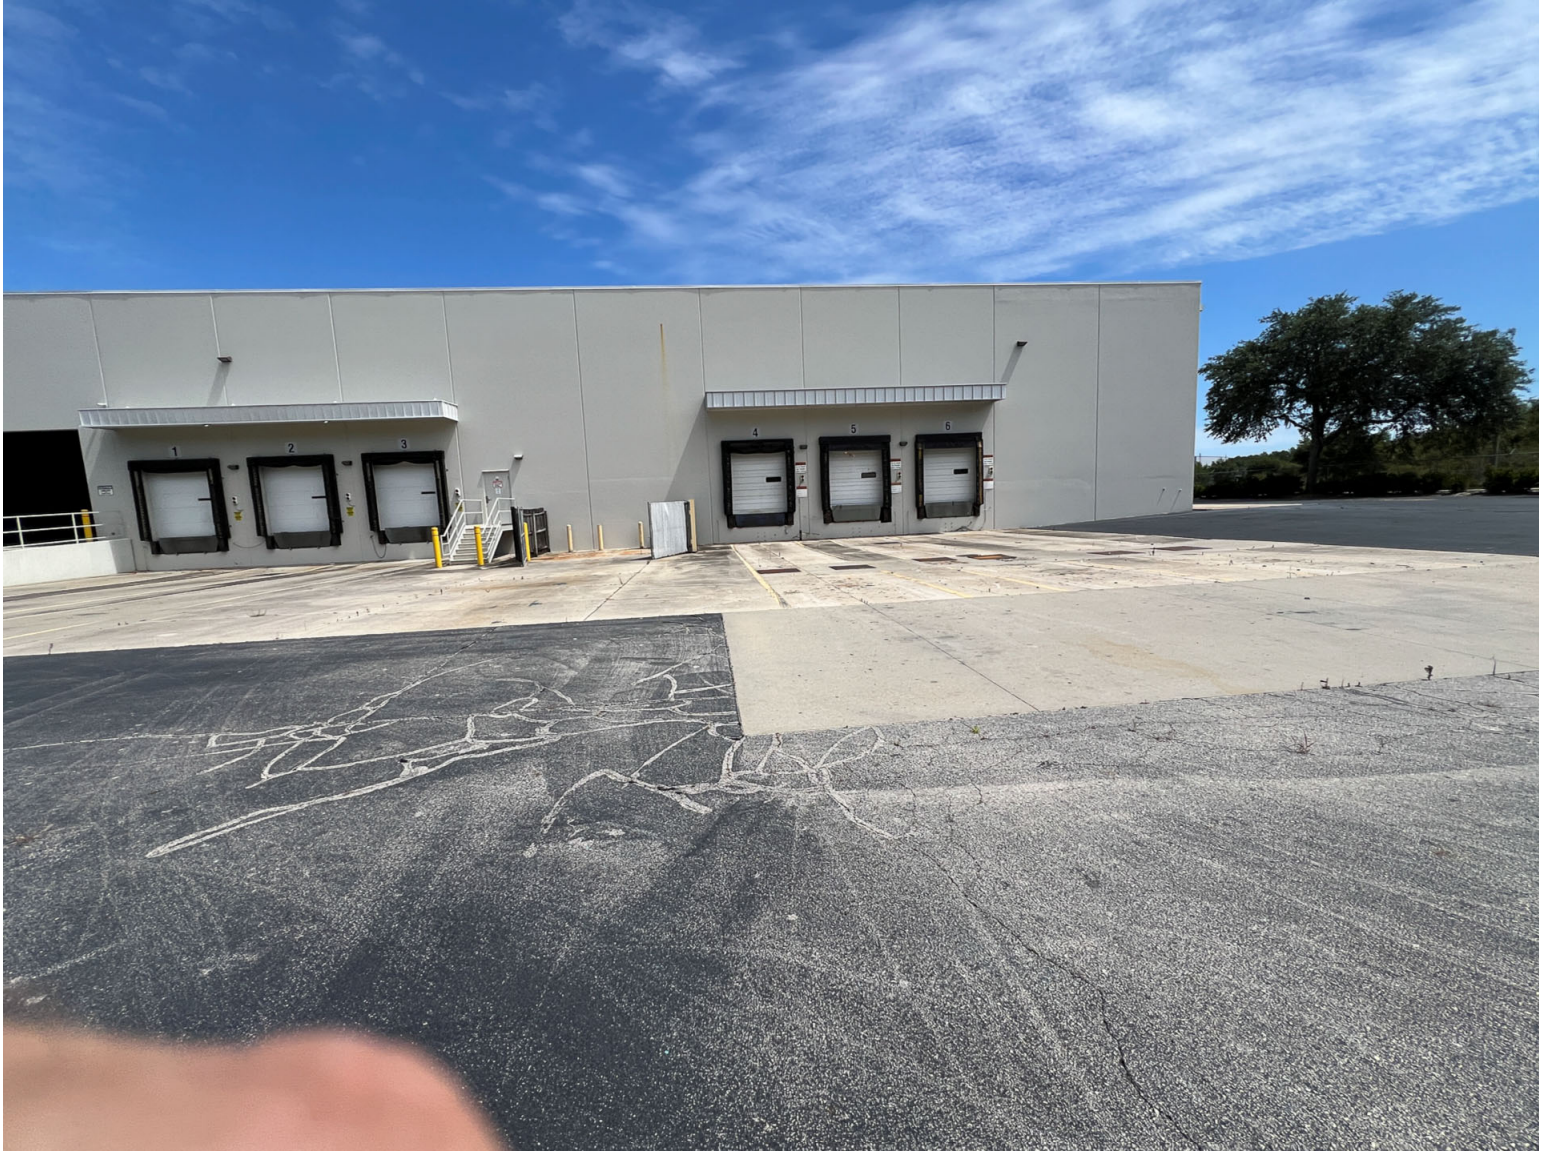
South elevation with two groups of (3) service doors, asphalt paving requires maintenance due to heavy duty semi-truck maneuvering

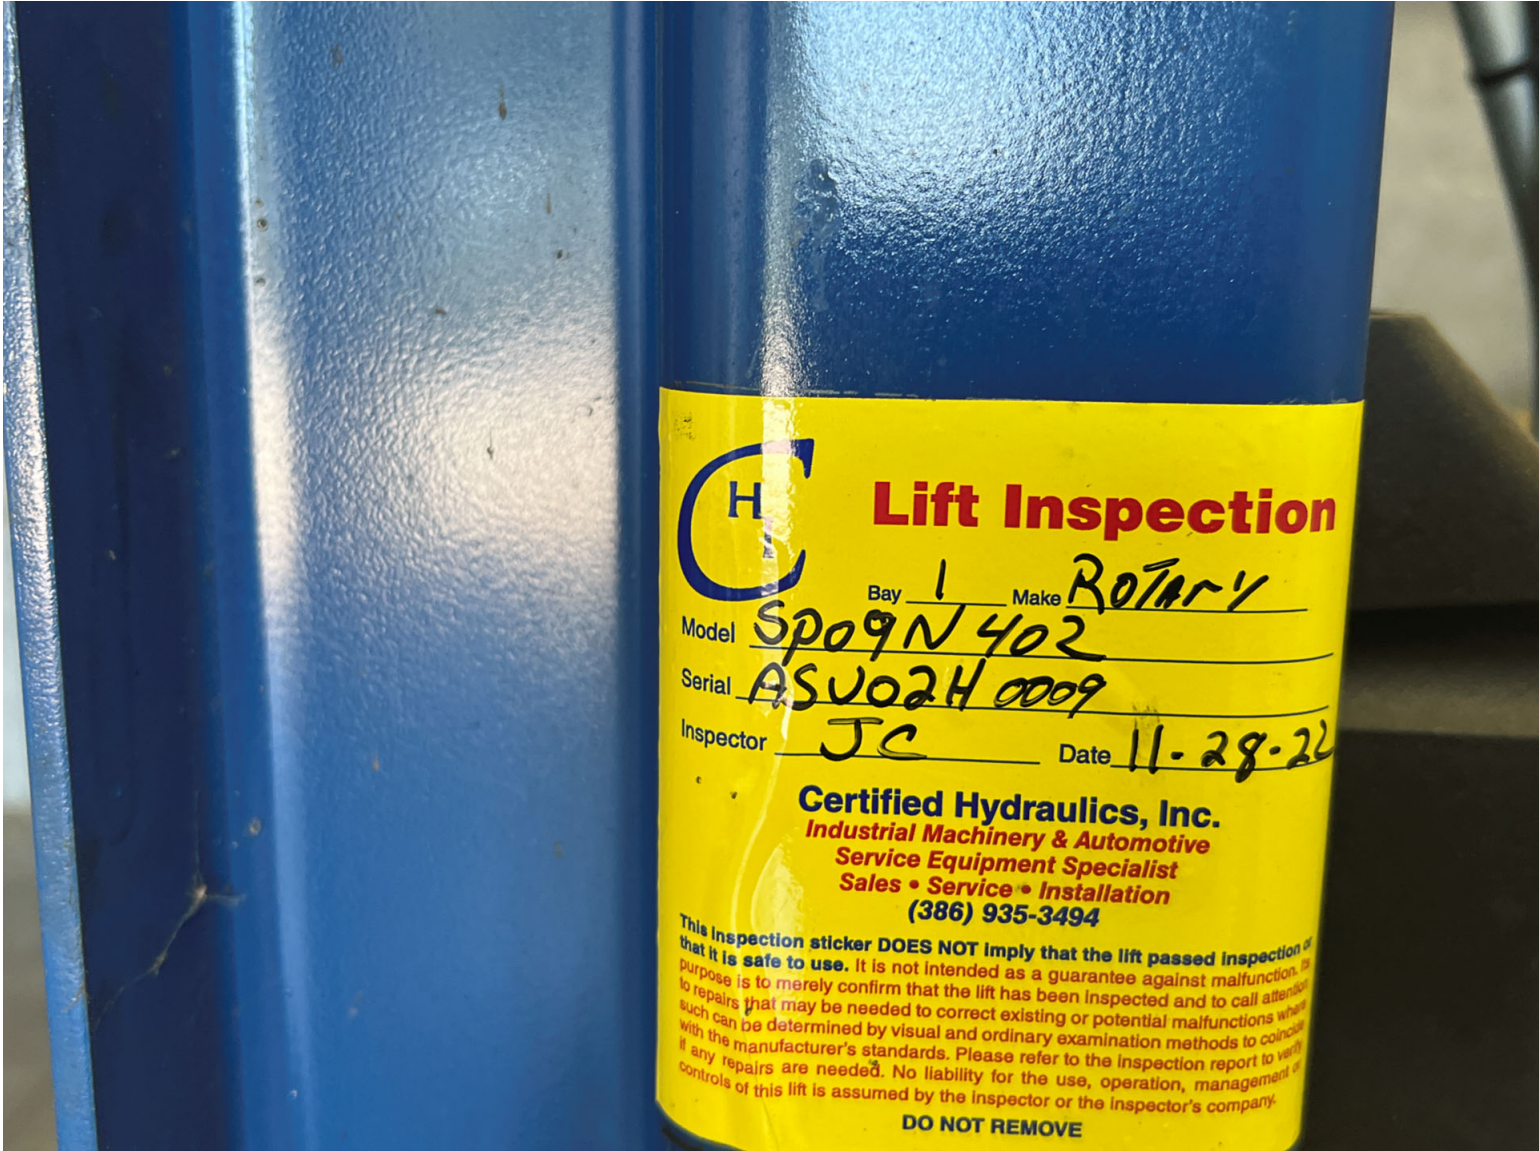
Vertical lift

Maintenance / service building vertical lift information
