RE: Due Diligence Report – Burkhardt Sales & Service

As part of the County's due diligence efforts to evaluate the conditions of the existing commercial industrial warehouse building (Burkhardt Sales & Service) located at 6125 NW 18<sup>th</sup> Drive, Gainesville, FL 32653, Paul Stresing Associates (PSA) was tasked with conducting an inspection of the facility to evaluate its condition prior to entering into a full purchase agreement to its purchase. On May 30, 2024, I was accompanied by KPI Engineering (KPI) where we walked the roof and interior of the facility with Mr. Matt Fultz of the Alachua County Facilities Department and Mr. Daniel Burkhardt, representing the seller where we gained access to the site and buildings to begin our evaluation efforts.

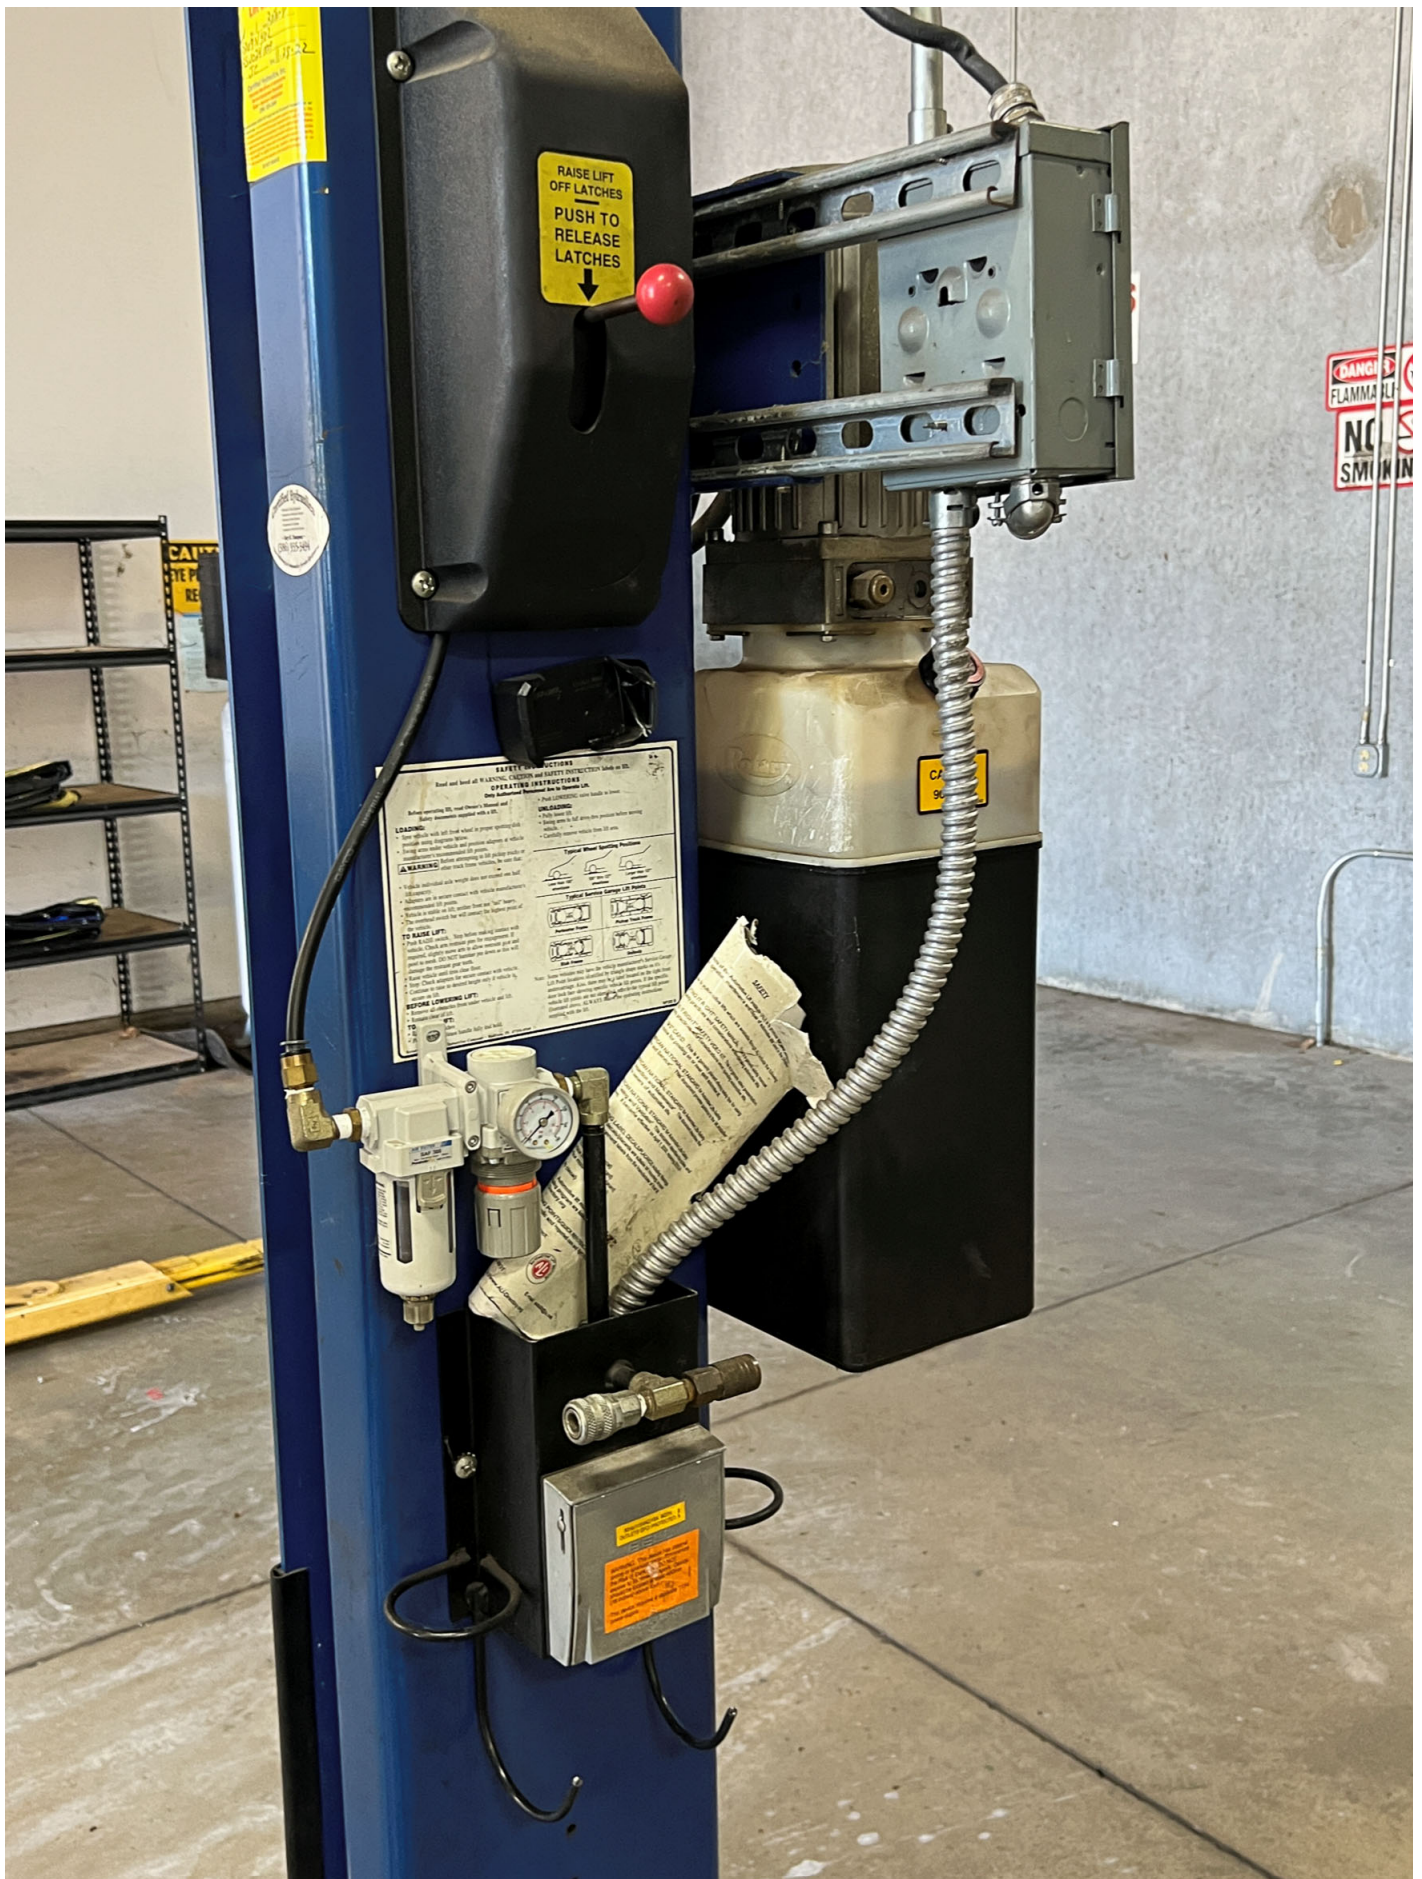
Maintenance / service building vertical lift information
